**MINERALS PROGRAM INSPECTION REPORT**  
**PHONE: (303) 866-3567**

| <b>MINE NAME:</b><br>Schwartzwalder Mine | <b>MINE/PROSPECTING ID#:</b><br>M-1977-300 | <b>MINERAL:</b><br>Uranium | <b>COUNTY:</b><br>Jefferson |
| <b>INSPECTION TYPE:</b><br>Monitoring | <b>WEATHER:</b><br>Clear | <b>INSP. DATE:</b><br>November 10, 2022 | <b>INSP. TIME:</b><br>13:00 |

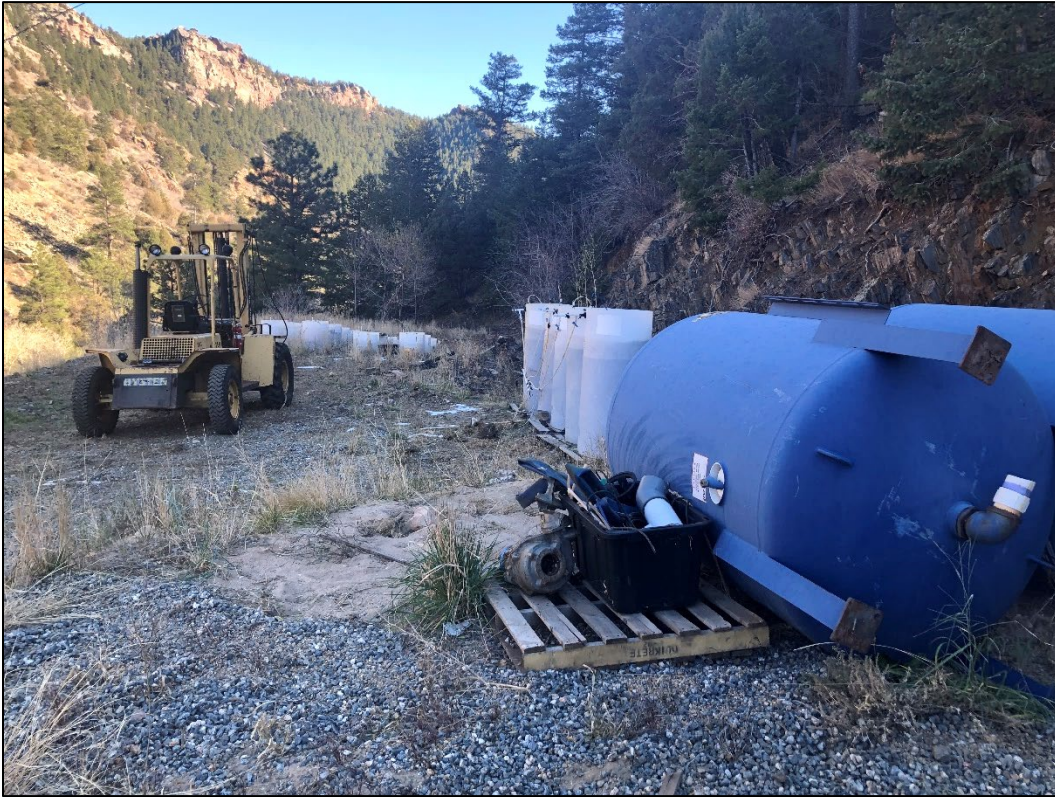
**Photo 1.** View looking southeast at eastern portion of top of mesa, showing materials to be removed for reclamation. Most of these materials were used in the wetland study that has concluded.

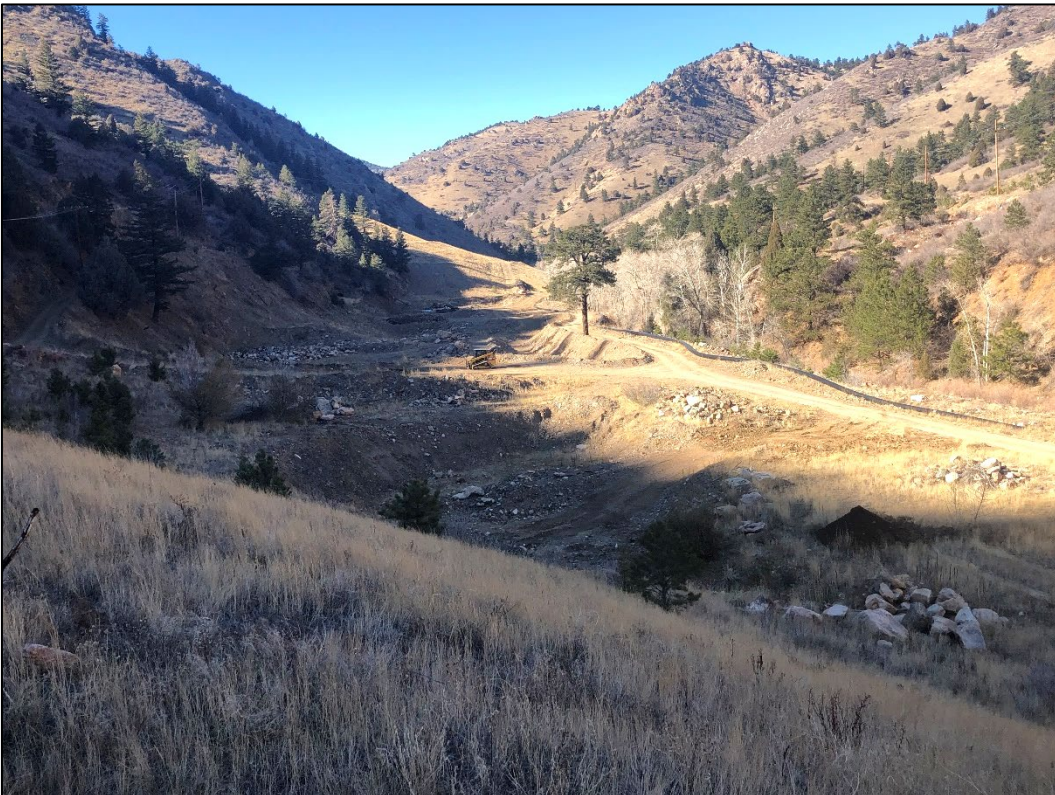
**Photo 2.** View looking northwest across valley from top of mesa, showing areas excavated for the alluvial valley excavation project.

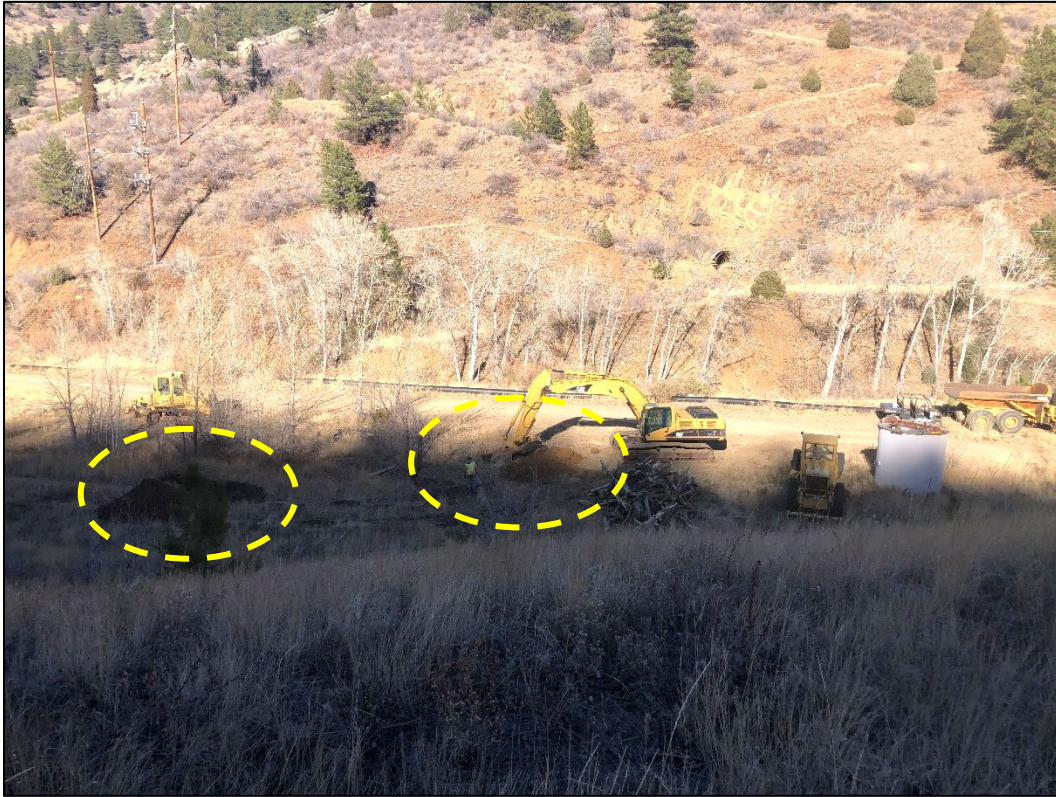
The operator has dug three additional soil test pits in the valley south of the creek, near the base of the mesa. These test pits indicate more usable soils may be present in this area, compared with the area north of the creek.

**Photo 3.** View looking north across valley from top of mesa, showing soil test pits (circled) being excavated near base of mesa during inspection.

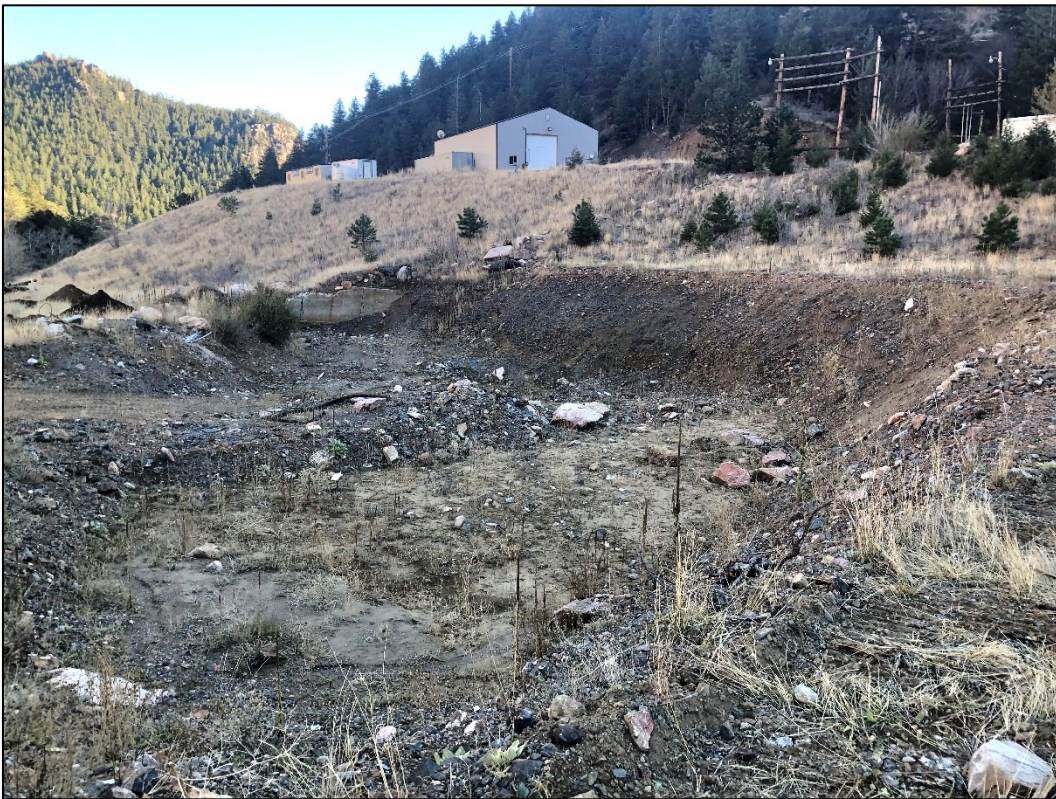
**Photo 4.** View looking southeast across central excavation area in valley. Note water treatment plant located at top of mesa (in background).

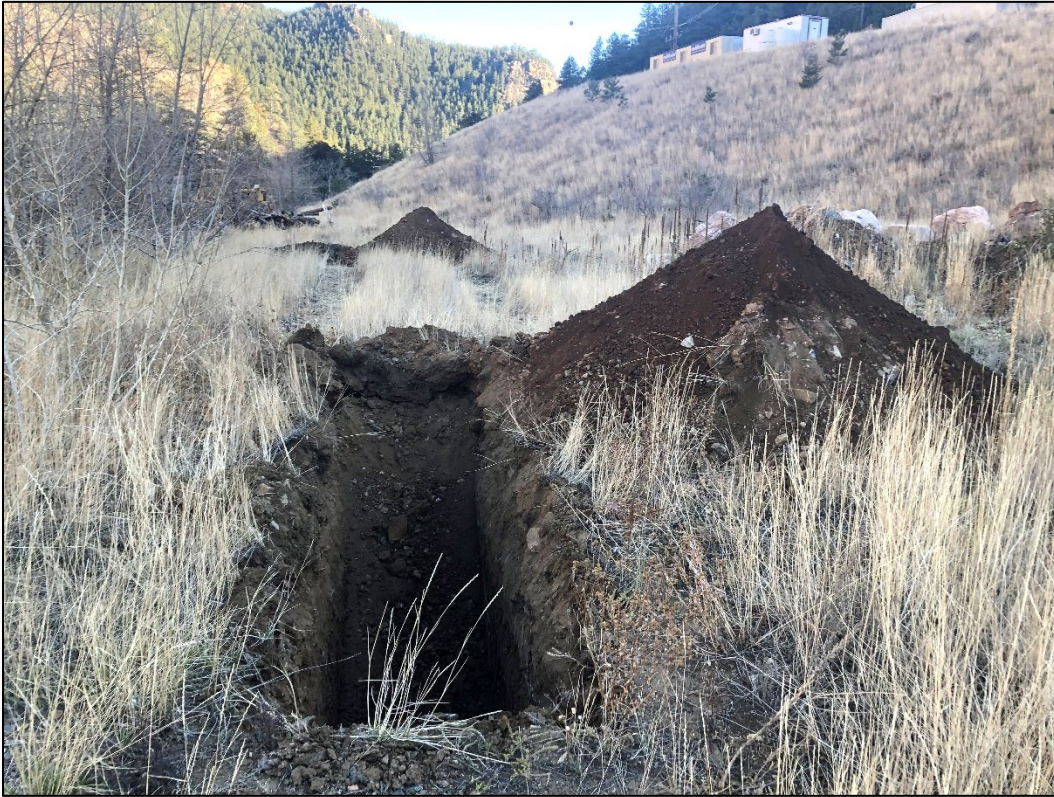
**Photo 5.** View looking southeast at westernmost soil test pit excavated near base of mesa.

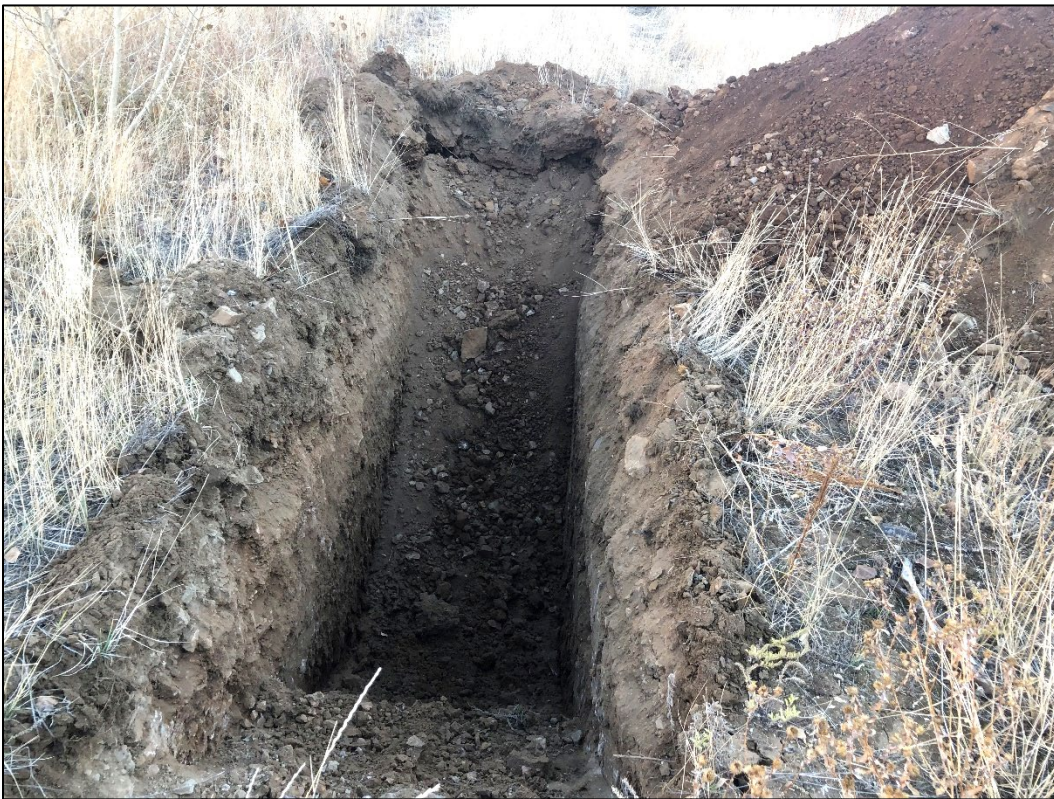
**Photo 6.** Closer view of westernmost soil test pit excavated near base of mesa.

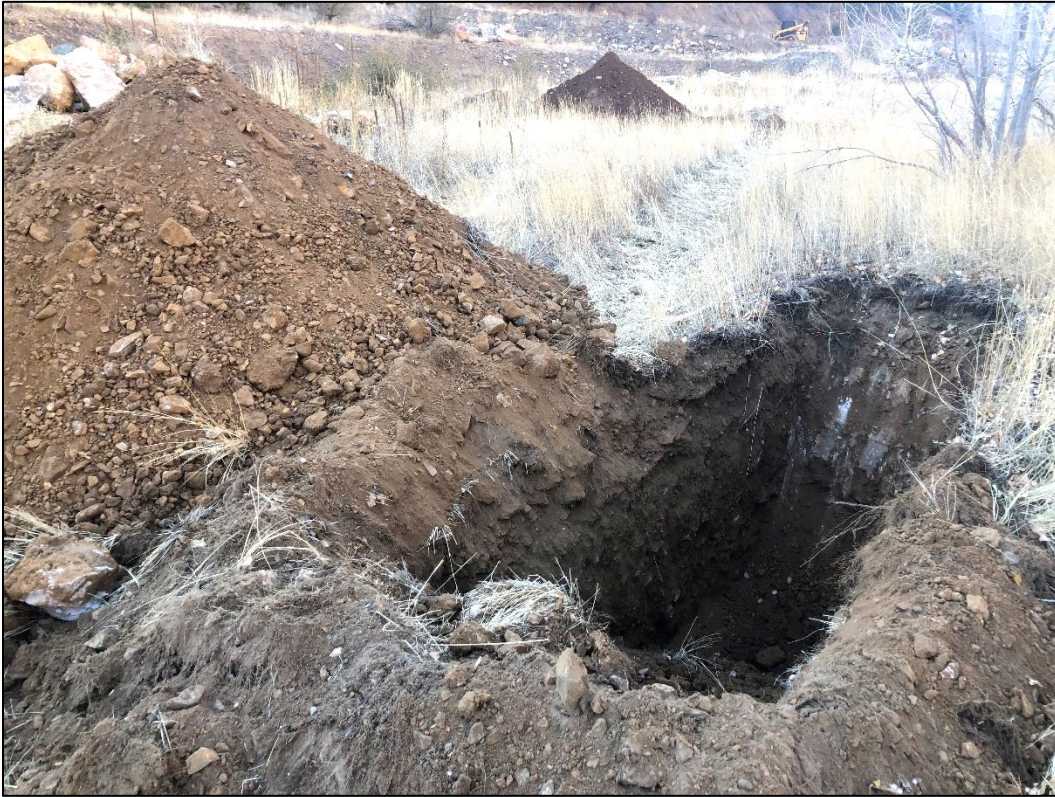
**Photo 7.** View looking northwest at center soil test pit excavated near base of mesa.

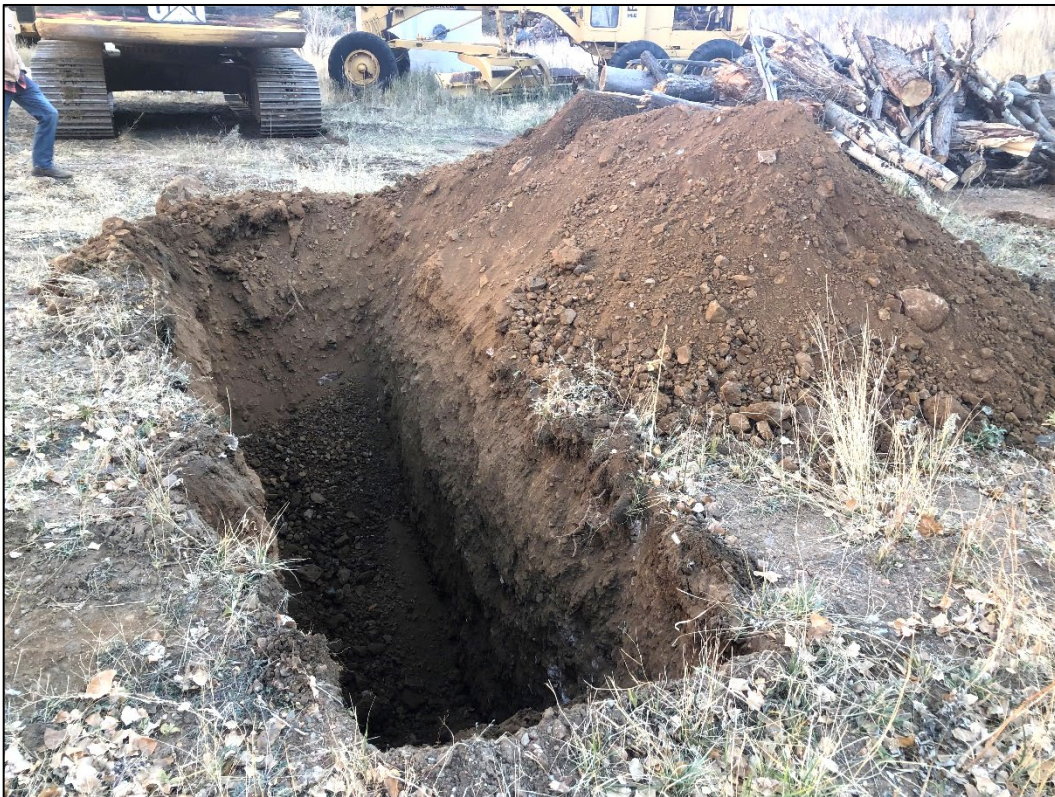
**Photo 8.** View looking southeast at easternmost soil test pit excavated near base of mesa.

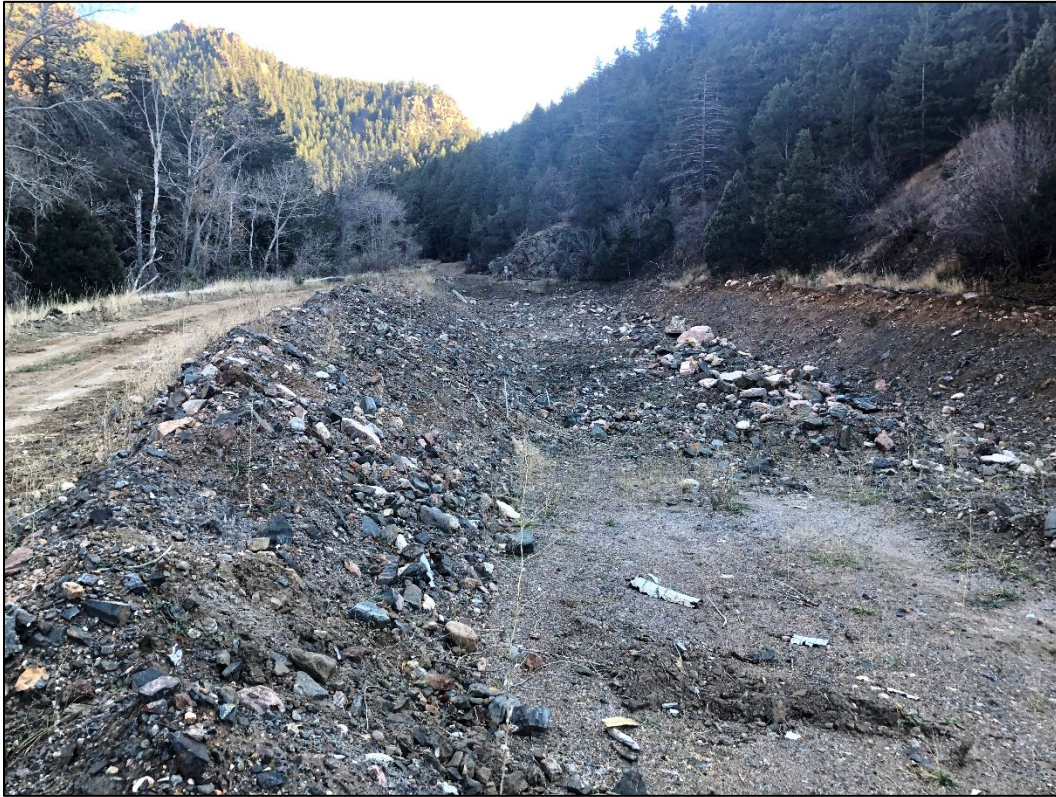
**Photo 9.** View looking southeast across southern excavation area in valley. The adjacent access road will need to be temporarily relocated in order to complete excavation in this area.

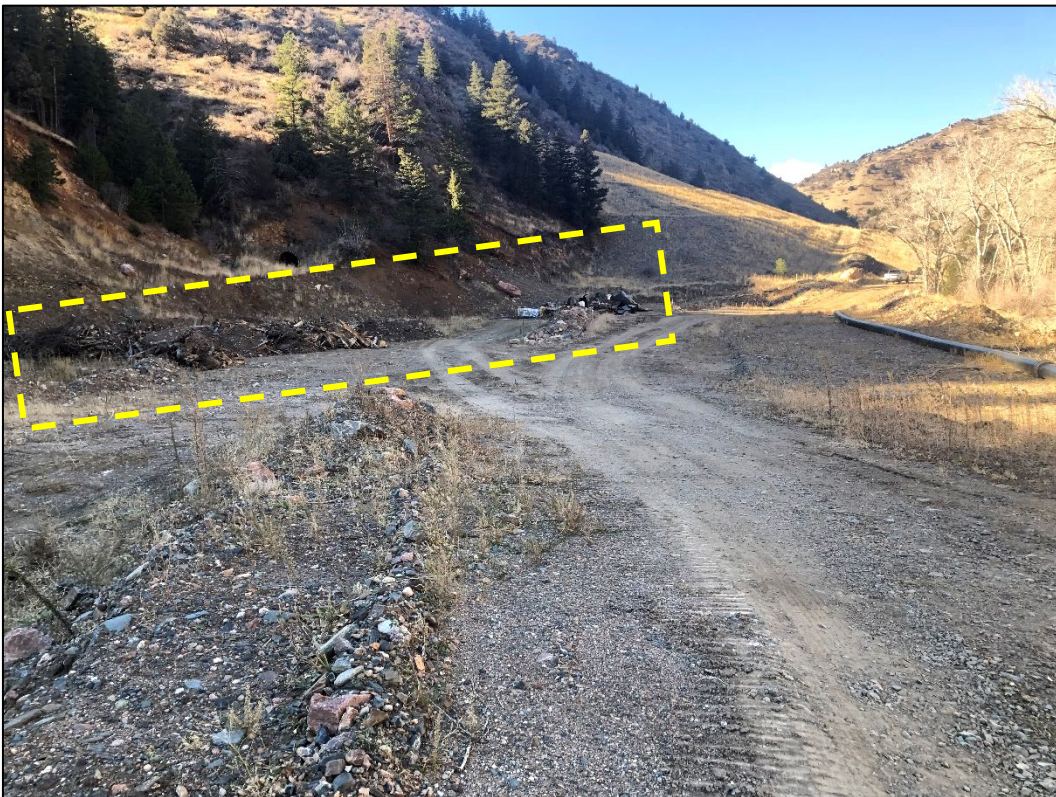
Excess organic materials (unable to be chipped), large rocks, and scrap metal are currently stored in separate piles along the southern canyon wall, near the Black Forest Mine. During the inspection, the operator mentioned possibly backfilling over at least some of these materials during construction of the SWRP extension. The large rocks may be placed on the surface after backfilling and recontouring, which would imitate natural conditions in the surrounding areas. The operator should be advised, the inclusion of scrap metal (or any other refuse) into the SWRP extension is not part of the approved plan. Additionally, the inclusion of this material into an Environmental Protection Facility (EPF), such as the SWRP, is not appropriate. Any scrap metal or other refuse will need to be disposed of off-site.

**Photo 10.** View looking northwest across northern excavation area in valley. Note materials (indicated; described in report) stored against southern canyon wall in area where SWRP extension will be constructed (near Black Forest Mine).

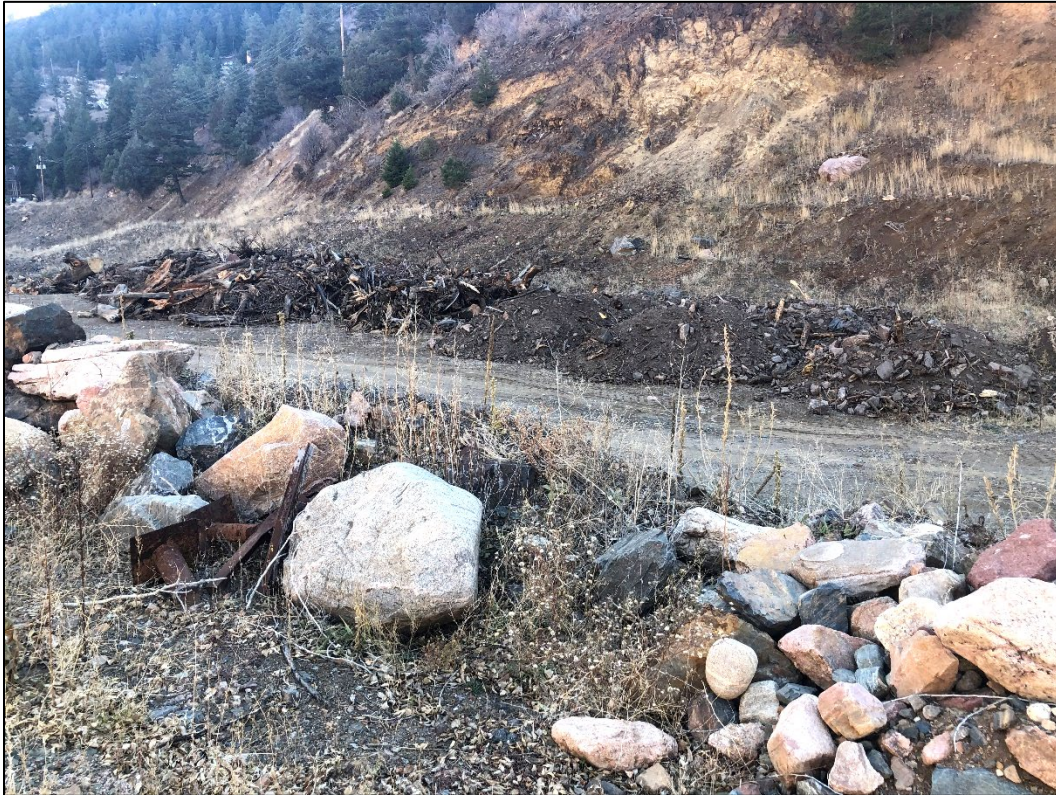
**Photo 11.** View looking south, showing closer view of organic materials (in background) and large rocks (in foreground) stored against southern canyon wall.

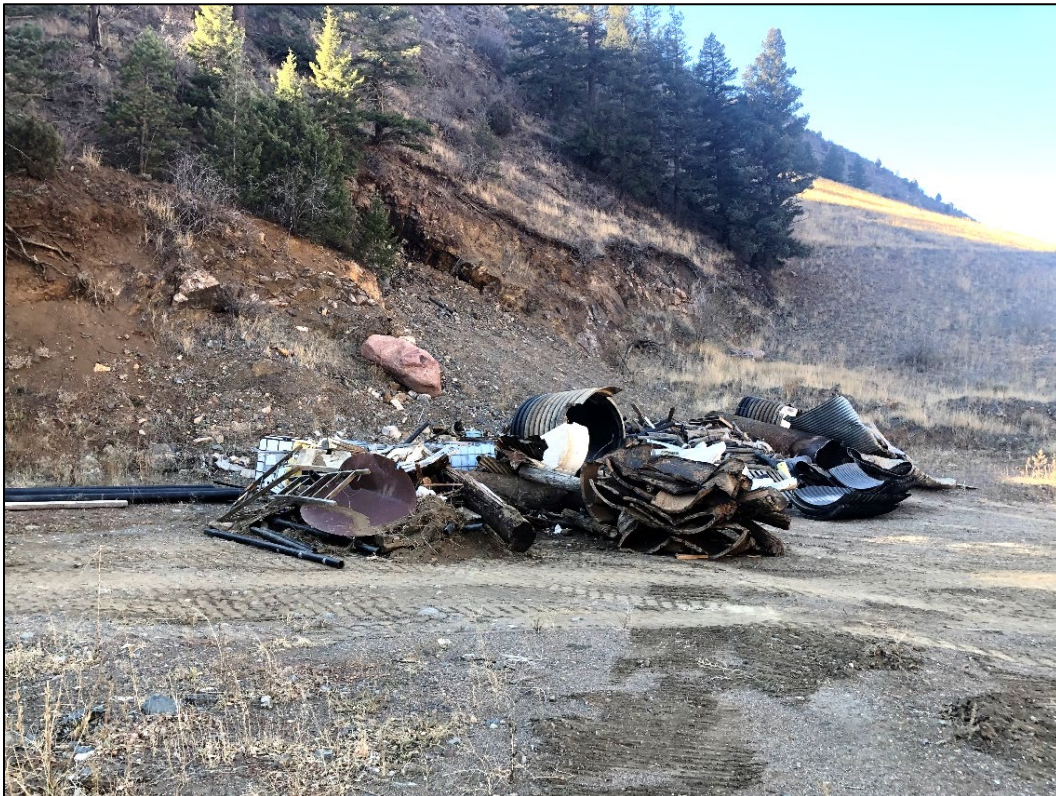
**Photo 12.** View looking northwest, showing closer view of scrap metal stored against southern canyon wall (near Black Forest Mine). The operator is not authorized to include scrap metal in the SWRP extension.

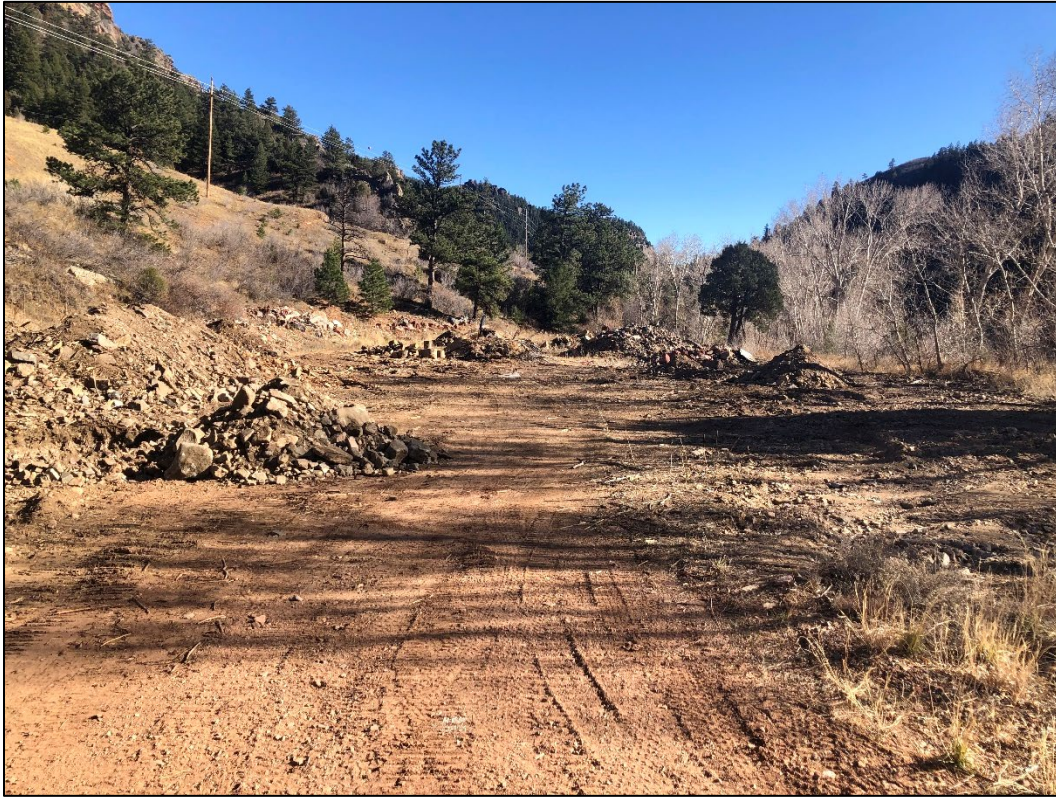
Current activities at the site include the removal of refuse and unused equipment and the excavation of soil test pits to determine whether sufficient growth medium exists on site for use in reclamation. In the staging area located north of the creek, the operator has removed the rest of the old equipment and empty storage containers that were stored in this area. All that exists in this area now are piles of rock (which can be used for riprap), a few small slash piles, a wood chipper, and a pile of wood mulch (which can be used for revegetation). Additionally, the operator has recently dug four soil test pits in this area. These test pits show a very rocky substrate is present in this area, with limited soils available for use as a growth medium.

**Photo 13.** View looking southeast across storage area located north of creek, showing old equipment and empty storage containers have been removed from this area.

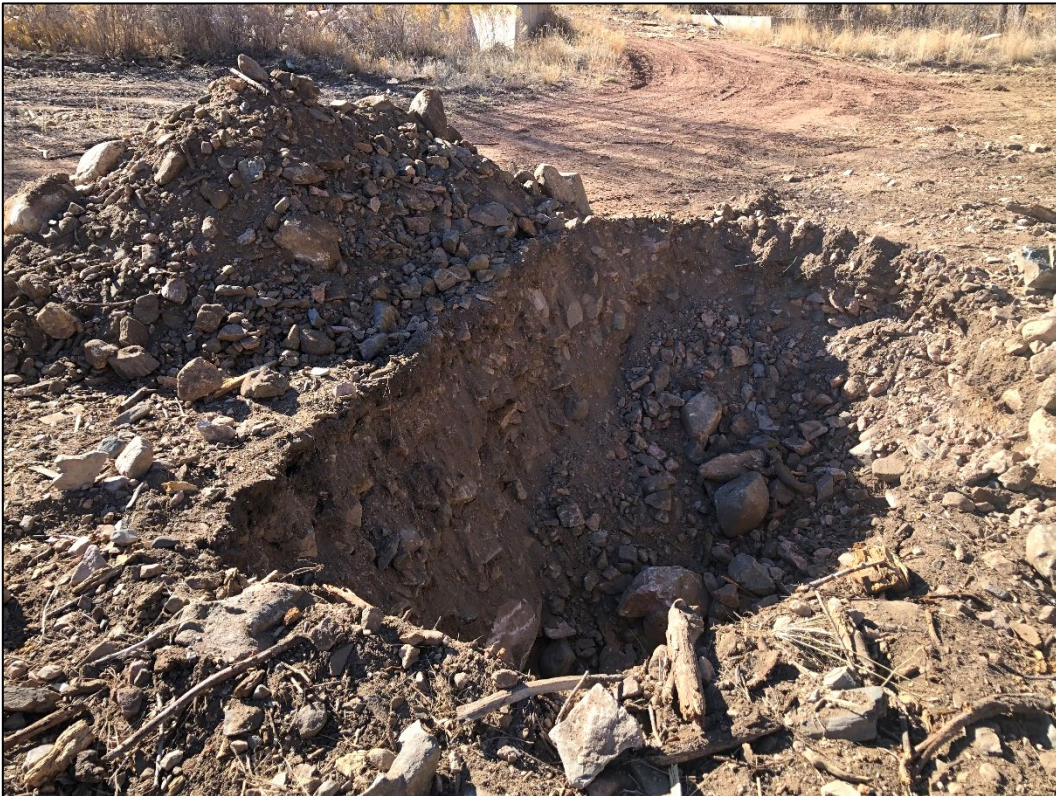
**Photo 14.** View looking northwest at westernmost soil test pit excavated in storage area located north of creek.

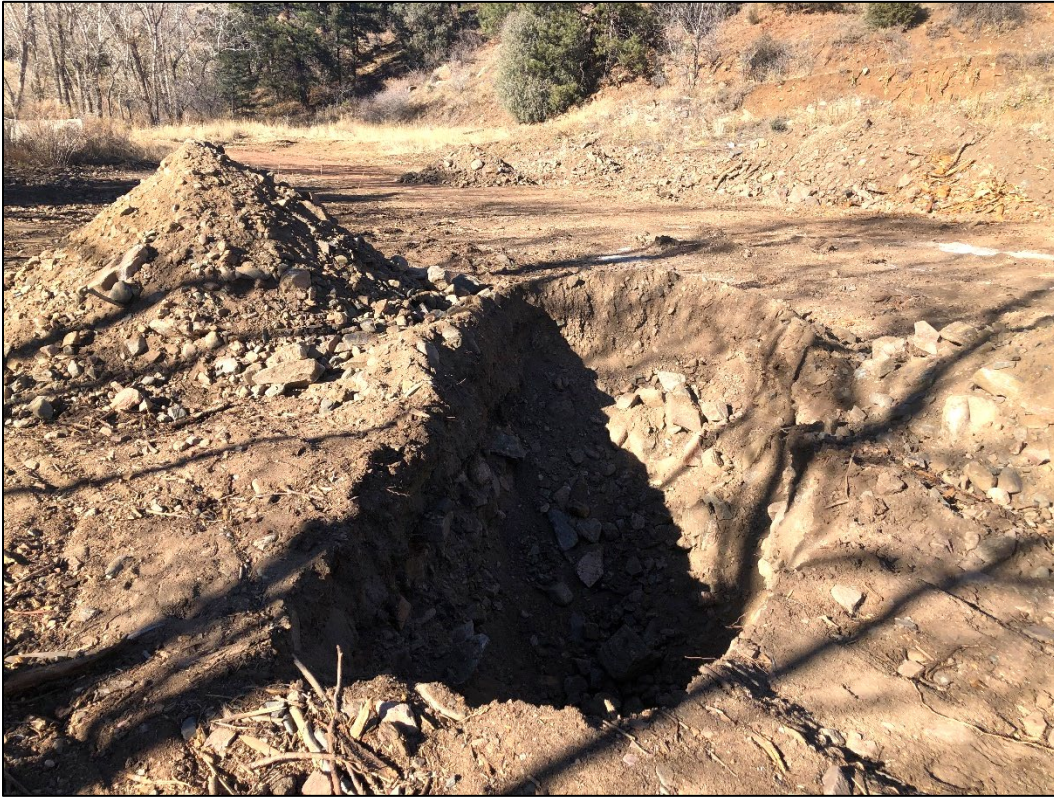
**Photo 15.** View looking northwest at 2<sup>nd</sup> soil test pit (from the west) excavated in storage area located north of creek.

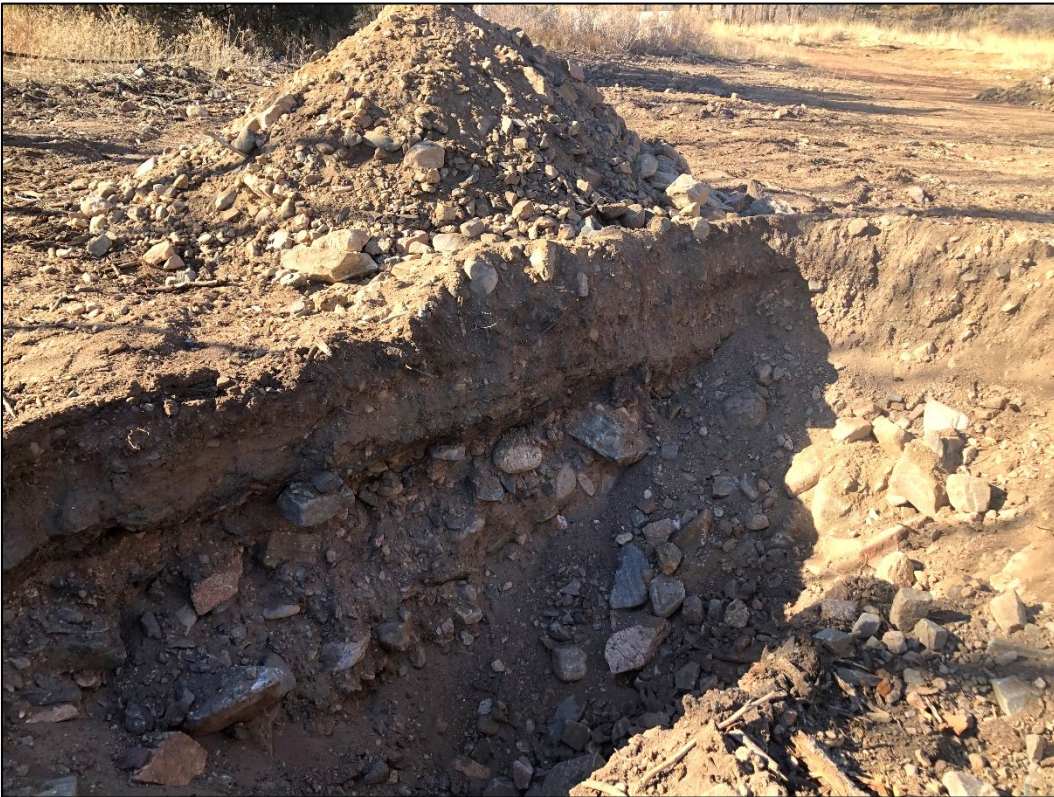
**Photo 16.** View looking northwest, showing closer view of 2<sup>nd</sup> soil test pit (from the west) excavated in storage area located north of creek.

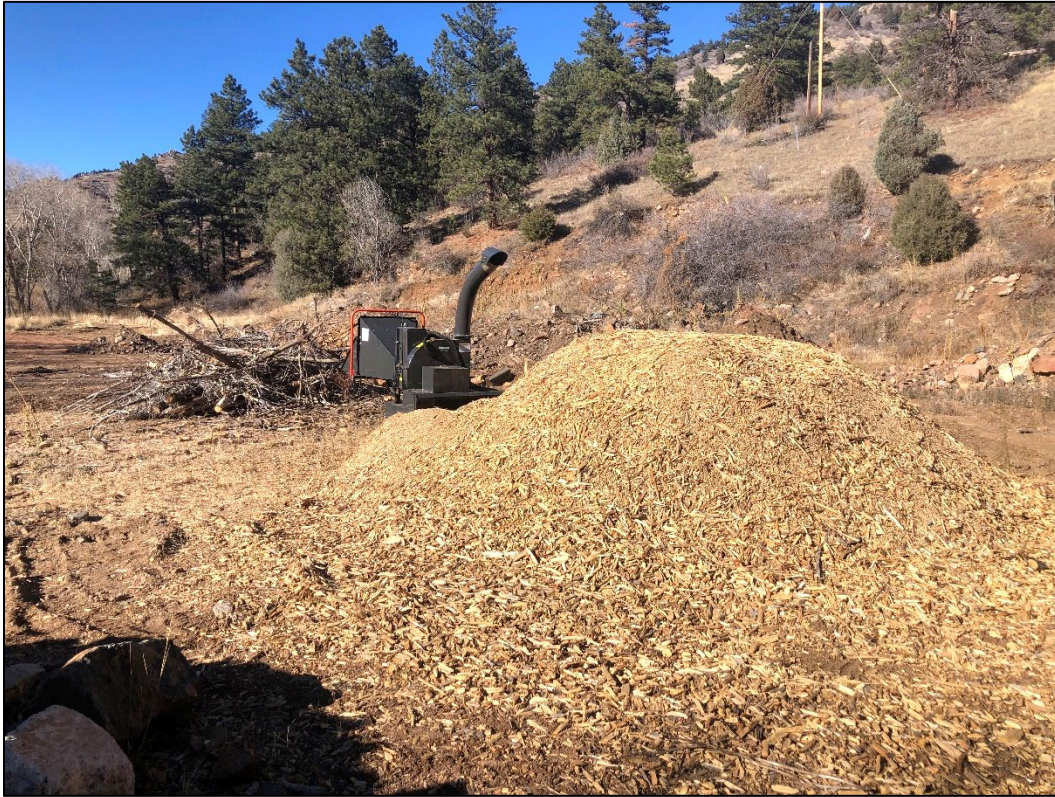
**Photo 17.** View looking northwest at wood chipper and mulch pile present in storage area located north of creek.

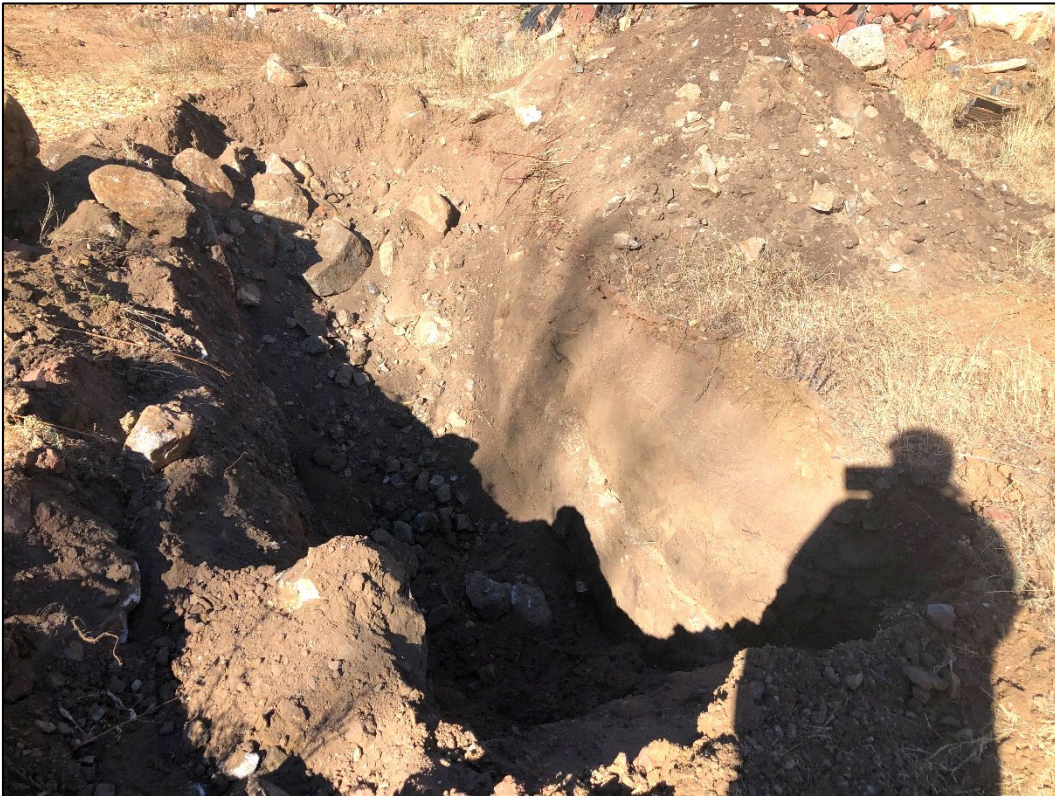
**Photo 18.** View looking north at 3<sup>rd</sup> soil test pit (from the west) excavated in storage area located north of creek.

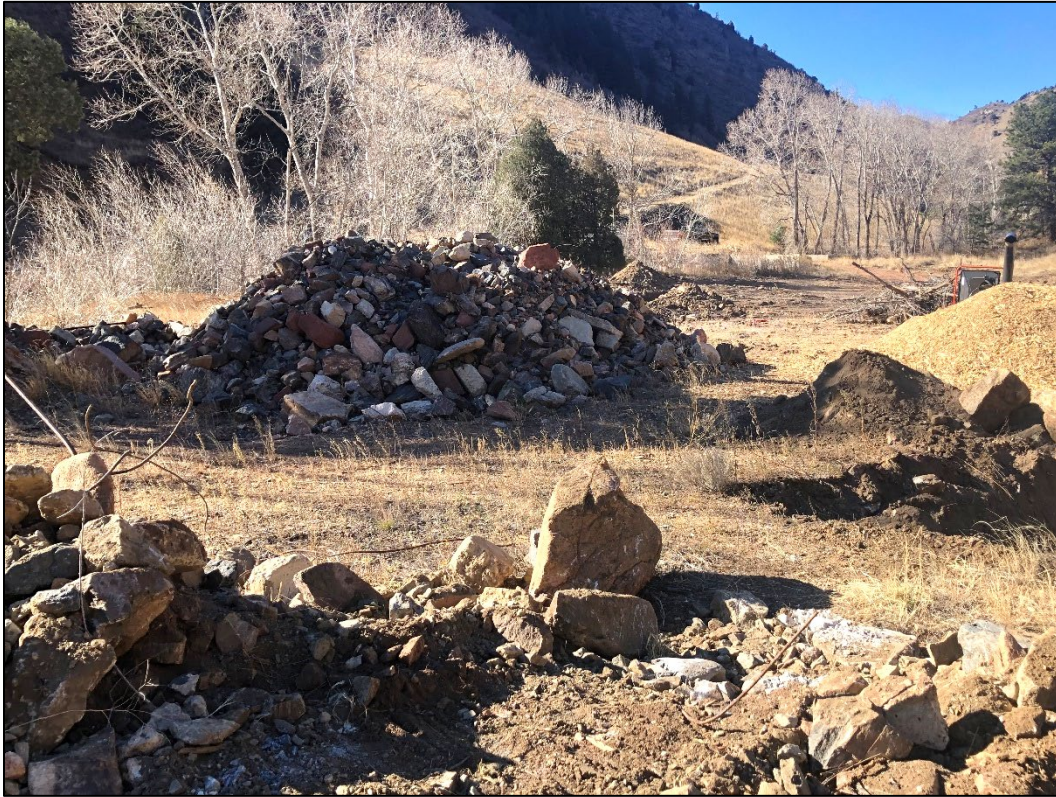
**Photo 19.** View looking northwest across storage area located north of creek, showing piles of rock stored in this area which could be used for riprap.

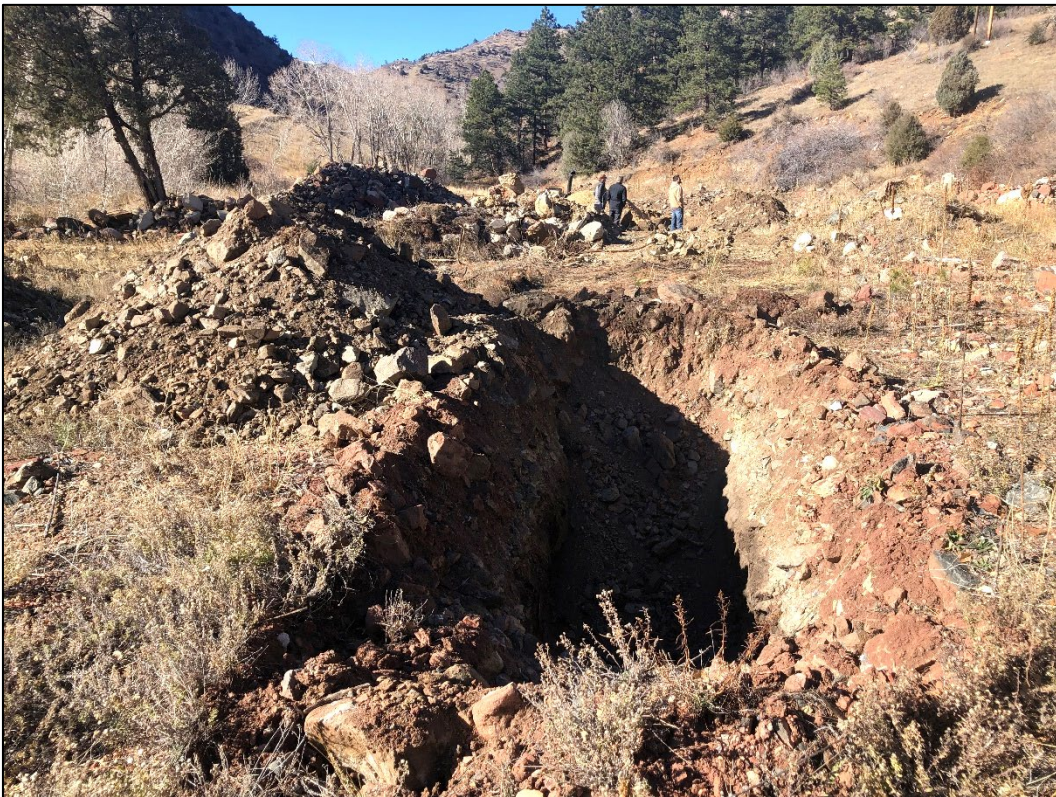
**Photo 20.** View looking northwest at 4<sup>th</sup> soil test pit (from the west) excavated in storage area located north of creek.
