**MINERALS PROGRAM INSPECTION REPORT**  
**PHONE: (303) 866-3567**

<b>MINE NAME:</b> Robinson Sons Gravel Pit No. 1	<b>MINE/PROSPECTING ID#:</b> M-2008-076	<b>MINERAL:</b> Sand and gravel and	<b>COUNTY:</b> Las Animas
<b>INSPECTION TYPE:</b> Monitoring	<b>WEATHER:</b> Clear	<b>INSP. DATE:</b> August 30, 2022	<b>INSP. TIME:</b> 10:00
<b>OPERATOR:</b> Robinson Sons Inc	<b>OPERATOR REPRESENTATIVE:</b>	<b>TYPE OF OPERATION:</b> 112c - Construction Regular Operation	
<b>REASON FOR INSPECTION:</b> Normal I&E Program	<b>BOND CALCULATION TYPE:</b> Partial Bond	<b>BOND AMOUNT:</b> \$52,815.00	
<b>DATE OF COMPLAINT:</b> NA	<b>POST INSP. CONTACTS:</b> None	<b>JOINT INSP. AGENCY:</b> None	
<b>INSPECTOR(S):</b> Peter Hays	<b>INSPECTOR'S SIGNATURE:</b>

August 30, 2022 Inspection Map

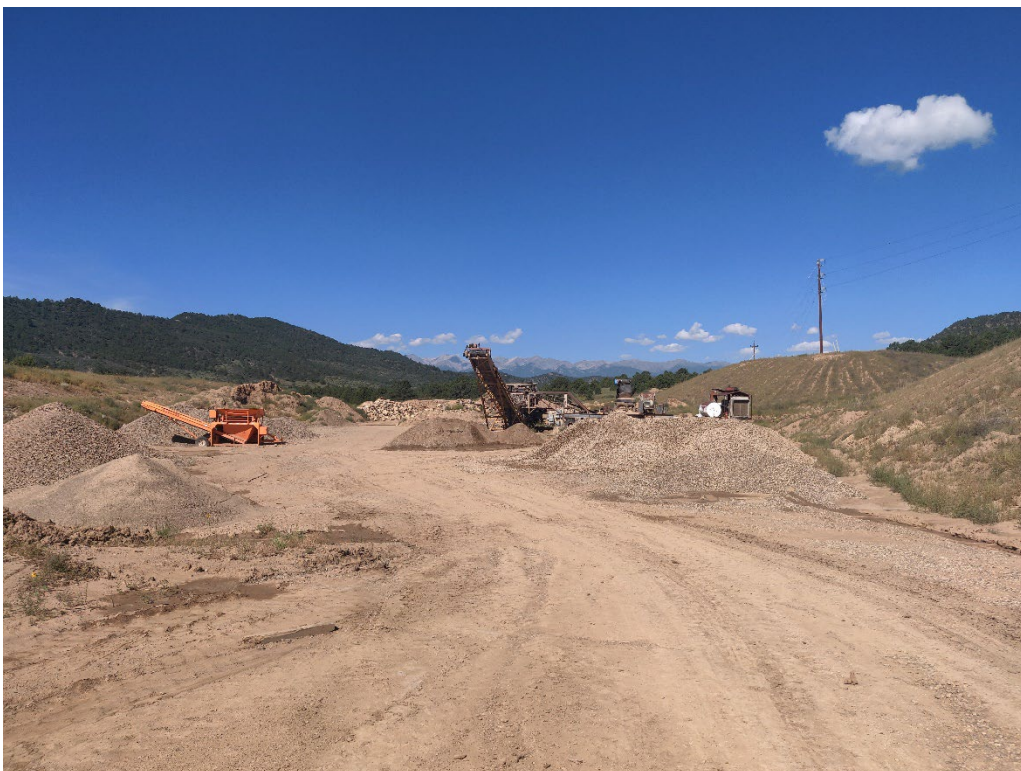
View of the Area 1 disturbance in the southwest corner of the area looking west

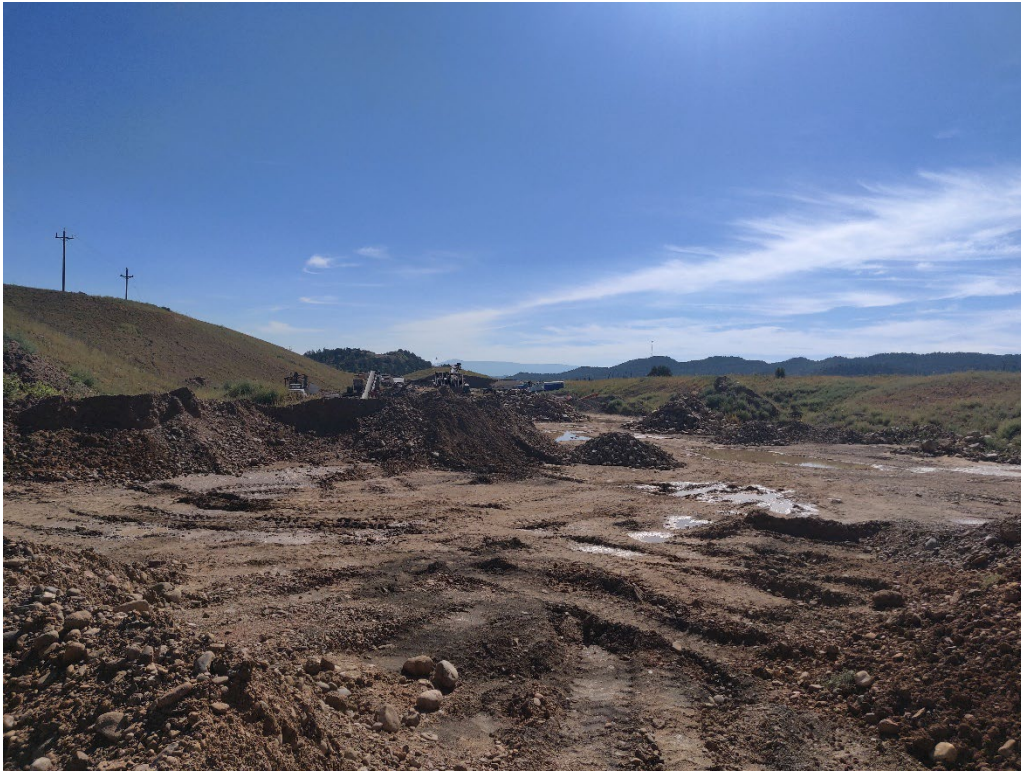
View of the Area 1 disturbance in the southwest corner of the area looking east

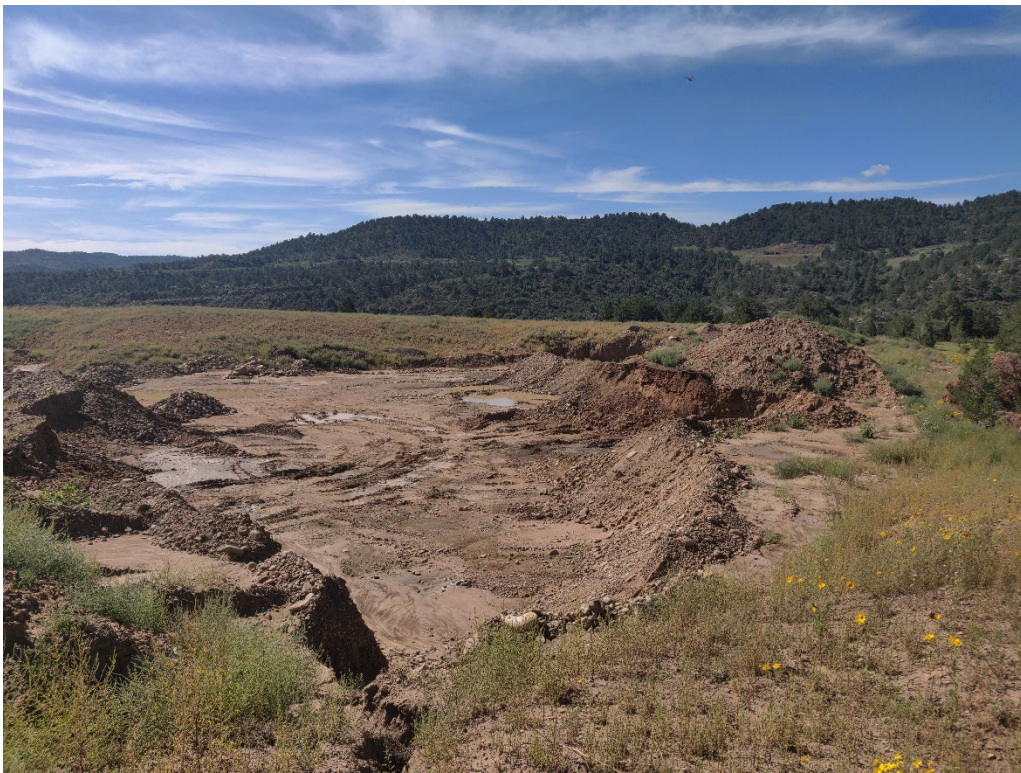
View of the highwall located in the southwest corner of Area 1 from the north side looking south

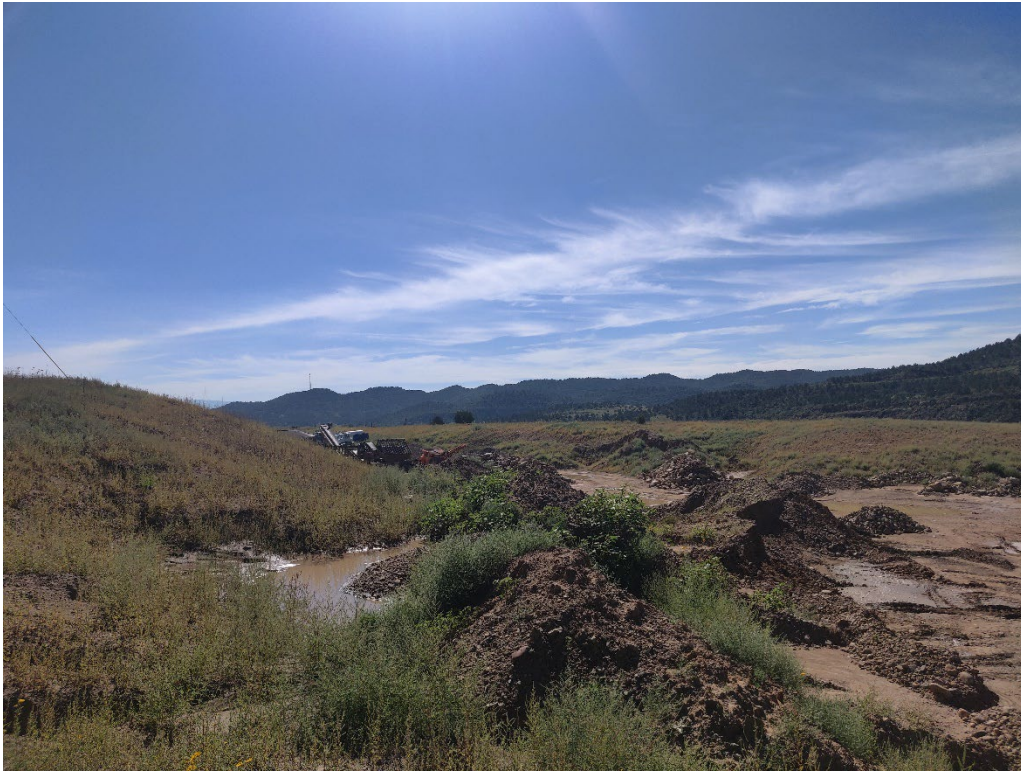
View of the Area 1 disturbance in the southwest corner of the area looking southeast

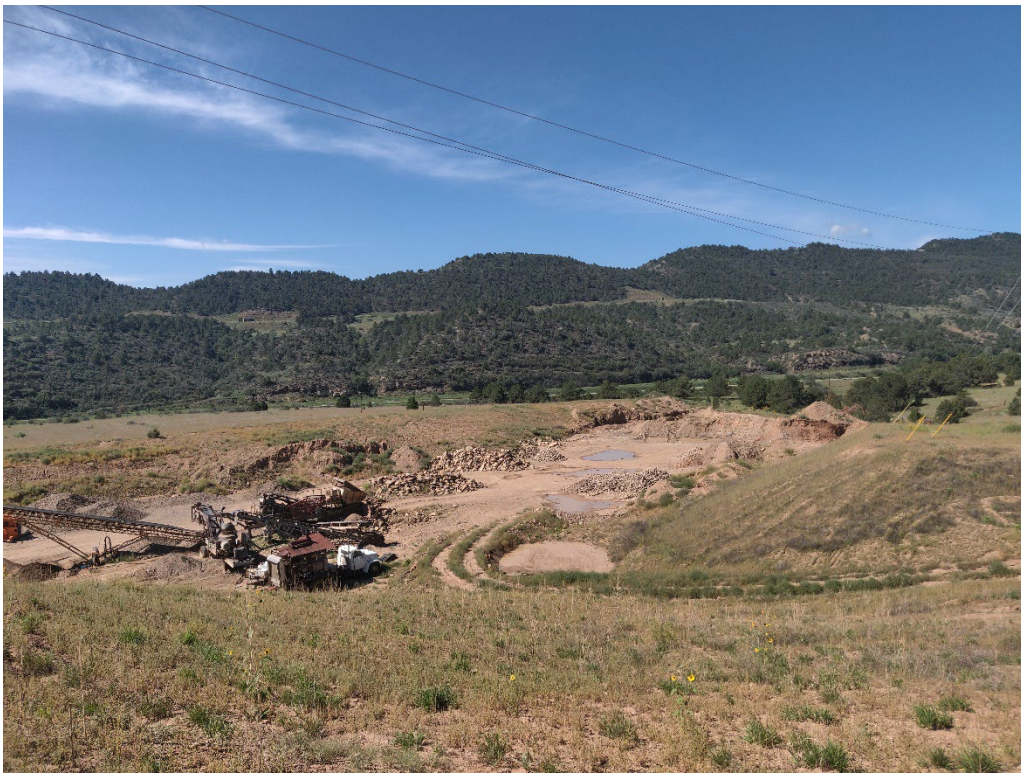
View of the Area 1 disturbance in the southwest corner of the area looking southwest

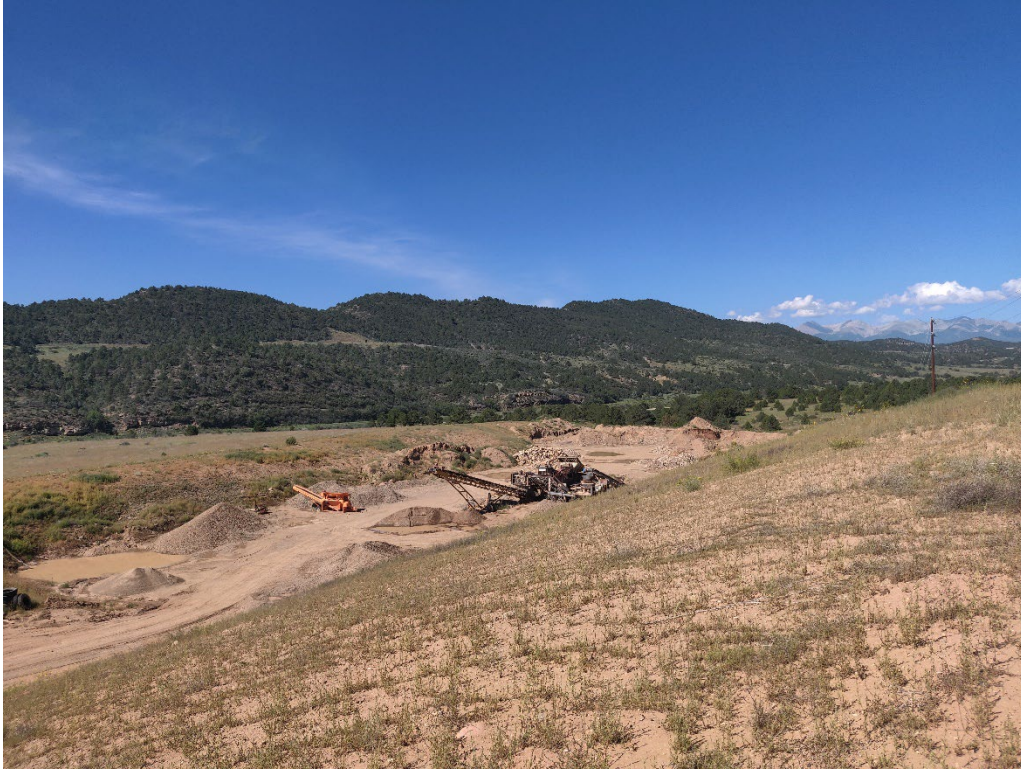
View of the Area 1 disturbance in the southwest corner of the area looking southwest

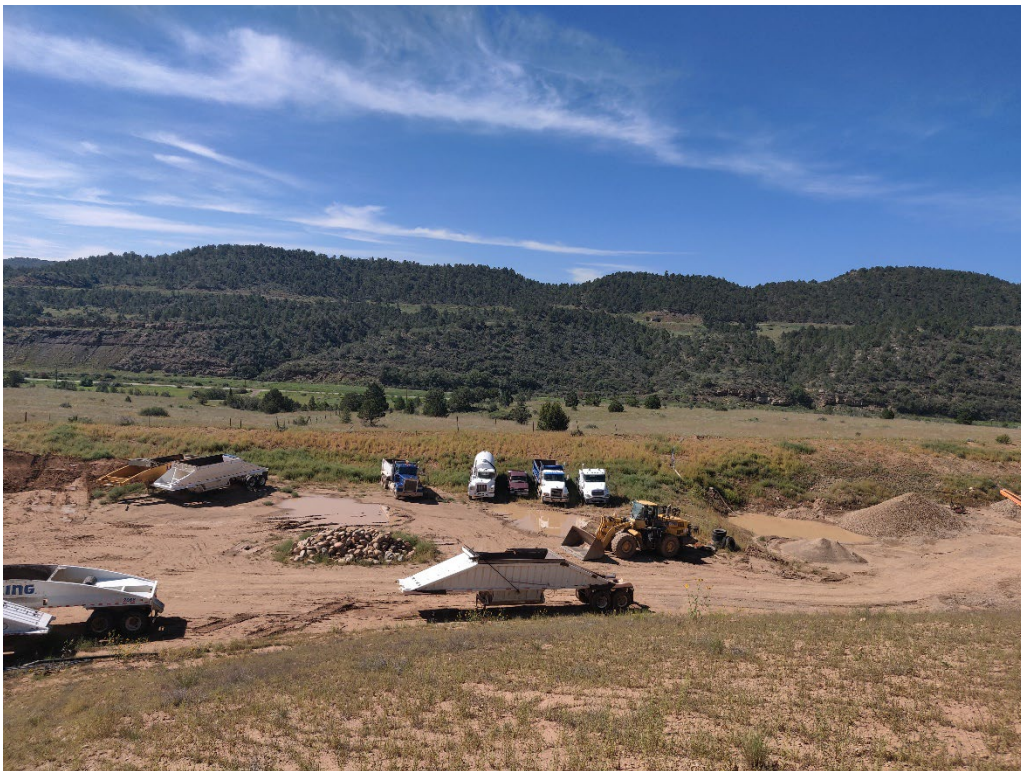
View of the Area 1 equipment storage area looking south

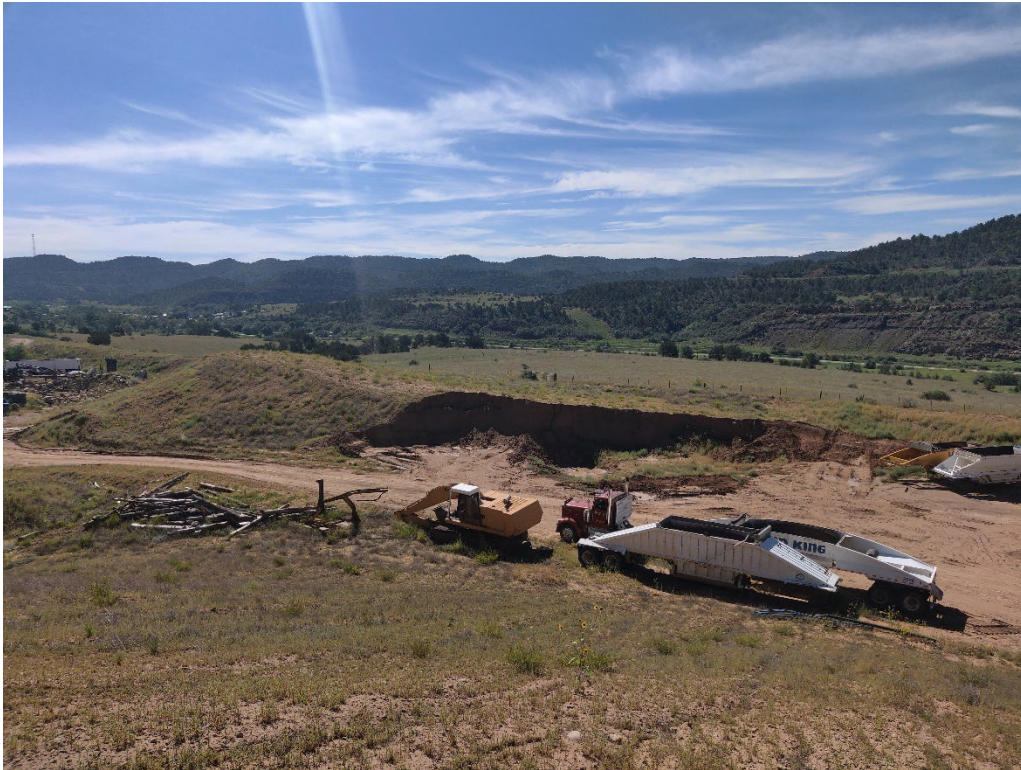
View of the Area 1 equipment storage area and highwall looking southeast

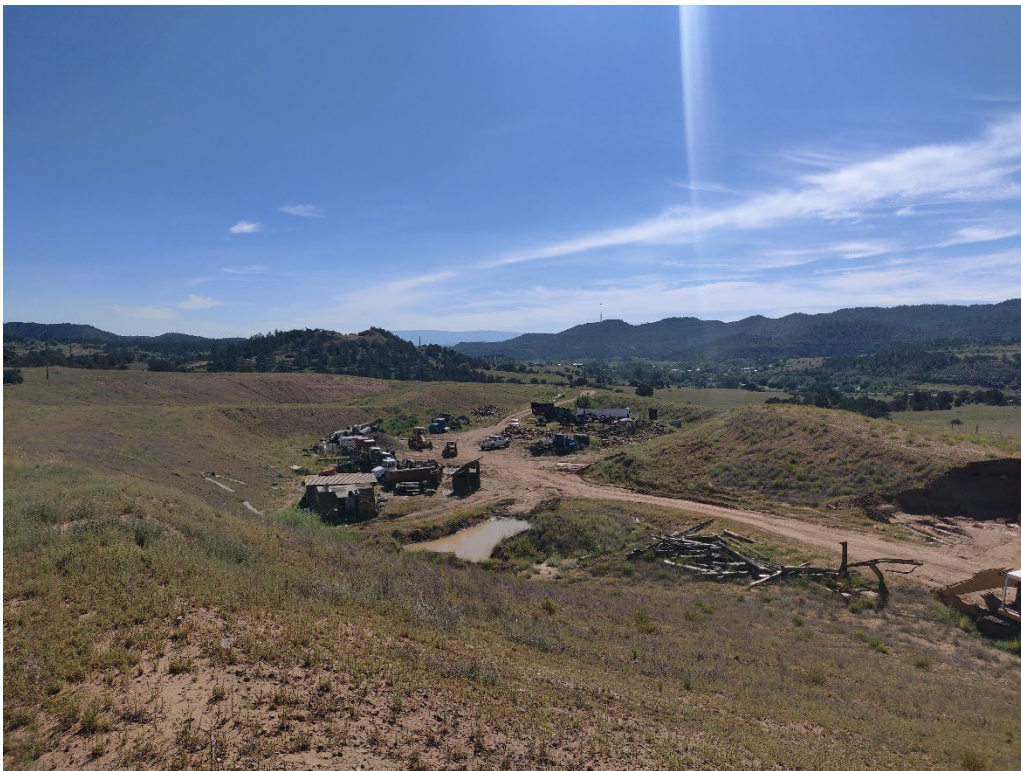
View of the Area 1 equipment storage area and highwall looking east

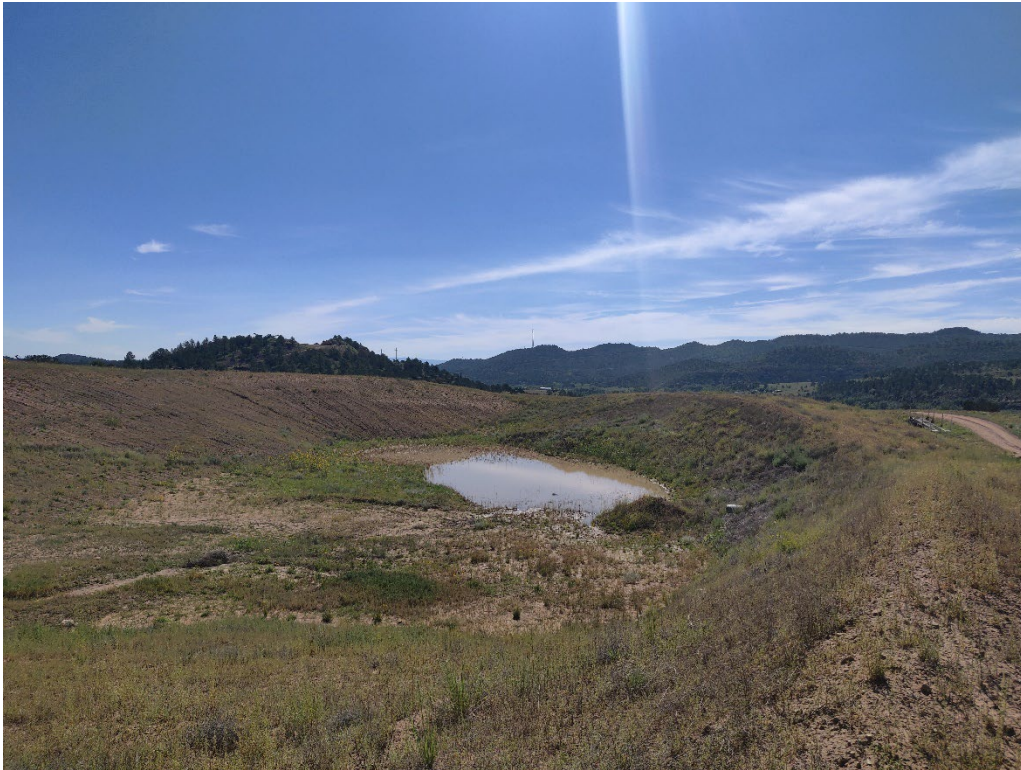
View of the water impoundment area located in the eastern portion of Area 1

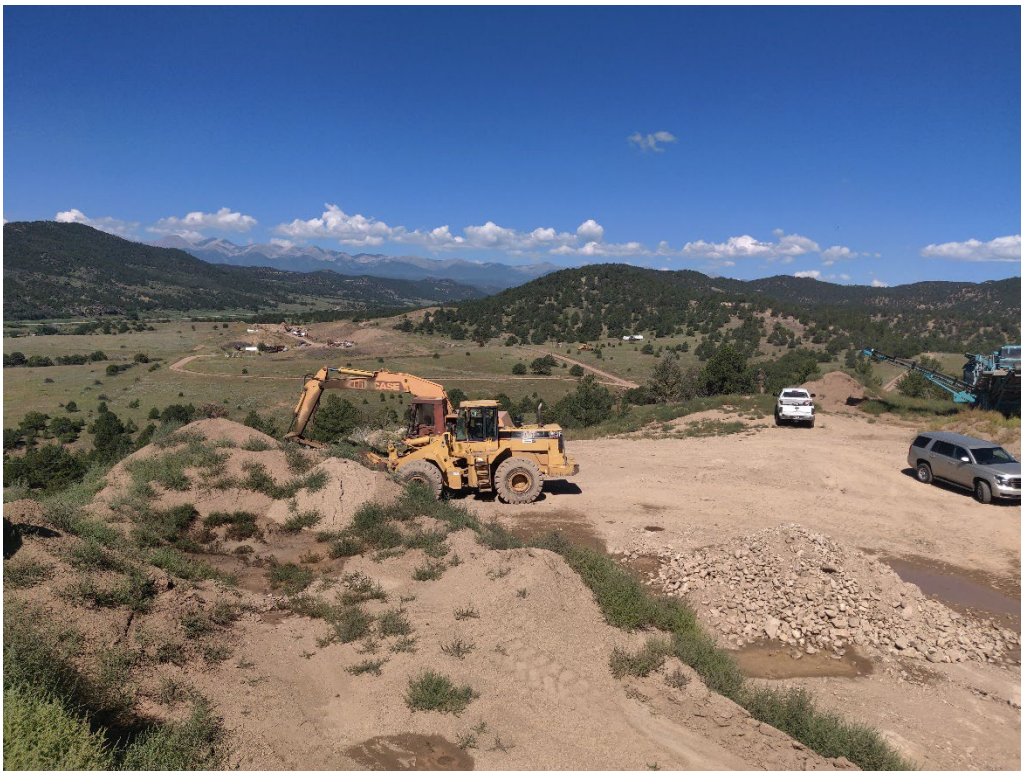
View of Area 2 from the highwall looking west

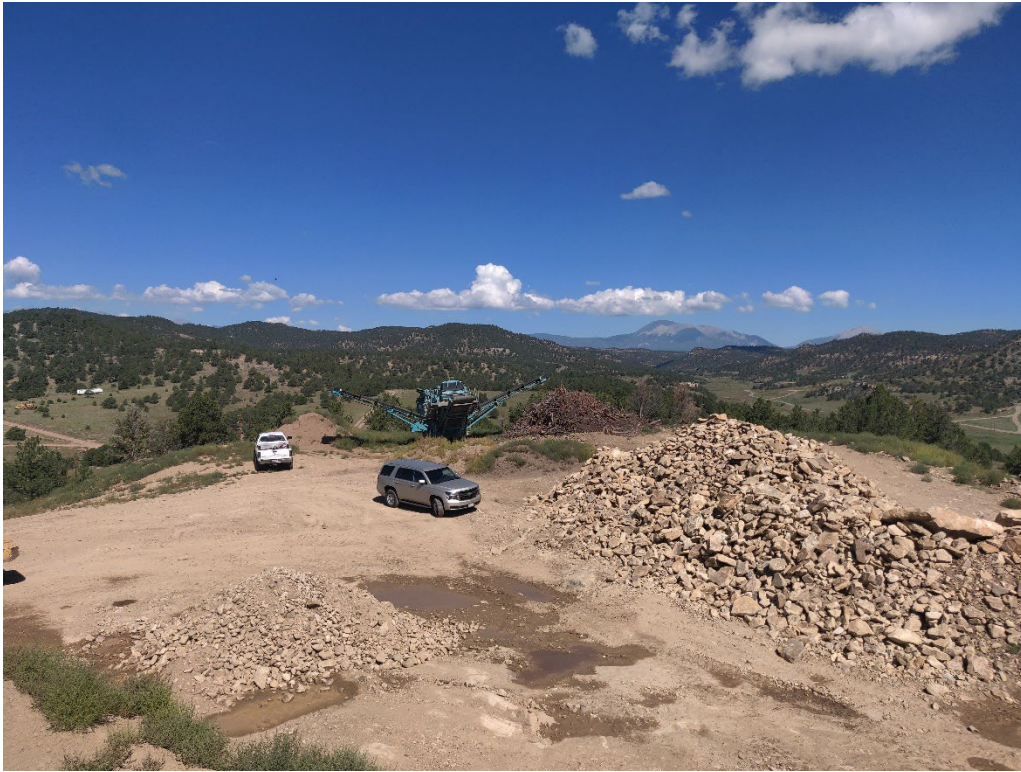
View of Area 2 from the highwall looking north

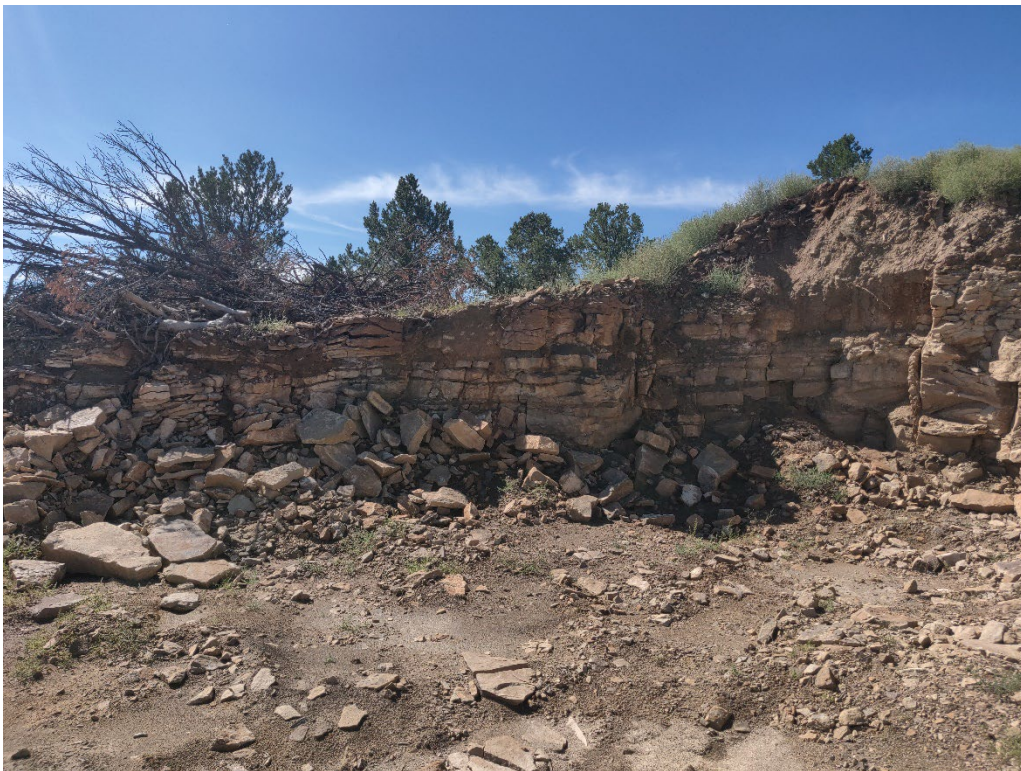
Area 2 consists of an access road, a lower work area and an upper mining area on top of the hill. The highwall located in the southeast portion of the area was estimated at fifteen (15) feet in height at a 1H:1V slope. Equipment and material stockpiles were located north of the highwall. The Operator stated the material excavated from the area is sold as rip-rap. A topsoil stockpile was observed in the southwest portion of the area.

View of the Area 2 highwall looking south
