MINERALS PROGRAM INSPECTION REPORT

MINE NAME: Cresson Project	MINE/PROSPECTING ID#: M-1980-244	MINERAL: Gold and silver	COUNTY: Teller
INSPECTION TYPE: Monitoring	INSPECTOR(S): Timothy Cazier, P.E.	INSP. DATE: August 23, 2022	INSP. TIME: 09:30
OPERATOR: Cripple Creek & Victor Gold Mining Company	OPERATOR REPRESENTATIVE: Johnna Gonzalez & Tony Matarrese	TYPE OF OPERATION: 112d-3 - Designated Mining Operation	
REASON FOR INSPECTION: Normal I&E Program	BOND CALCULATION TYPE: None	BOND AMOUNT: \$209,491,188.00	
DATE OF COMPLAINT: NA	POST INSP. CONTACTS: None	JOINT INSP. AGENCY: None	
WEATHER: Cloudy	INSPECTOR'S SIGNATURE:

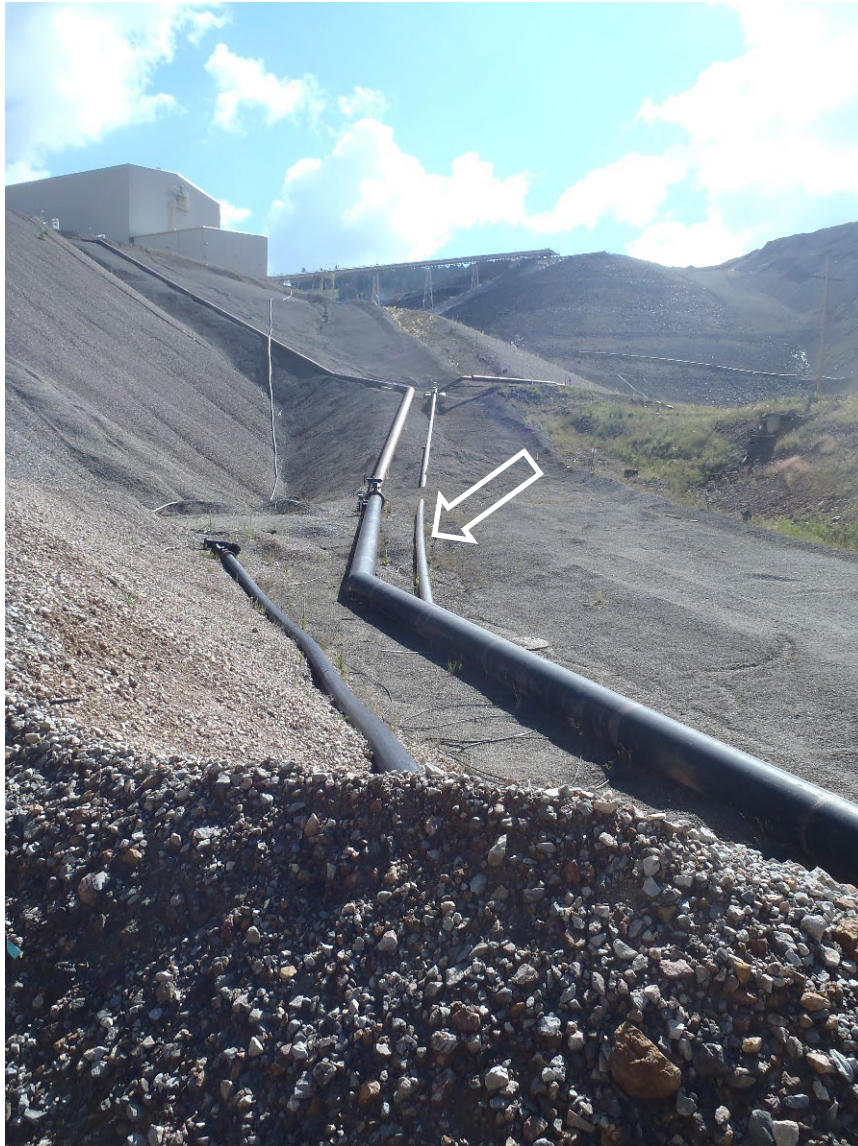
High Grade Mill Stormwater: The DRMS is in the process of reviewing TR-130, having provided four rounds of adequacy letters as of November 17, 2022. Based on discussions with site representatives during the inspection, the objective for TR-130 is to divert as much runoff that currently reports to the HGM area away from the mill platform, while directing meteoric water falling directing on the mill platform to VLF2 via the small barren line (see **Photo 1**), which would be pumped to the ADR2 Spent solution tank.

Photo 1. Small barren line to ADR2 (looking east towards the HGM)

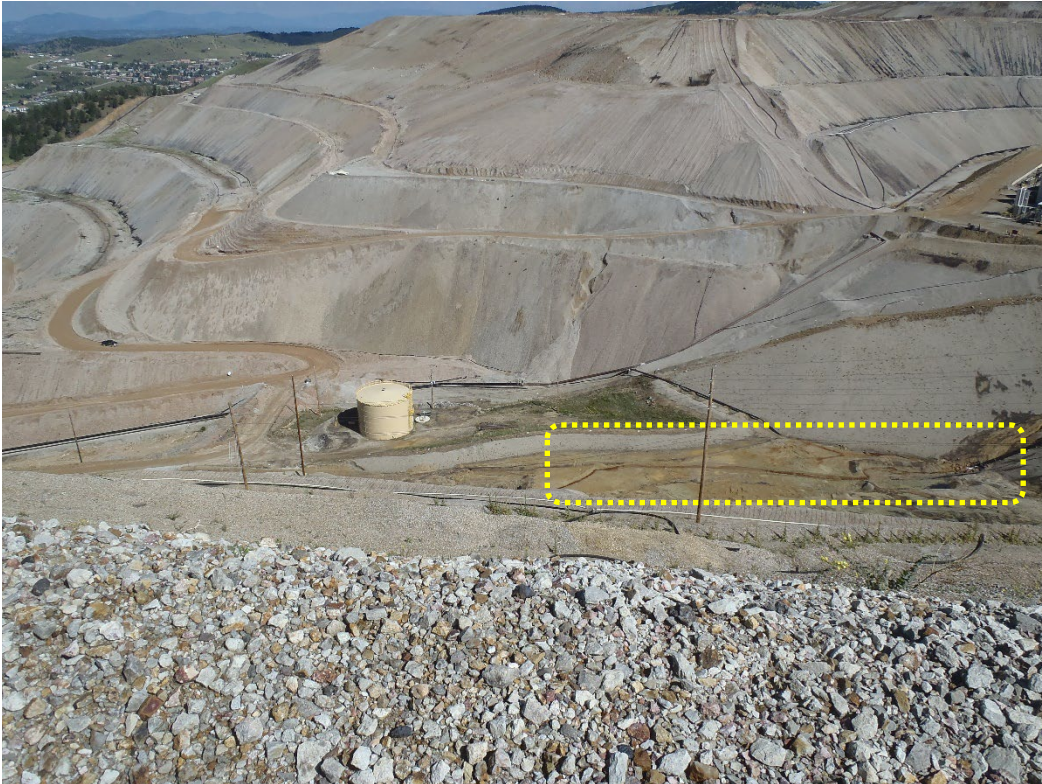
Meteoric water falling on the HGM side of VLF1 would be directed to the New Sump (see **Photo 2**). During the inspection, discussions were had over the importance of managing water in the New Sump in accordance with the Wildlife Protection Plan requiring ponded process water to be less than 3 ft. x 3 ft. Site representatives stated the New Sump are could not be ripped given the vertical proximity to the VLF1 liner. CC&V's response (dated 11/7/2022) to the DRMS' third adequacy review letter committed to: A) manage water in the New Sump area as process water; and B) If ponding is identified in the "New Sump" area that is larger than 3-feet by 3-feet, operators will hand excavate if necessary to allow for ponded water to infiltrate. [*The New Sump was originally designated as such with the submittal of TR-79 in July 2016. It is no longer "new" and frequently causes initial confusion when referred to in permitting/revision documentation as it implies a new sump is being proposed or added to the system. [In order to prevent future confusion, the DRMS strongly recommends renaming the "New Sump", to something more descriptive.](#)*] The name change could be presented in the response to our fourth adequacy review letter.

Photo 2. New Sump (new in 2016, TR-79) area (looking north from VLF1 overlook).

- The need to adhere to the approved wildlife protection plan with less than 3 ft. x 3 ft. of ponded process water.
- How to ensure the infiltration of process water in the New Sump without mechanical ripping.

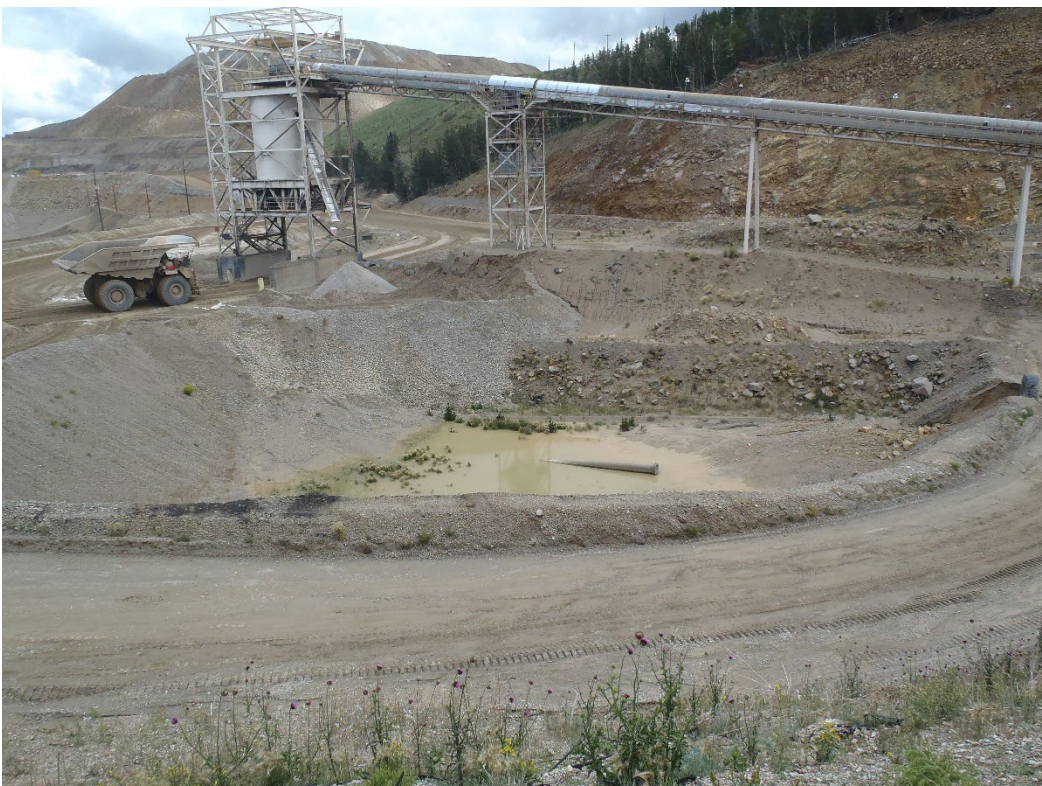
Meteoric water currently reporting to the HGM from the area east of the Load Out Bin (LOB) is planned to be diverted to the Detention Pond (see **Photo 3**, identified/located in TR-130). Stormwater reporting to the Detention Pond would be directed to EMP 11 (see **Photo 4**) via a proposed riser pipe inlet in the Detention Pond and proposed gravity flow pipeline paralleling the LOB conveyor (see **Photo 5**).

Photo 3. Detention Pond to be improved with a riser inlet (looking north towards the LOB).

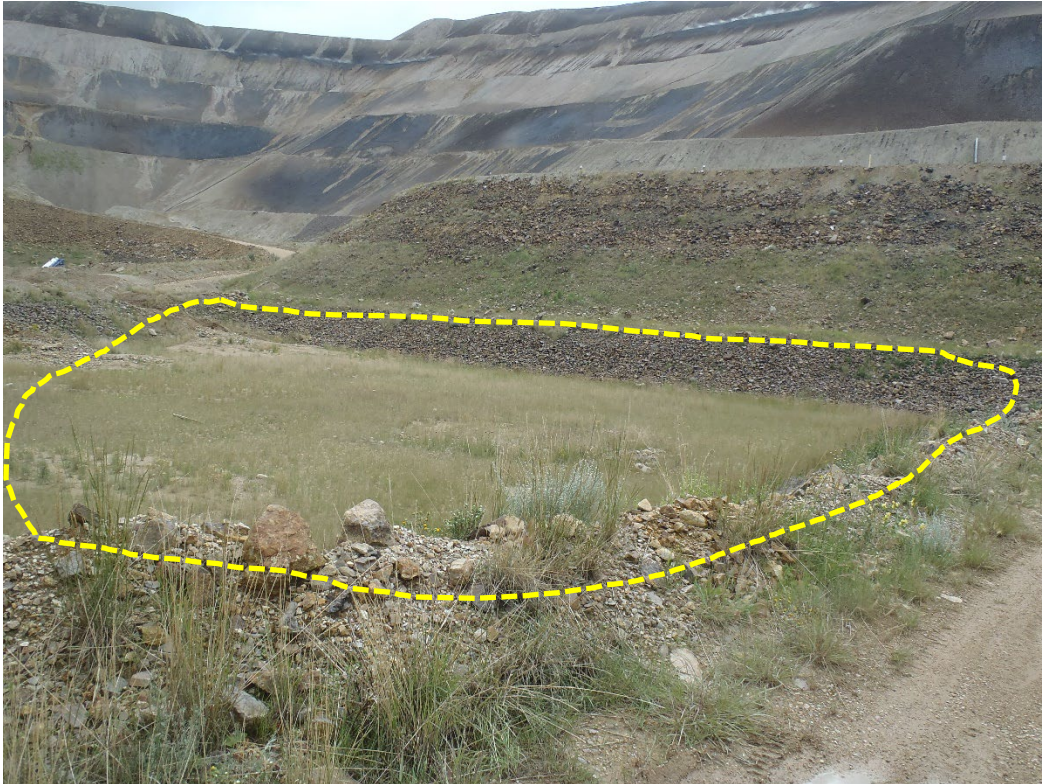
Photo 4. EMP 11 (looking south from between the Phase IV pumps and the crusher)

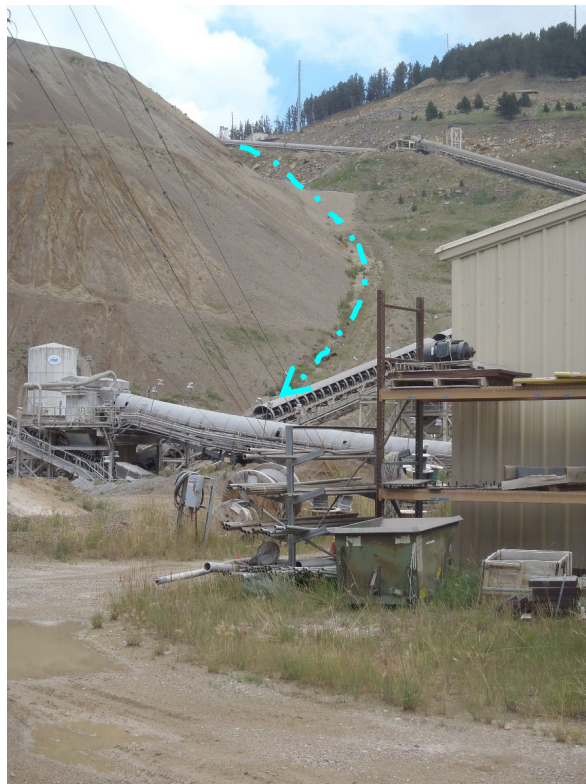
Photo 5. Proposed pipe alignment from the Detention Pond (looking north).

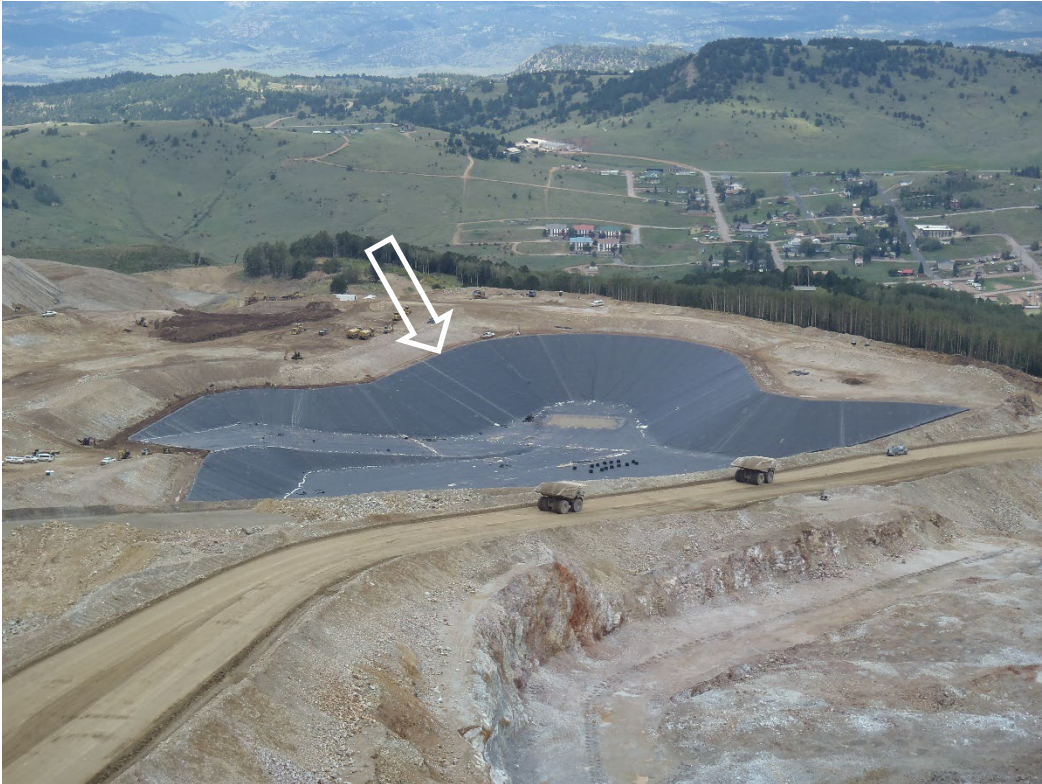
VLF 2 Phase III construction: Mr. Jeff Gaul was present for the overview and status update for the Phase III construction. Mr. Gaul stated all the PSSA liner (~550 thousand square feet, including soil liner fill and 100 mil thickness plastic liner) had been installed (see **Photo 6**) and was awaiting drain cover fill (DCF). Low Volume Solution Collection fill was being processed south of the Phase III area (see **Photo 7**).

Photo 6. Installed VLF2 Phase III PSSA liner above the HGM (looking west towards Cripple Creek).

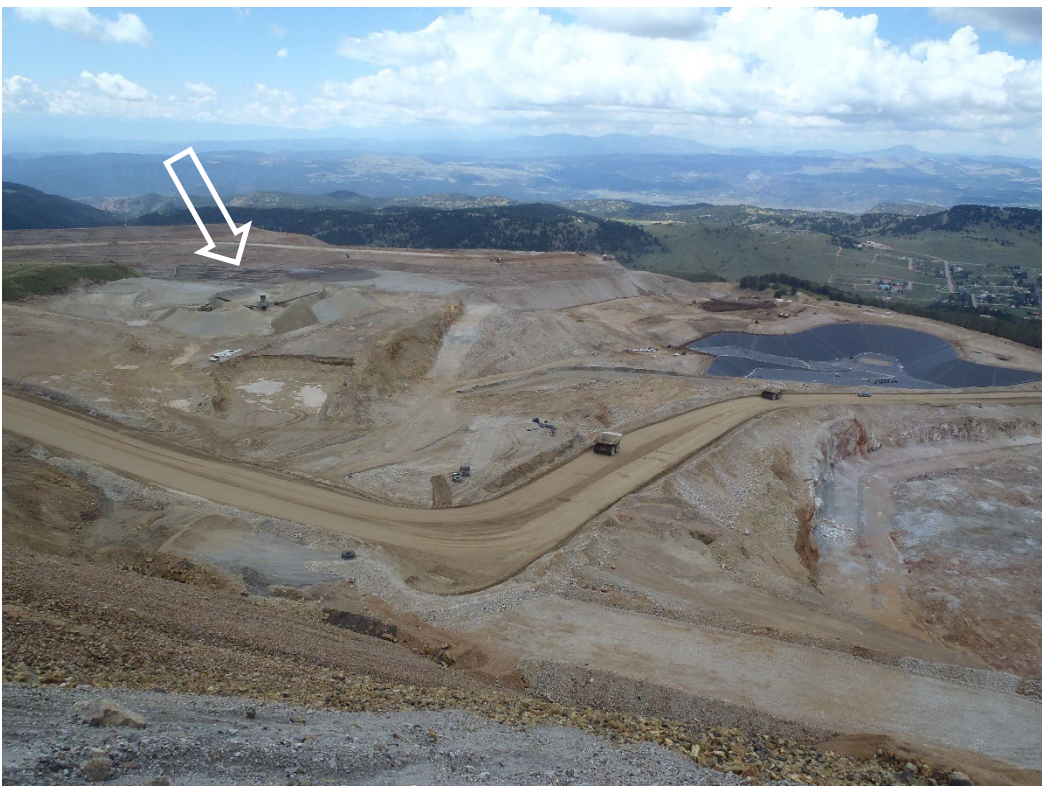
Photo 7. Processing LVSC fill for Phase III VLF2 (looking west, PSSA liner on right).
