STATE OF  
COLORADO

Cazier - DNR, Tim <tim.cazier@state.co.us>

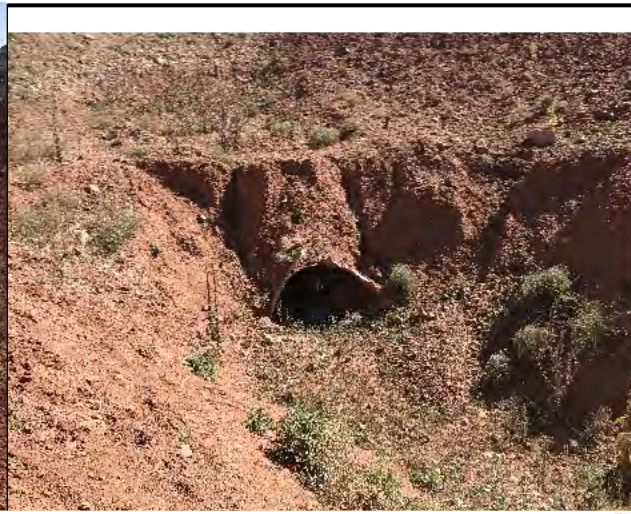
5. Dry above culvert. Note piping for pump if needed.

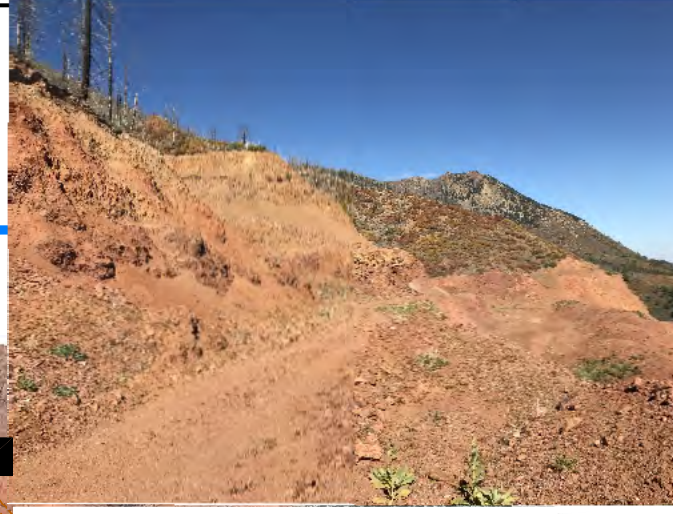
4. Stable granite slopes above landslide.

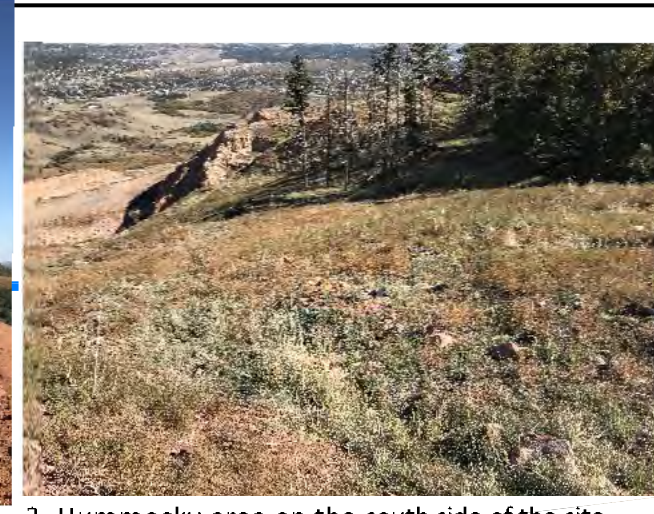
3. Hummocky area on the south side of the site remains stable without new cracks.

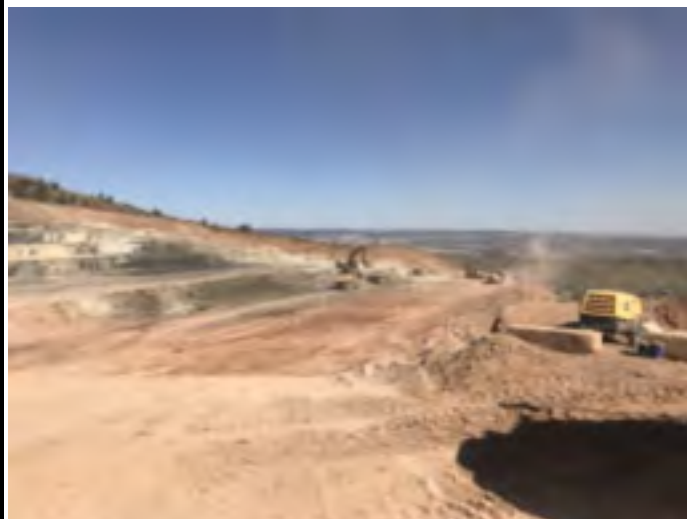
7. Excavator loads haul trucks at shop borrow area.
