PERMIT INFORMATION

Permit Number: C-1981-038	County: Delta			
Mine Name: Bowie No. 1 Mine	Operation Type: Underground			
Operator: Bowie Resources, LLC	Permit Status: Active			
Operator Address:	Ownership: Private			
Mr. Basil R Bear				
P.O. Box 1488	Operator Representative Present:			
Paonia, CO 81428				
	Basil Bear			
Operator Representative Signature: (Field Issuance Only)

INSPECTION INFORMATION

A complete inspection was conducted by Rob Zuber of DRMS on November 29, 2022.

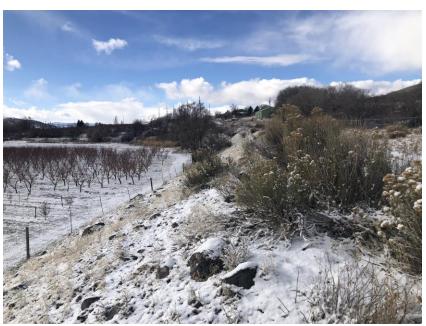
The slope below the loadout is stable. No erosion was seen at the loadout.

Loadout slope, looking southwest

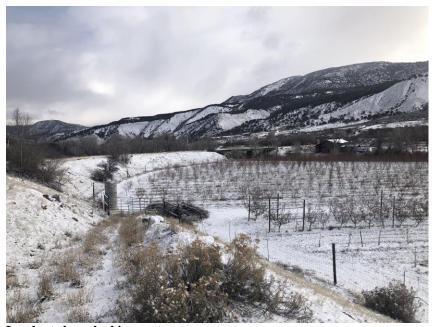
Loadout slope, looking east

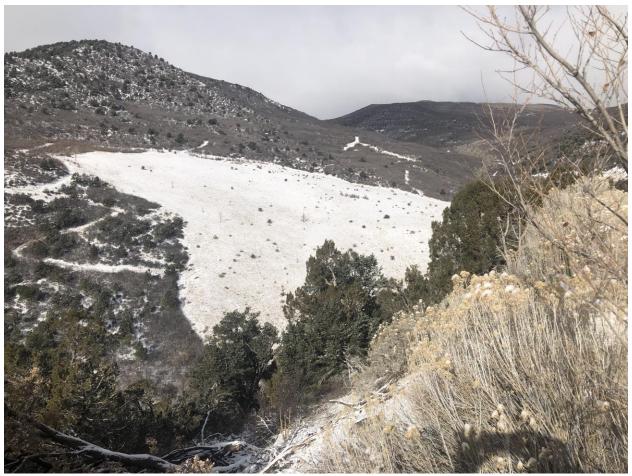
The West Mine was in good shape, as viewed from Johnson Road.

West Mine from Johnson Road

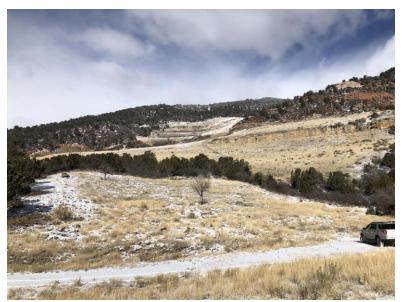
East Mine from Old Waste Disposal Area

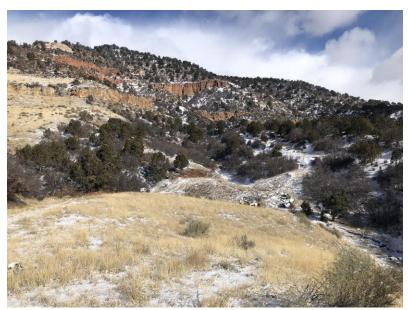
Drainage above Old Waste Disposal Area
