**Figure 2**  
**Castle Concrete Aggregates - Pueblo East Pit - Monitoring Wells**  
**Depth to Ground Water**  
**Phase 1 Area**

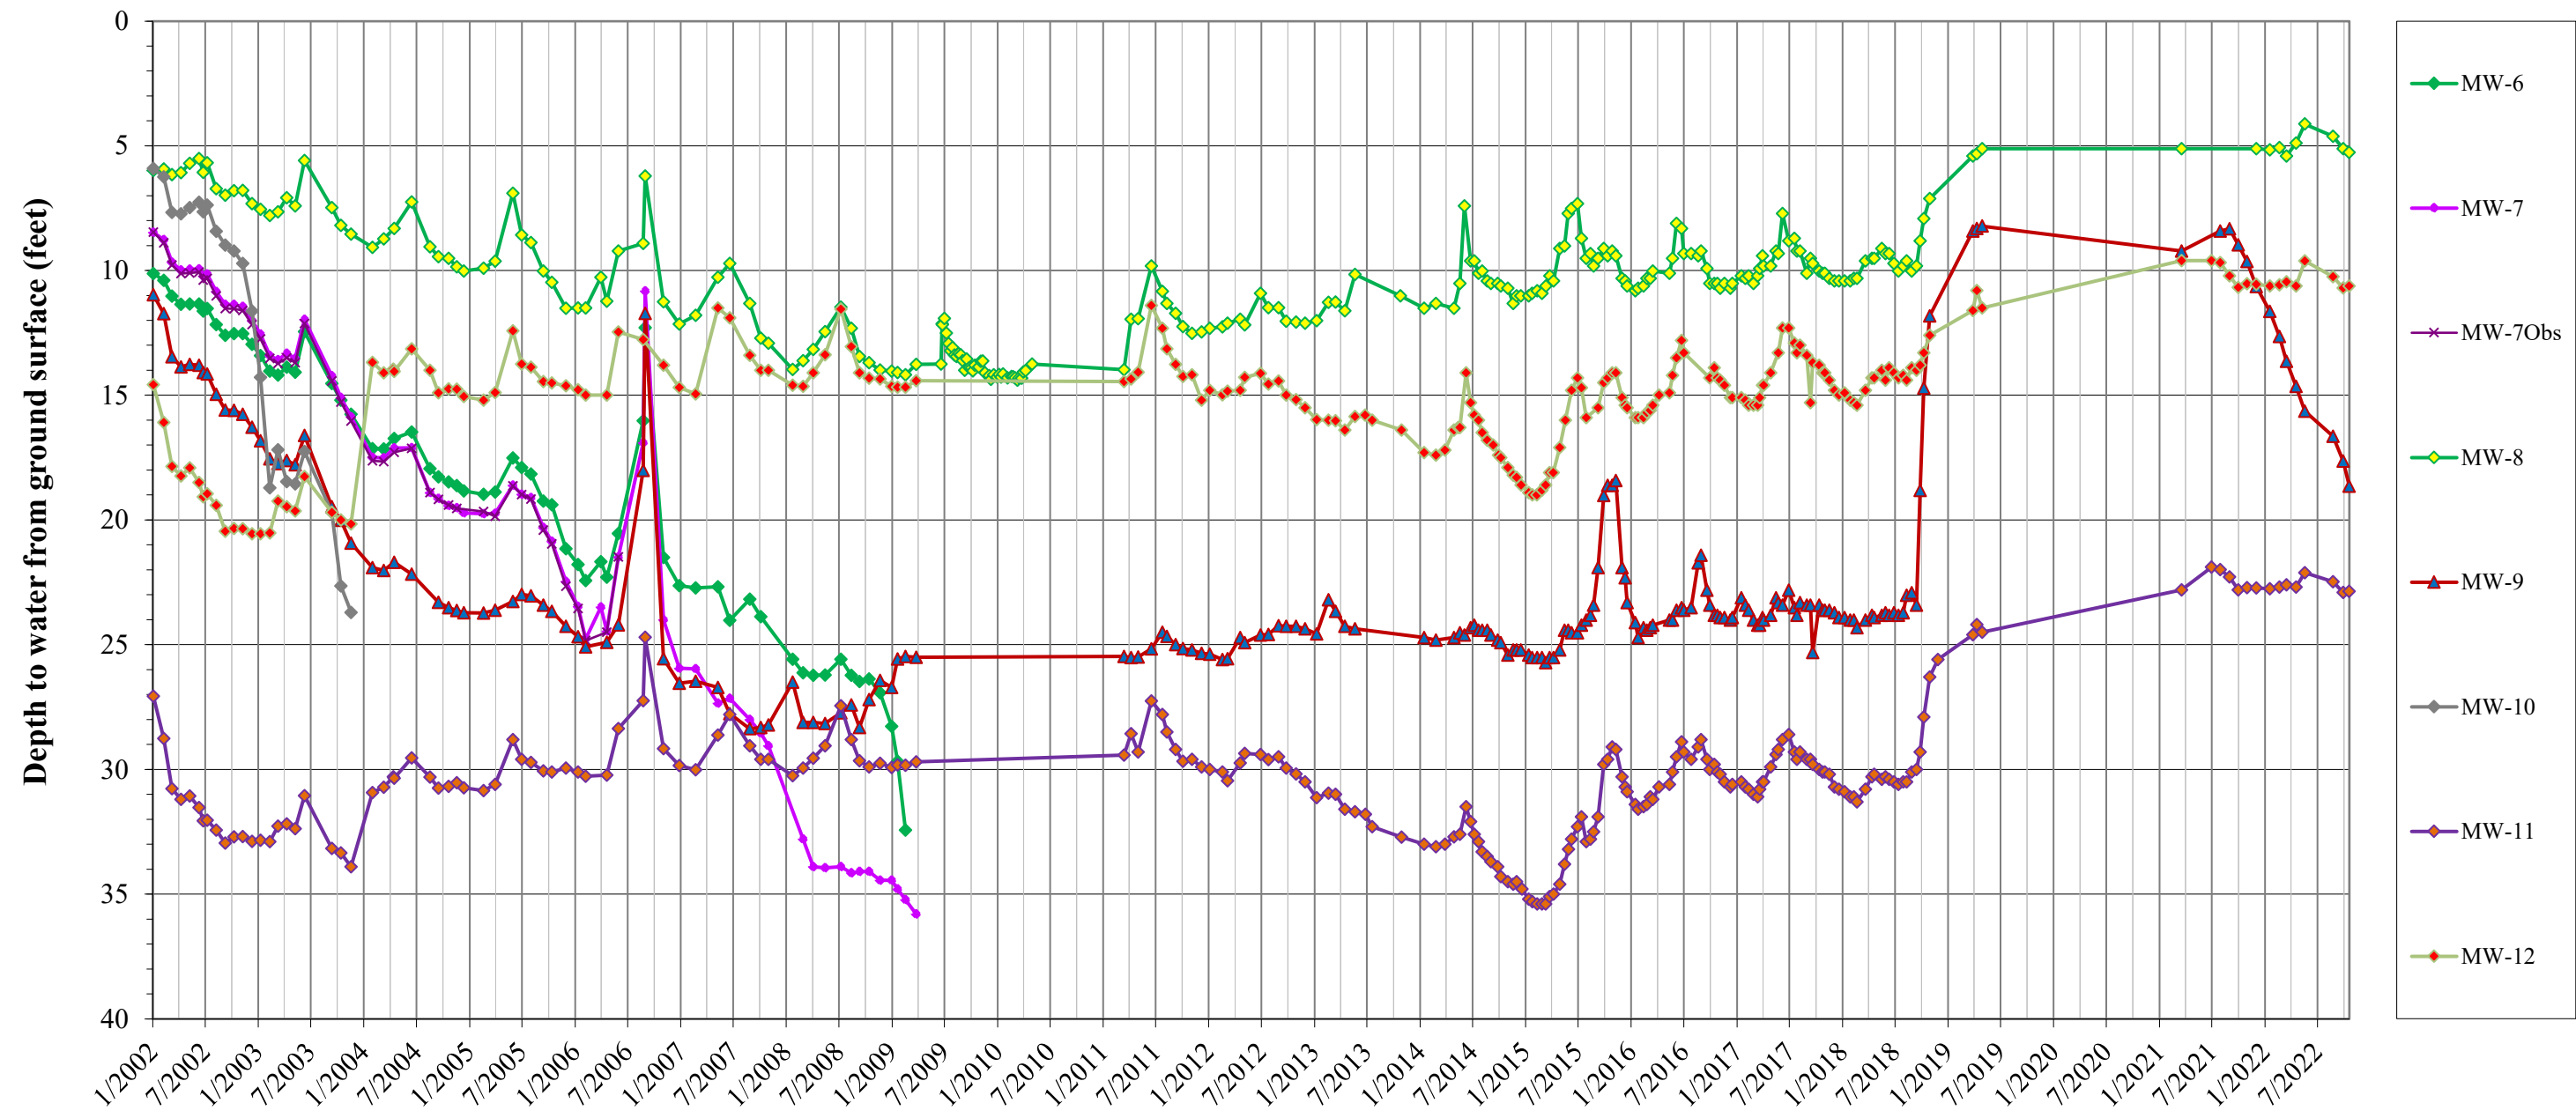
Notes:  
 -Several wells, including MW-6, 7, 7Obs and 10, have either been mined through and abandoned or are inaccessible and are no longer measured.  
 -Significant decrease in depth to ground water in wells in September 2018 due to cessation of dewatering activities at the Phase 1 pit.

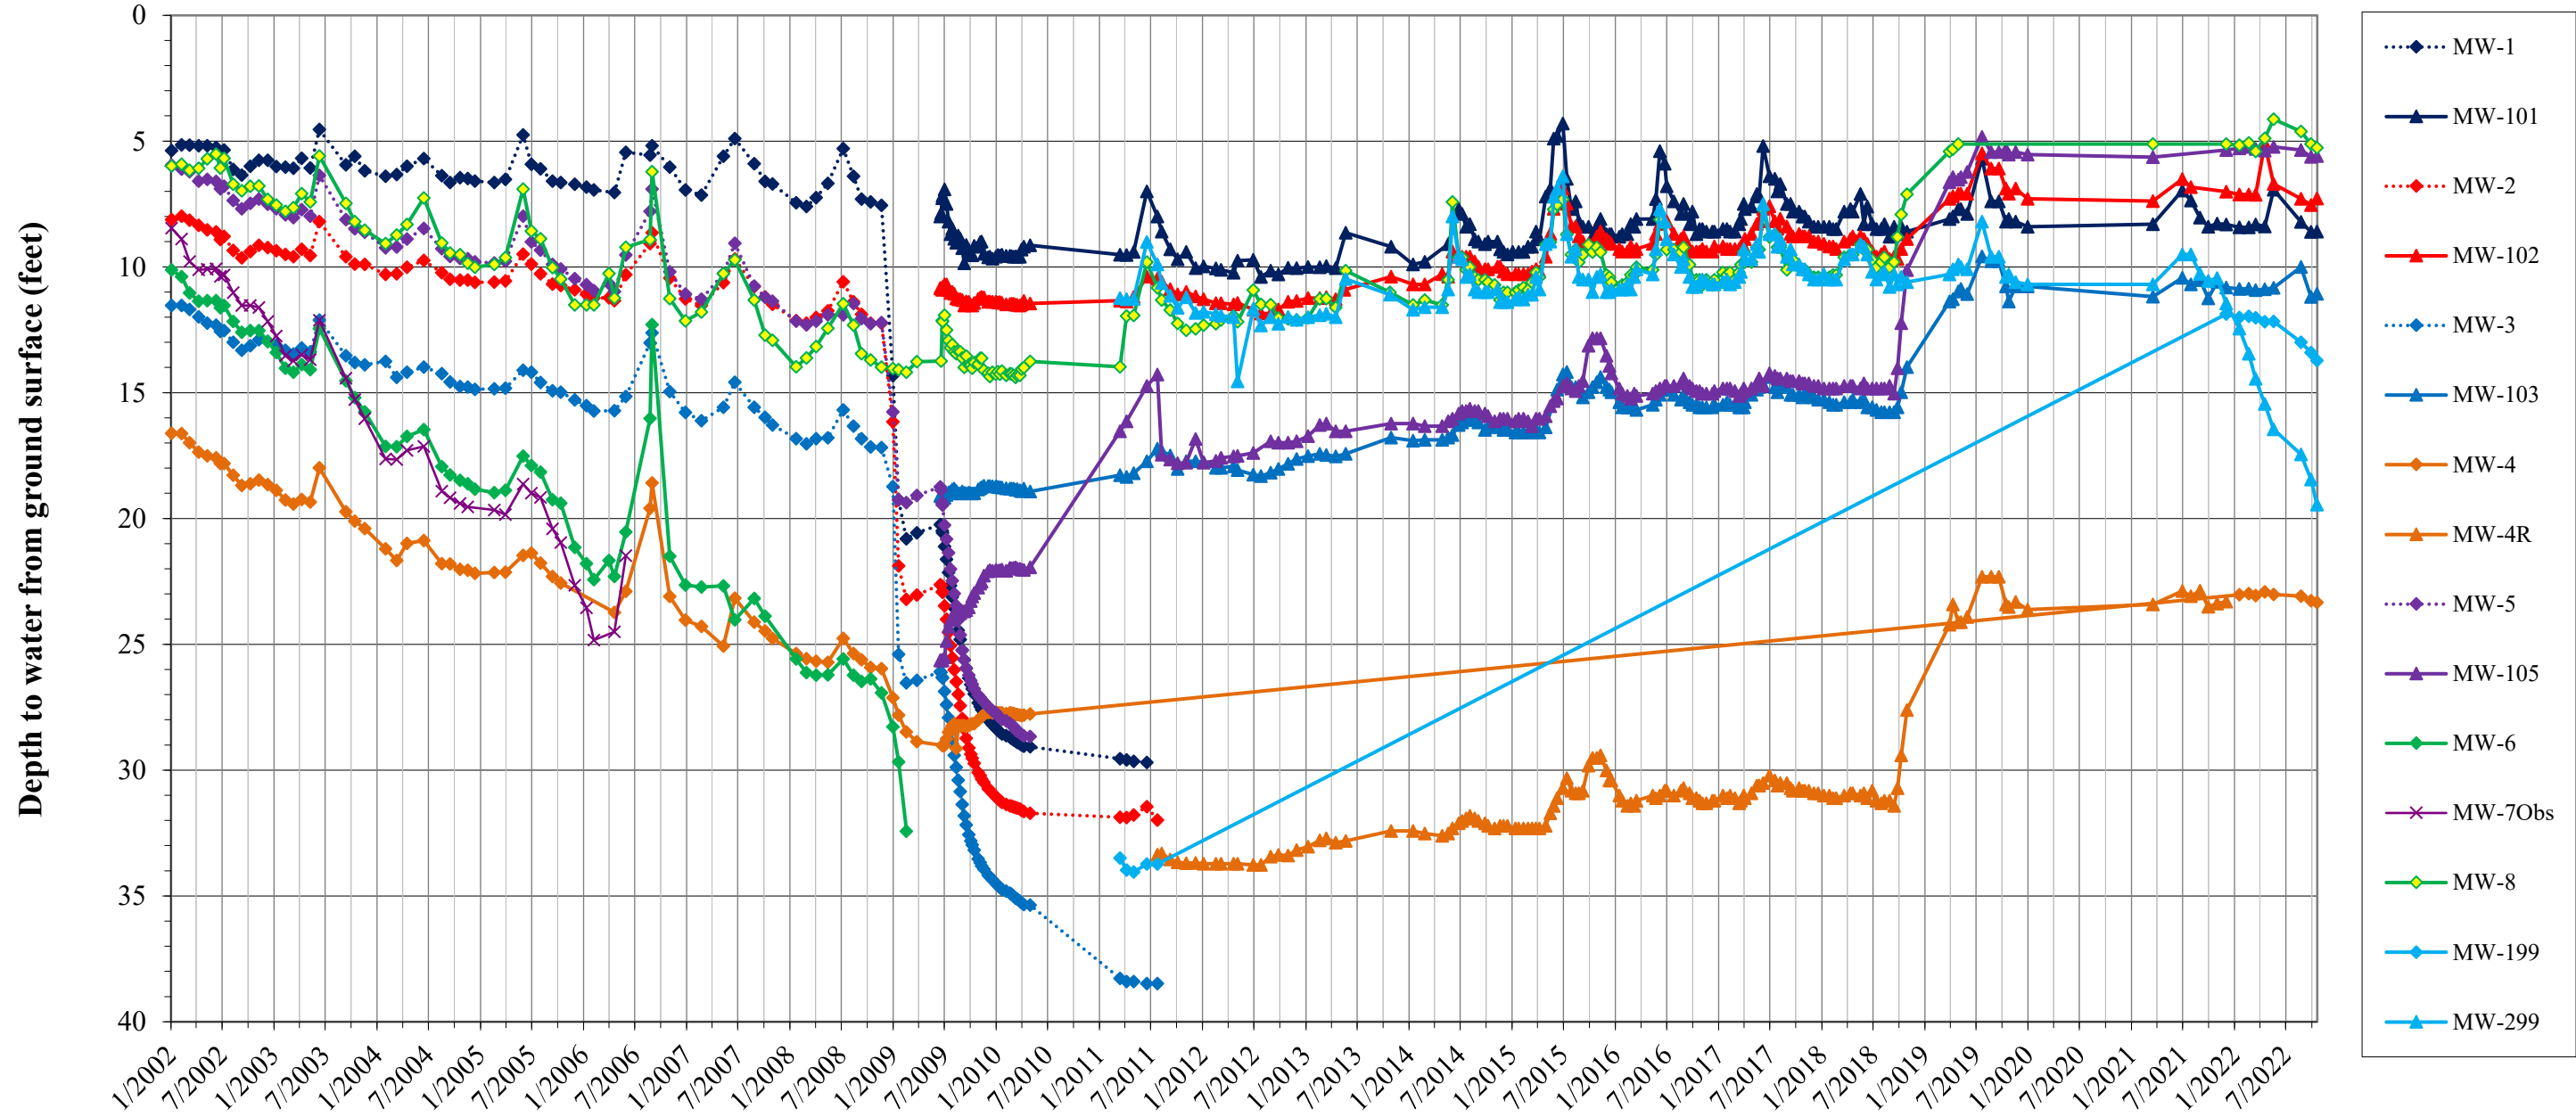
**Figure 3**  
**Castle Concrete Aggregates- Pueblo East Pit - Monitoring Wells**  
**Depth to Ground Water**  
**Phase 2 Area**

- Several wells, including MW-1, 199, 2, 3, 4, 5, 6, 7 and 7Obs have either been mined through and abandoned or are inaccessible and are no longer measured.
- Wells MW-1, MW-2, MW-3, MW-5, and MW-199 were located within the slurry wall, and are not representative of local ground water conditions after November 2008.
- MW-4R is located at higher elevation than MW-4, resulting in a greater depth to water than in MW-4. Offset between MW-4 data in May 2010 and MW-4R data from July 2011 to present are the result of differing ground surface elevations.
- Depth to water for MW-101,102,103 and 105 assume the same measuring height above ground surface as MW-1,2,3 and 5, respectively.
- Significant decrease in depth to ground water in certain wells in September 2018 due to cessation of dewatering activities at the Phase 1 pit.

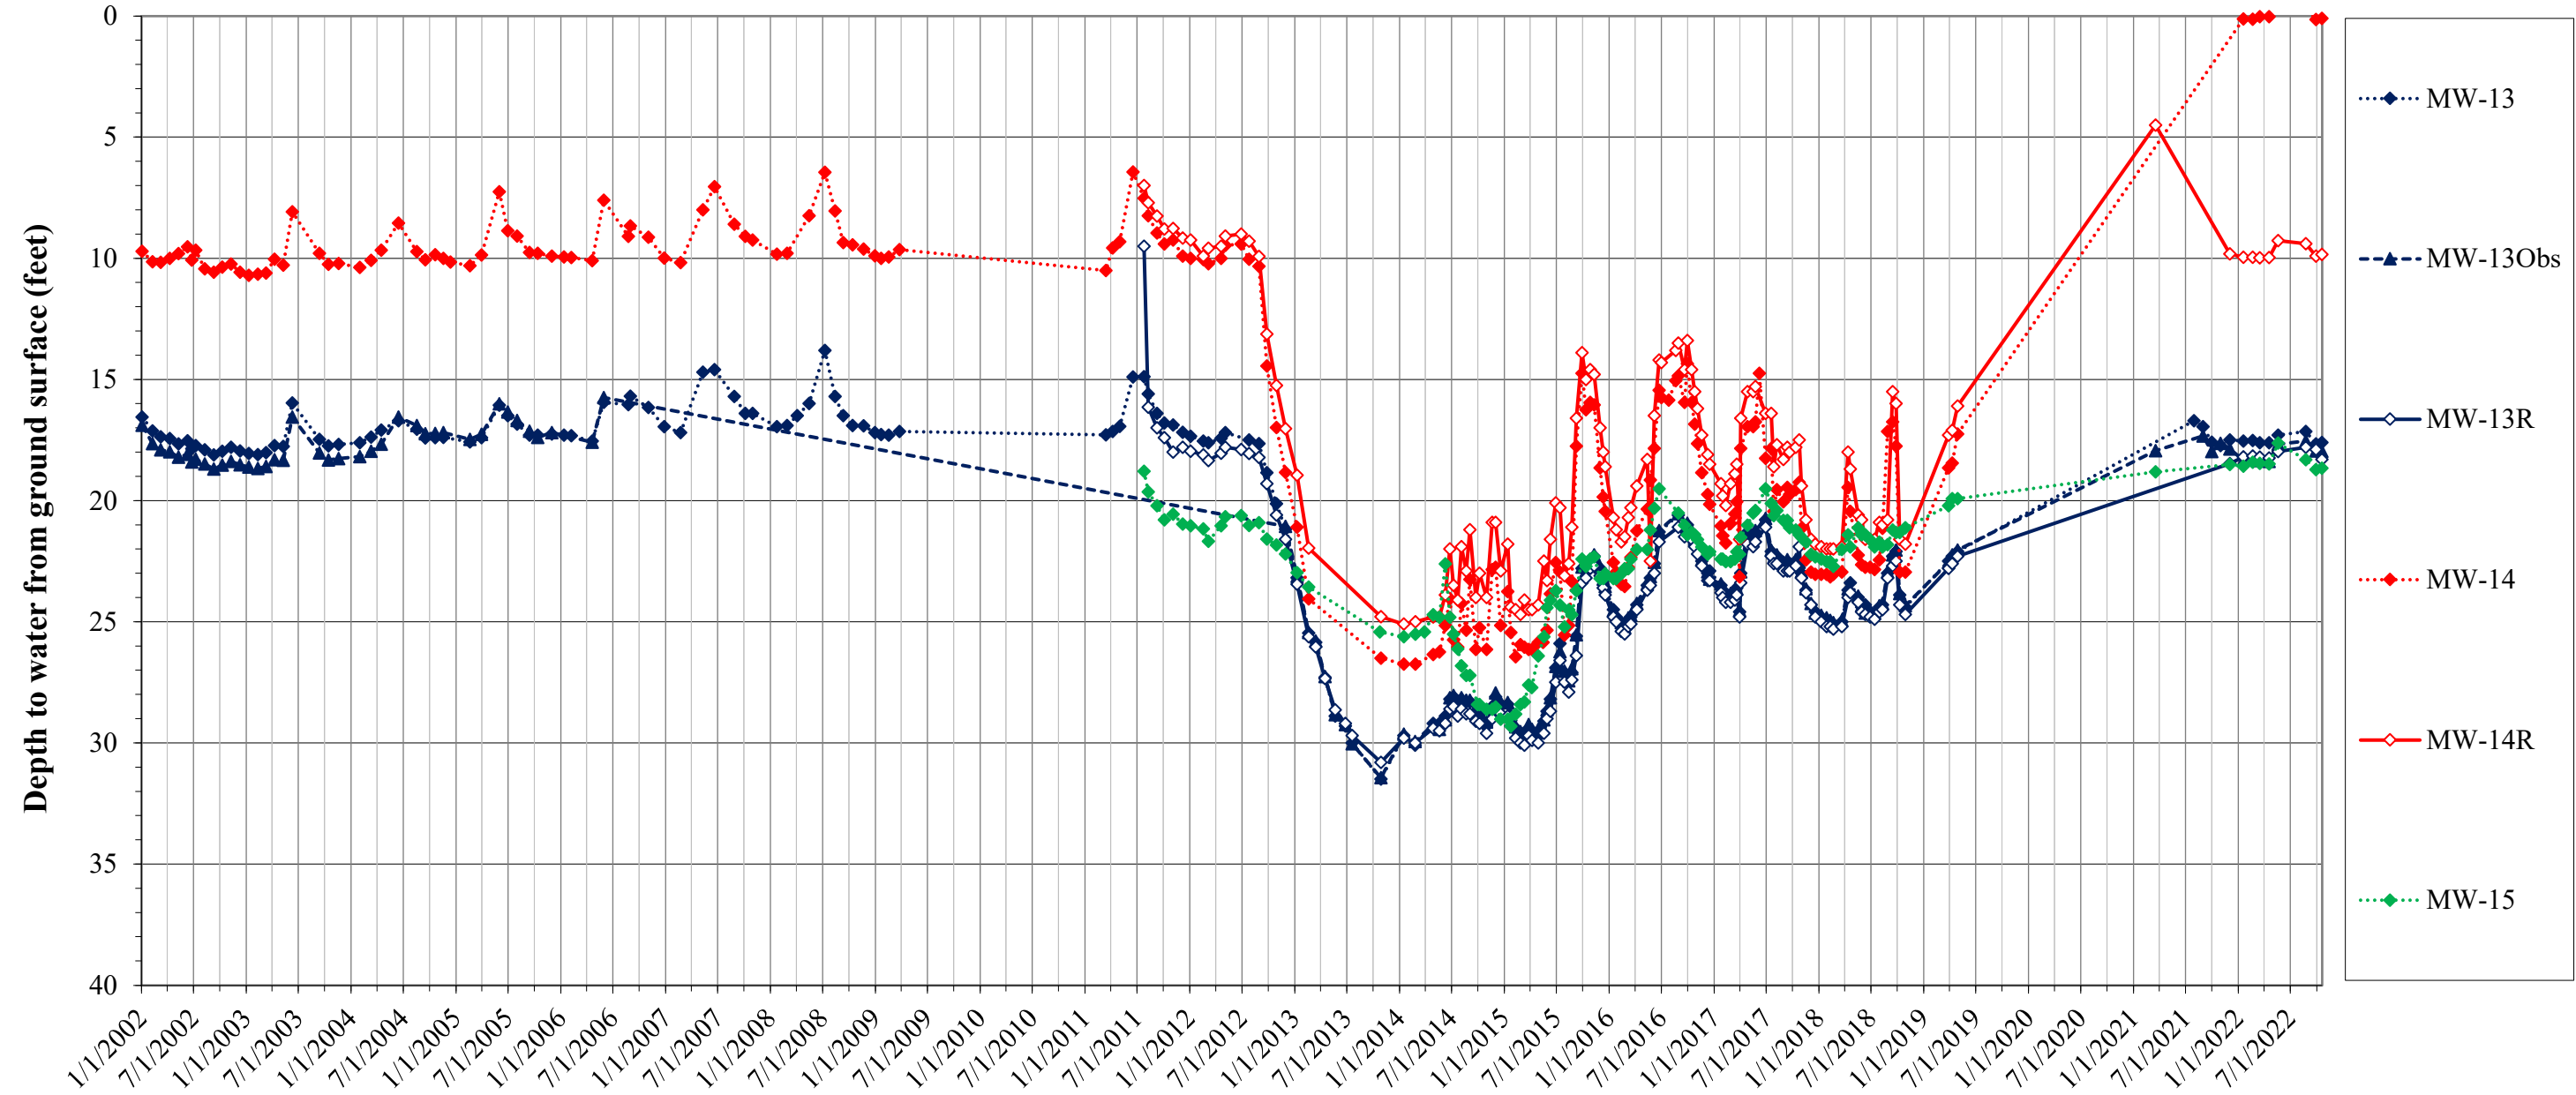
**Figure 4**  
**Castle Concrete Aggregates- Pueblo East Pit - Monitoring Wells**  
**Depth to Ground Water**  
**Phase 7 Area**

Notes:  
 -Increase in depth to water starting in late 2012 due to beginning of dewatering operations at Phase 7.  
 -Gradual decrease in depth to water from late 2015 to April 2019 present due to reduction in the footprint of the dewatered area. Significant decrease in depth to ground water as of March 2021 due to cessation of dewatering activities at Phase 7 pit in October 2020.
