## **PERMIT INFORMATION**

# INSPECTION INFORMATION

A partial inspection was conducted by Rob Zuber of DRMS on December 1, 2022. No Coors Energy Company (CEC) representative was present at the inspection.

The site is in Permanent Cessation. Reclamation activities were completed in the fall of 2020. However, due to poor success in some areas, Coors Energy reclaimed these areas a second time in spring 2022.

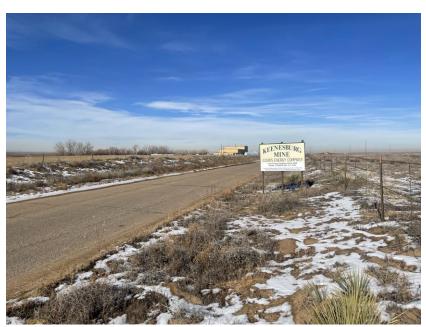
**Entrance sign**

The entrance sign was in place and contained all necessary information. Boundary markers were seen on all sides of the site.

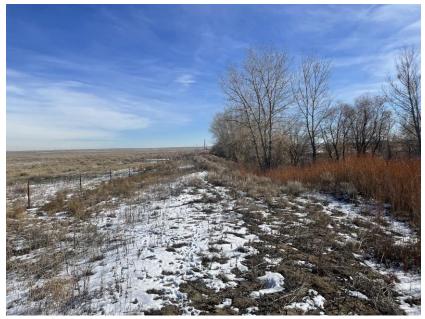
**Sediment Pond 2**

Sediment Pond 2 and the Dugout Pond contained little to no water (thick vegetation obscures the bottoms). They were not discharging during the inspection. There were no signs that either pond had discharged recently. No problems were observed.

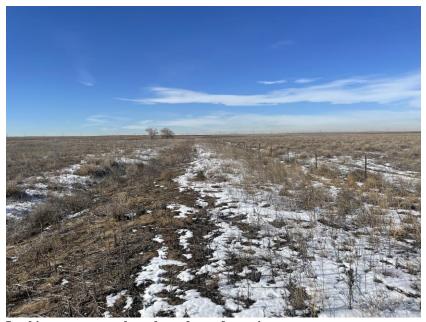
Looking west at northern boundary of permit area

The boundary of the site was observed, and no signs of pollutant loading from the mine site, or any other problems, were seen.

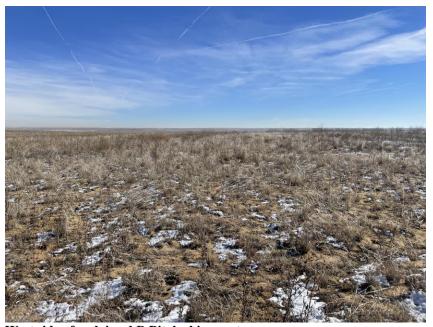
West side of reclaimed B Pit, looking east

Very little grass was seen in the recently reclaimed areas on the eastern part of the site. The predominant plant on the reclaimed roads is Russian thistle.

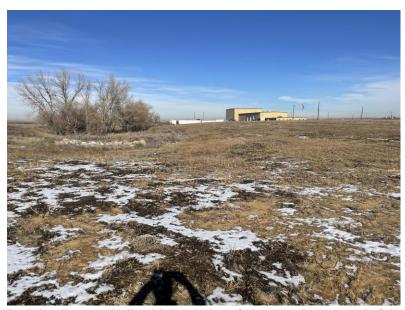
No erosion problems were seen onsite, and the entire site was inspected. The steep area east of the Dugout Pond was stable.

Reclaimed topsand piles (right portion of photo) and upper end of the Dugout Pond
