## MINERALS PROGRAM INSPECTION REPORT

<b>MINE NAME:</b> Calhan Clay Pit	<b>MINE/PROSPECTING ID#:</b> M-1993-080	<b>MINERAL:</b> Clay (general)	<b>COUNTY:</b> El Paso
<b>INSPECTION TYPE:</b> Monitoring	<b>INSPECTOR(S):</b> Timothy Cazier, P.E.	<b>INSP. DATE:</b> June 29, 2022	<b>INSP. TIME:</b> 09:00
<b>OPERATOR:</b> The Summit Pressed Brick and Tile Company	<b>OPERATOR REPRESENTATIVE:</b> Julie Welte	<b>TYPE OF OPERATION:</b> 112c - Construction Regular Operation	
<b>REASON FOR INSPECTION:</b> Normal I&E Program	<b>BOND CALCULATION TYPE:</b> None	<b>BOND AMOUNT:</b> \$43,890.00	
<b>DATE OF COMPLAINT:</b> NA	<b>POST INSP. CONTACTS:</b> None	<b>JOINT INSP. AGENCY:</b> None	
<b>WEATHER:</b> Clear	<b>INSPECTOR'S SIGNATURE:</b>

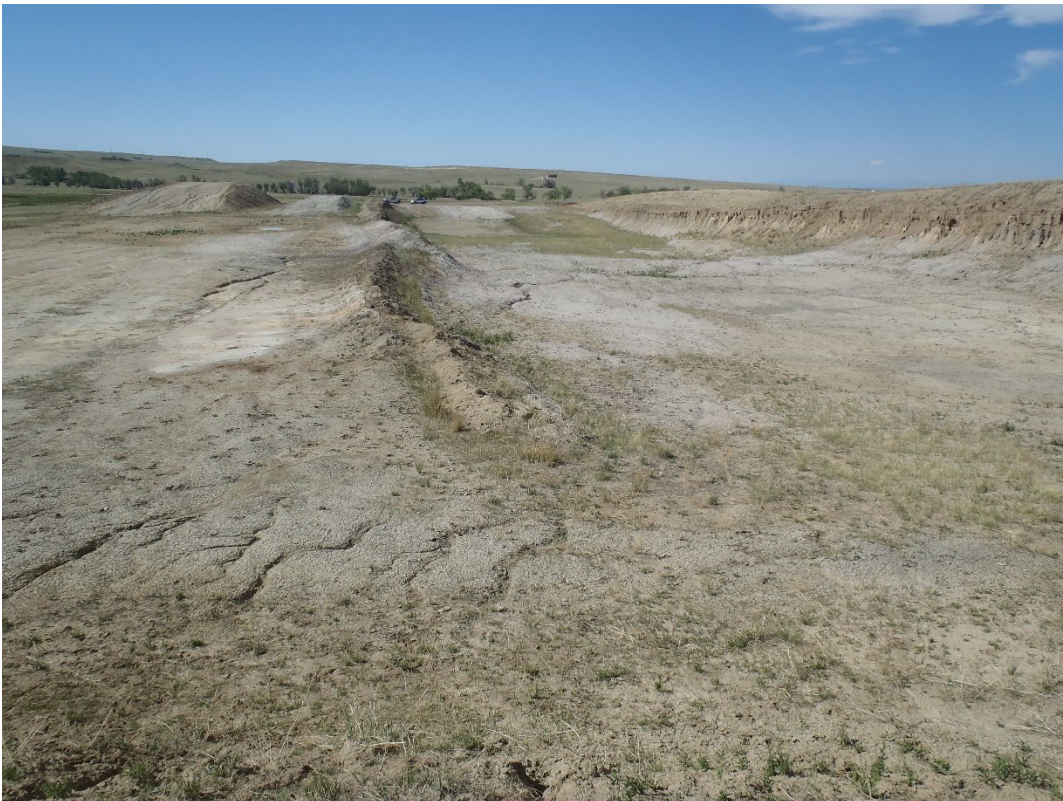
Backfilling and Grading: Sufficient backfill material (overburden) appeared to be available. Additionally, material could be pushed down from the crest on the east highwall (see **Photo 1**).

Photo 1. East and west highwalls (looking SSW), stripped and product stockpile area on left.

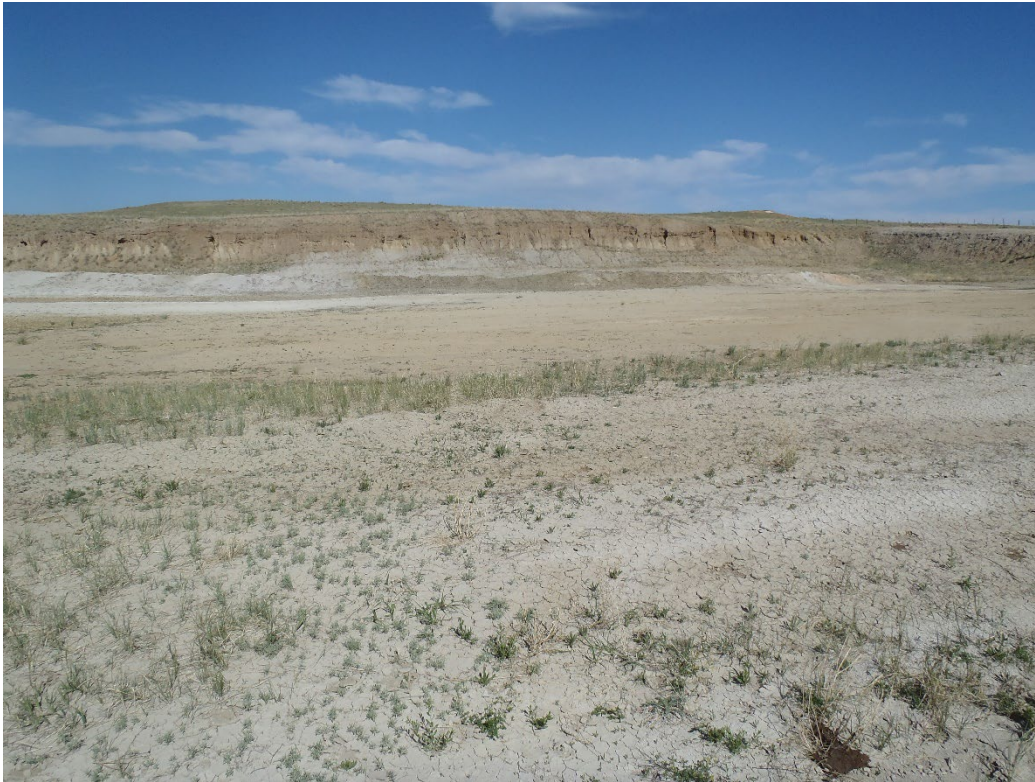
Photo 2. West highwall (looking west across pit; note topsoil stockpile on crest).

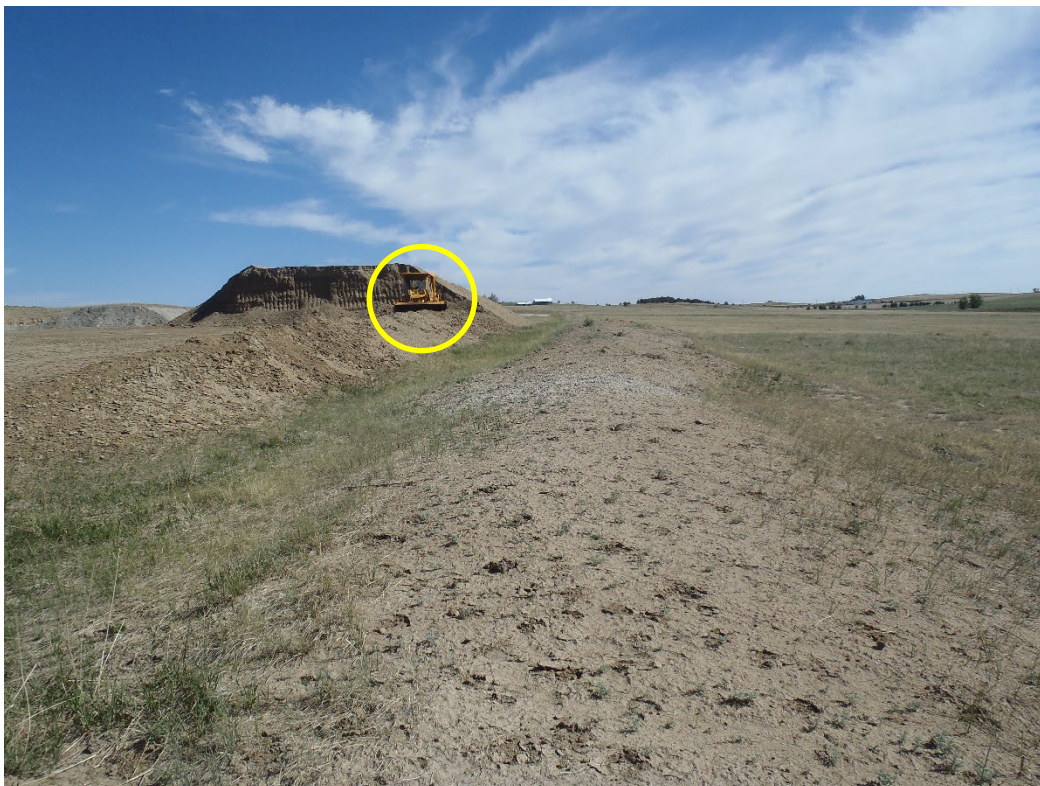
Support Facilities On-site: A loader was observed on site (see **Photo 3**).

Signs and Markers: The permit sign was properly posted (see **Photo 4**) and affected area boundaries were marked: T-posts were found on the north and south corners of the east side (see **Photo 5**), with berms on the north and east boundaries (see **Photos 3 and 6**). A fence delineates the west boundary, but the north and south

Photo 3. Loader on east side, south of clay stockpile (looking north; note berm marking boundary on right).

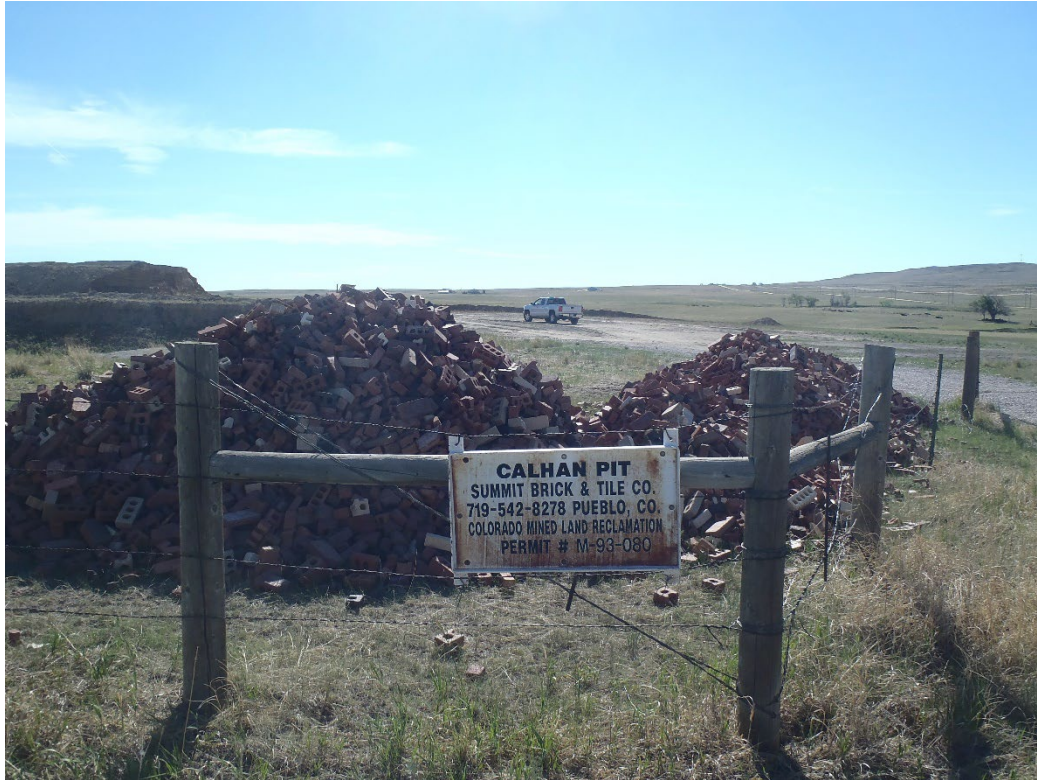
Photo 4. Permit sign at entrance off Fairplay Rd (looking east).

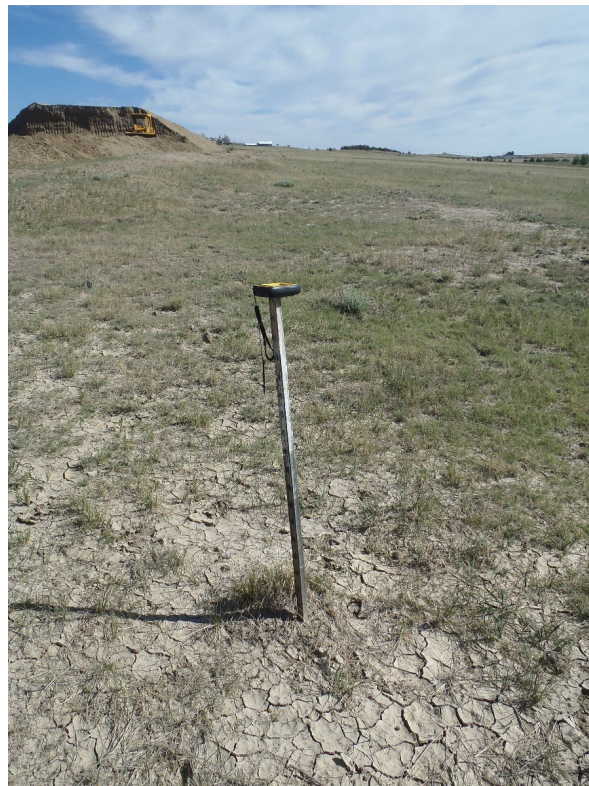
Photo 5. Typical east affected boundary corner post (SE corner).

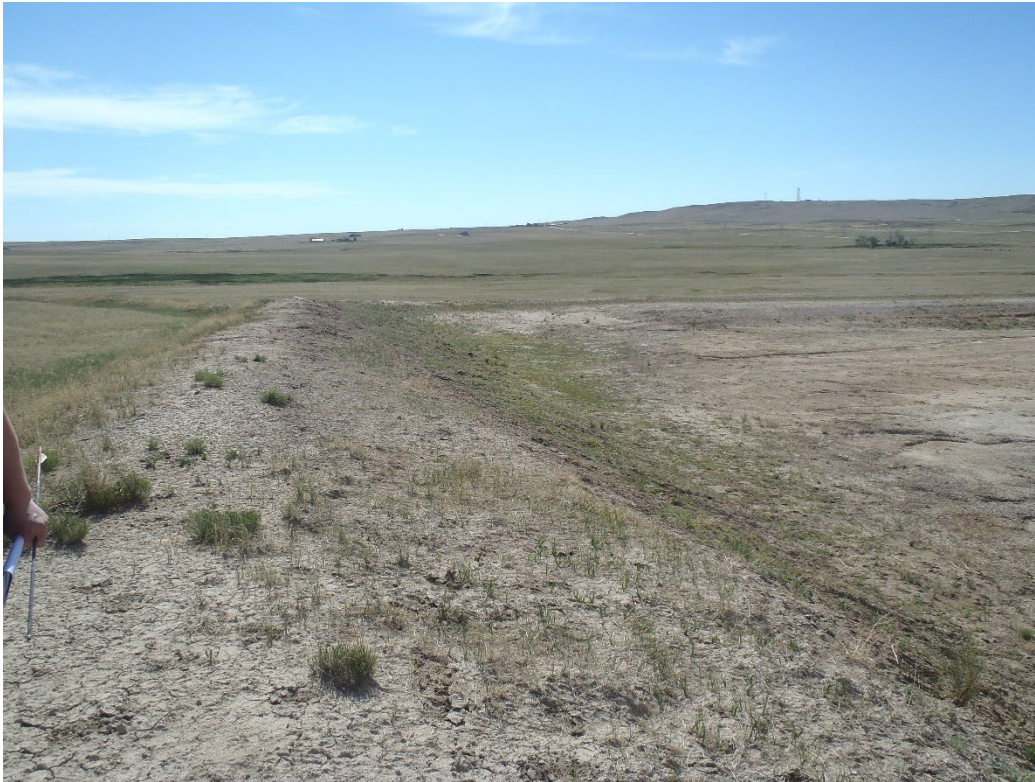
Photo 6. North affected area boundary berm (looking east).

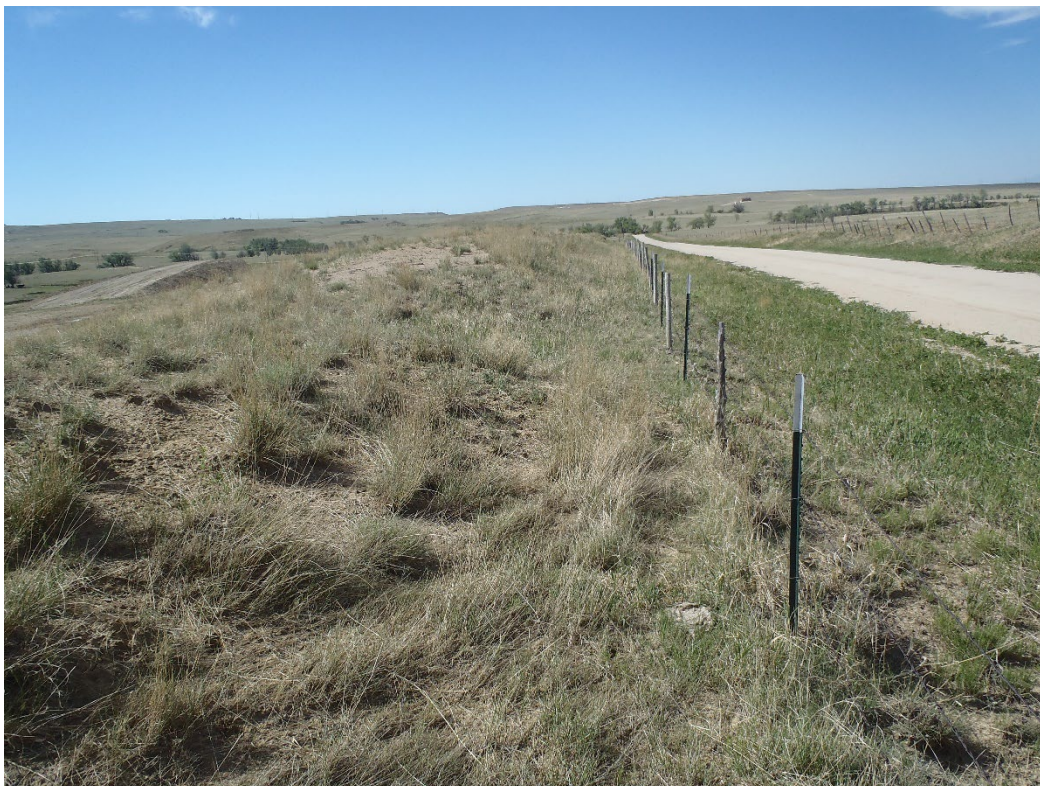
Topsoil: The topsoil stockpile is in the west side of the pit and is stabilized with established grass (see **Photo 7**).

Photo 7. Vegetated topsoil stockpile (left side of photo, west side, looking south).
