MINERALS PROGRAM INSPECTION REPORT
PHONE: (303) 866-3567

MINE NAME: JD-9 Mine	MINE/PROSPECTING ID#: M-1977-306	MINERAL: Uranium and vanadium	COUNTY: Montrose
INSPECTION TYPE: Monitoring	WEATHER: Clear	INSP. DATE: October 11, 2022	INSP. TIME: 14:00
OPERATOR: Highbury Resources Inc.	OPERATOR REPRESENTATIVE: Scott Pottorffs, Dana Cline	TYPE OF OPERATION: 112d-1 - Designated Mining Operation	
REASON FOR INSPECTION: Normal I&E Program	BOND CALCULATION TYPE:	BOND AMOUNT: \$100.00	
DATE OF COMPLAINT: NA	POST INSP. CONTACTS: None	JOINT INSP. AGENCY: U.S. Energy	
INSPECTOR(S): Dustin Czapla	INSPECTOR'S SIGNATURE:

Upper Monogram Area

Bull Canyon Area

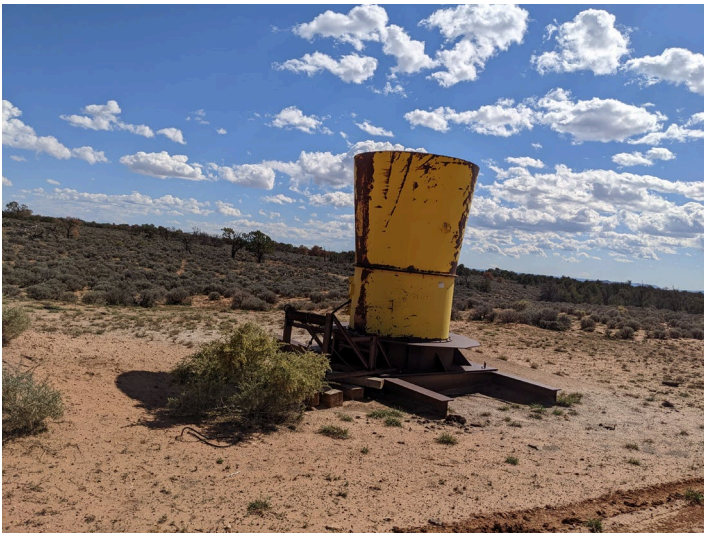
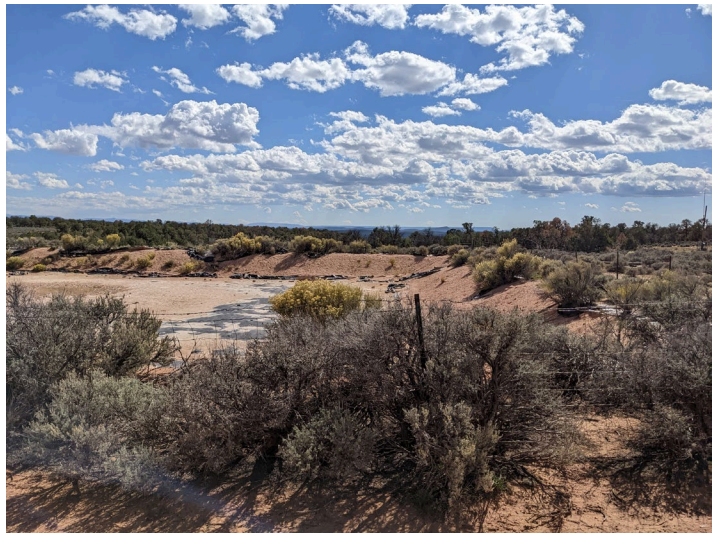
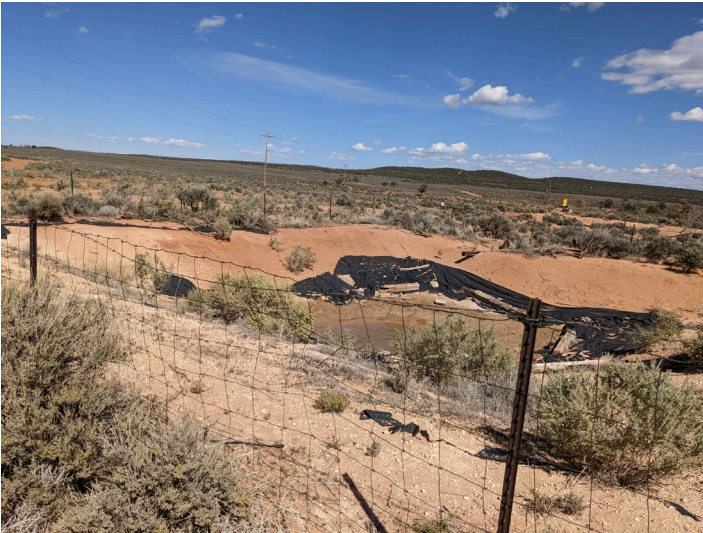
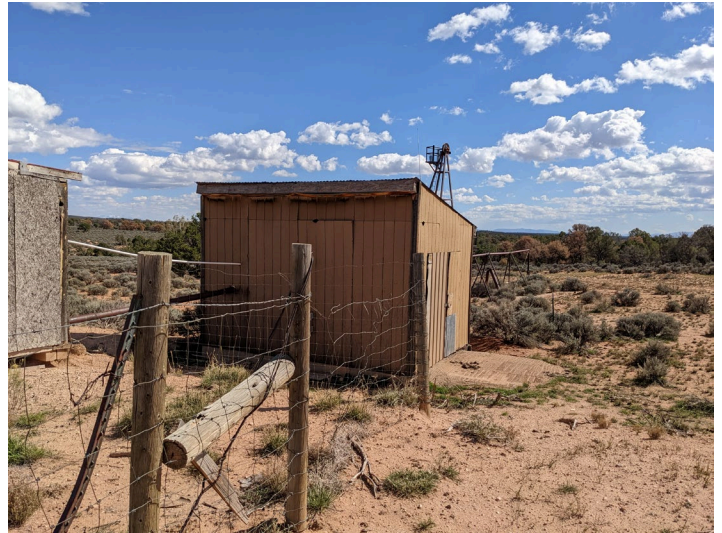
Vent fans and water treatment plant are located in this area. The water treatment plant is not currently in use. Pond liners are dilapidated and not functional. Water was not observed in any of the ponds. Conditions are similar to those observed during the Division's last inspection. No problems or violations were noted in this area.

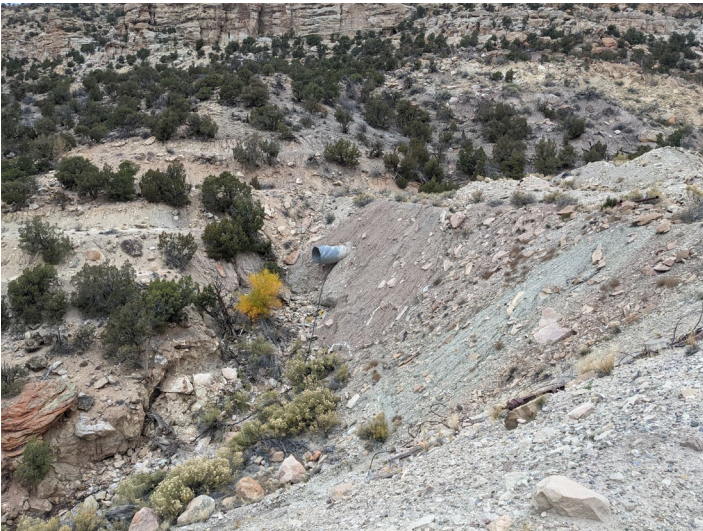
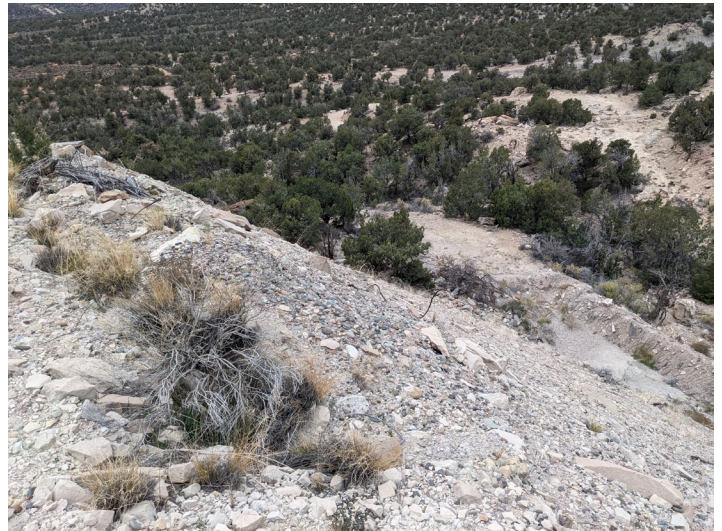
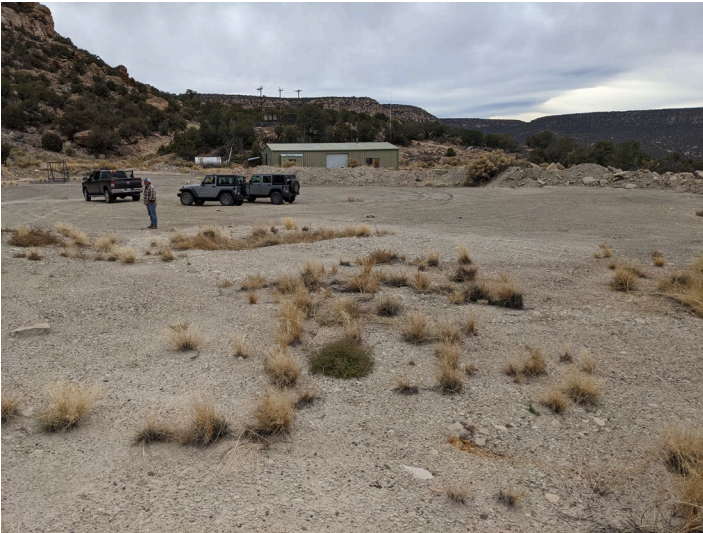
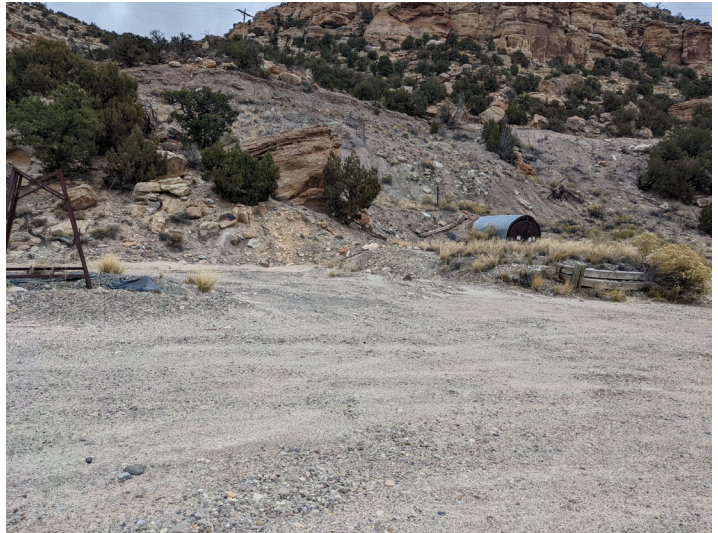
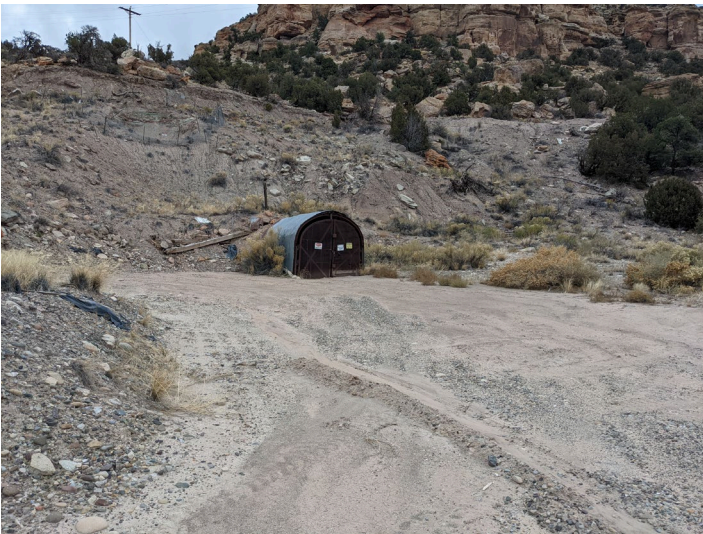
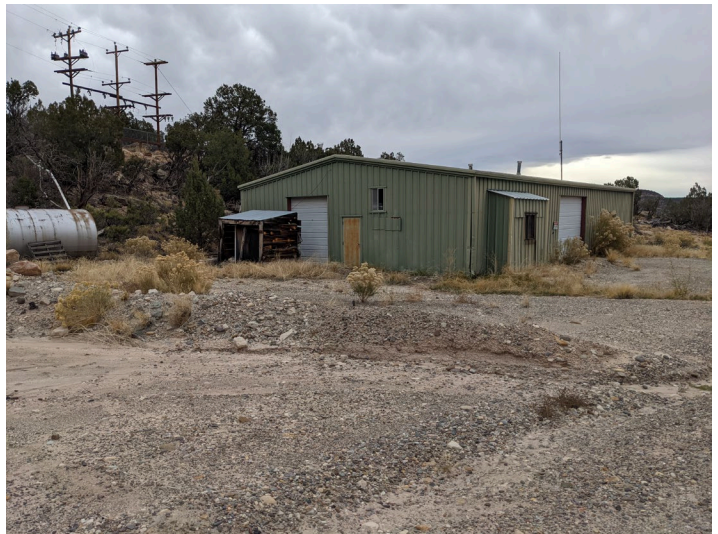
This area consists of a collapsed portal, a metal building, waste rock pile and associated stormwater control structures. Overall, the area is well kept. Stormwater control structures appear to be maintained and functioning as designed. Conditions are similar to those observed during the Division's last inspection of this area. No problems or violations were noted.
