MINERALS PROGRAM INSPECTION REPORT
PHONE: (303) 866-3567

MINE NAME: C-JD-8	MINE/PROSPECTING ID#: M-1984-014	MINERAL: Uranium and vanadium	COUNTY: Montrose
INSPECTION TYPE: Monitoring	WEATHER: Clear	INSP. DATE: October 11, 2022	INSP. TIME: 13:30
OPERATOR: Highbury Resources Inc.	OPERATOR REPRESENTATIVE: Scott Pottorffs, Dana Cline	TYPE OF OPERATION: 112d-1 - Designated Mining Operation	
REASON FOR INSPECTION: Normal I&E Program	BOND CALCULATION TYPE:	BOND AMOUNT: \$69,950.00	
DATE OF COMPLAINT: NA	POST INSP. CONTACTS: None	JOINT INSP. AGENCY: U.S. Energy	
INSPECTOR(S): Dustin Czapla	INSPECTOR'S SIGNATURE:

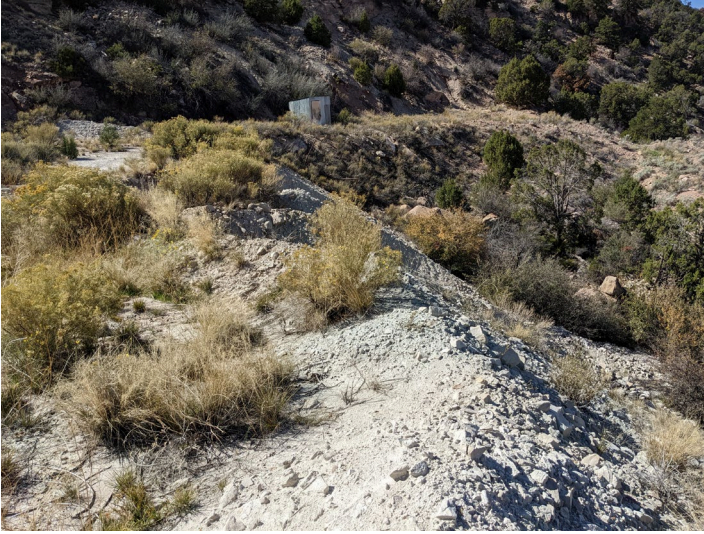
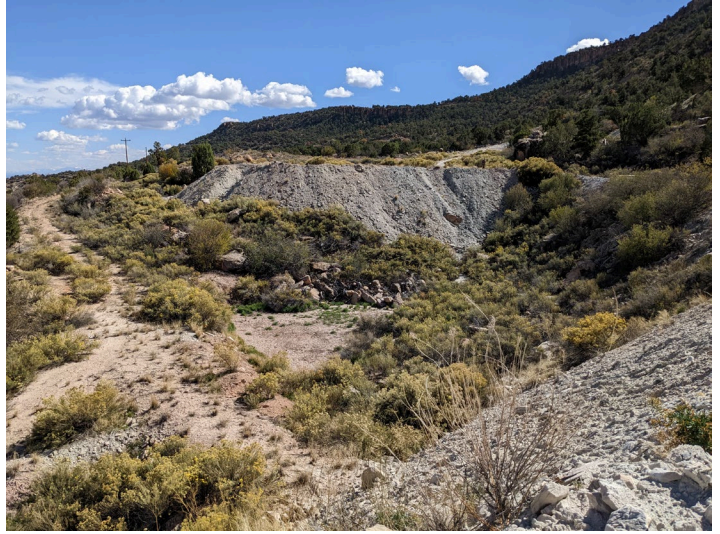
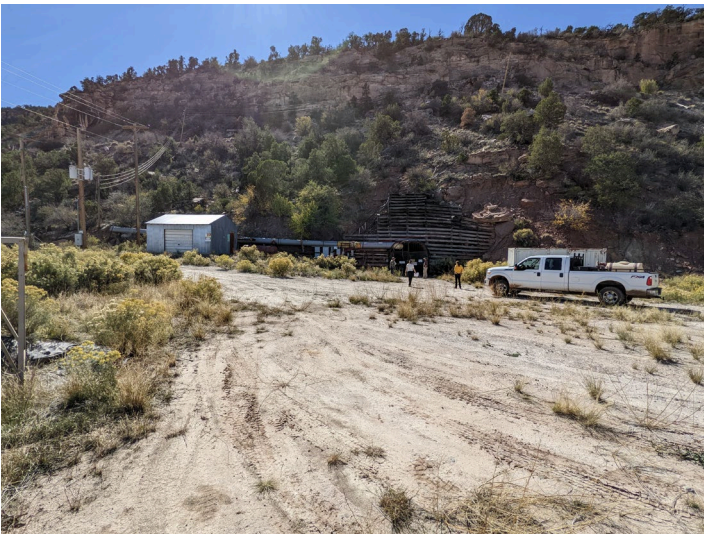
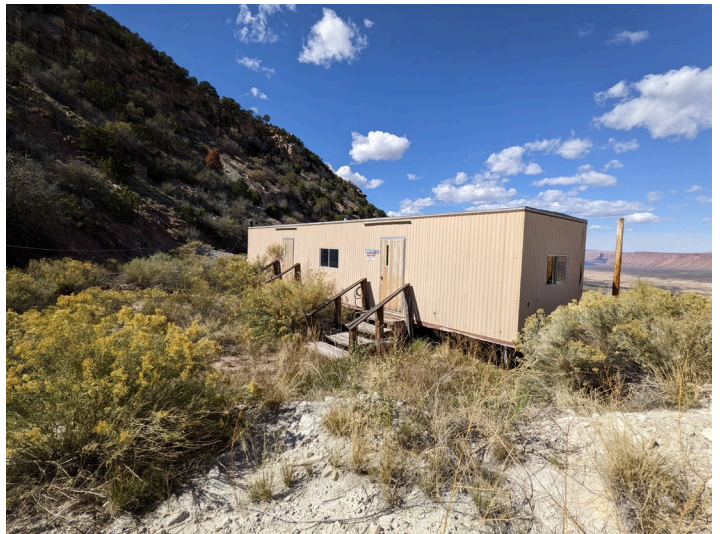
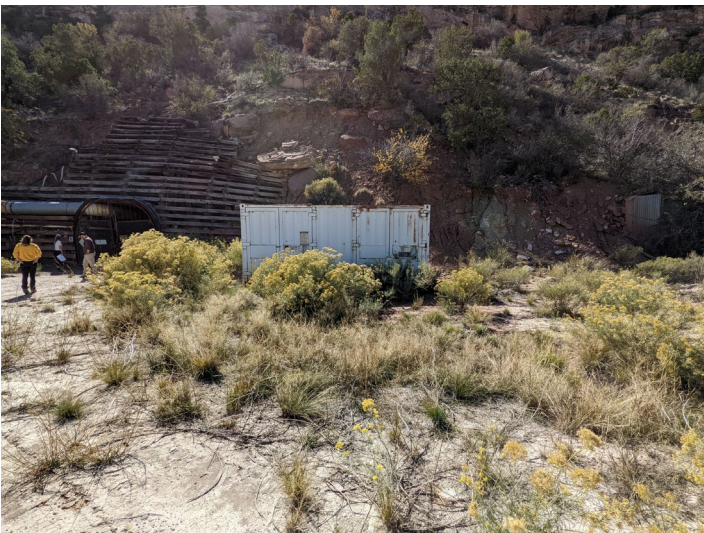
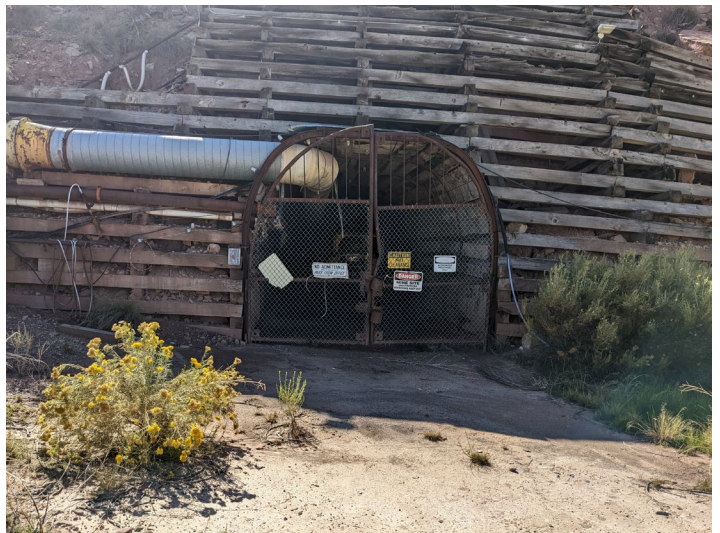
An office building, compressor shed and ventilation system are located on the main mine bench. Unused mining equipment and empty fuel tank have been removed from the site. Stormwater control structures appeared maintained and functional. No problems or violations were noted during this inspection. Final reclamation has not yet commenced.
