**MINERALS PROGRAM INSPECTION REPORT**  
**PHONE: (303) 866-3567**

| <b>MINE NAME:</b><br>Van 4 Shaft | <b>MINE/PROSPECTING ID#:</b><br>M-1997-032 | <b>MINERAL:</b><br>Uranium and vanadium | <b>COUNTY:</b><br>Montrose |
| <b>INSPECTION TYPE:</b><br>Monitoring | <b>WEATHER:</b> Clear | <b>INSP. DATE:</b><br>October 11, 2022 | <b>INSP. TIME:</b><br>15:00 |

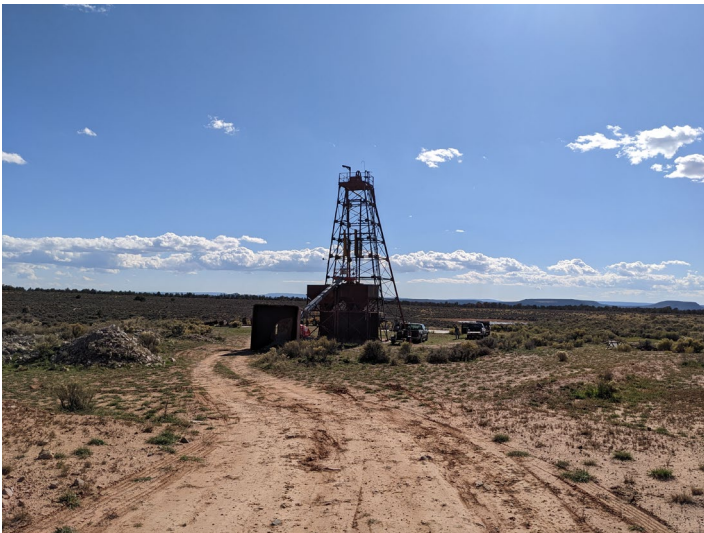
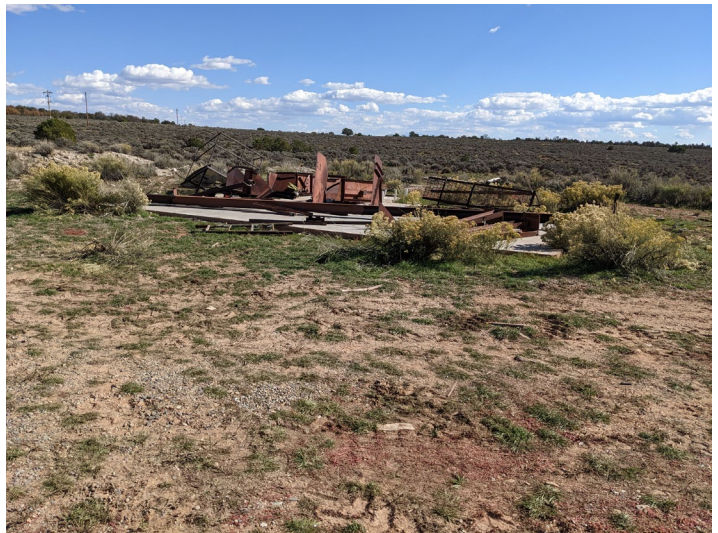
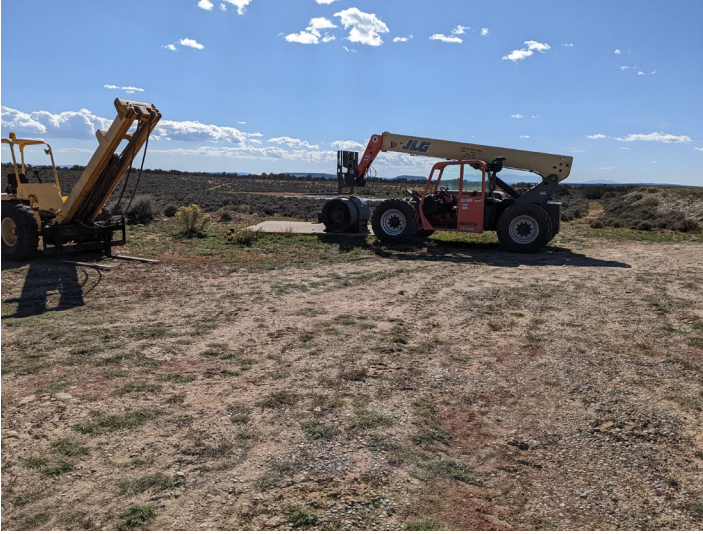
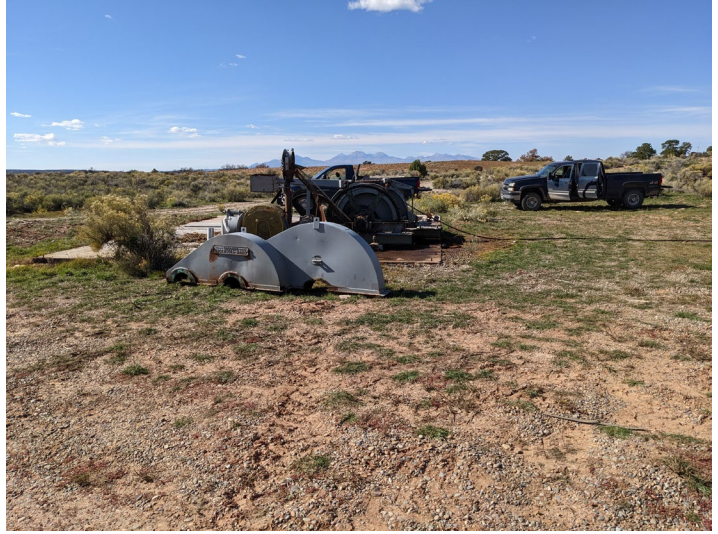
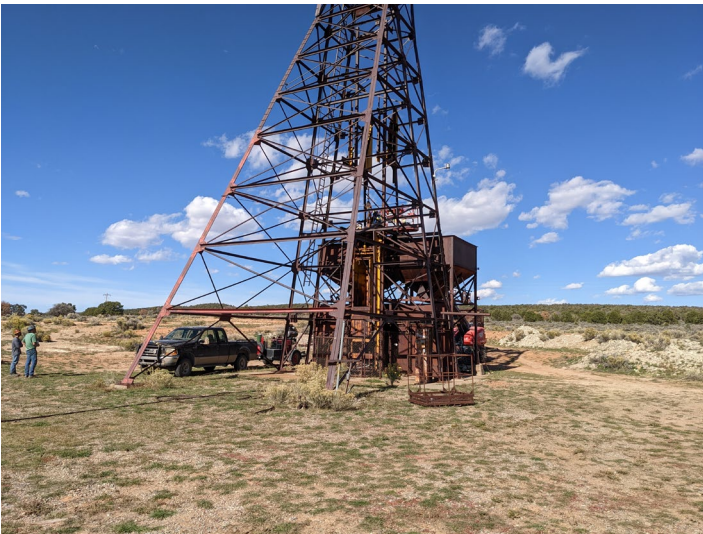
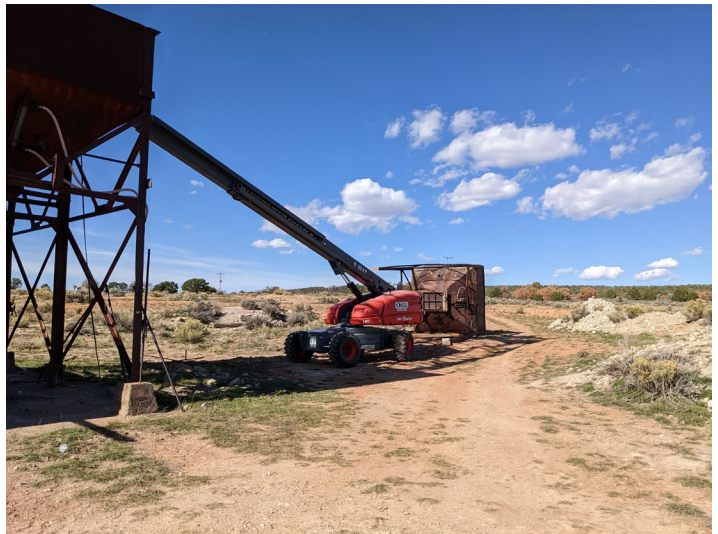
The metal shop building, shed and hoist house have been removed. The slab foundations are still in place. The operator was disassembling the headframe during this inspection.
