MINERALS PROGRAM INSPECTION REPORT
PHONE: (303) 866-3567

MINE NAME: Yetter Pit	MINE/PROSPECTING ID#: M-1996-050	MINERAL: Sand and gravel	COUNTY: Logan
INSPECTION TYPE: Monitoring	WEATHER: Clear	INSP. DATE: November 21, 2022	INSP. TIME: 10:00
OPERATOR: R & J Yetter Sand & Gravel LLC	OPERATOR REPRESENTATIVE: Jewelie Yetter	TYPE OF OPERATION: 110c - Construction Limited Impact	
REASON FOR INSPECTION: Normal I&E Program	BOND CALCULATION TYPE: Complete Bond	BOND AMOUNT: \$17,500.00	
DATE OF COMPLAINT: NA	POST INSP. CONTACTS: None	JOINT INSP. AGENCY: None	
INSPECTOR(S): Nikie Gagnon	INSPECTOR'S SIGNATURE:

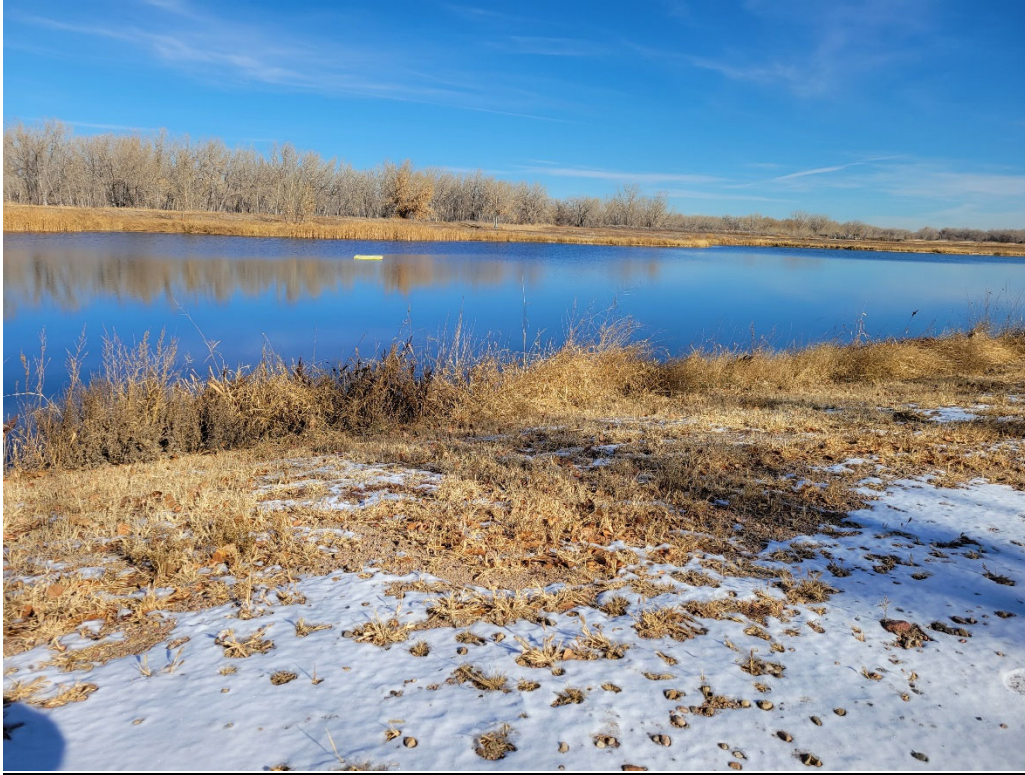
Looking northeast across pond. Vegetation well established around pond.

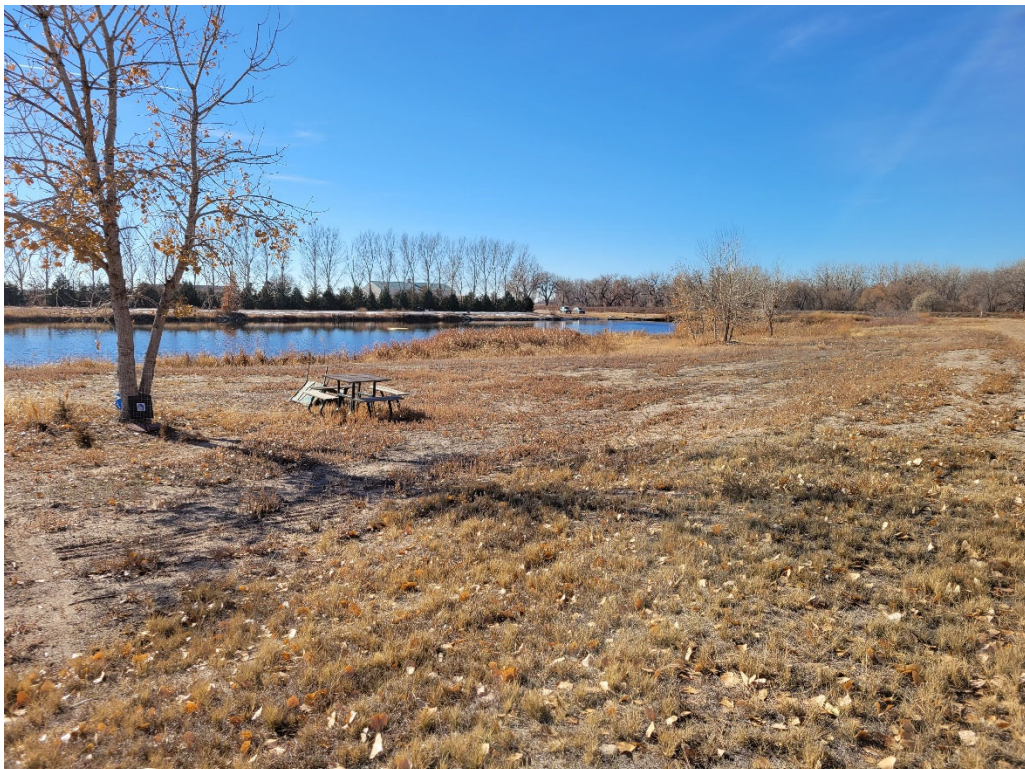
Looking west. Recreation area on the northern shore.

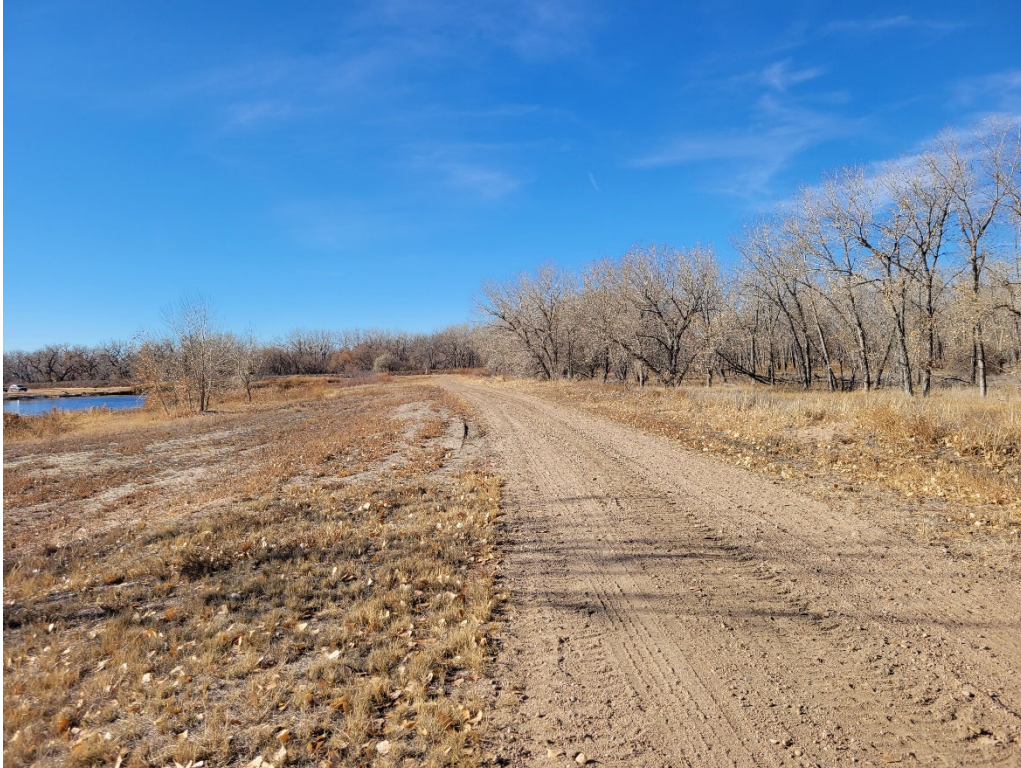
Reclamation work is complete. The pit was backfilled and graded and all stockpiles have been removed. The shoreline slopes are no steeper than 3H:1V. There is an approved access road around the pond that will be used for recreation access.

Looking west, access road around perimeter of pond.

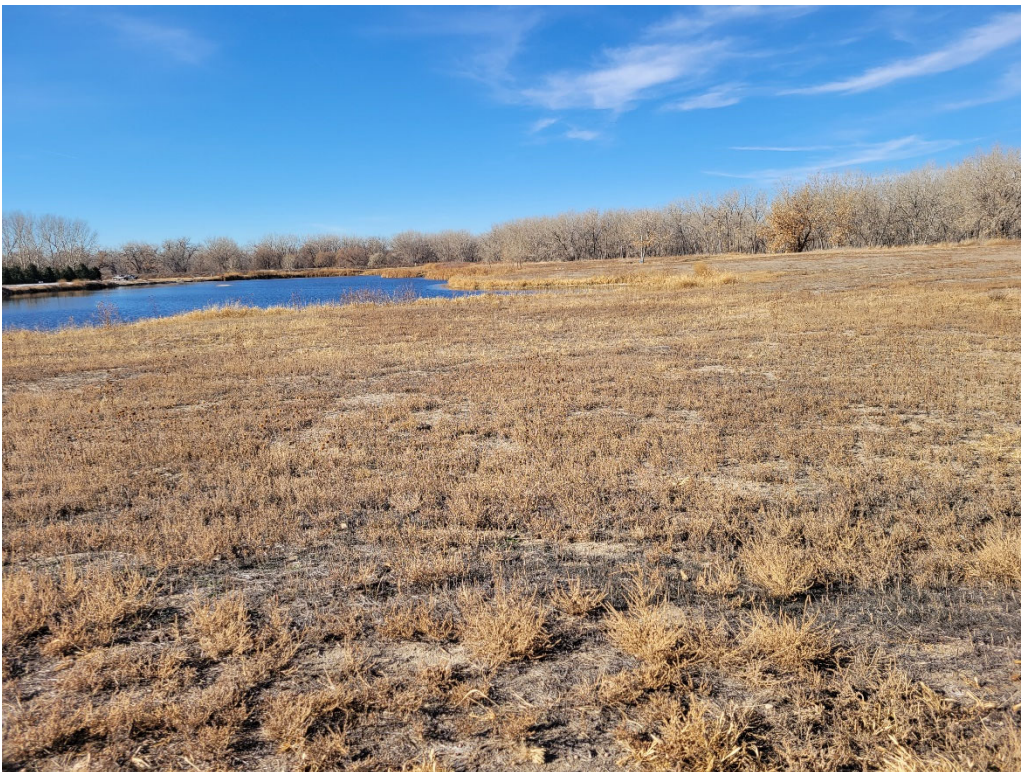
The desired vegetation is established across the majority of the permit area. The northeastern corner of the permit area was drill seeded in 2021. The grass is patchy and bare ground is exposed in this area. Dead annual weed stalks indicate some soil stabilization and reduced wind erosion which will allow native grasses to establish over time. The Division recommends broadcast seeding again in the spring once the ground thaws.

Looking west across seeded area northeastern side of pond.

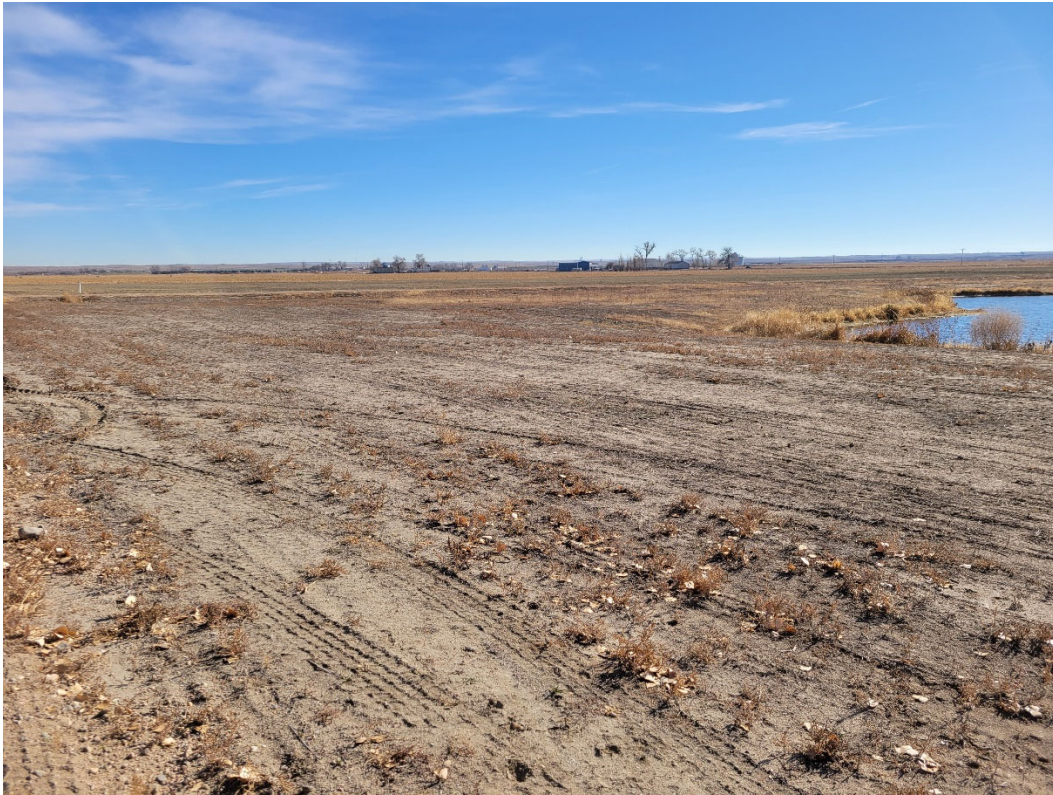
Looking east, northeast corner, seeded in 2021.

The site is in very good condition with no problems noted. During the inspection, the Division recommended the permittee seek release of the permit once the native grasses establish in the bare spots on the north/east sides of the pond.

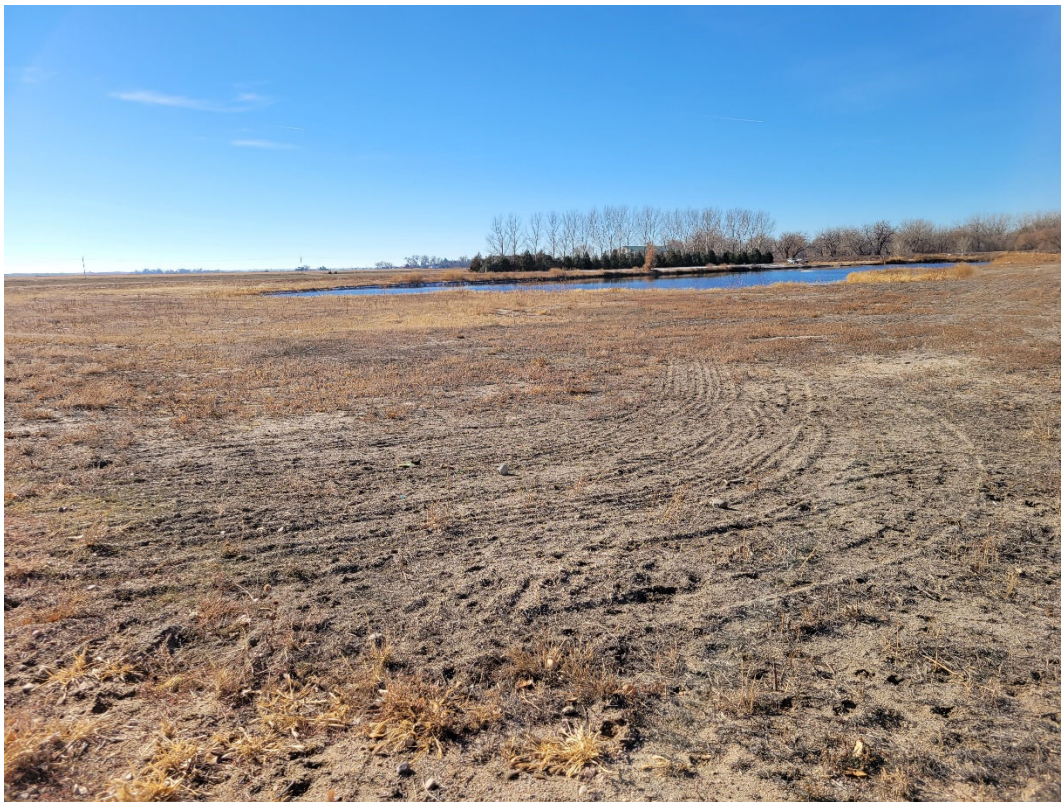
Looking south from northeastern corner of permit area.

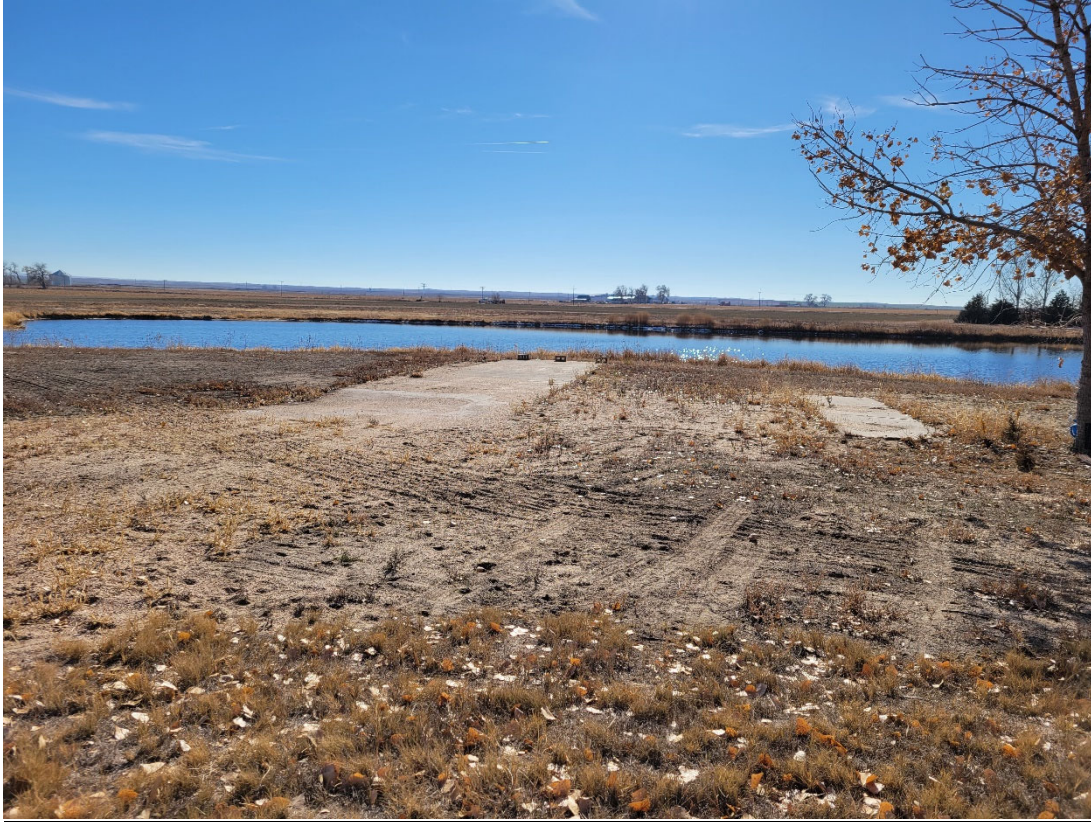
RV/camping area on north side of pond.

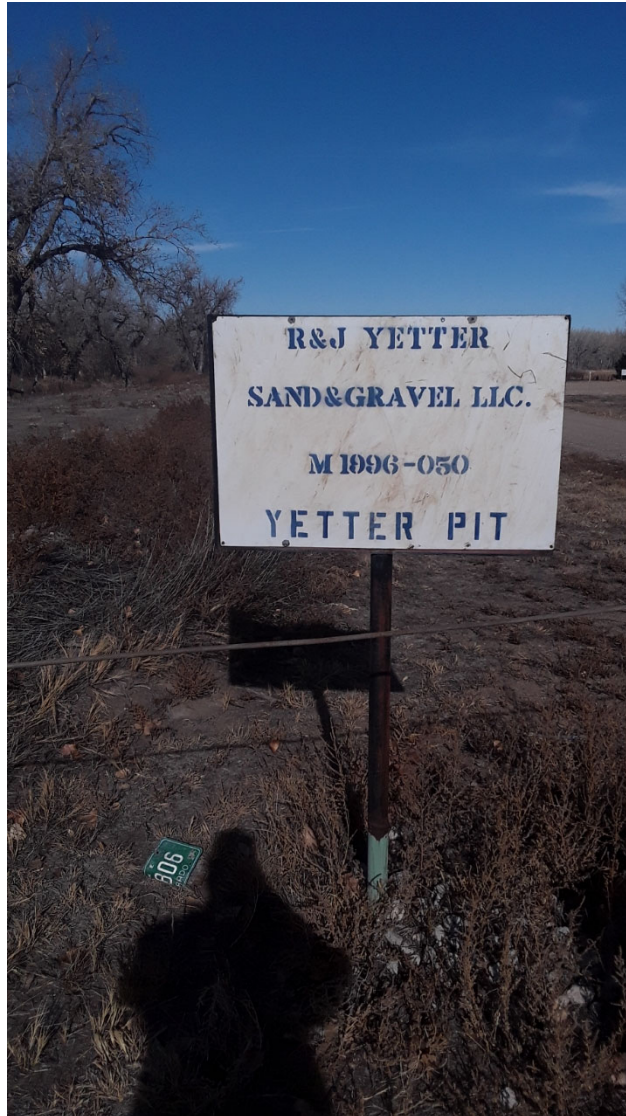
The permit boundary is clearly marked with 2-inch PVC posts. During the inspection, the mine identification sign was not posted at the entrance. Mrs. Yetter indicated the sign had fallen off of the post and it was immediately reinstalled by the land owner. Shortly after the inspection, the Mrs. Yetter sent the Division a photo of the sign in place at the entrance to the property.

Mine sign reinstalled. Photo provided by Operator on 11/21/22.
