MINERALS PROGRAM INSPECTION REPORT
PHONE: (303) 866-3567

MINE NAME: Agnus Dei Lode Claim	MINE/PROSPECTING ID#: M-2013-052	MINERAL: Gemstones and quartz (quartzite/quartzose s	COUNTY: El Paso
INSPECTION TYPE: Monitoring	WEATHER: Clear	INSP. DATE: October 12, 2022	INSP. TIME: 14:10
OPERATOR: Jean Marie Cowman	OPERATOR REPRESENTATIVE: Jean Cowman	TYPE OF OPERATION: 110(2) - Hard Rock Limited Impact	
REASON FOR INSPECTION: Normal I&E Program	BOND CALCULATION TYPE:	BOND AMOUNT: \$6,553.53	
DATE OF COMPLAINT: NA	POST INSP. CONTACTS: U.S.Forest Service	JOINT INSP. AGENCY: U.S.Forest Service	
INSPECTOR(S): Timothy Cazier, P.E.	INSPECTOR'S SIGNATURE:

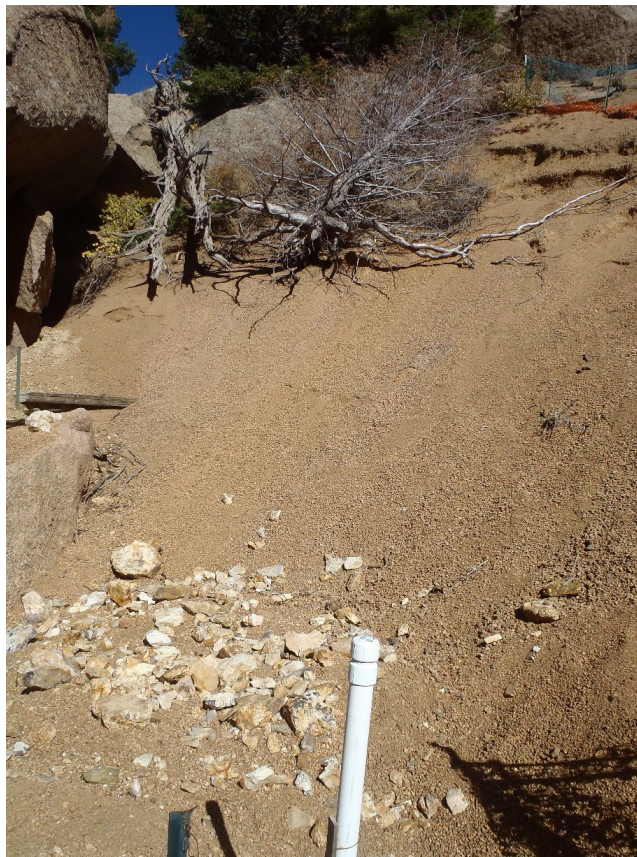
Backfilling and Grading: The main pit observed during the previous inspection had been backfilled (see **Photo 1**).

Photo 1. Backfilled pit (looking NE).

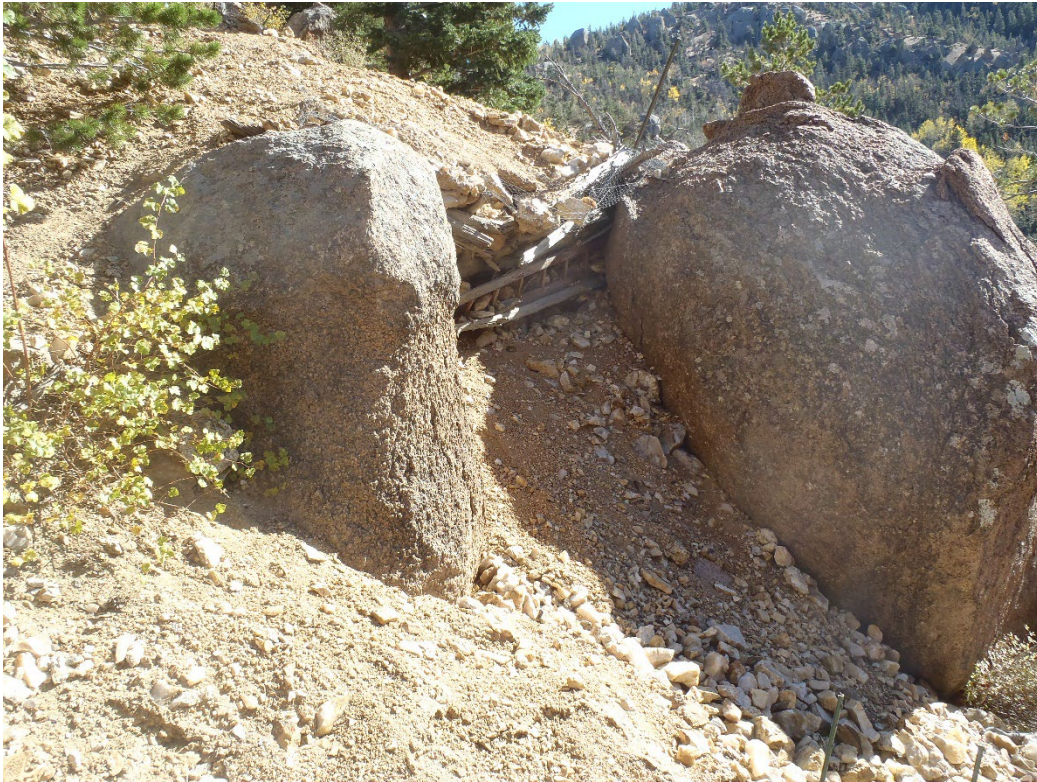
Excess Spoil and Dev. Waste: The crib wall remains (see **Photo 2**) stabilizing some of the excavated spoil. As stated in the previous inspection report, the DRMS continues to have concerns about the durability of this non-engineered structure. The second from top log has broken since the previous inspection (see **Photo 3**). A failure will almost certainly result in offsite impacts given the steep terrain. If offsite impacts occur, the DRMS may pursue enforcement actions commensurate with those impacts.

Photo 2. Crib wall (looking SSE).

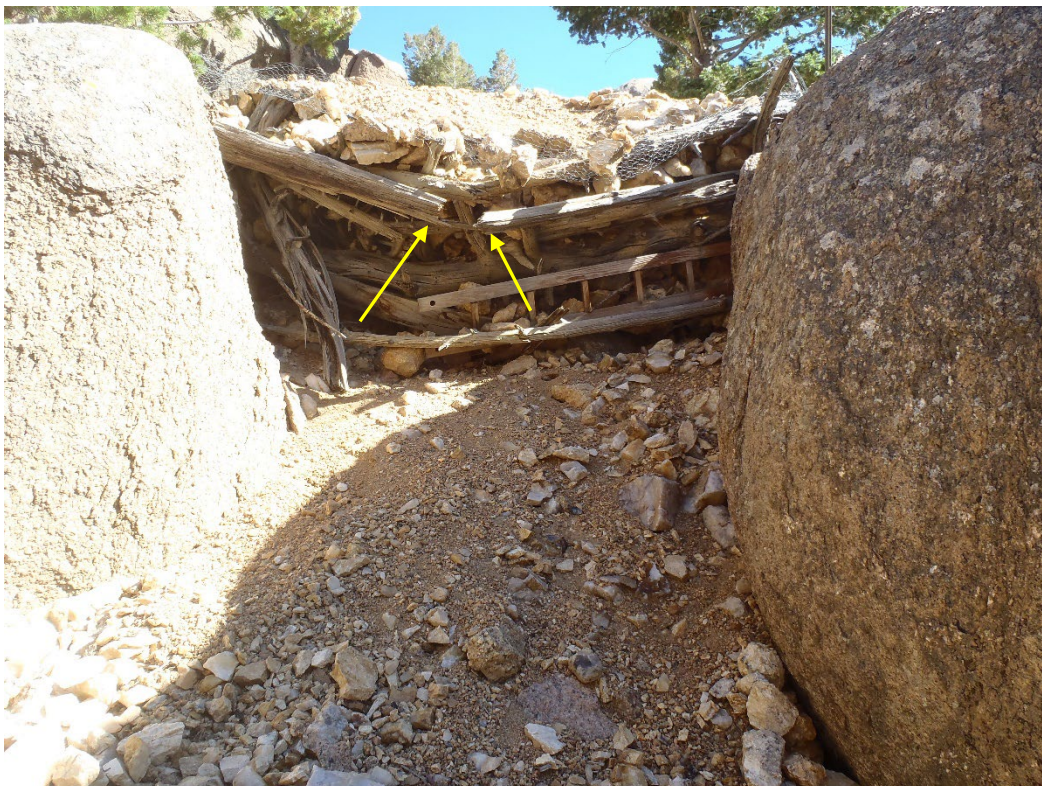
Photo 3. Crib wall (looking east from below – *compare now broken log with similar 2017 inspection photo*).

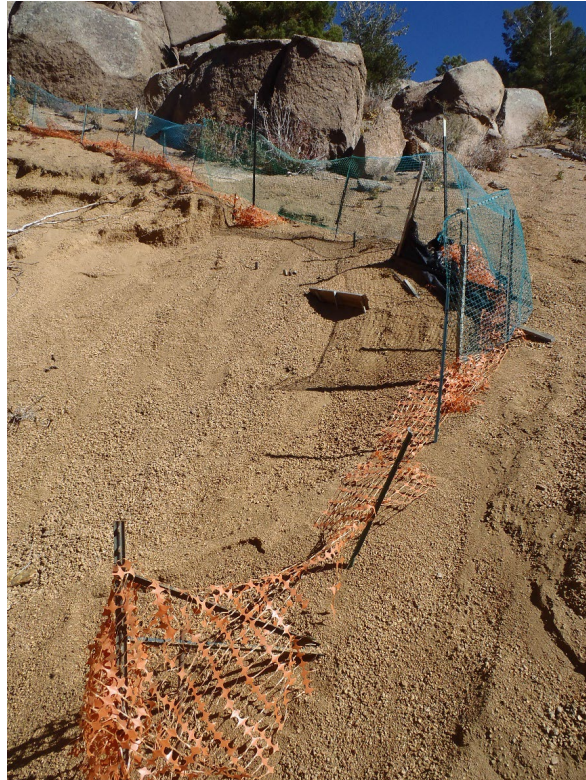
Reclamation Success: No reclamation has been initiated. The orange construction fence surrounding the

primary dig site (see **Photo 4**) is in tatters and should be removed.

Photo 4. Tattered orange construction fence (should be removed).

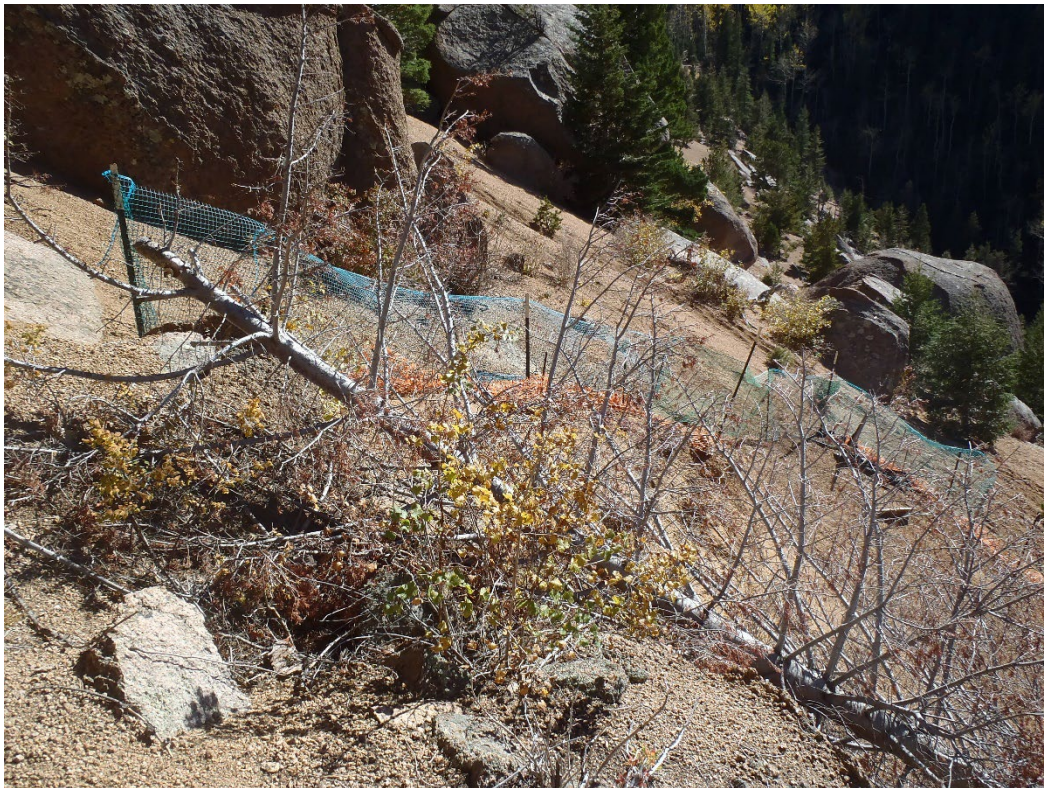
Revegetation: No noxious weeds were observed. The surrounding area has very sparse vegetation (see **Photo 5**)

Topsoil: Topsoil is non-existent at this site.

Photo 5. Typical sparse vegetation and lack of topsoil on site (looking SW from above main pit).

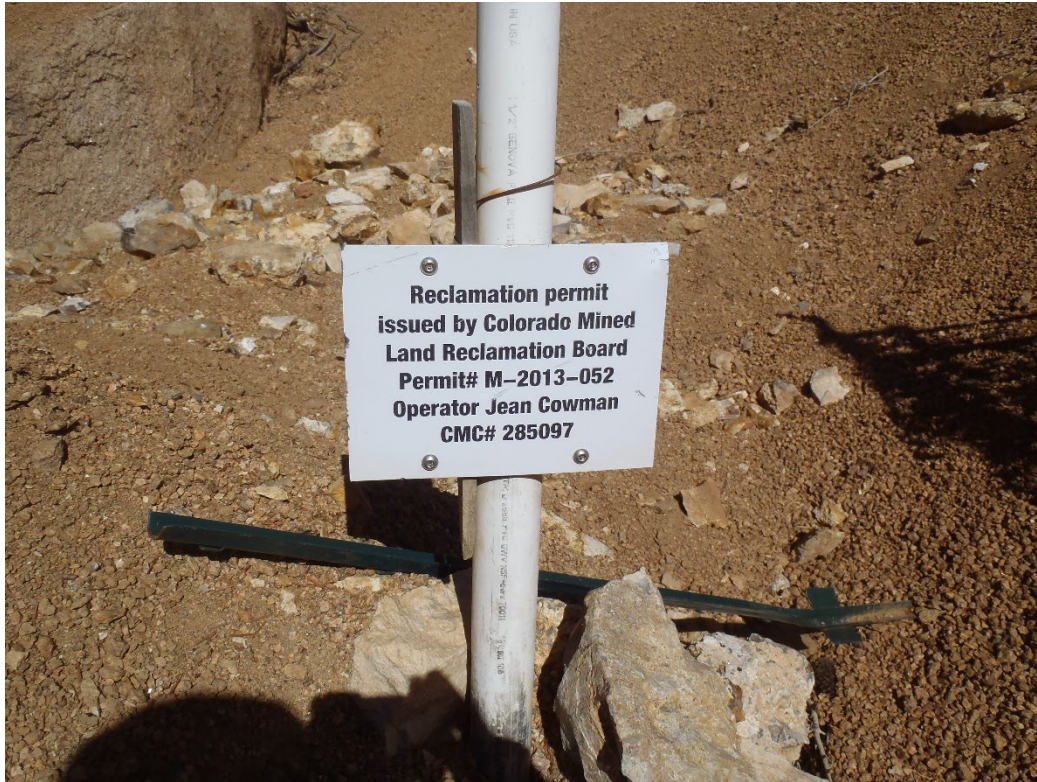
Signs and Markers: The permit sign was properly posted (see **Photo 6**) and three boundary markers (see **Photo 7**) were observed to delineate the affected area boundary. The fourth (north corner) marker could not be located. Ms. Cowman committed to getting this marker relocated.

Photo 6. Permit sign.

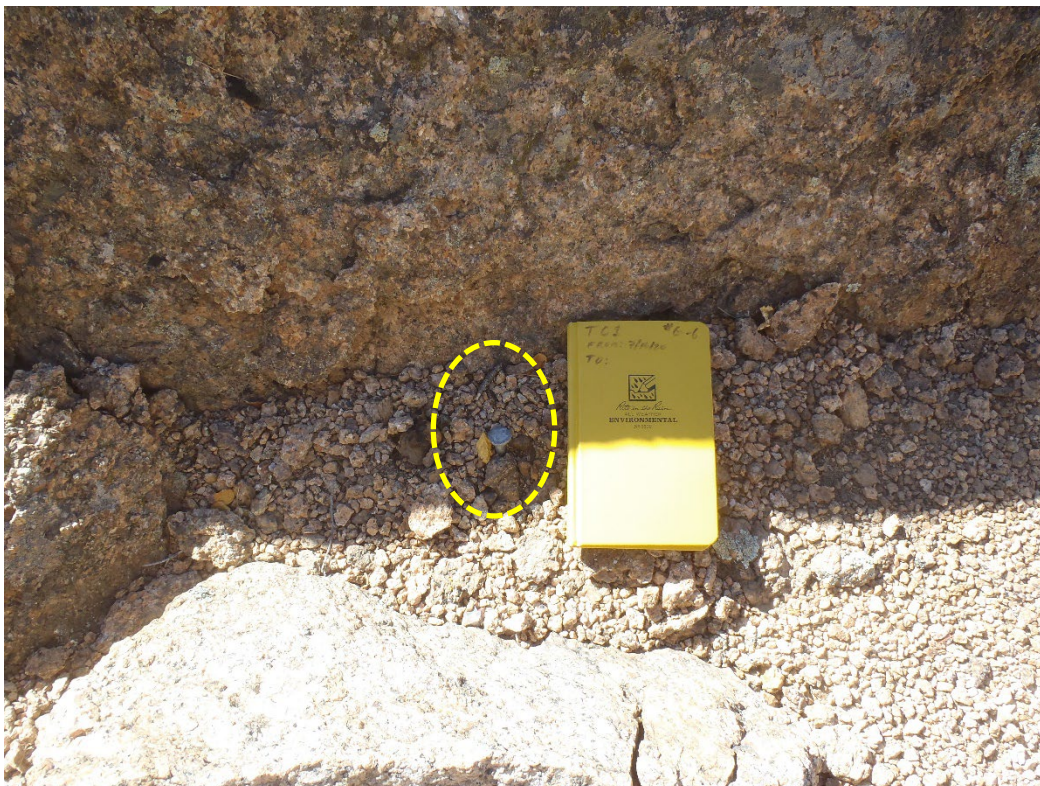
Photo 7. Typical affected area pin marker (west side).
