PERMIT INFORMATION

Permit Number: C-1981-014 Mine Name: Southfield Mine Operator: Energy Fuels Coal, Inc. Operator Address: Mr John Adams P.O. Box 773457 Steamboat Springs, CO 80477	County: Fremont Operation Type: Underground Permit Status: Revoked Ownership: Private
	Operator Representative Present: None
Operator Representative Signature: (Field Issuance Only)

INSPECTION INFORMATION

Inspection Start Date: December 7, 2022 Inspection Start Time: 08:00 Inspection End Date: December 7, 2022 Inspection End Time: 08:30	Inspection Type: Coal Complete Inspection Inspection Reason: Normal I&E Program Weather: Clear
Joint Inspection Agency: None	Joint Inspection Contacts: None
Post Inspection Agency: None	Post Inspection Contacts: None
Inspector(s): Zach Trujillo	Inspector's Signature:

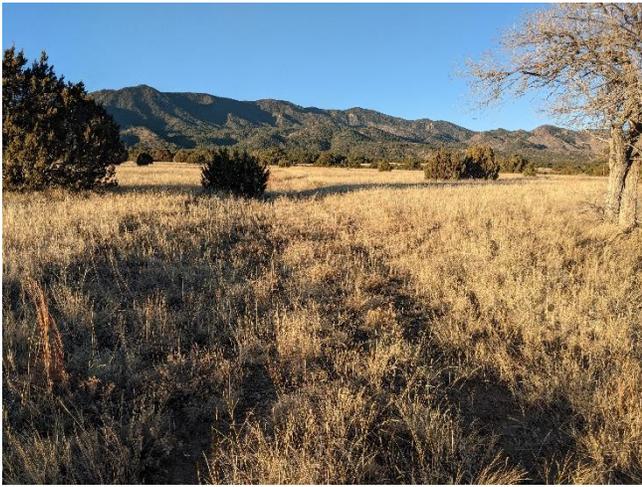
The reclaimed road spur and access road to the NW-MW well were inspected. The road spur is very well vegetated and is indiscernible from the adjacent undisturbed areas. The access road for the NW-MW well continues to show increased vegetation as well as the NW-MW well pad.

Access road to NW-MW pad.

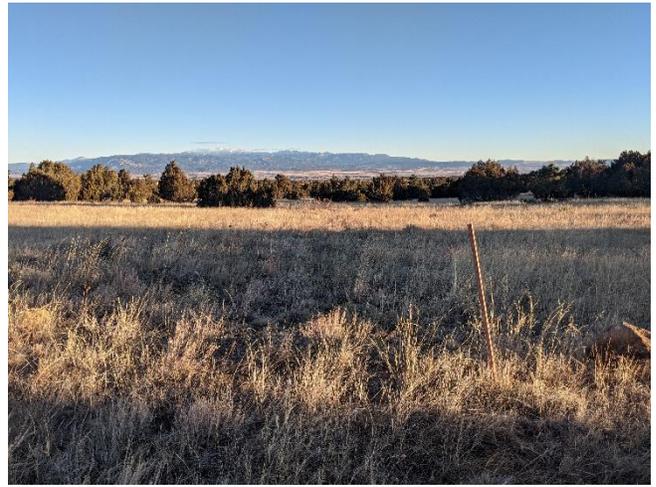
Road spur.

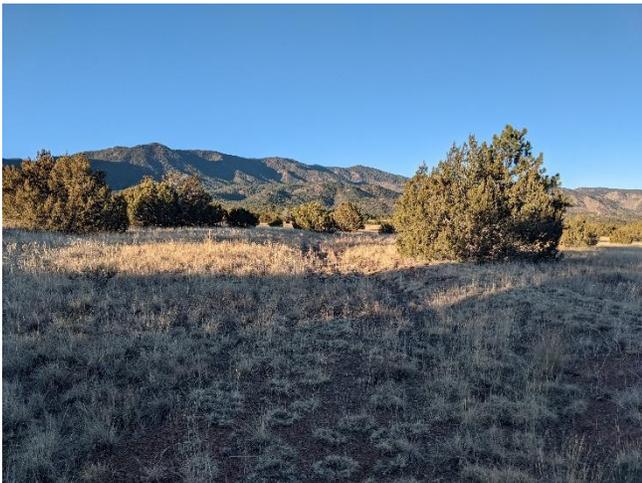
The two track road off County Road 51 was inspected. This portion of the remaining disturbance was not reclaimed however vegetation continues to establish itself along the road. Cactus, shrubs and grasses have naturally encroached from the surrounding undisturbed area. No signs of use was observed on the road as well as erosion.

Two track road.
