## MINERALS PROGRAM INSPECTION REPORT

<b>MINE NAME:</b> Cresson Project	<b>MINE/PROSPECTING ID#:</b> M-1980-244	<b>MINERAL:</b> Gold and silver	<b>COUNTY:</b> Teller
<b>INSPECTION TYPE:</b> Monitoring	<b>WEATHER:</b> Clear	<b>INSP. DATE:</b> November 28, 2022	<b>INSP. TIME:</b> 09:30
<b>OPERATOR:</b> Cripple Creek & Victor Gold Mining Company	<b>OPERATOR REPRESENTATIVE:</b> Tony Matarrese, Brian Doering	<b>TYPE OF OPERATION:</b> 112d-3 - Designated Mining Operation	
<b>REASON FOR INSPECTION:</b> Normal I&E Program	<b>BOND CALCULATION TYPE:</b> None	<b>BOND AMOUNT:</b> \$209,491,188.00	
<b>DATE OF COMPLAINT:</b> NA	<b>POST INSP. CONTACTS:</b> None	<b>JOINT INSP. AGENCY:</b> None	
<b>INSPECTOR(S):</b> Amy Eschberger	<b>INSPECTOR'S SIGNATURE:</b>

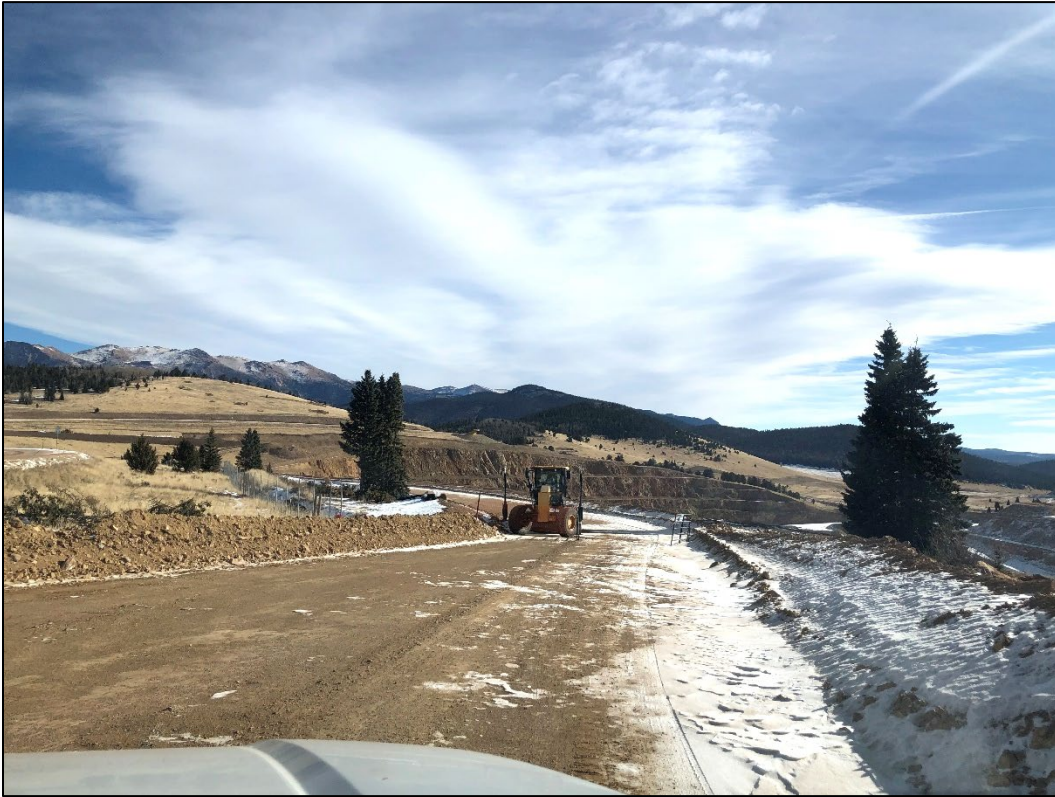
**Photo 1.** View looking east at new Ironclad access road at its western terminus off the existing access road/Co Rd 82.

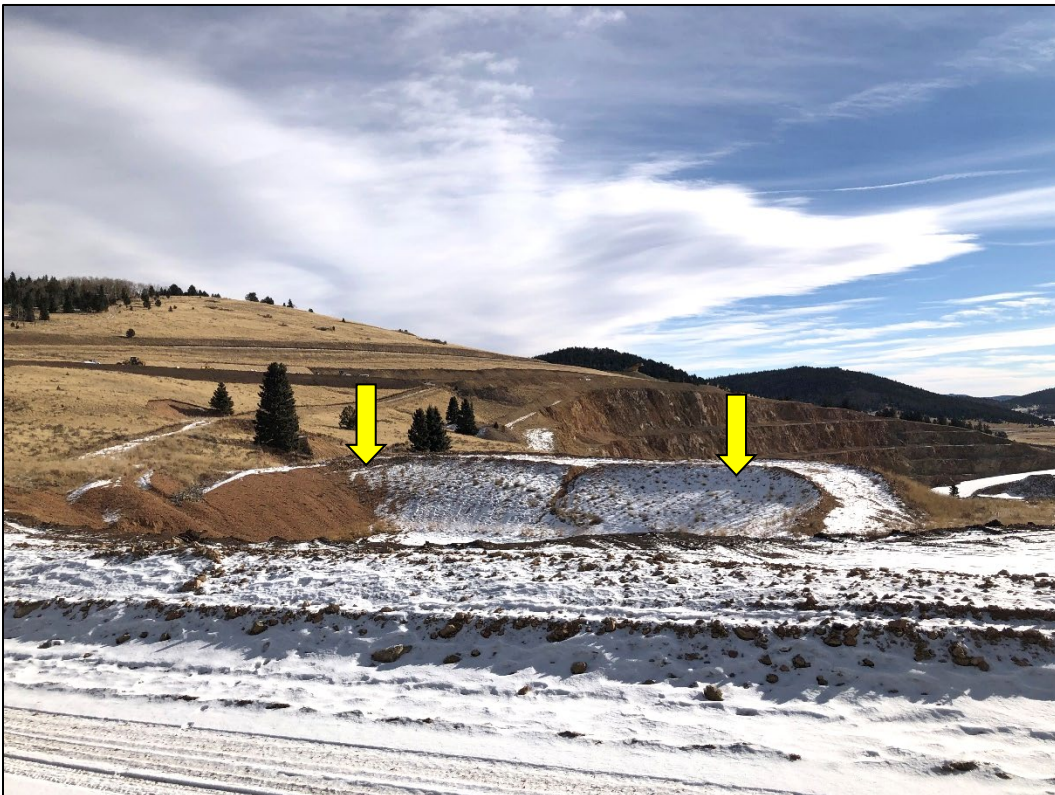
new road alignment appeared to be complete. However, the road had not yet been surfaced with gravel, and the four culverts and associated riprap aprons had not yet been installed. The Division did observe two stormwater sump BMPs constructed south of the new road alignment, one near Station 16+00 and the other near Station 64+00. Safety berms were constructed along both sides of the road. The road alignment appeared to have been constructed in accordance with TR-128, including the fairly tight curve to the northeast immediately east of the mine overlook. The operator stated the new access road was constructed to meet the requirements of a commercial driveway, as specified by the Teller County Department of Transportation (TCDOT). The main reason why the operator decided to stick with the approved alignment is that straightening the curve would require a final grade that is steeper than 10%, which would not meet TCDOT requirements for a commercial driveway. Creating a final grade that is less than 10% would require a significant amount of additional fill to be imported to the site. Therefore, the operator decided to stick with the approved alignment which meets TCDOT requirements. The operator indicated the county would be inspecting the road later that week to approve the final grading. The Division observed the disturbed areas adjacent to the road which had already been graded and some portions retopsoiled. These areas will be seeded as soon as practical (most likely in spring 2023).

**Photo 2.** View looking south at stormwater sump BMP (indicated) constructed south of new Ironclad access road, near Station 16+00.

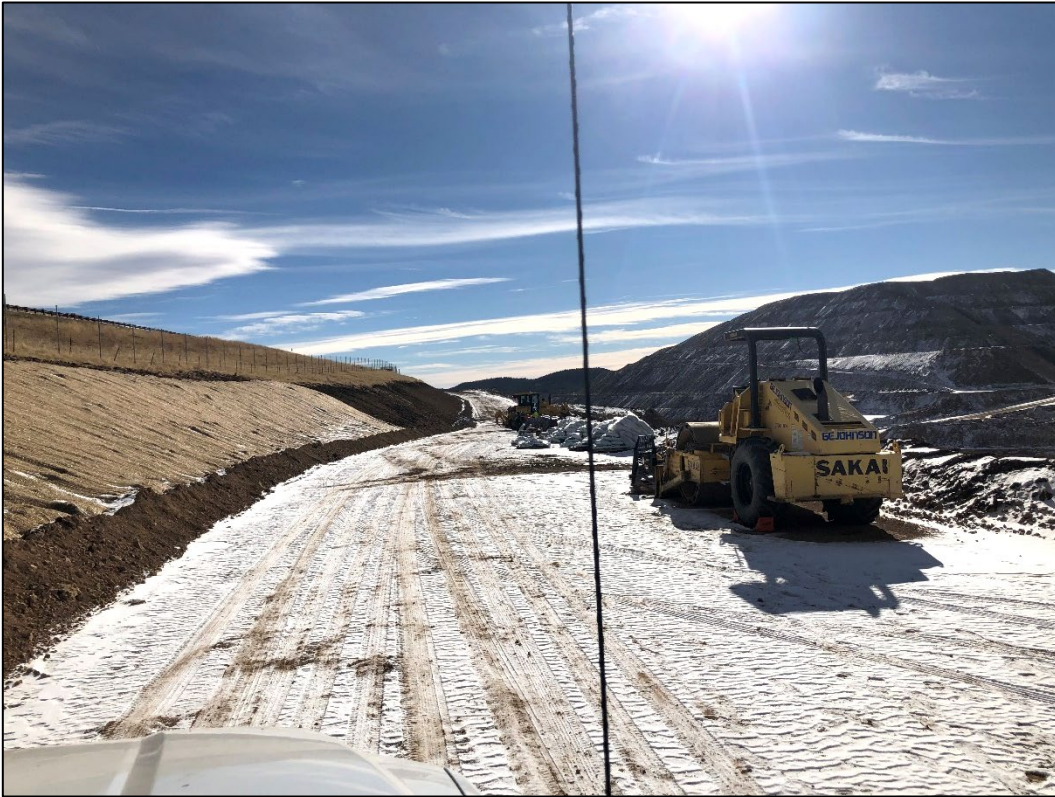
**Photo 3.** View looking east at section of new Ironclad access road located directly south of Co Rd 82, showing northern disturbed slope (at left) which has been graded, retopsoiled, and prepared for seeding.

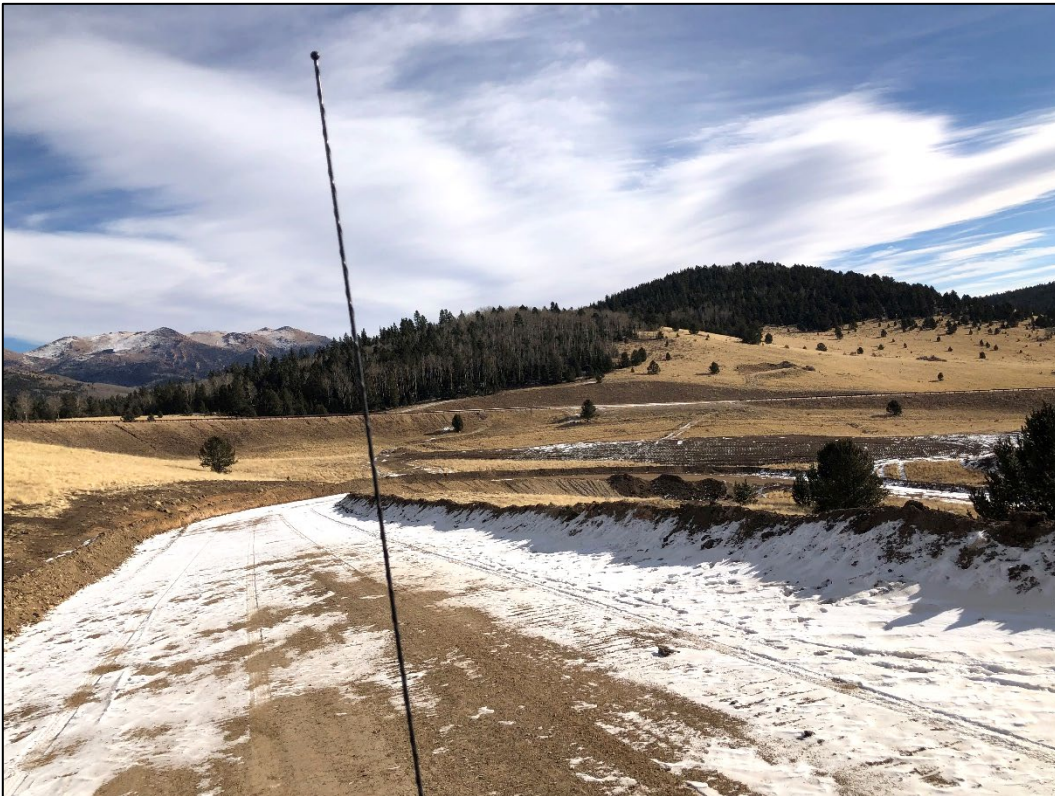
In July of this year, the operator notified the Division they were considering a revision to the road alignment approved in TR-128. The revision would be to the eastern half of the road, mainly to straighten out a tight curve. At that time, the Division informed the operator the proposed revision to the road alignment was not significant enough to warrant a new Technical Revision submittal. However, the operator would need to submit an Addendum to TR-128 that includes a revised Drawing A05 – Site Plan showing the new road alignment, a description of the deviations and an explanation of why they were needed, and a description of how the revised alignment does not have any significant impacts to the stormwater management plan, geotechnical stability analysis, reclamation plan, or reclamation bond approved in TR-128. The operator later informed the Division they had decided to stick with the road alignment approved in TR-128. Therefore, an Addendum is no longer needed.

**Photo 4.** View looking northeast at section of new Ironclad access road with tight curve to the northeast. Operator was considering straightening out this section, but decided to stick with the approved alignment.

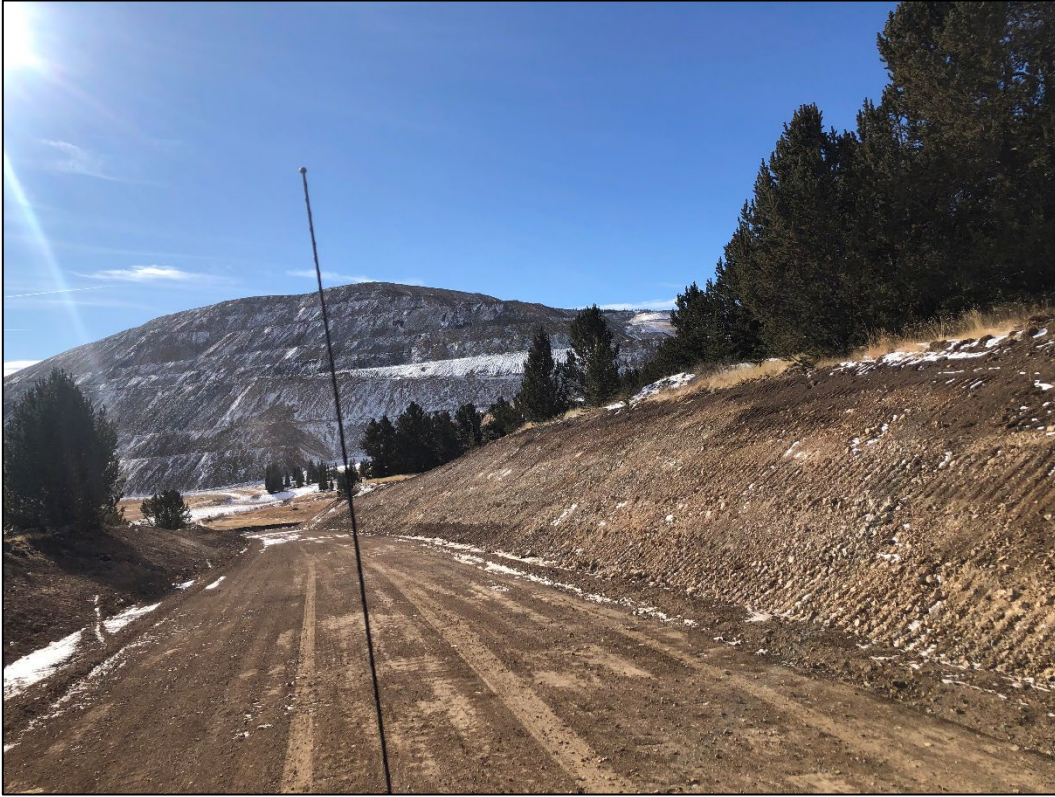
**Photo 5.** View looking south/southwest at section of new Ironclad access road located south of tight curve, showing disturbed western slope (at right) which has been graded and will be retopsoiled and seeded as soon as practical.

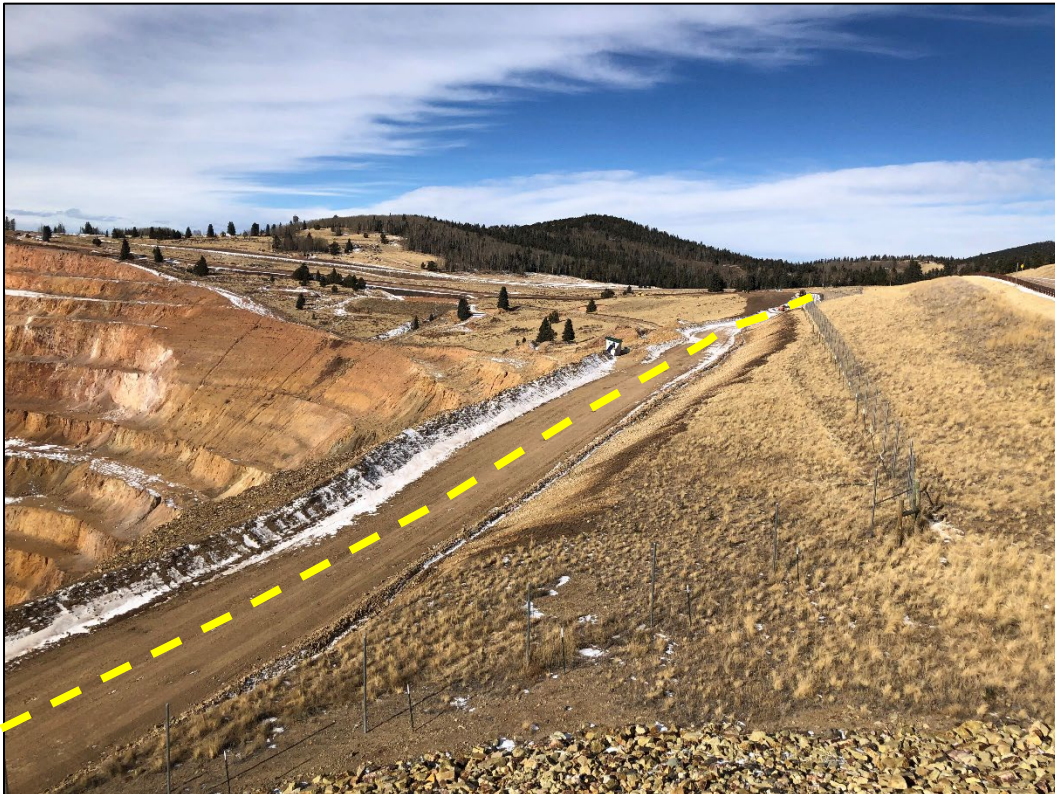
**Photo 6.** View looking west from mine overlook off of Co Rd 82, showing western portion of new Ironclad access road alignment (delineated with yellow dashed line).

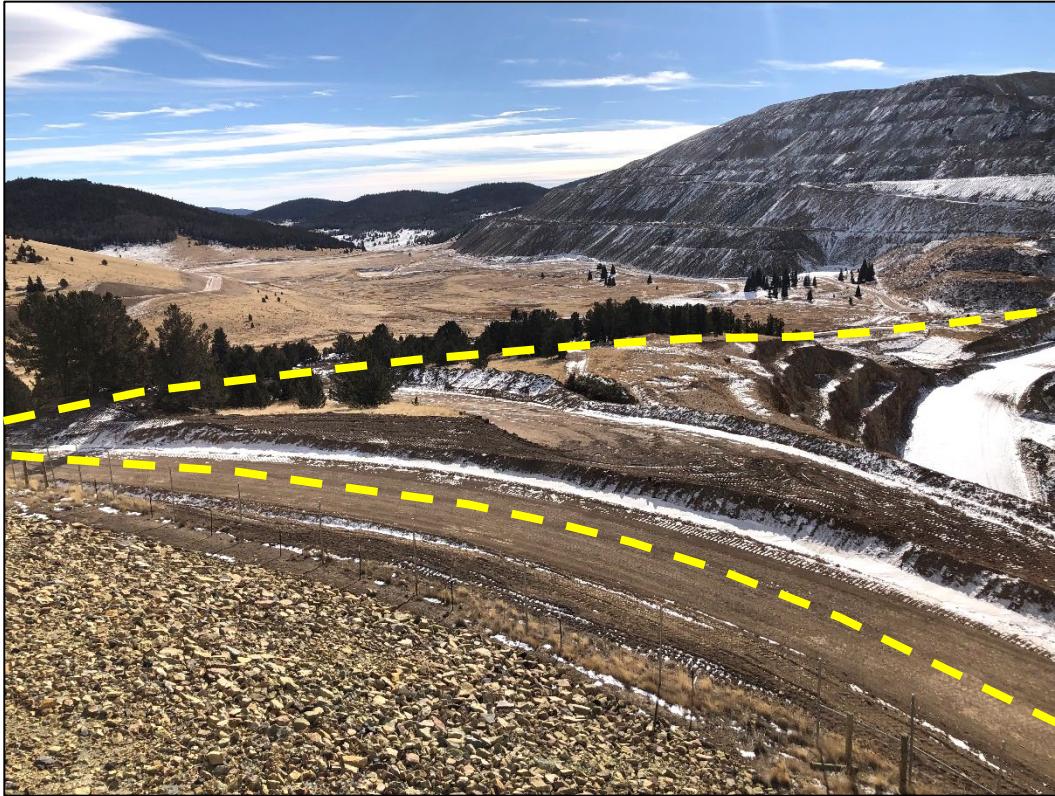
**Photo 7.** View looking east from mine overlook off of Co Rd 82, showing eastern portion of new Ironclad access road alignment (delineated with yellow dashed line).

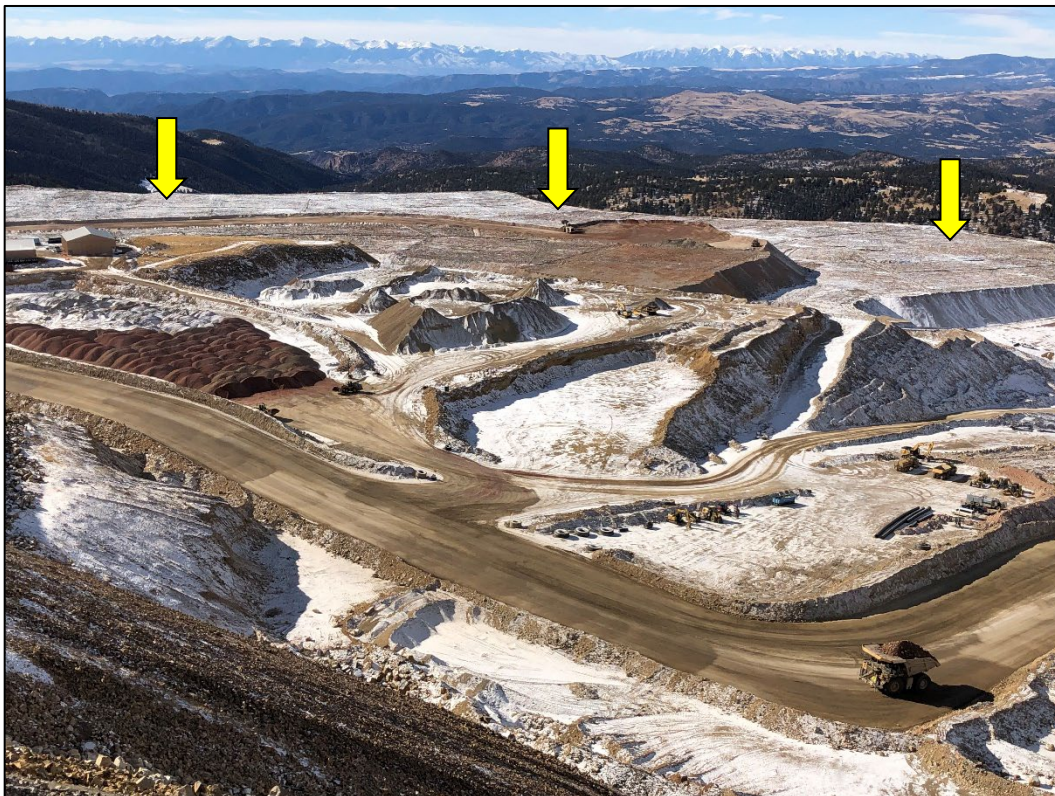
The Division observed the tops of the VLF-2 lifts (from both the overlook location and by vehicle) and did not observe any solution ponding that exceeded the 3 foot x 3 foot surface limit.

**Photo 8.** View looking southwest across top of VLF-2 (indicated) from overlook at northwestern edge of SGOSA.

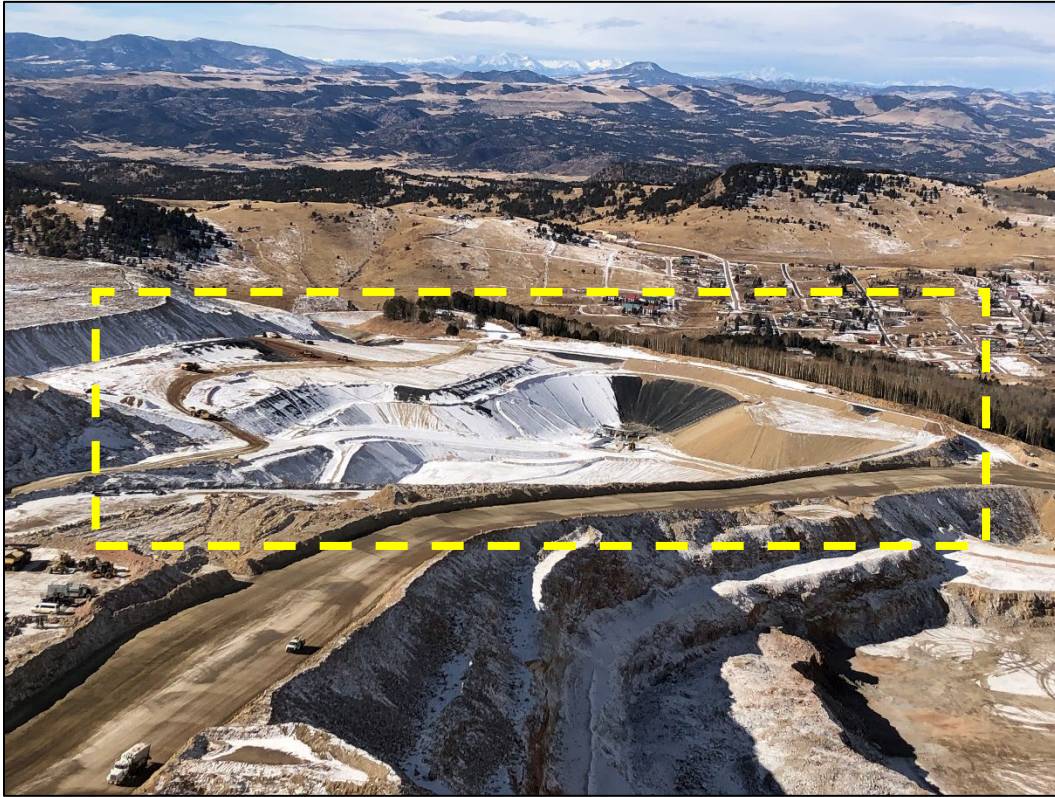
The Division observed the VLF-2 Phase 3 construction area from an overlook located at the northwestern edge of the SGOSA. The operator indicated they are in the process of placing Drain Cover Fill (DCF) on this facility. The operator mentioned during the inspection that the Record of Construction Report (ROC Report) for Phase 3 may not be submitted until February 2023. However, in a meeting held on December 5, 2022, the operator stated the required ROC Report would be submitted (in a Technical Revision) by the end of 2022. The operator should be reminded, no process solution may be placed on the VLF-2 Phase 3 facility until the Division has reviewed and approved the ROC Report for this facility.

**Photo 9.** View looking west across VLF-2 Phase 3 (indicated) from overlook at northwestern edge of SGOSA. Operator plans to submit ROC report for Phase 3 by the end of this year.

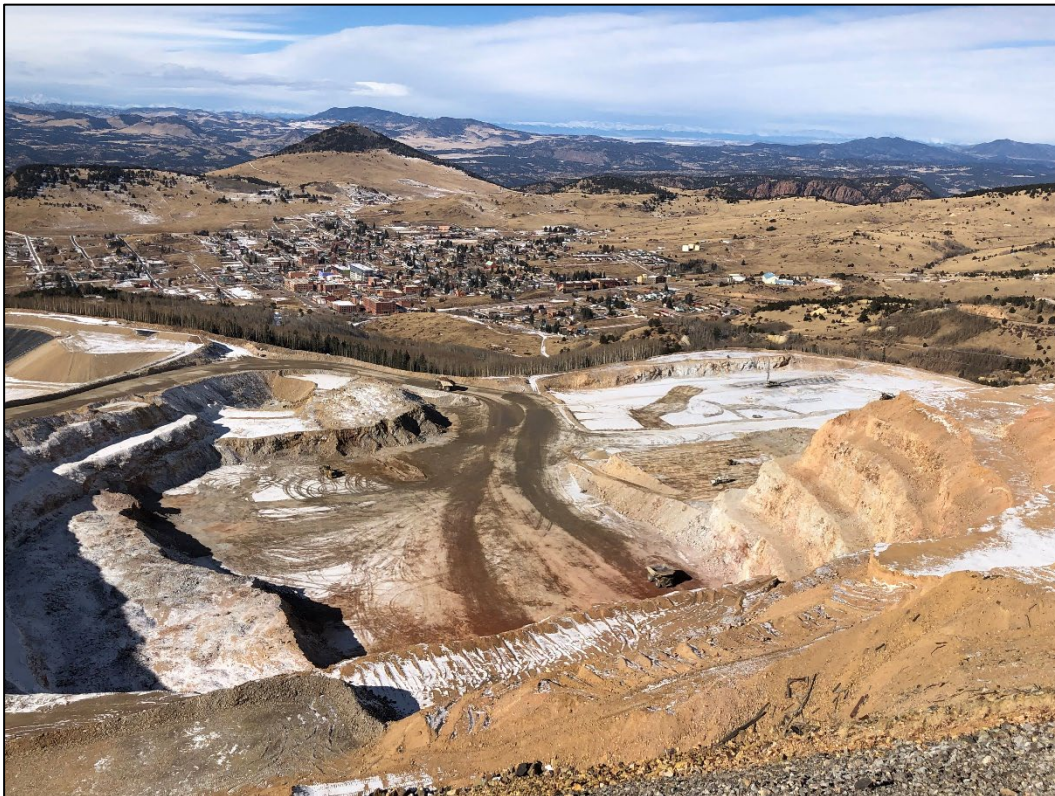
Mining activities were occurring in the portion of the Schist Island pit located directly north/northeast of the lined VLF-2 Phase 3 area.

**Photo 10.** View looking northwest across Schist Island mining area located north/northeast of VLF-2 Phase 3.

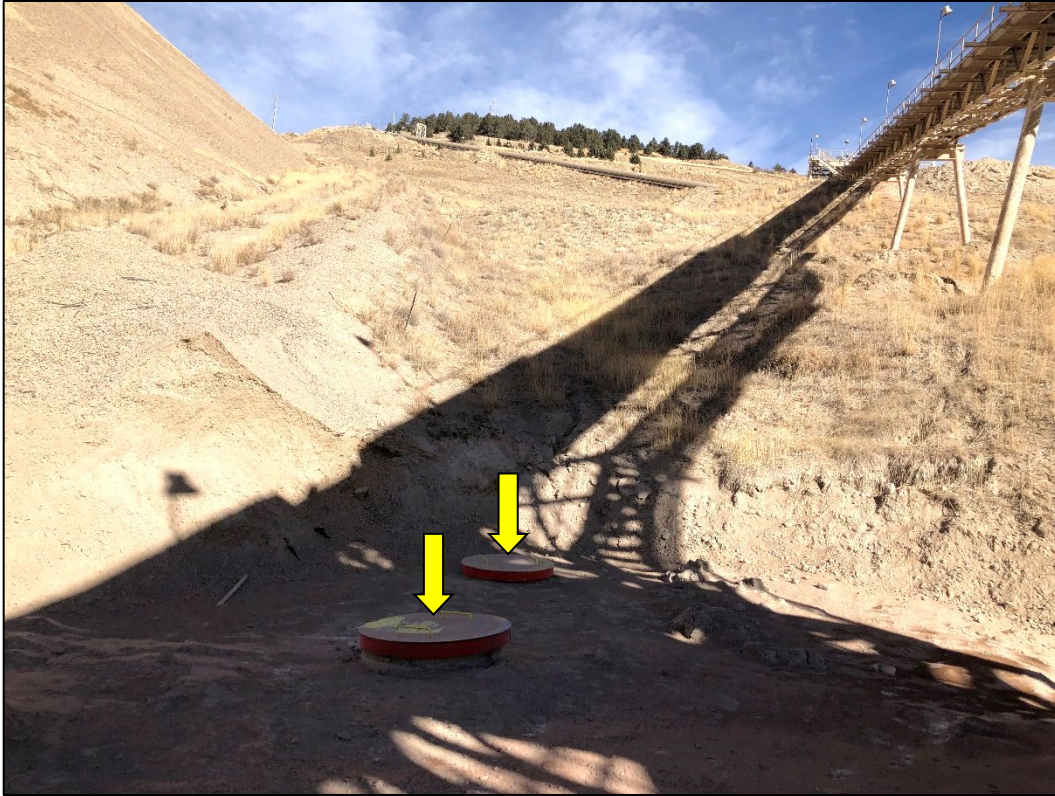
In order to prevent meteoric water and sediment from infiltrating LDS-12 and LDS-13 and from sediment completely burying these sumps after big storm events, the operator cleaned out the two sediment basins located upgradient from the sump area, made stormwater improvements around the sumps, and installed new tighter-fitting lids on the sumps. This work was completed in early October of this year. The operator had initially considered installing extensions on LDS-12 and LDS-13, but later decided not to install the extensions since they would need to be removed every time the crane was set up to perform maintenance work on the conveyor that overlies these sumps.

**Photo 11.** View looking northeast at LDS-12 and LDS-13 (for VLF-1; indicated) located in crusher area. In October of this year, operator excavated material from around these sumps, cleaned out upgradient sediment basins, and installed new tighter fitting lids on the sumps.

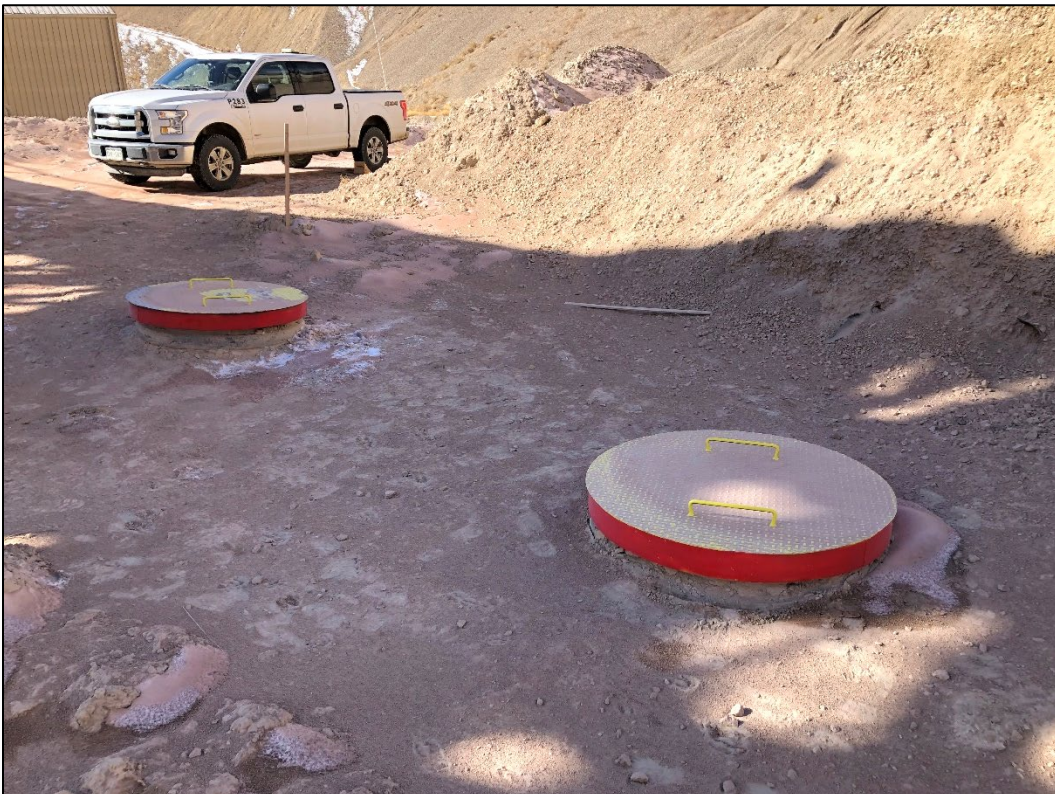
During the inspection, the Division observed the modifications made in the area of LDS-12 and LDS-13 were consistent with what was reported on October 17, 2022. Both of these sumps were dry during the inspection. Even with the modifications made, the location of these two sumps at the base of a steep slope and also underneath a conveyor that transports crushed material to the Load Out Bin requires these areas to be maintained and cleared out on a regular basis in order to prevent the sumps from being buried and thus unable to be inspected for the weekly monitoring program. Since the modifications were made in October, the operator has not observed any issues with LDS-12 or LDS-13 during their weekly sump monitoring. However, it may not be until the next monsoon season (July-August) before the stormwater improvements around these sumps are truly tested.

**Photo 12.** Closer view of LDS-12 and LDS-13 (for VLF-1), showing new tighter fitting lids installed to help prevent infiltration of meteoric water and sediment into these sumps.

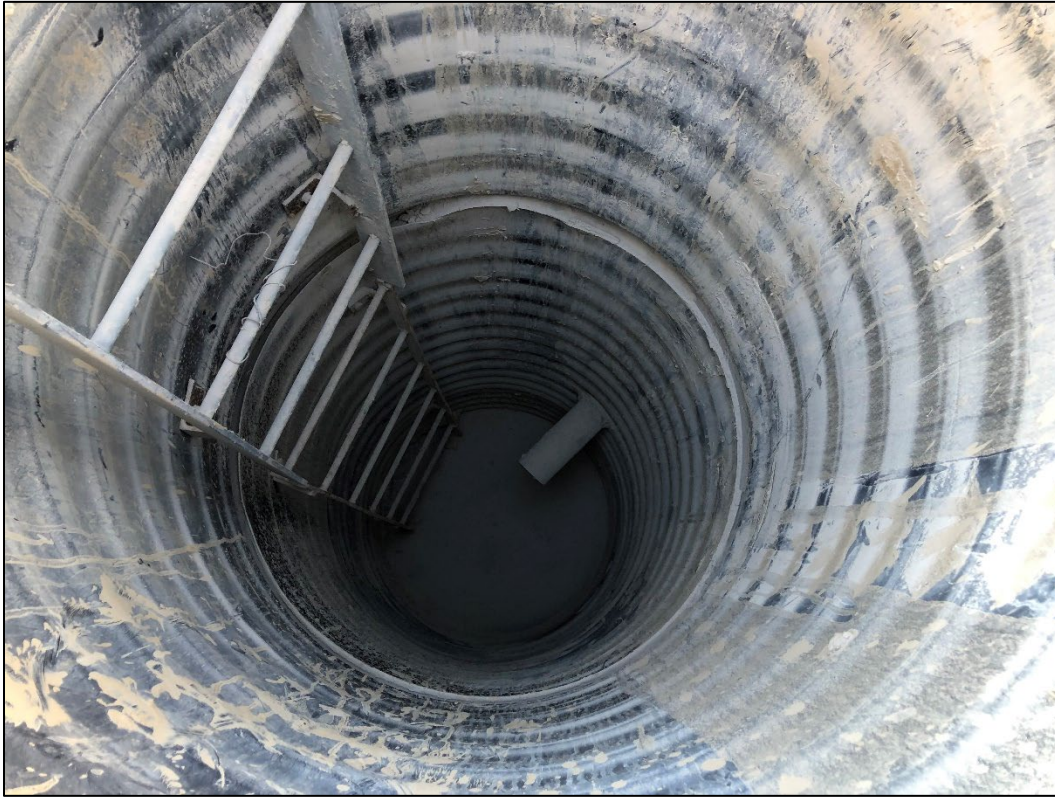
**Photo 13.** View inside LDS-12 (for VLF-1), showing sump dry during inspection. This sump had approximately one foot of water in it during Division's July 26, 2022 inspection.

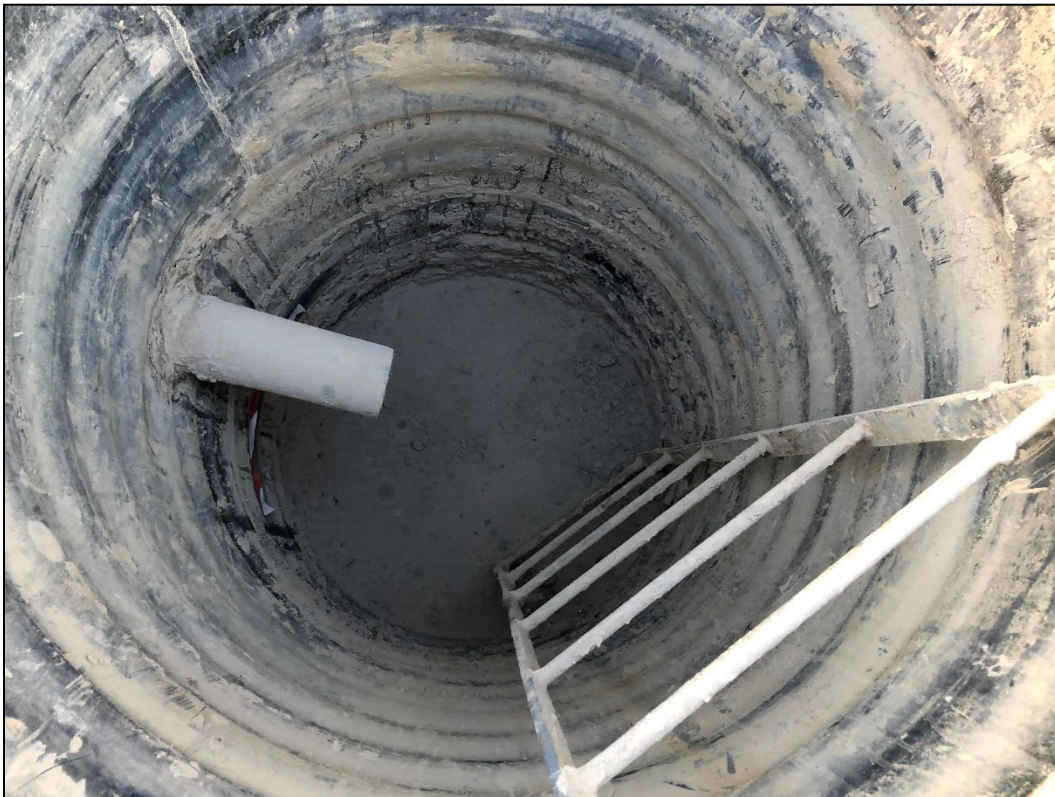
**Photo 14.** View inside LDS-13 (for VLF-1), showing sump dry during inspection. This sump had more than a foot of muddy water in it during Division's July 26, 2022 inspection.
