PERMIT INFORMATION

Permit Number: C1981033 Mine Name: Bear Mine Operator: N/A Operator Address: N/A	County: Gunnison Operation Type: Underground Permit Status: Revoked Ownership: Private
	Operator Representative Present: N/A
Operator Representative Signature: (Field Issuance Only)

INSPECTION INFORMATION

Inspection Start Date: November 29, 2022 Inspection Start Time: 14:00 Inspection End Date: November 29, 2022 Inspection End Time: 15:00		Inspection Type: Coal Complete Inspection Inspection Reason: Normal I&E Program Weather: Clear	
Joint Inspection Agency: None		Joint Inspection Contacts: 	
Post Inspection Agency: None		Post Inspection Contacts: 	
Inspector(s): Leigh Simmons	Inspector's Signature:

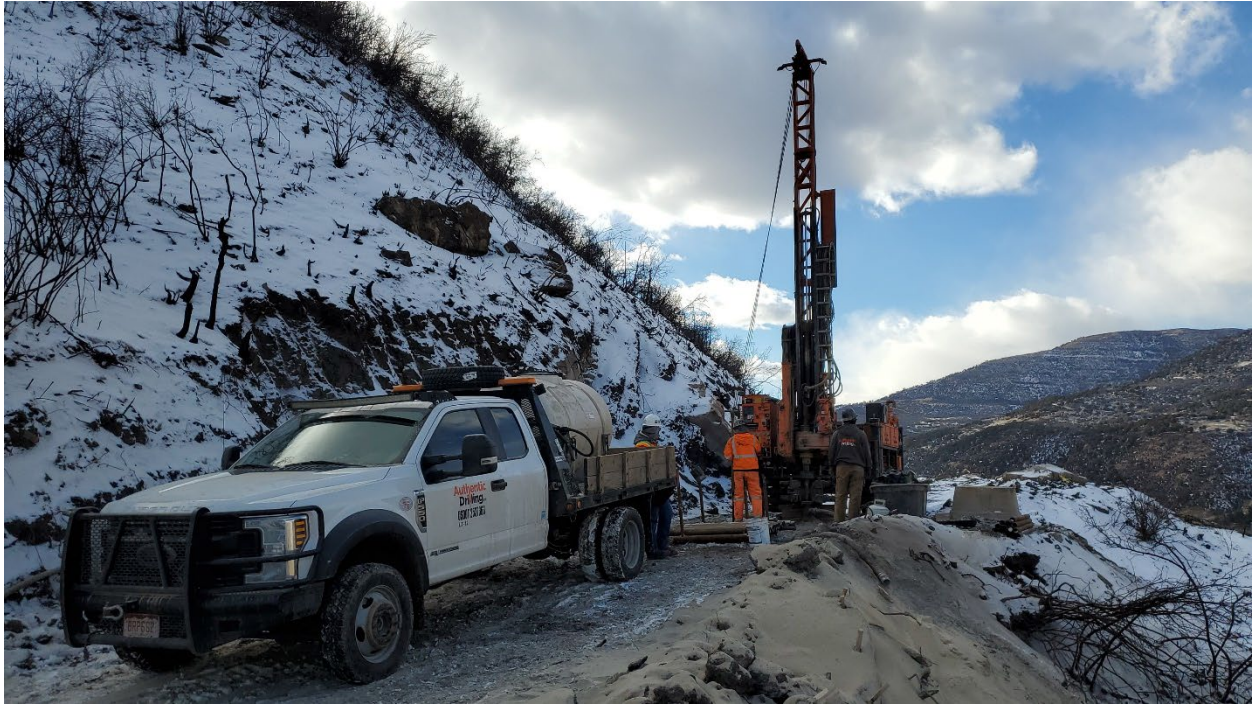
Jeff DeTienne of Tetra Tech described the drilling program. Three holes of a planned 20 had been drilled. The drillers expected to be on site until Christmas. The drilling method was air/rotary. The drill rig advanced a 6 5/8" surface casing into competent rock, then a 3" hole was drilled until either a large void or the target (C or B seam) was encountered. Depending on the conditions encountered the hole could be immediately grouted or could be capped with a thermocouple in place.

Figure 1: Air/rotary drill rig

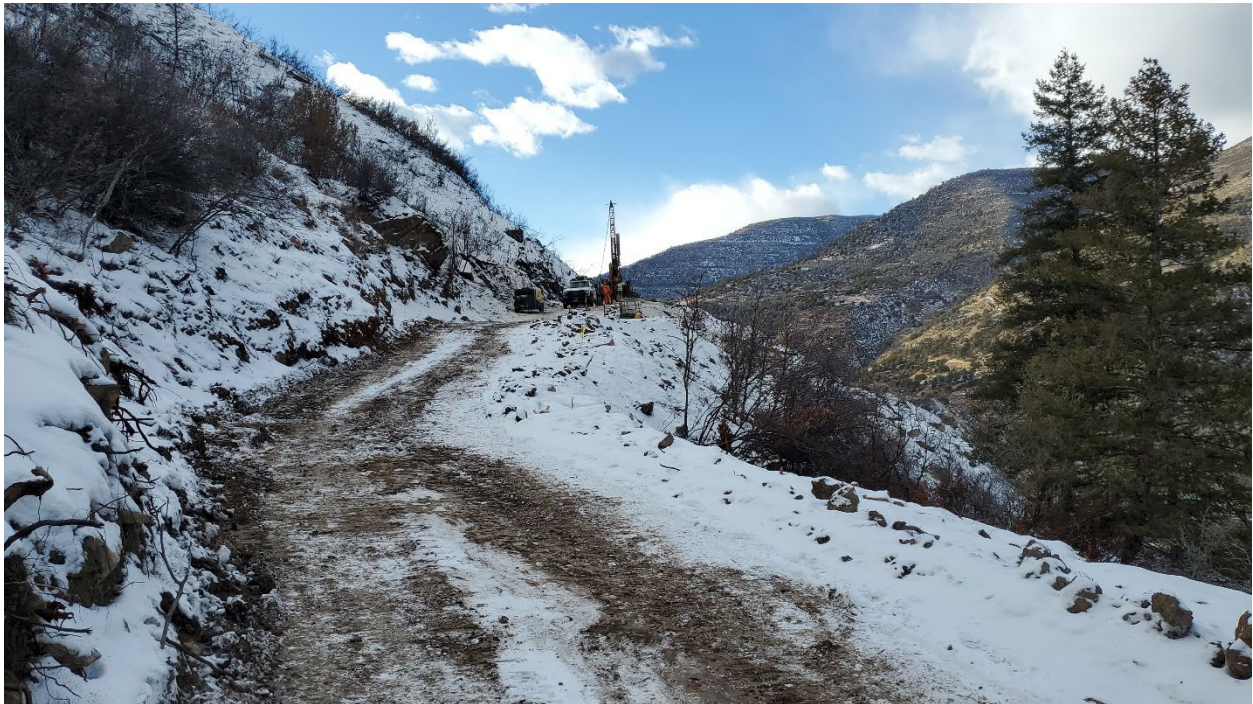
Bower Brothers had been contracted to maintain road access to the bench. Another road had been constructed from the first hairpin to give access immediately below the escarpment - the goal was to provide access for the drill rig to get to the B seam without encountering voids.

Figure 2: Access to drilling site

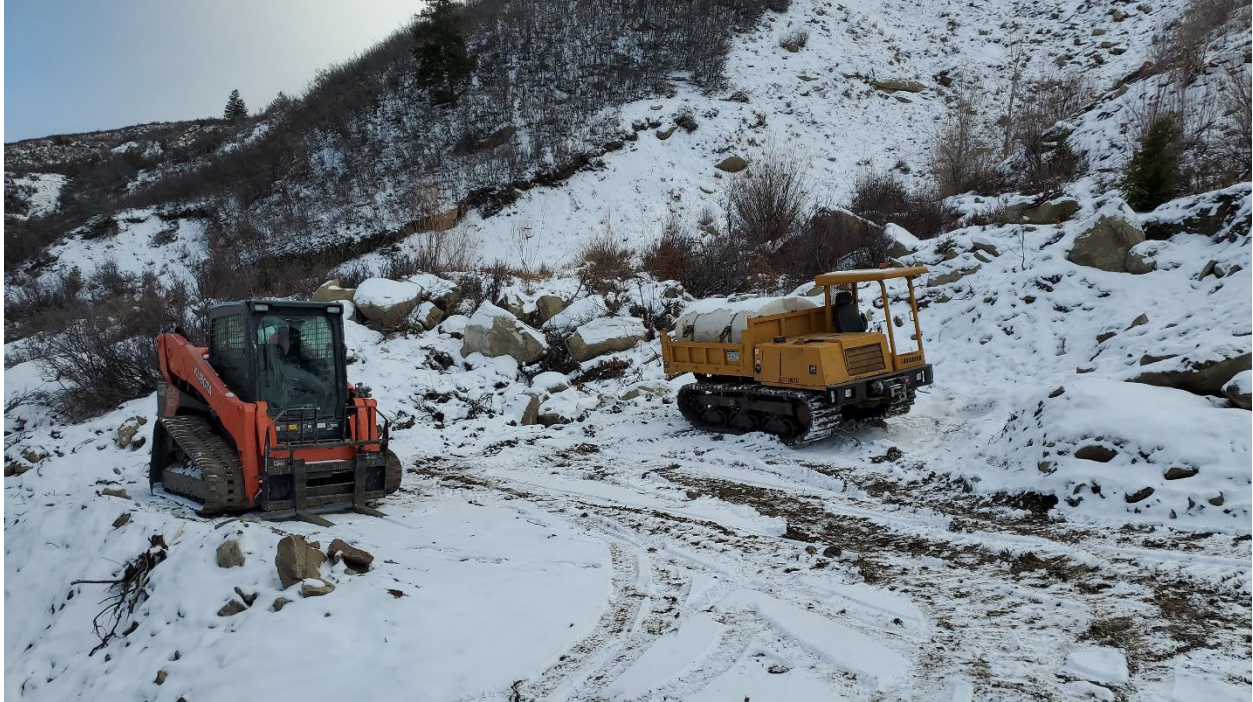
Figure 3: Equipment on site

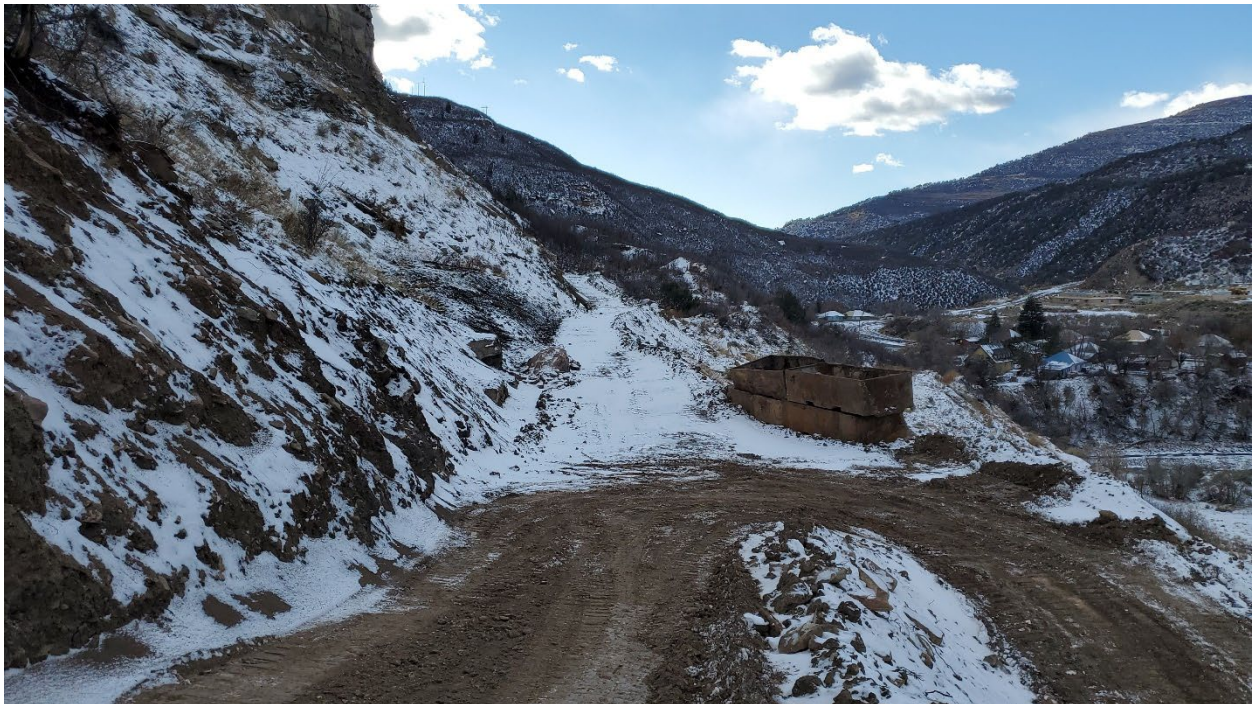
Figure 4: Road access from first hairpin below escarpment
