**PERMIT INFORMATION**

<b>Permit Number:</b> C1981033 <b>Mine Name:</b> Bear Mine <b>Operator:</b> N/A <b>Operator Address:</b> N/A	<b>County:</b> Gunnison <b>Operation Type:</b> Underground <b>Permit Status:</b> Revoked <b>Ownership:</b> Private
	<b>Operator Representative Present:</b>  N/A
<b>Operator Representative Signature: (Field Issuance Only)</b>

<b>Inspection Start Date:</b> December 12, 2022 <b>Inspection Start Time:</b> 14:00 <b>Inspection End Date:</b> December 12, 2022 <b>Inspection End Time:</b> 15:00		<b>Inspection Type:</b> Coal Partial Inspection <b>Inspection Reason:</b> Normal I&E Program <b>Weather:</b> Snowing	
<b>Joint Inspection Agency:</b>  None		<b>Joint Inspection Contacts:</b>  	
<b>Post Inspection Agency:</b>  None		<b>Post Inspection Contacts:</b>  	
<b>Inspector(s):</b>  Leigh Simmons	<b>Inspector's Signature:</b>

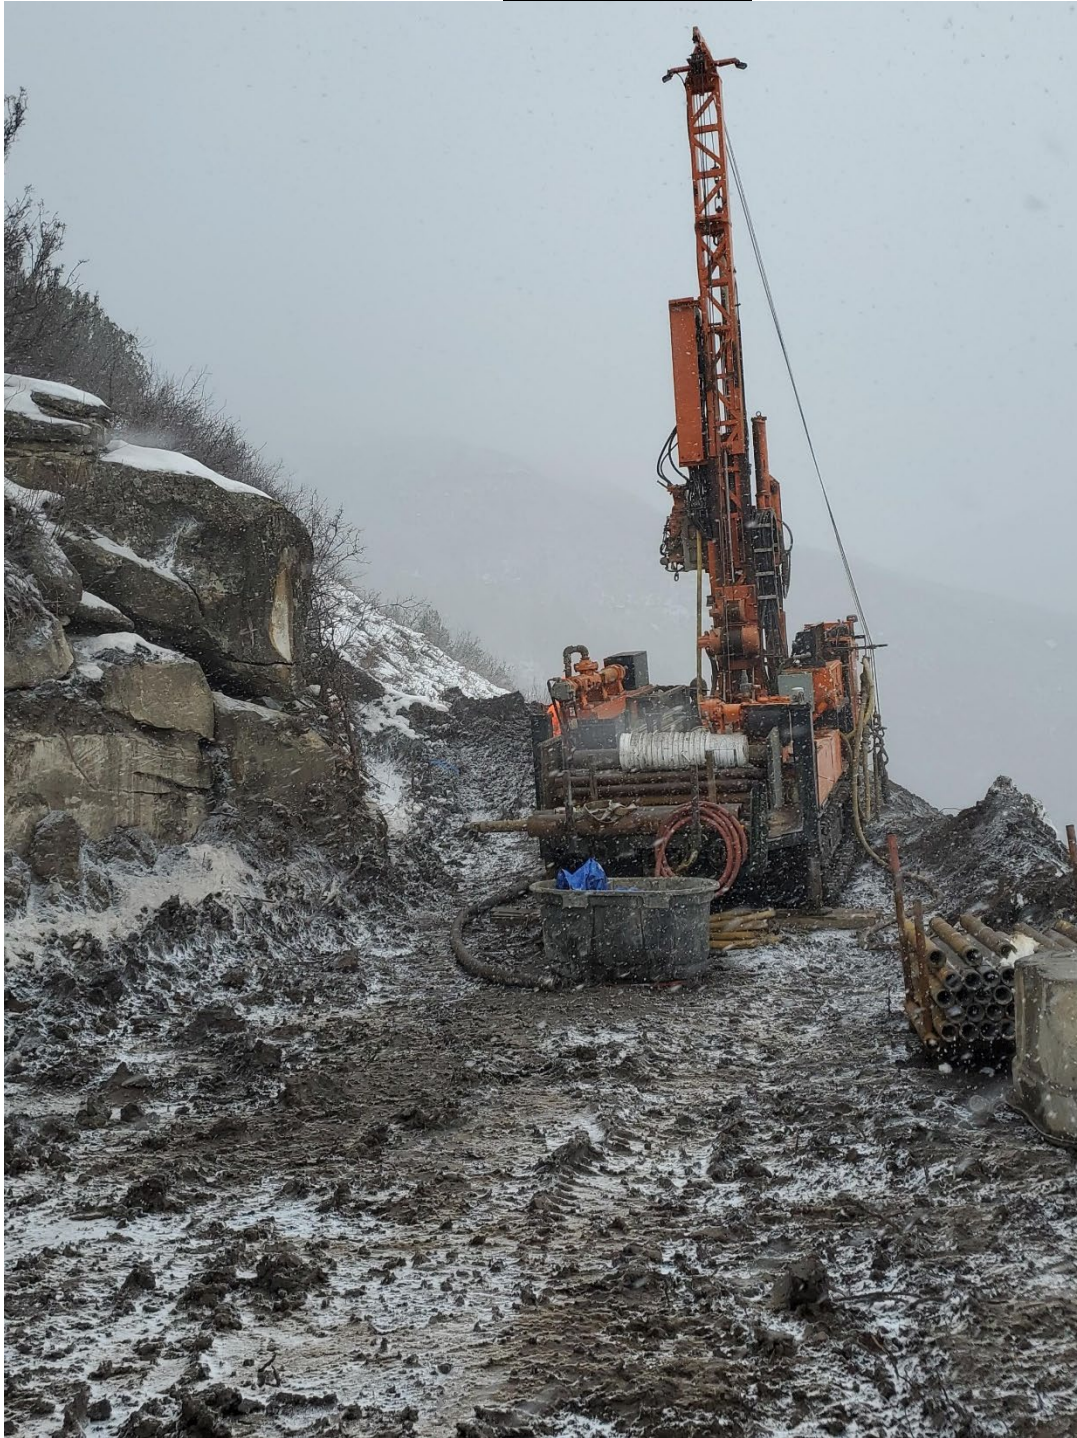
Mark Mikos of the Division was on site, overseeing the drilling project. Five holes had been completed by the time of the inspection; progress had been delayed by unexpectedly warm and wet conditions during the first two weeks of December which made access to the bench very difficult.

*Figure 1: Drill rig on the bench above the escarpement*

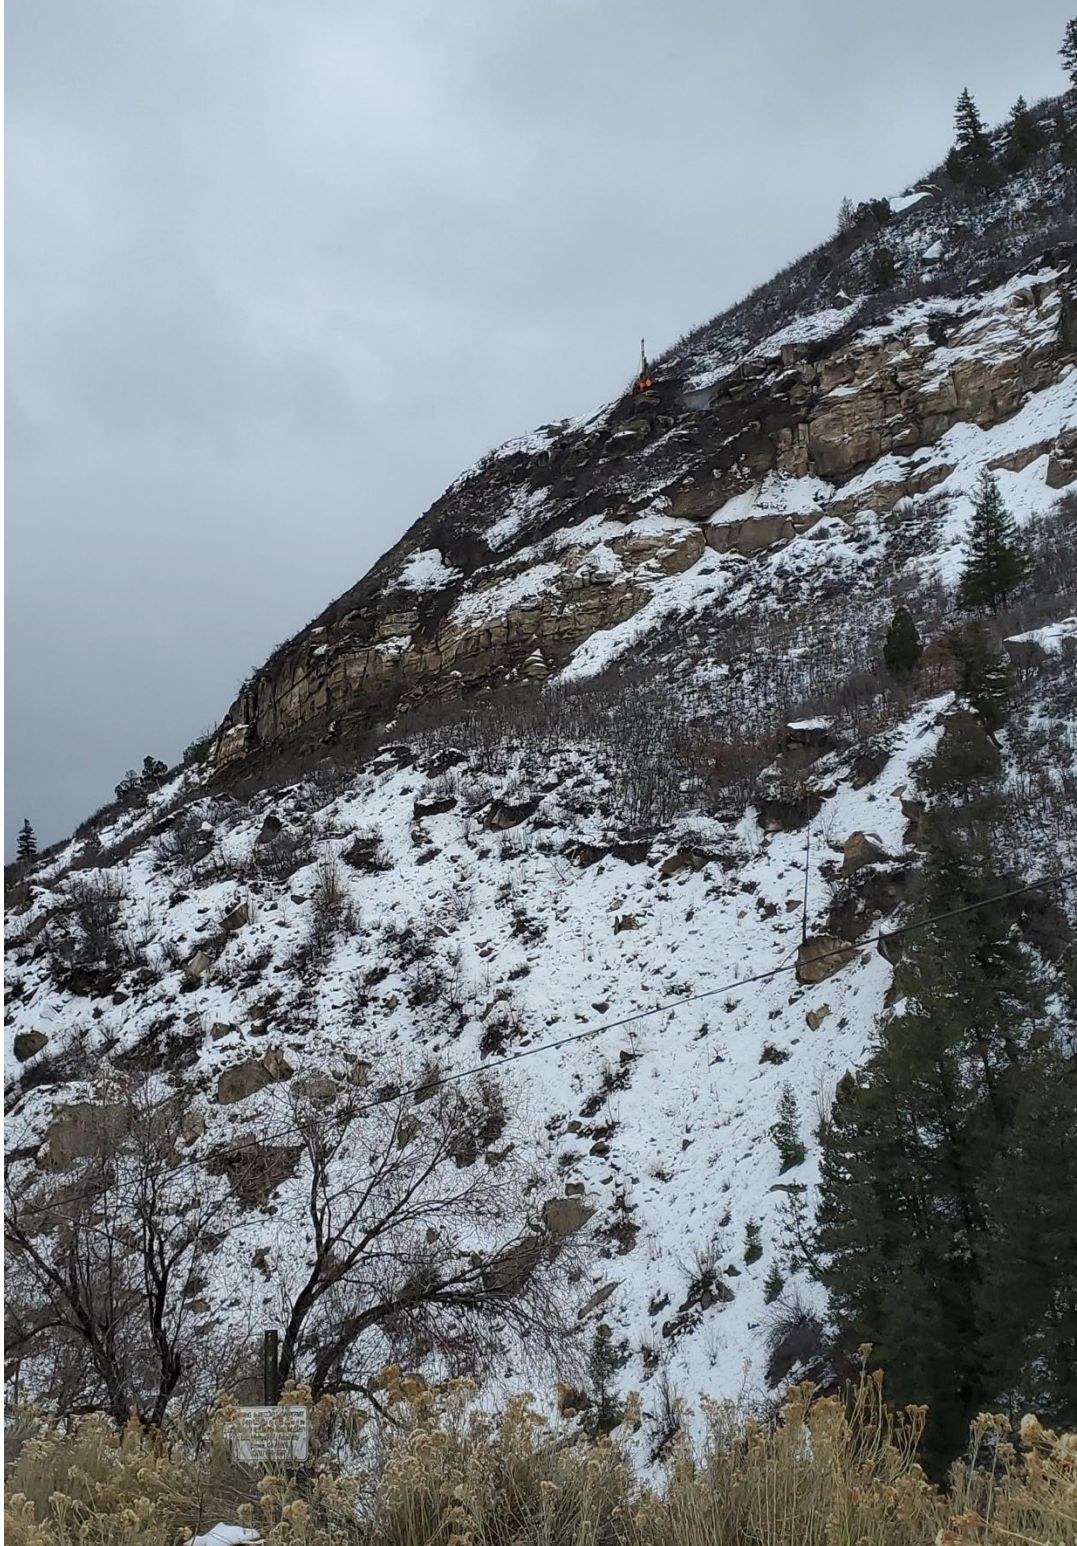
*Figure 2: The drill rig above the slide area, taken from the mine access in Somerset*
