December 14, 2022

Project No.: 19125

Regarding: Daniels Sand Pit 2, Permit No. M-1973-007-SG  
Slope Stability Monthly Monitoring Report

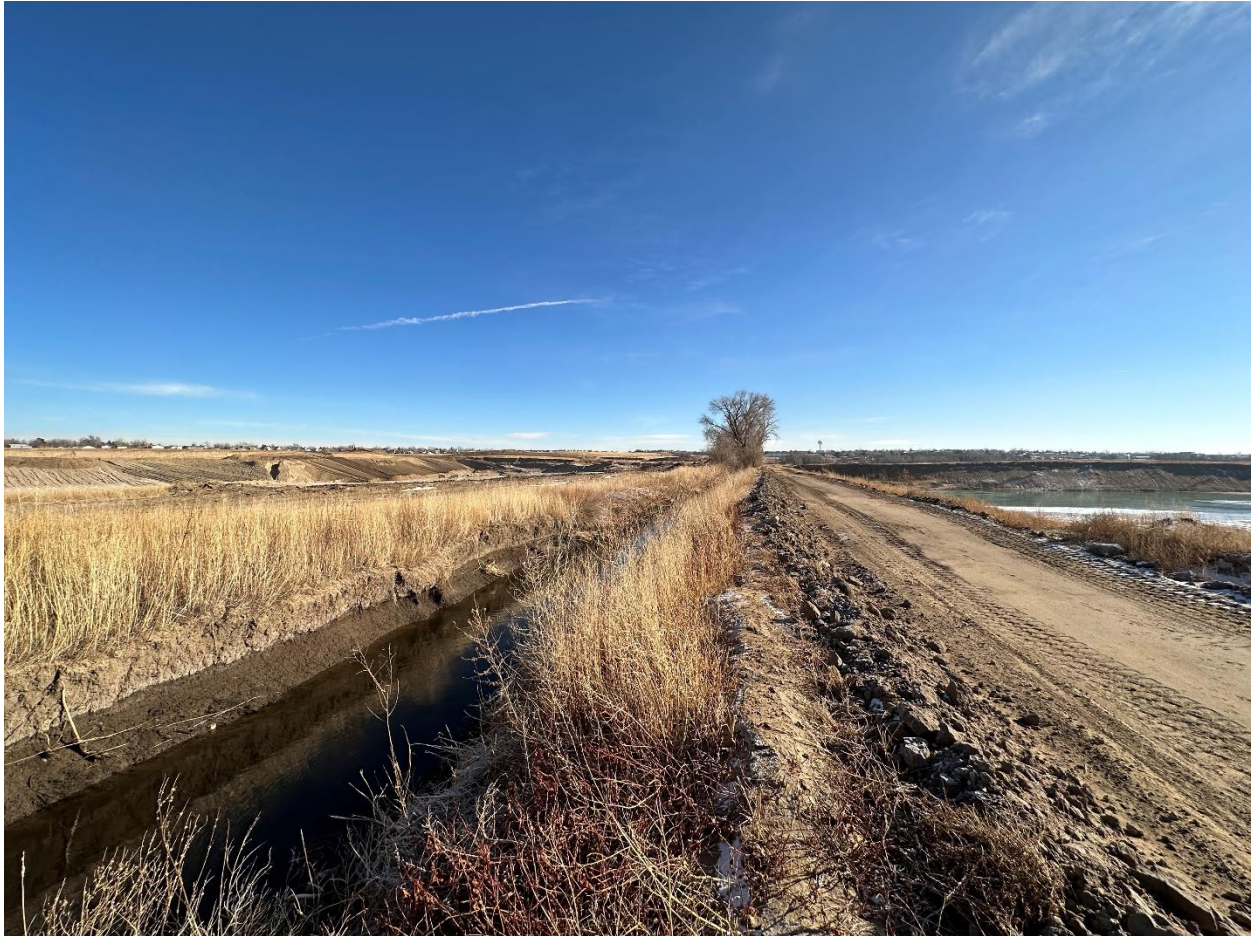
- Weather: 15-39°, sun and clouds mix, winds 5-10 mph, some snow cover
- Visual observation of the Fountain Mutual Ditch:
  - No tension cracks
  - No toe erosion that was visible
  - Vegetation growing on banks and at invert of ditch
  - Tumbleweeds present in ditch
  - Water flowing in ditch
  - No sloughed slope surfaces
  - The condition of the ditch is stable

Photo 1. Fountain Mutual Ditch looking east

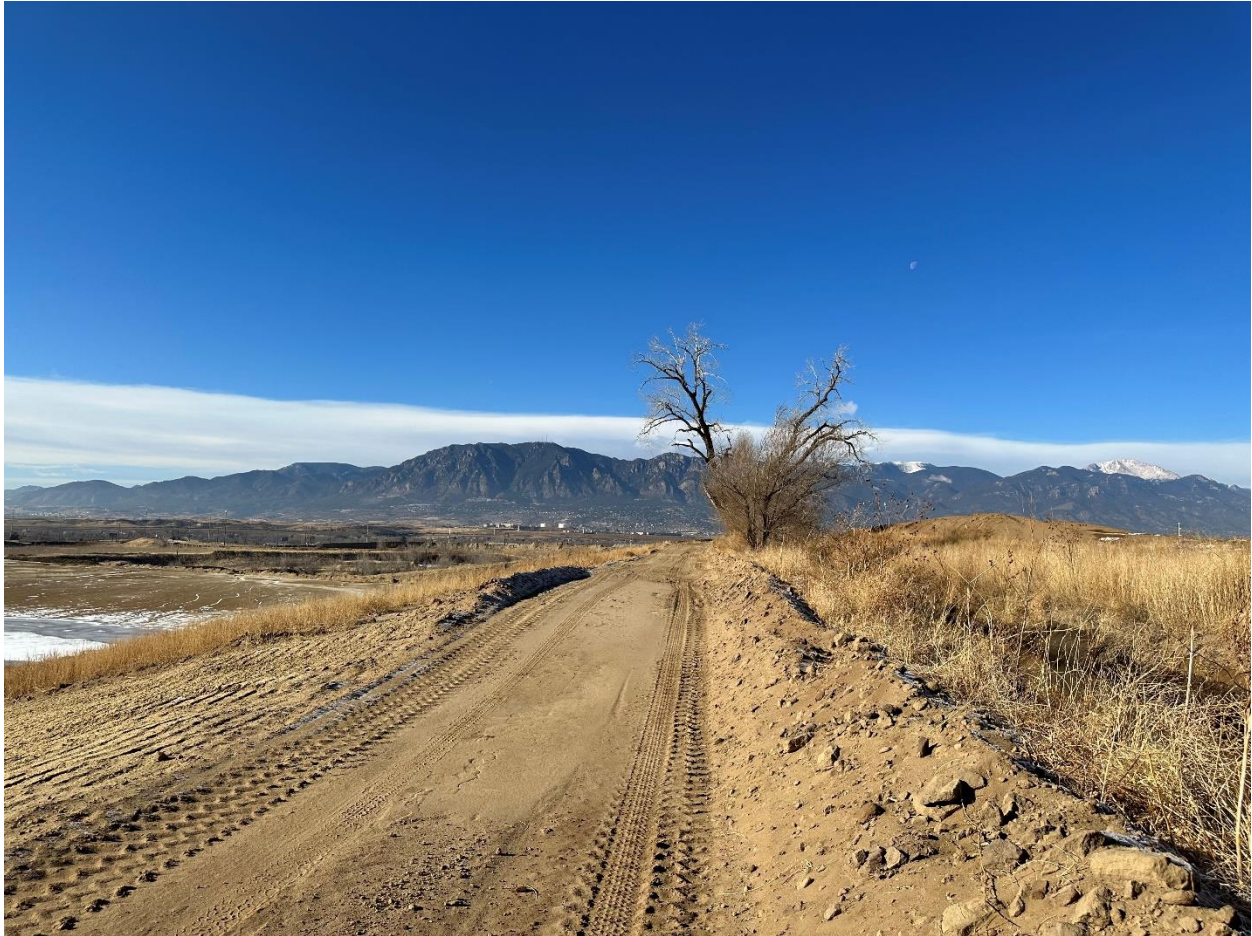
Photo 2. Fountain Mutual Ditch looking west with berm

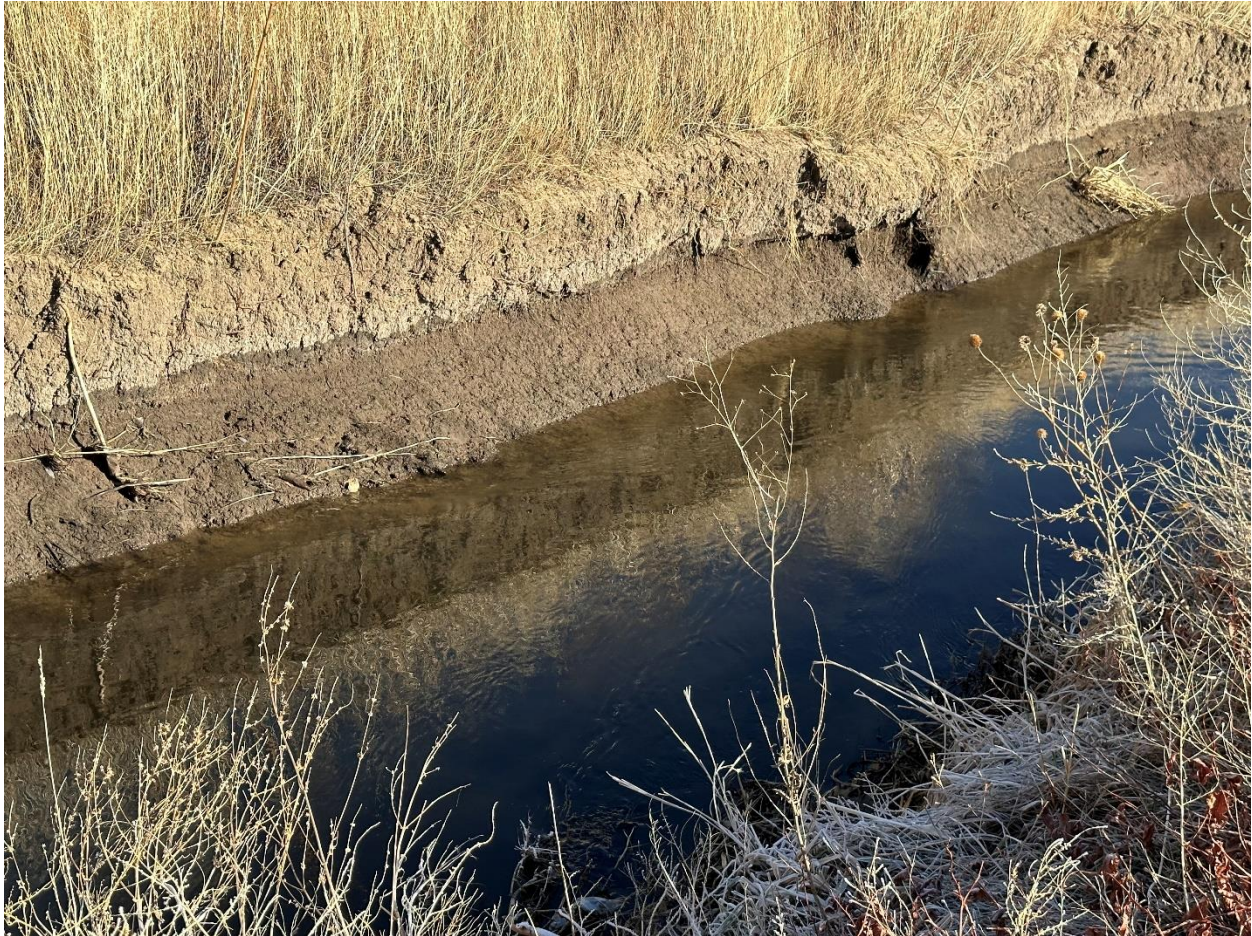
Photo 3. Fountain Mutual Ditch invert

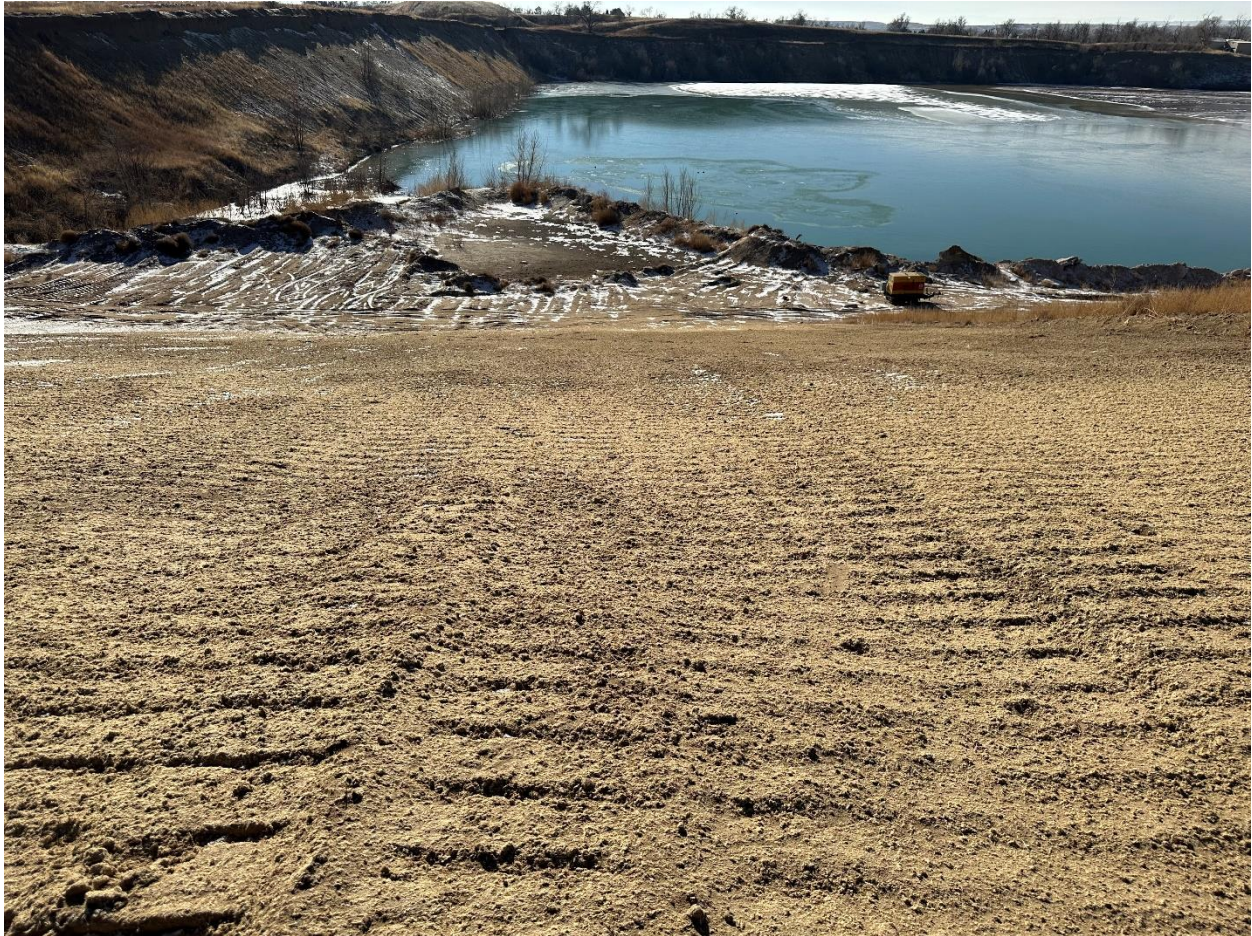
- Visual observations of the Buttress Slope
  - The buttress slope varies from 3H:1V to 4H:1V
  - Vegetation (mainly weeds) are growing in some locations on the buttress
  - Several locations visible evidence of surface water runoff and erosion gullies throughout alignment

Photo 4. Buttress slope looking south that was recently repaired (western slope)

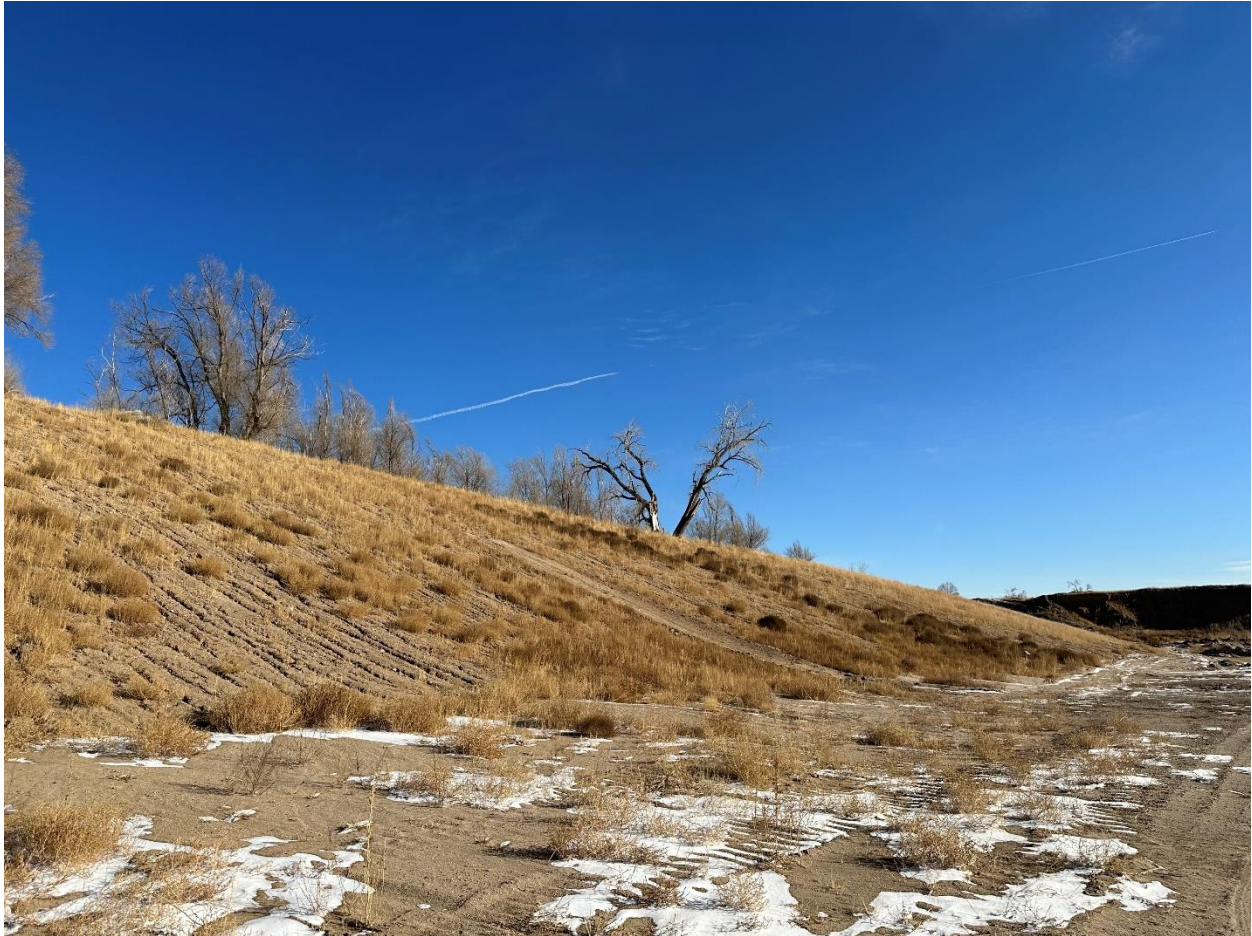
Photo 5. Buttress slope looking east from toe

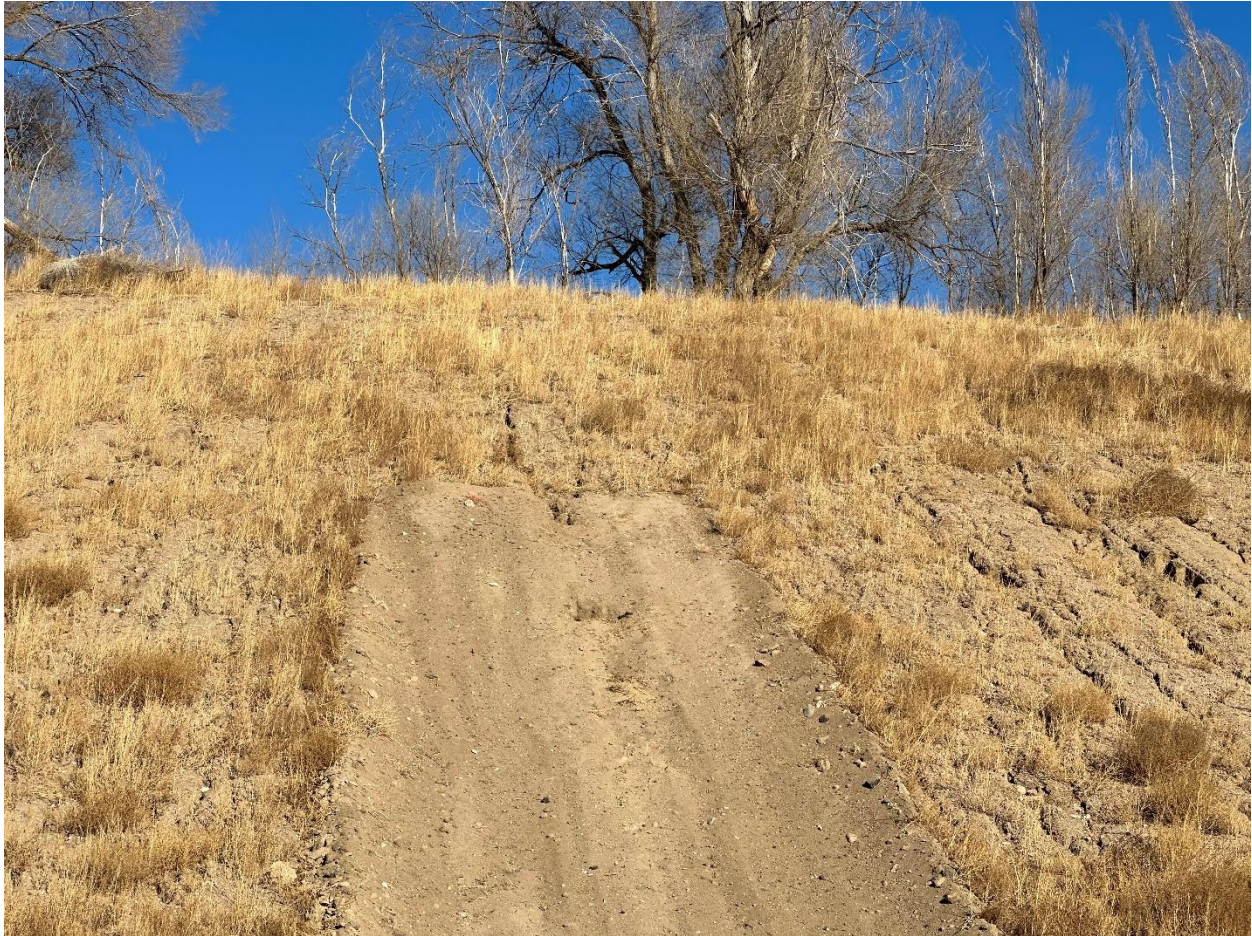
Photo 6. Buttress slope repair looking north from toe, erosion occurring around repair

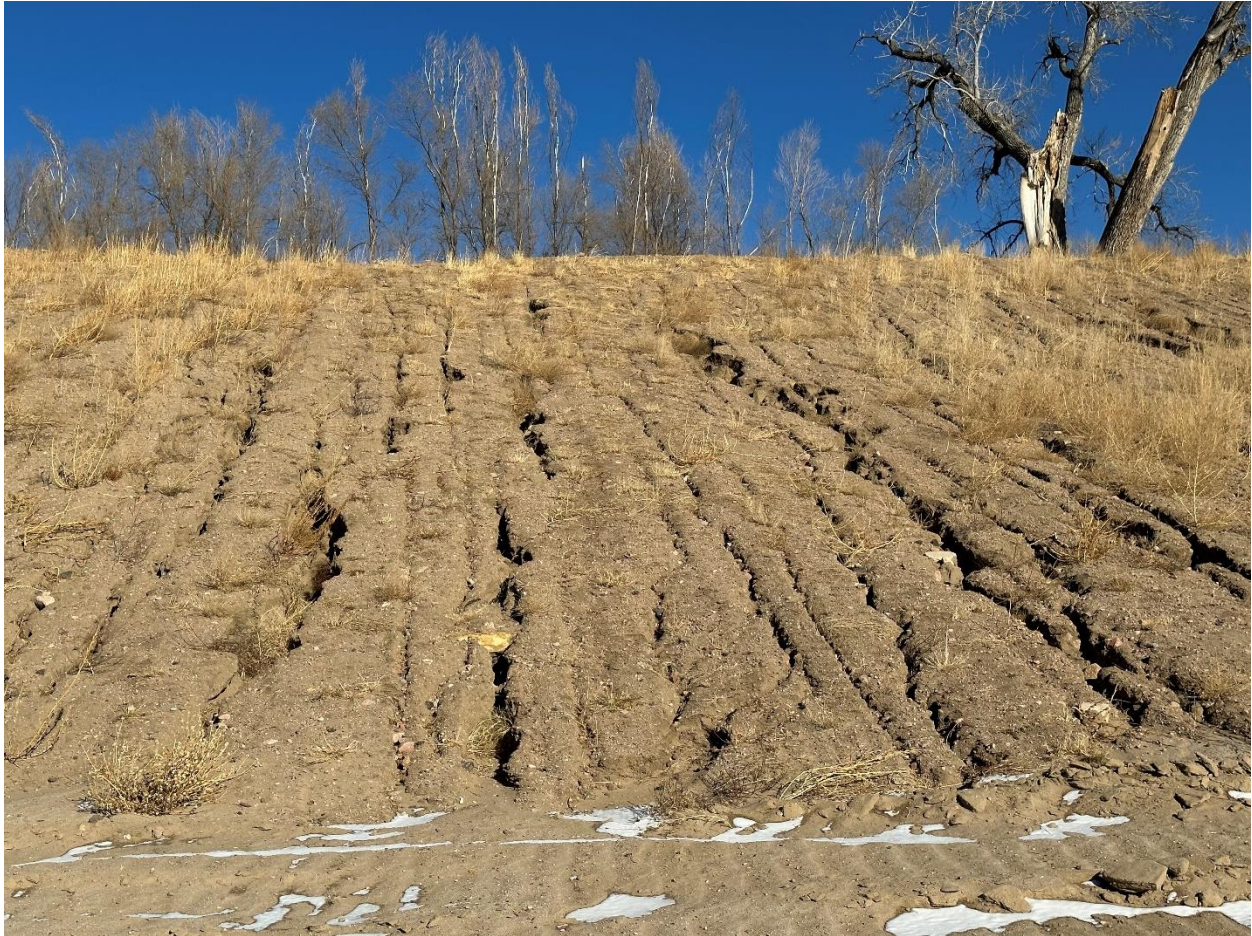
Photo 7. Buttress slope looking north, note evidence of drainage/erosion gullies forming. More sediment near toe
