MINERALS PROGRAM INSPECTION REPORT
PHONE: (303) 866-3567

MINE NAME: Cross Gold Mine	MINE/PROSPECTING ID#: M-1977-410	MINERAL: Gold, copper, silver,	COUNTY: Boulder
INSPECTION TYPE: Monitoring	WEATHER: Cloudy	INSP. DATE: December 12, 2022	INSP. TIME: 09:30
OPERATOR: Grand Island Resources LLC	OPERATOR REPRESENTATIVE: Sergio Rivera Je'an-Paul Brewer	TYPE OF OPERATION: 110(2) - Hard Rock Limited Impact	
REASON FOR INSPECTION: Normal I&E Program	BOND CALCULATION TYPE: None	BOND AMOUNT: \$546,751.00	
DATE OF COMPLAINT: NA	POST INSP. CONTACTS: None	JOINT INSP. AGENCY: None	
INSPECTOR(S): Patrick Lennberg	INSPECTOR'S SIGNATURE:

SIGNATURE DATE: December 16, 2022

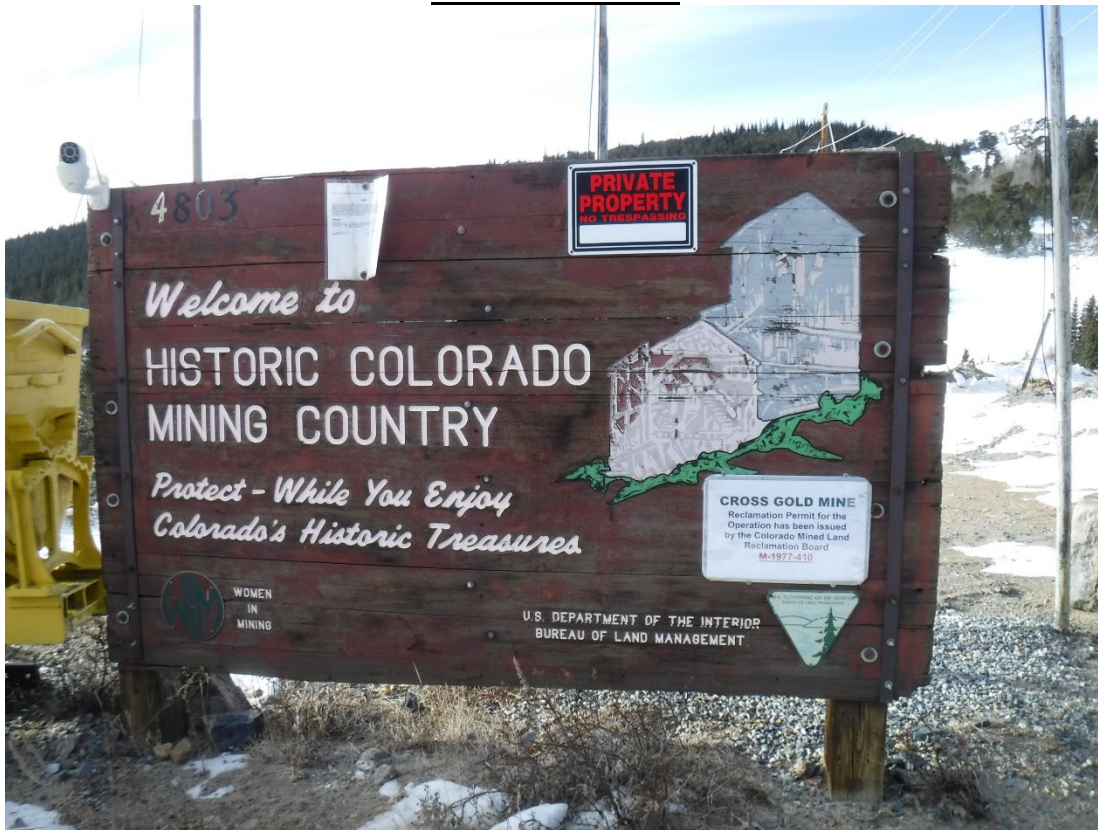
The Cross Gold Mine is a 110(2) underground mine operation permitted for 9.9 acres for the mining of gold, silver, and other minerals. The permit area includes two discharging mine openings: the Cross Mine portal (at the Cross Mine) and the Idaho Tunnel portal (at the Caribou Mine). Discharge from these mines is directed to a series of plastic-lined ponds prior to being treated and discharged into Coon Track Creek at the permitted discharge point (CO0032751). The mine is located on land owned by the permittee. The site is located approximately 4 miles northwest of Nederland, CO in Boulder County, at an elevation of approximately 9,760 feet. Access to the site is off of Caribou Road. A separate entrance exists for each of the two mines at the site, the Cross Mine (to the south) and the Caribou Mine (to the north). The approved post-mining land use is a combination of forestry and residential. A mine sign was observed at the Caribou Mine entrance as required by Rule 3.1.12.

Photo 1: Mine sign at the primary mine entrance location

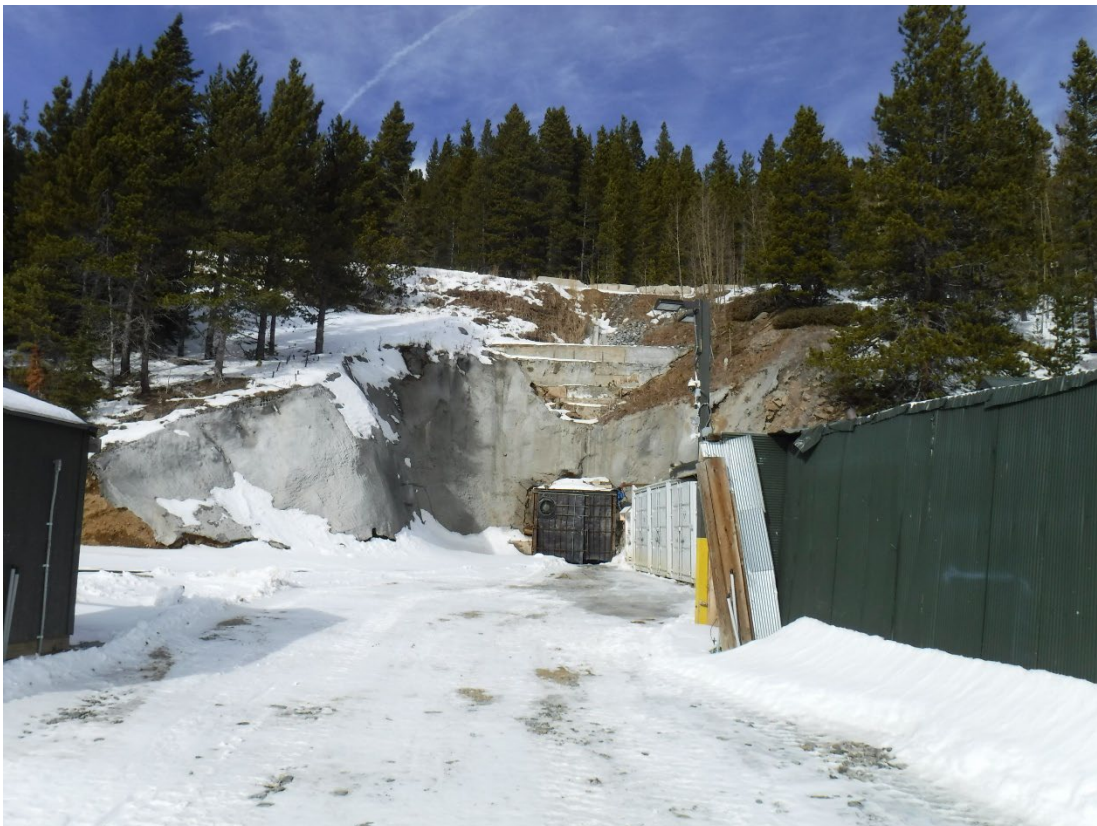
Also discussed during the inspection were activities related to the Idaho Tunnel. While in the field the operator stated they were reviewing TR's 5, 7, and 9 along with AM-2 as they relate to rebuilding the Idaho Tunnel entrance. The operator stated it appears, from their initial permit file review, that no additional revisions with the Division were needed to reconstruct the entrance. The inspector stated they were

unfamiliar with that particular aspect of the permit and additional research on the topic would be completed once they returned to the office. The Division reviewed recent revisions including the ones stated above and could not find where the new construction details of the Idaho Tunnel entrance were addressed in the recent revisions. The revisions mentioned; TR-5 addressed rehabilitation of the old entrance to allow safer entrance into the tunnel, TR-7 addressed the geotechnical stability of the slopes around the entrance after rehabilitation work and in response to problem citation in the March 2020 inspection, TR-9 was submitted because of a stipulation in the approval of TR-7 which updated the geotechnical stability analysis of the tunnel rehabilitation work demonstrating the portal slopes meet the stability requirements of the Mined Land Reclamation Board. In AM-2 no details of the tunnel entrance reconstruction were provided although a line-item was used for reclamation of the tunnel entrance. However, that line-item was more of a placeholder until additional details could be provided. Therefore, the Division believes a Technical Revision would be needed that provides the design details of the entrance reconstruction along with any needed geotechnical stability analysis and any local permitting as needed. If the operator can demonstrate a Technical Revision is not needed they may do so. Finally, if there is any significant alteration of the reclamation plan or an increase in the affected land acreage the operator may need to convert to an appropriate 112d permit.

Photo 2: Current conditions at the Idaho Tunnel entrance

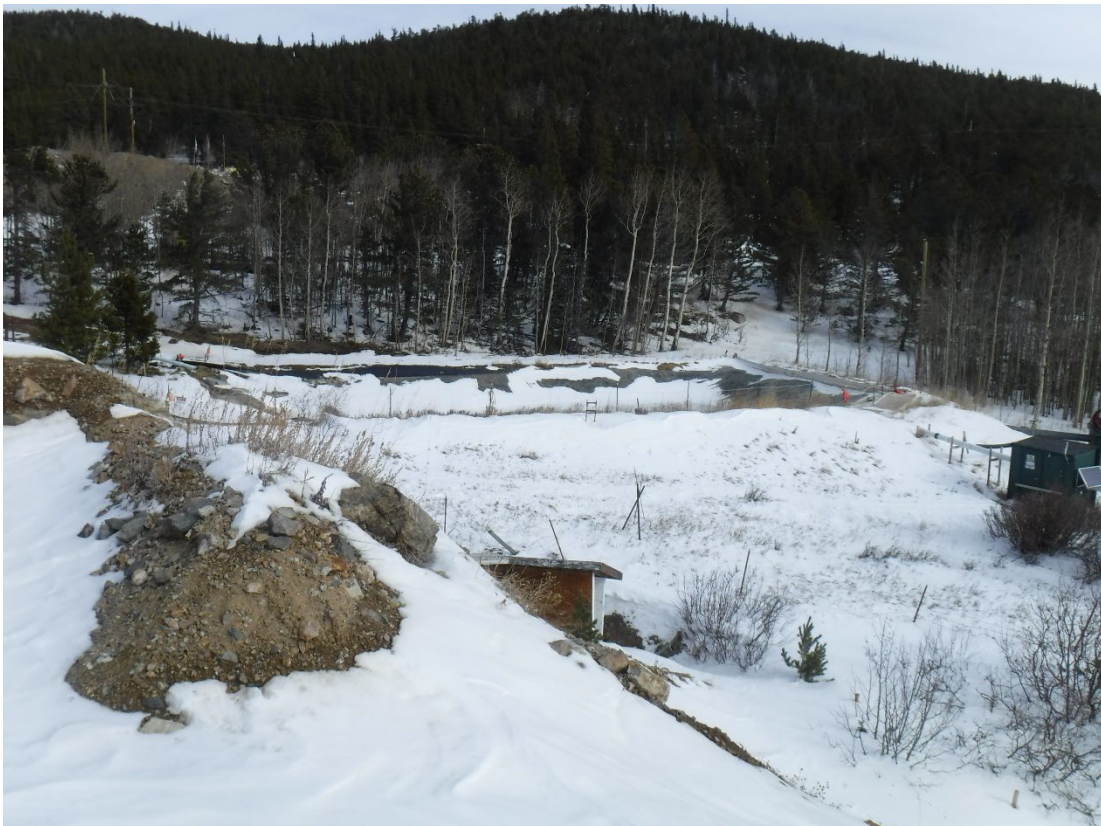
Photo 6: Pond 2

During the inspection Pond 2 was noted to be dry. The operator stated the pond was cleaned out over the summer and the integrity of liner checked. The liner was found to be in good condition and sediment removed from the pond was currently undergoing TCLP testing for disposal purposes. The Division reiterated, from previous inspections, that when the operator determines a proper disposable facility for the sediment that they provide the Division with the letter of acceptance from the facility along with the analytical results. It was also stated these similar documents were also needed for disposal of the water treatment sludge.

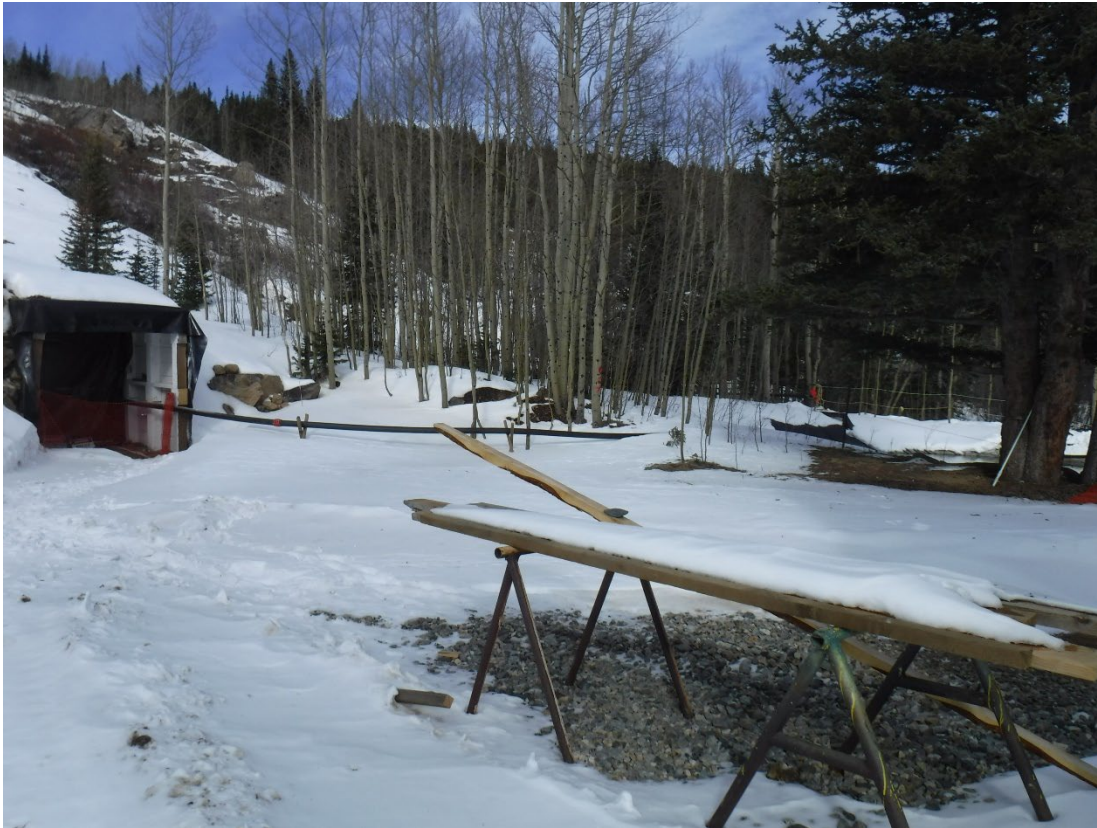
Photo 7: Cross Mine entrance and the approximate location, between aspen and conifer trees, of where the water treatment plant will be relocated to

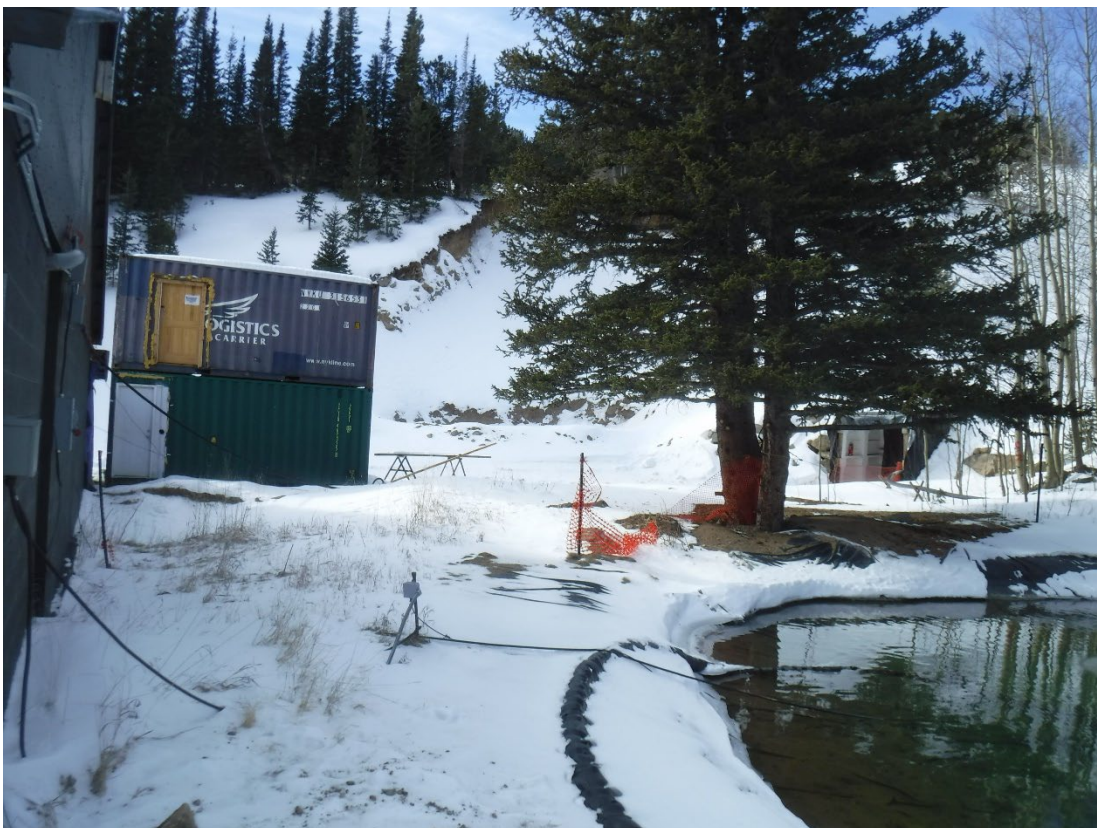
Photo 8: Cross Mine snow-shed is going to be replaced in the area from the middle right of the picture to the middle left
