MINERALS PROGRAM INSPECTION REPORT
PHONE: (303) 866-3567

MINE NAME: Dick Casey Concr Pit	MINE/PROSPECTING ID#: M-1978-349	MINERAL: Sand and gravel	COUNTY: Garfield
INSPECTION TYPE: Monitoring	WEATHER: Clear	INSP. DATE: November 1, 2022	INSP. TIME: 11:10
OPERATOR: Oldcastle SW Group, Inc. dba United Compas County	OPERATOR REPRESENTATIVE: Tyra Bartuska	TYPE OF OPERATION: 112c - Construction Regular Operation	
REASON FOR INSPECTION: Normal I&E Program	BOND CALCULATION TYPE: Complete Bond	BOND AMOUNT: \$377,400.00	
DATE OF COMPLAINT: NA	POST INSP. CONTACTS: None	JOINT INSP. AGENCY: None	
INSPECTOR(S): Clayton Wein	INSPECTOR'S SIGNATURE:

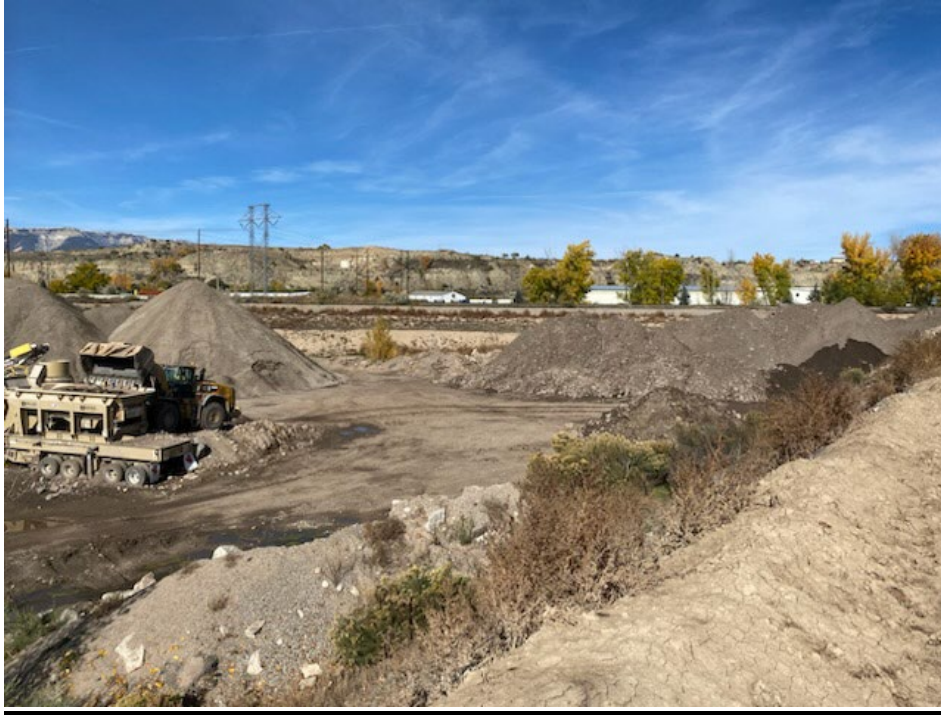
The inspection started in the western portion of the permitted area at the batch plant. The area was well kept and there were no indications of erosional features. To the east of the batch plant is the excavated portions of the mine site. The pits were observed to be stable with no erosional issues noted (Photos 1 through 4). There were stockpiled materials in the middle of the pit floor. The highwalls were observed to be stable. Sediment control structures for the pit were in good condition and keeping the pit floor from impounding water. Topsoil for the Dick Casey Pit is located within the M-2005-075, Glen Pit.

Photo 1: The north end of the active pit.

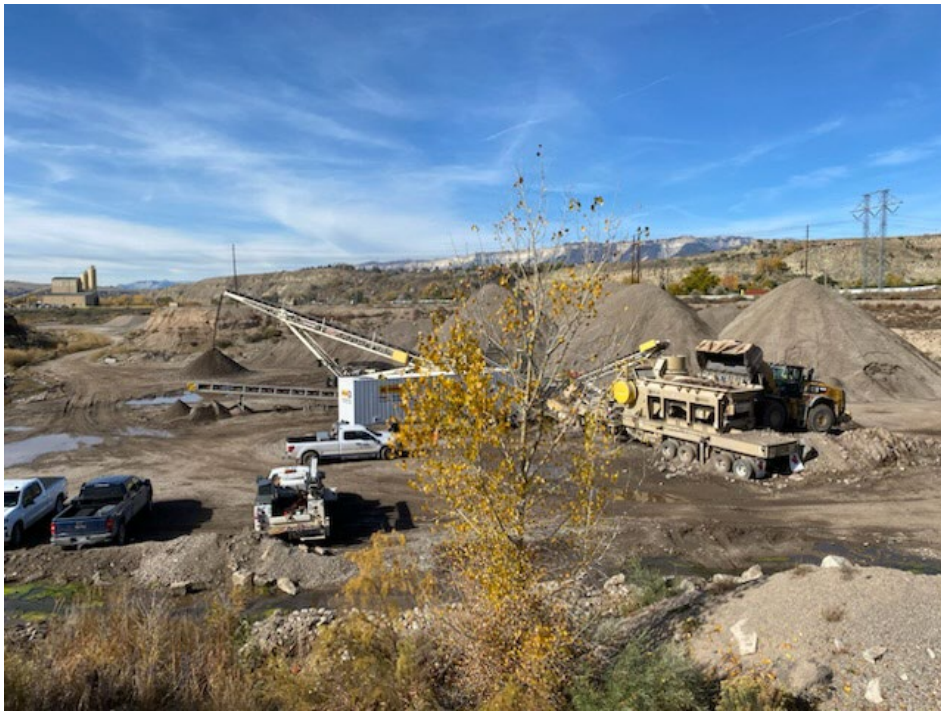
Photo 2: The middle portion of the active pit.

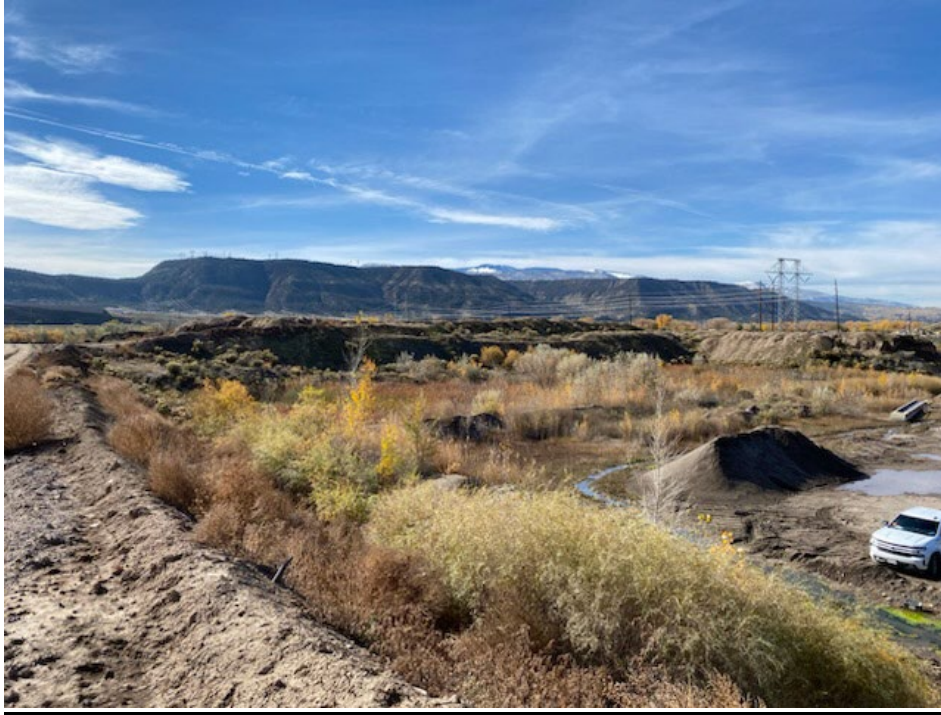
Photo 3: The southern end of the active pit.

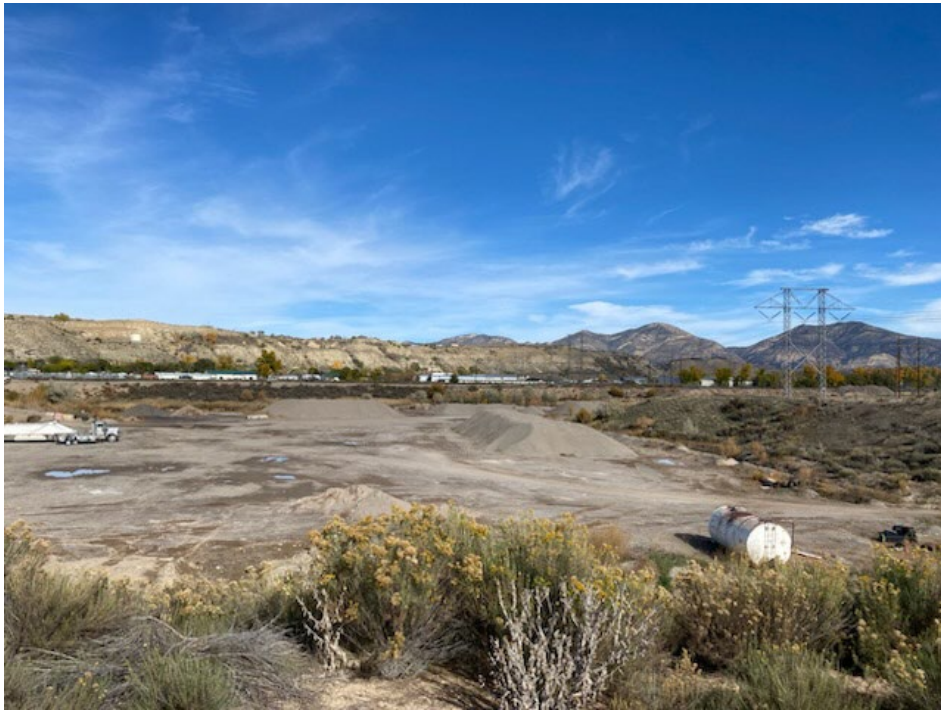
Photo 4: The inactive pit. The photo was taken looking to the northeast.
