MINERALS PROGRAM INSPECTION REPORT
PHONE: (303) 866-3567

MINE NAME: Chambers Pit	MINE/PROSPECTING ID#: M-1979-205	MINERAL: Sand and gravel	COUNTY: Garfield
INSPECTION TYPE: Monitoring	WEATHER: Clear	INSP. DATE: November 1, 2022	INSP. TIME: 11:10
OPERATOR: Oldcastle SW Group, Inc. dba United Compas County	OPERATOR REPRESENTATIVE: Tyra Bartuska	TYPE OF OPERATION: 112c - Construction Regular Operation	
REASON FOR INSPECTION: Normal I&E Program	BOND CALCULATION TYPE: Complete Bond	BOND AMOUNT: \$212,000.00	
DATE OF COMPLAINT: NA	POST INSP. CONTACTS: None	JOINT INSP. AGENCY: None	
INSPECTOR(S): Clayton Wein	INSPECTOR'S SIGNATURE:

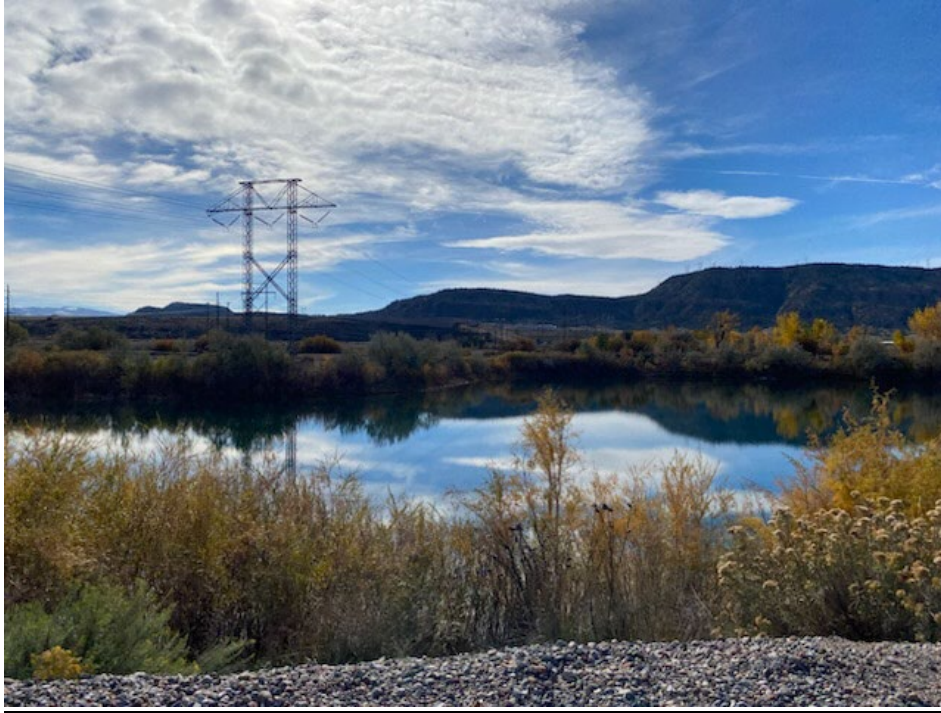
The inspection for the Chambers Pit started at the main pit area (Photo 1). This area has been fully reclaimed and is now a pond. This portion of the site is referred to as the central lake. The reclamation was stable and there were no erosional concerns identified. The reclamation work could apply for an acreage reduction if the operator wishes. The scale house located to the north of the central lake was in good repair. The pad was stable and there were no indications of erosion.

Photo 1: The Central Lake of the Chambers Pit.

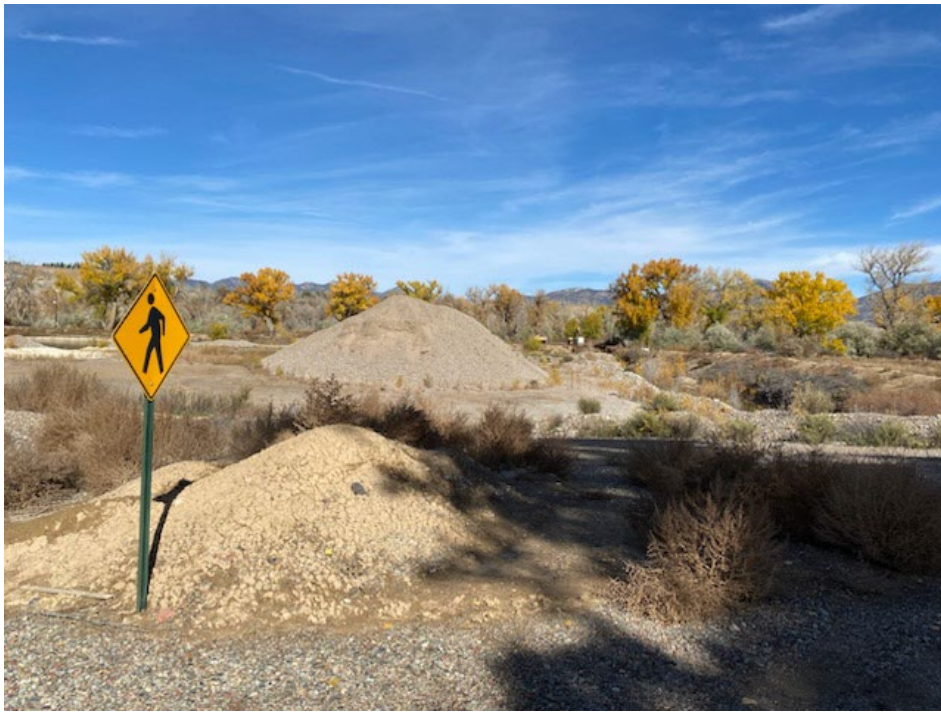
AM-2 added acres of the Scott Pit to the permit area (Photos 2 through 4). There are two main areas to the Scott Pit, the west area and the east area. The west area has been fully reclaimed. The site was stable with no indications of erosional features. The scale house and scale have been removed from the site. The east portion of the Scott Pit is where mining activity occurs. The pit was stable. There were no erosional concerns identified. Stockpiled material was observed on the east end of the pit. The topsoil and overburden stockpile was located to the southwest of the pit. The stockpile was stable with vegetative cover. There were no indications of erosional features or loss of topsoil resources. Fuel for mining equipment is not stored on-site. Fuel will be brought in on an as needed basis with a mobile tank.

Photo 2: Stockpiled material at the AM-2 Scott Pit.

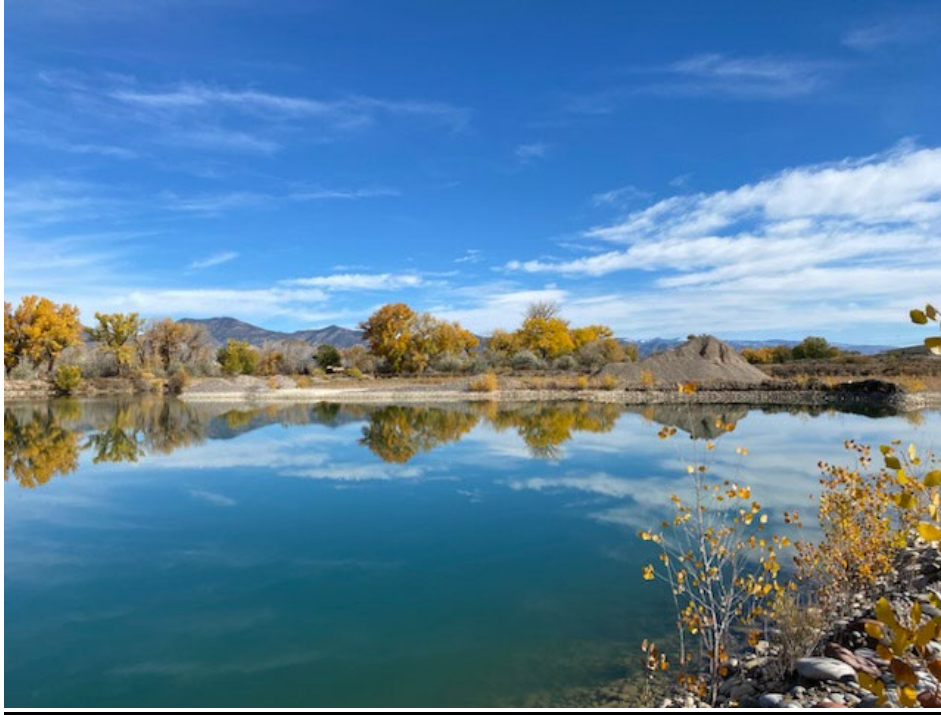
Photo 3: The central portion of the Scott Pit.

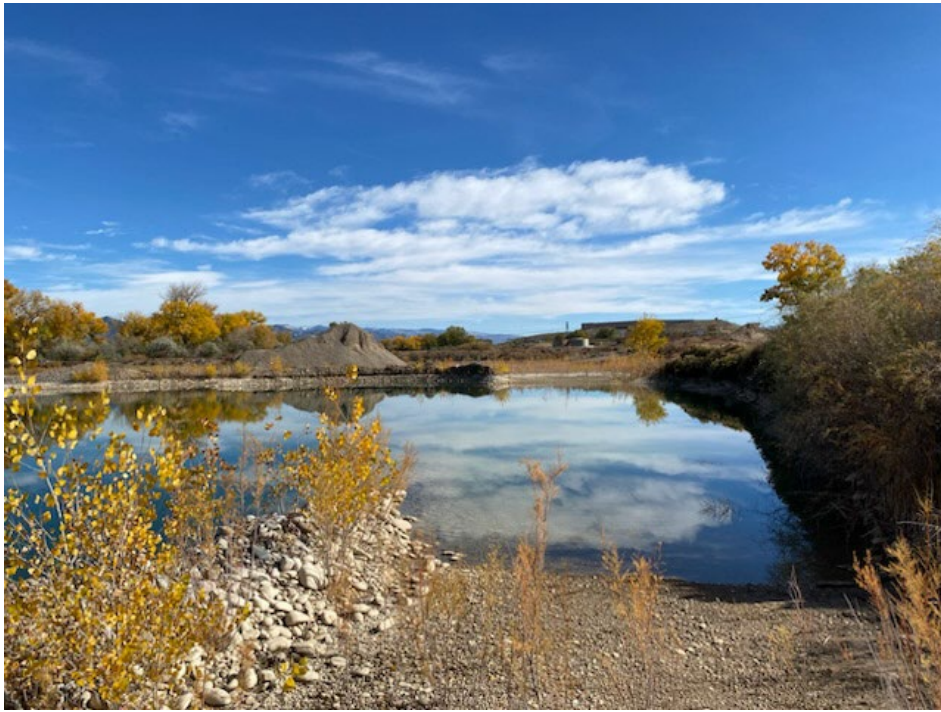
Photo 4: The western edge of the Scott Pit, the photo was taken looking to the east.
