MINERALS PROGRAM INSPECTION REPORT
PHONE: (303) 866-3567

MINE NAME: Barton Pit	MINE/PROSPECTING ID#: M-2000-149	MINERAL: Gravel	COUNTY: Logan
INSPECTION TYPE: Monitoring	WEATHER: Clear	INSP. DATE: November 21, 2022	INSP. TIME: 11:15
OPERATOR: Dumb and Dumber Trucking, LLC	OPERATOR REPRESENTATIVE: Travis and Brian Barton	TYPE OF OPERATION: 112c - Construction Regular Operation	
REASON FOR INSPECTION: Normal I&E Program	BOND CALCULATION TYPE: Complete	BOND AMOUNT: \$49,700.00	
DATE OF COMPLAINT: NA	POST INSP. CONTACTS: None	JOINT INSP. AGENCY: None	
INSPECTOR(S): Nikie Gagnon	INSPECTOR'S SIGNATURE:

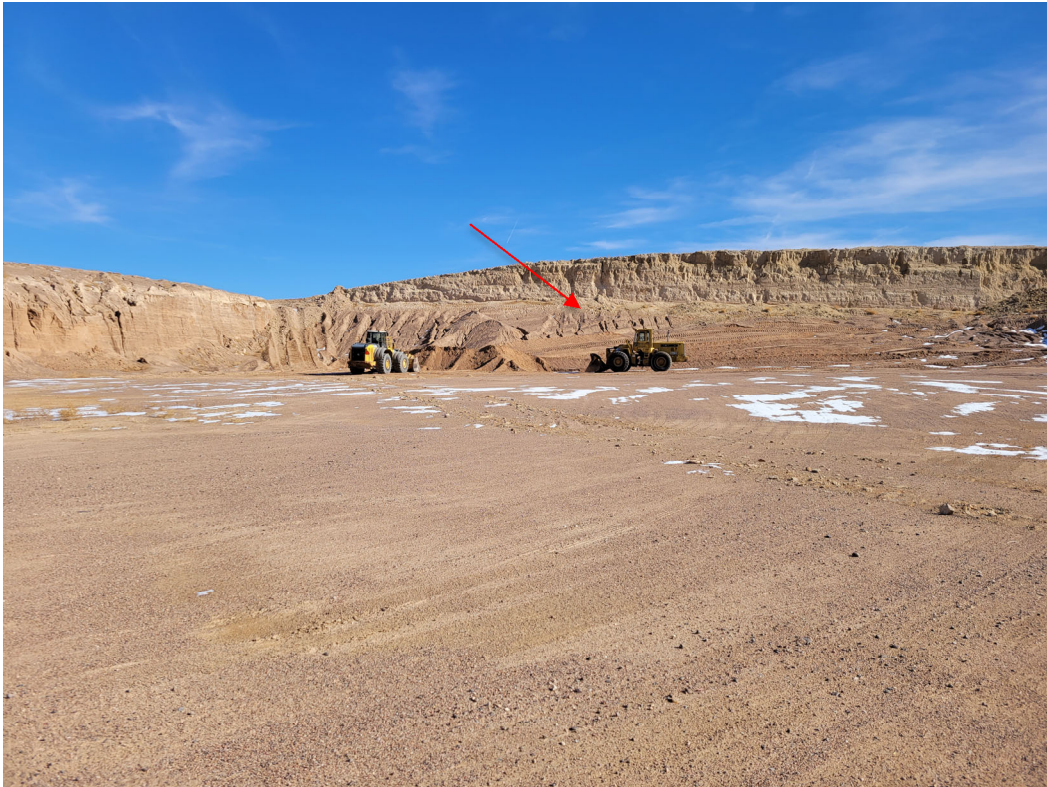
Looking southeast at mining Area 1. Arrow points to recent grading.

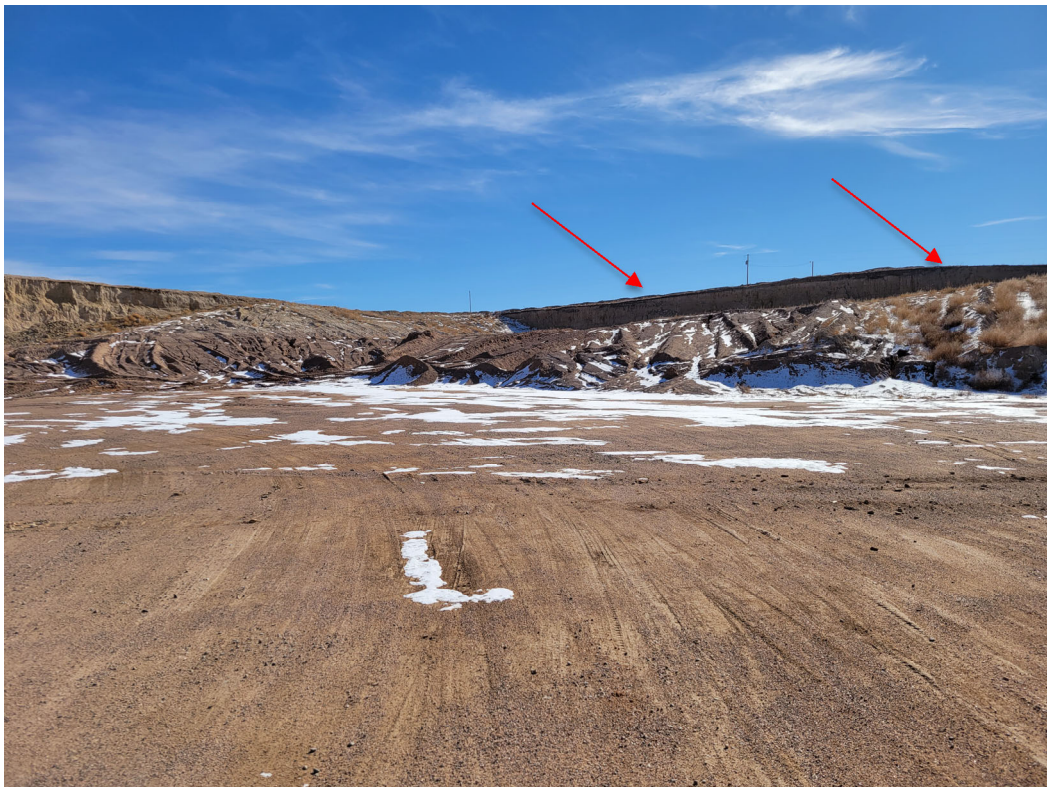
Topsoil was observed above the highwalls and stockpiled in the western portion of Area 2.

Looking south/southwest mining Area 1. Arrows points to overburden/topsoil stored above the highwall.

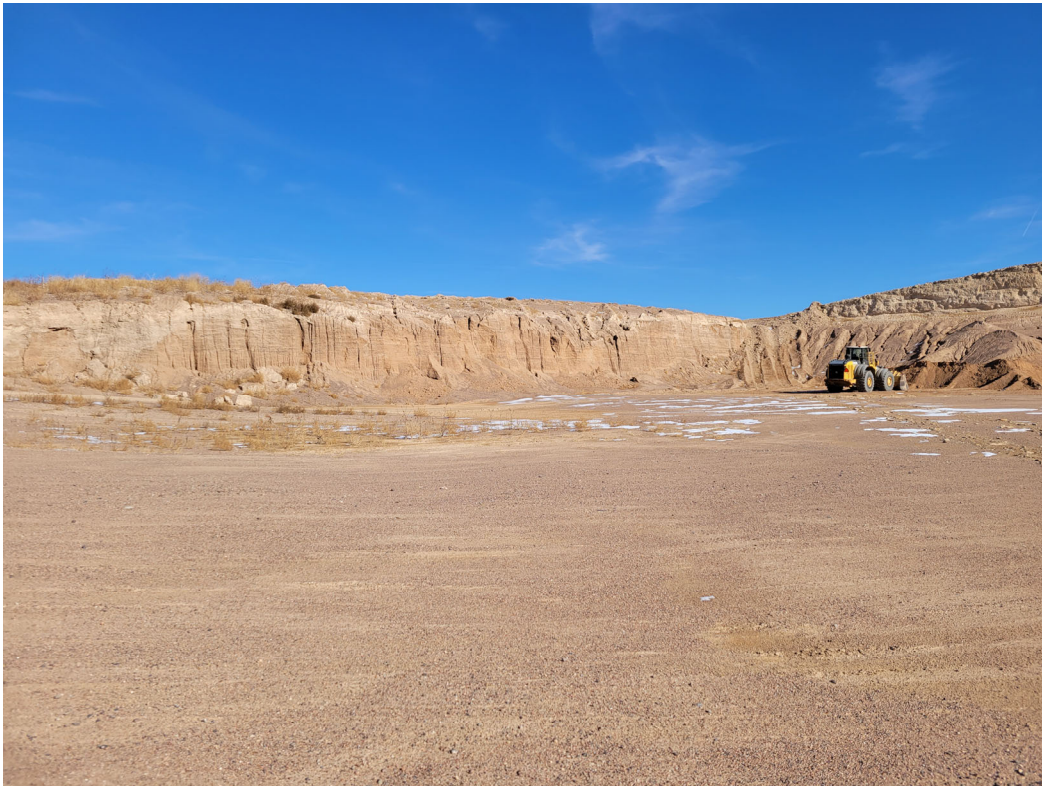
Looking north at mining Area 3. Operator plans to start mining this over the next year.

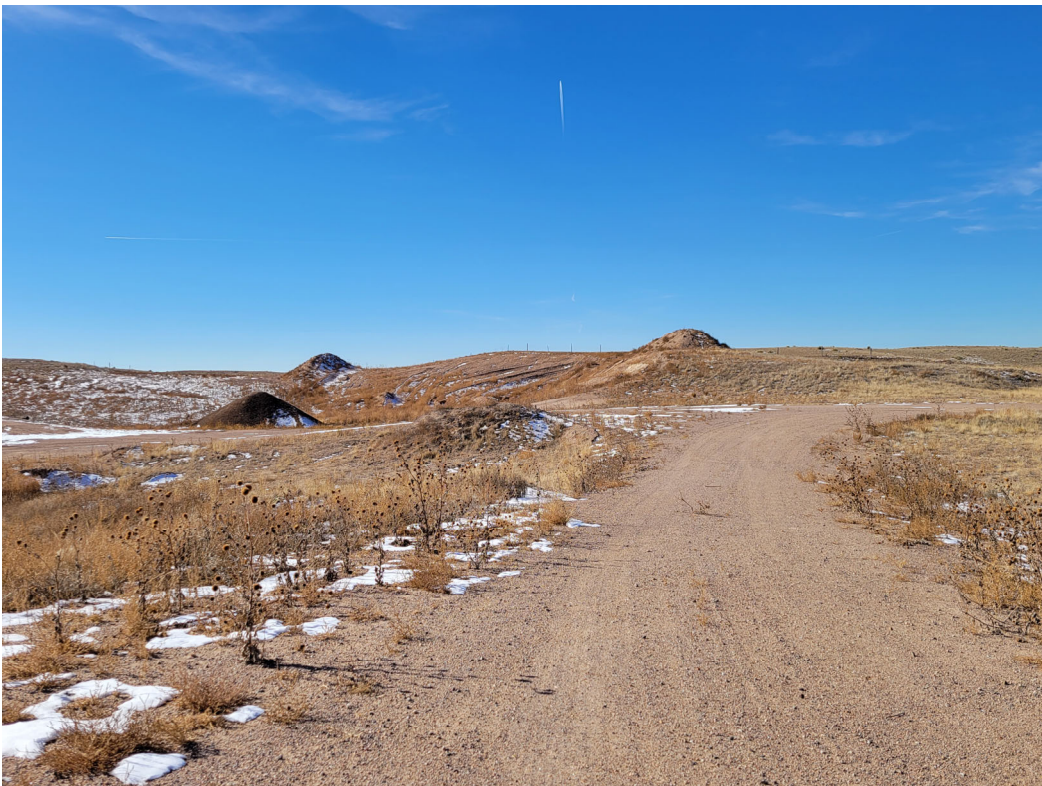
Access road in foreground leading to Area 2.

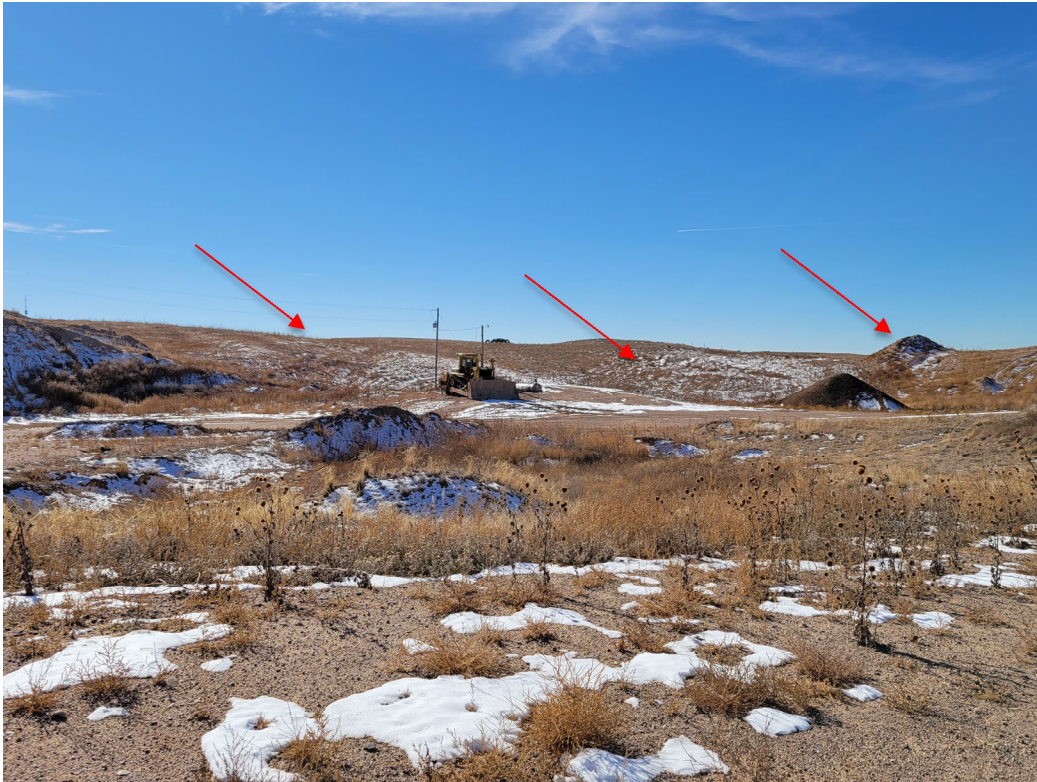
According to the mine and reclamation plans, mining will occur close to 3H:1V and final reclaimed slopes will be 3H:1V. The western portion of Area 2 has been graded to 3:1 and annual vegetation is growing on the slopes. Rills caused by stormwater runoff were noted in Area 2. The Division recommends repairing this area to control slope erosion. The high walls in Area 1 are nearly vertical, however, during the inspection there was evidence of recent grading work on the east and south sides of the pit where the operator is reducing the slopes to 3:1.

Looking west at mining Area 2, reggraded to 3H:1V slope, topsoil/overburden pile

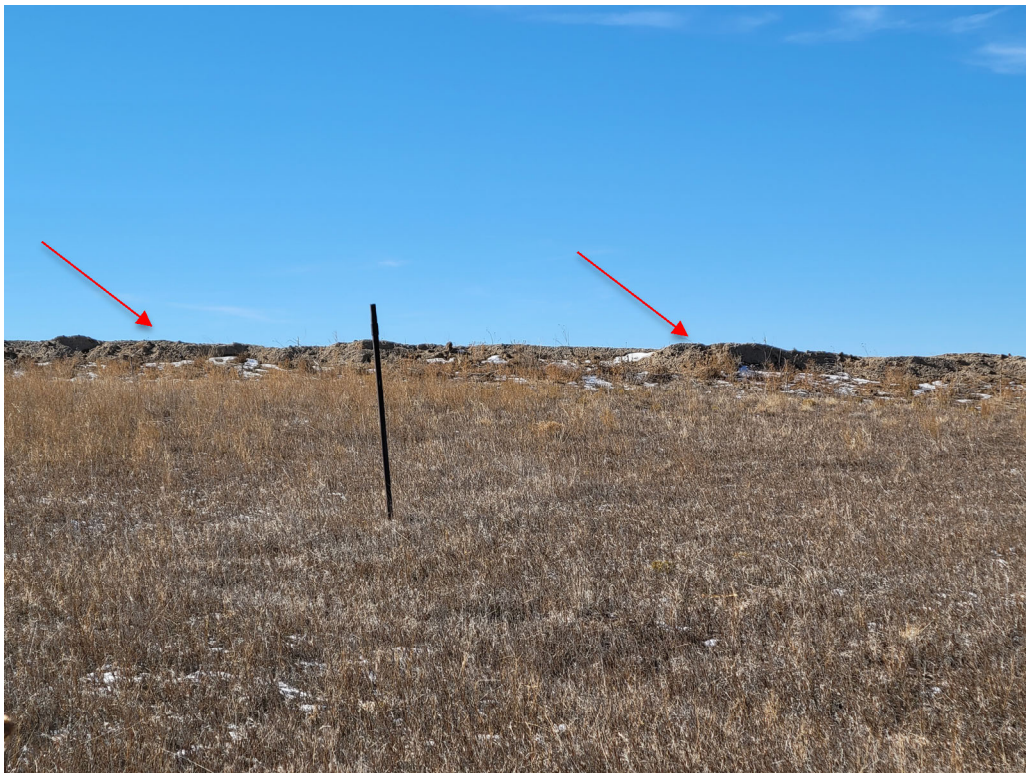
Looking west at boundary marker on east side of Area 1. 25' setback between highwall and road.
Arrow points to topsoil/overburden stored above highwall

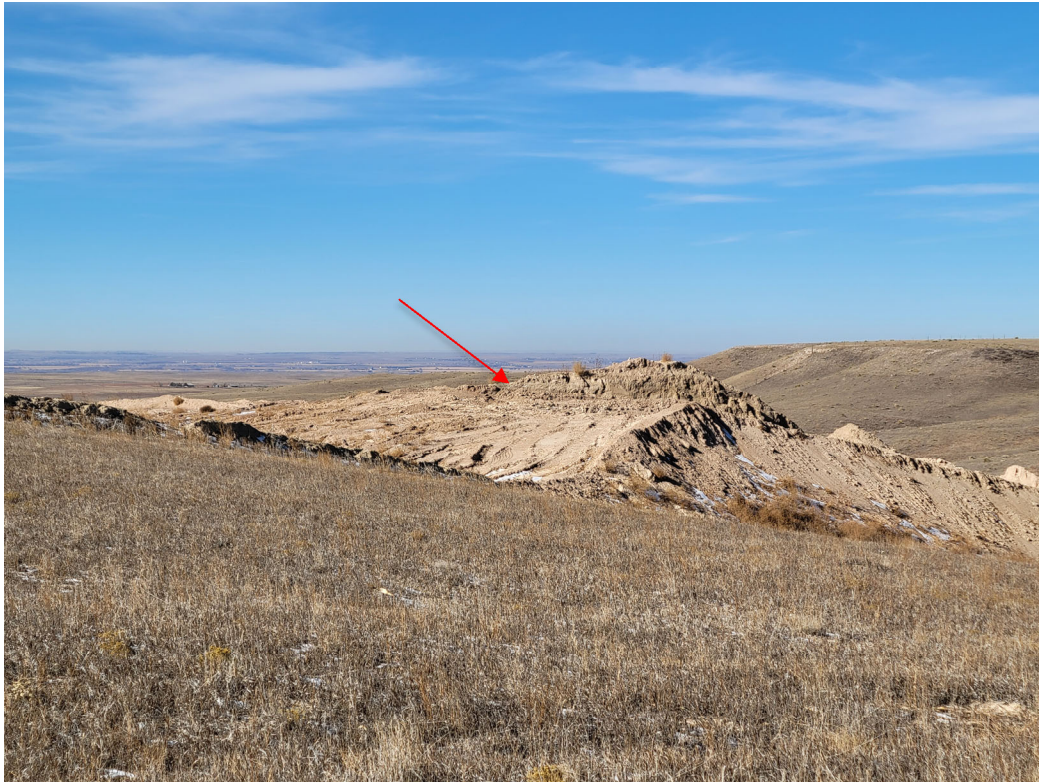
Looking northwest above highwall along county road. Minimum of 10' setback.
Arrow points to overburden stored above highwall

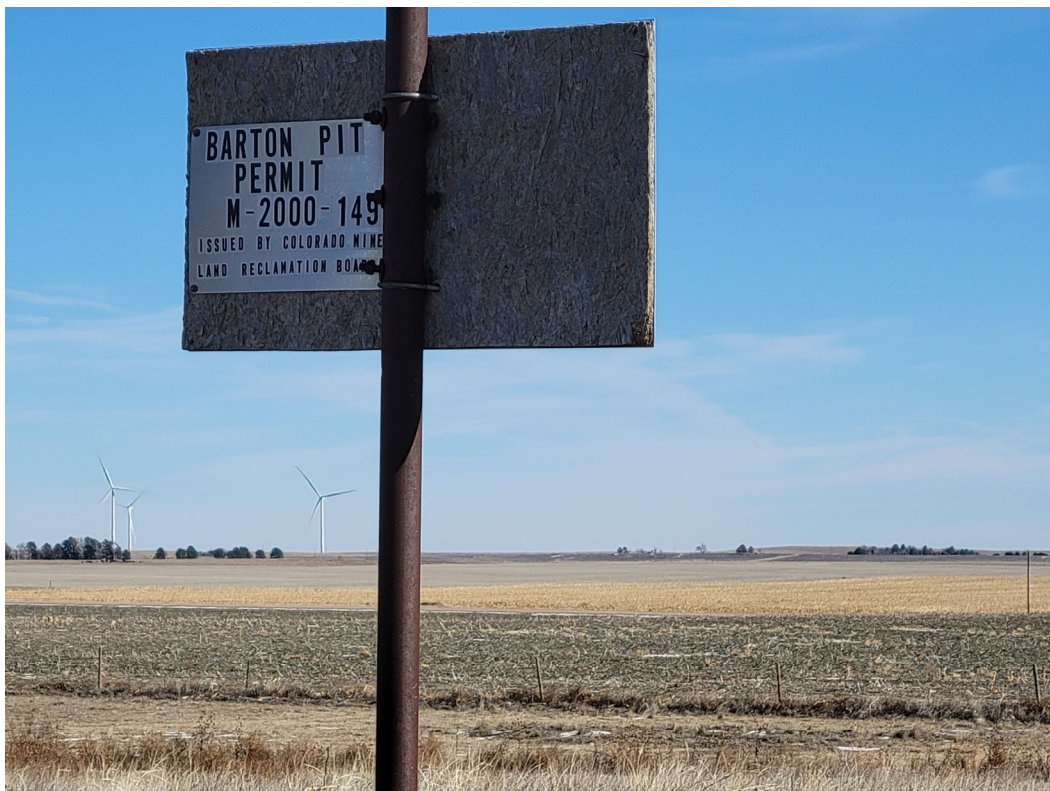
The mine sign was posted at the entrance and the permit boundary were marked by metal t-posts and a barbed wire fence runs around the perimeter of the property.

Mine sign observed at entrance to the pit facing the county road.
