MINERALS PROGRAM INSPECTION REPORT
PHONE: (303) 866-3567

MINE NAME: Nahcolite Project	MINE/PROSPECTING ID#: M-1983-194	MINERAL: Carbonates	COUNTY: Rio Blanco
INSPECTION TYPE: Monitoring	WEATHER: Clear	INSP. DATE: December 9, 2022	INSP. TIME: 11:00
OPERATOR: Natural Soda LLC	OPERATOR REPRESENTATIVE: Kirk Daehling	TYPE OF OPERATION: 112d-3 - Designated Mining Operation	
REASON FOR INSPECTION: Normal I&E Program	BOND CALCULATION TYPE: None	BOND AMOUNT: \$4,433,331.00	
DATE OF COMPLAINT: NA	POST INSP. CONTACTS: DRMS	JOINT INSP. AGENCY: None	
INSPECTOR(S): Amy Yeldell	INSPECTOR'S SIGNATURE:

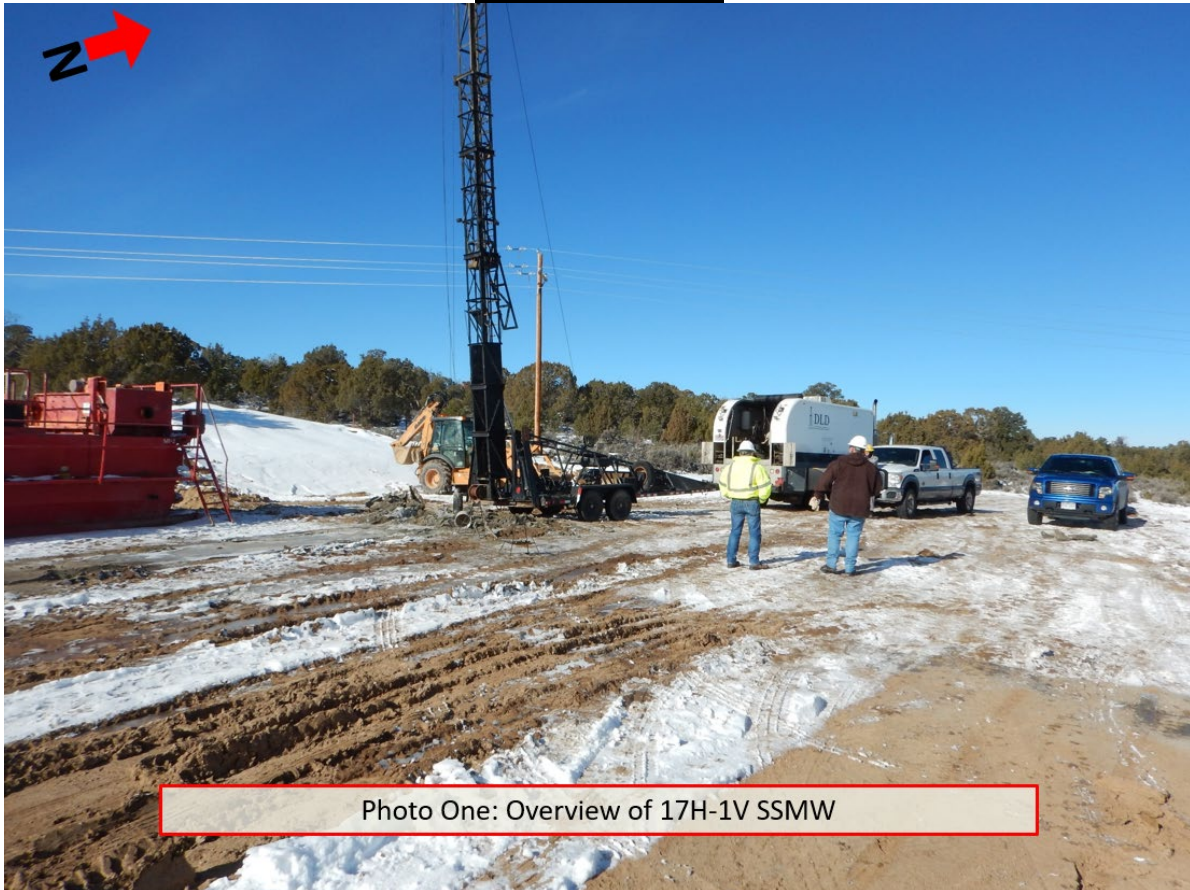
The new 17H-1V SSMW (TR 48 and 49) has just been completed. Crews were observed on site running a Collar Locator and Cement Bond Log (CBL). This is a newly constructed pad. Currently topsoil is located on the southwest side of the pad. In the spring the pad will be interim reclaimed.

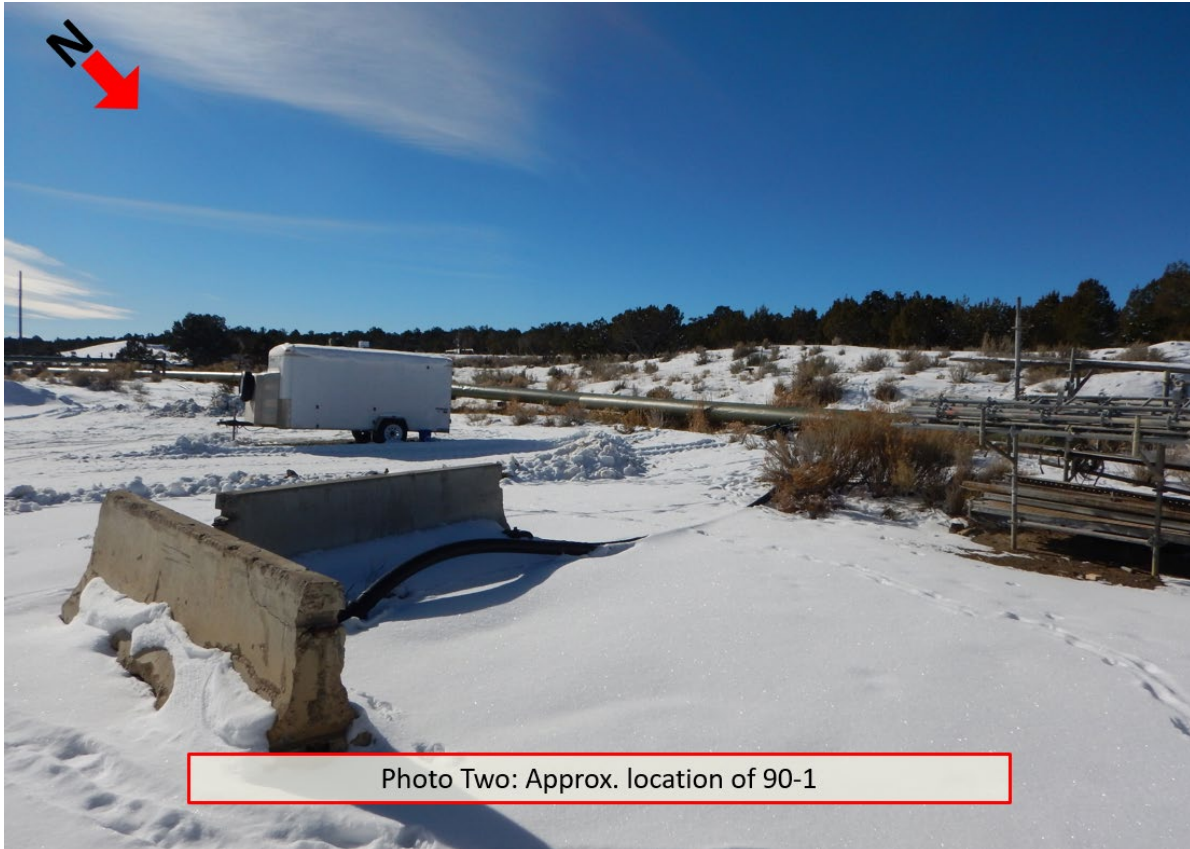
Well 90-1 was plugged and abandoned earlier this fall. It is located adjacent to the well field connex on a graveled surface. Casing has been cut off below the surface and no additional reclamation is anticipated at this time.

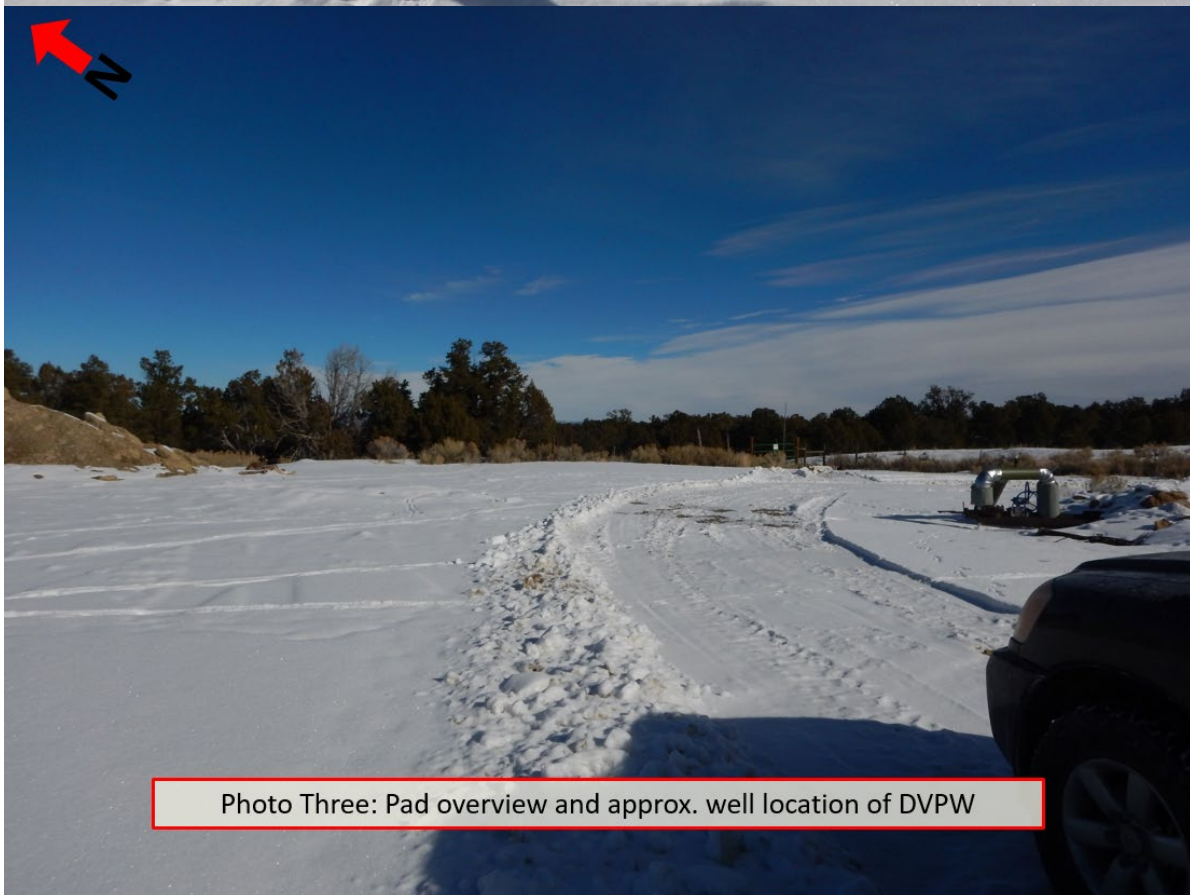
Well DVPW-1(A) has also been plugged and abandoned. The well casing is cut off below the surface. This pad is also used for staging. At this time there is no plans to reclaim the pad. The disturbed area may be repurposed and in the future the pipeline for new production wells may run through this pad area.

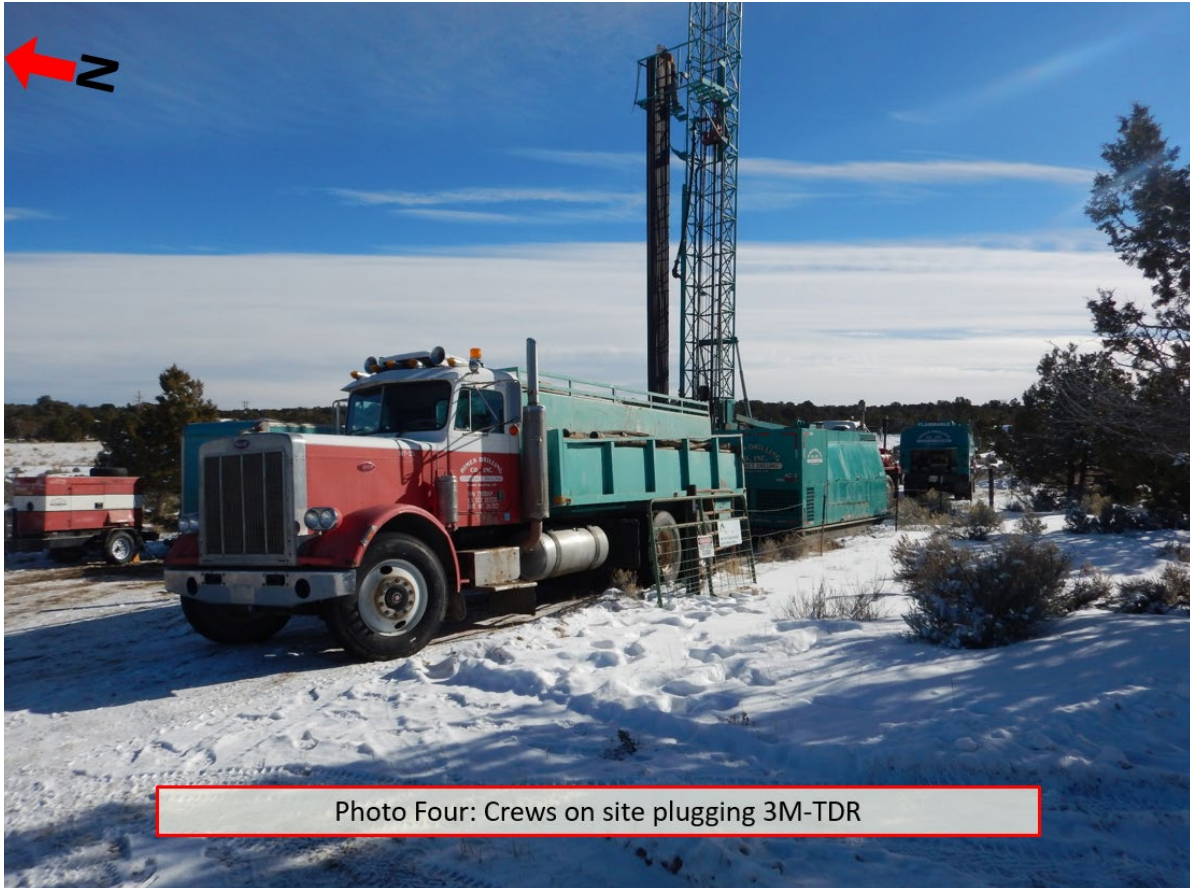
3M-TDR was actively being plugged at the time of the inspection. Crews were on site, so for safety we did not get close.

Photo Four: Crews on site plugging 3M-TDR

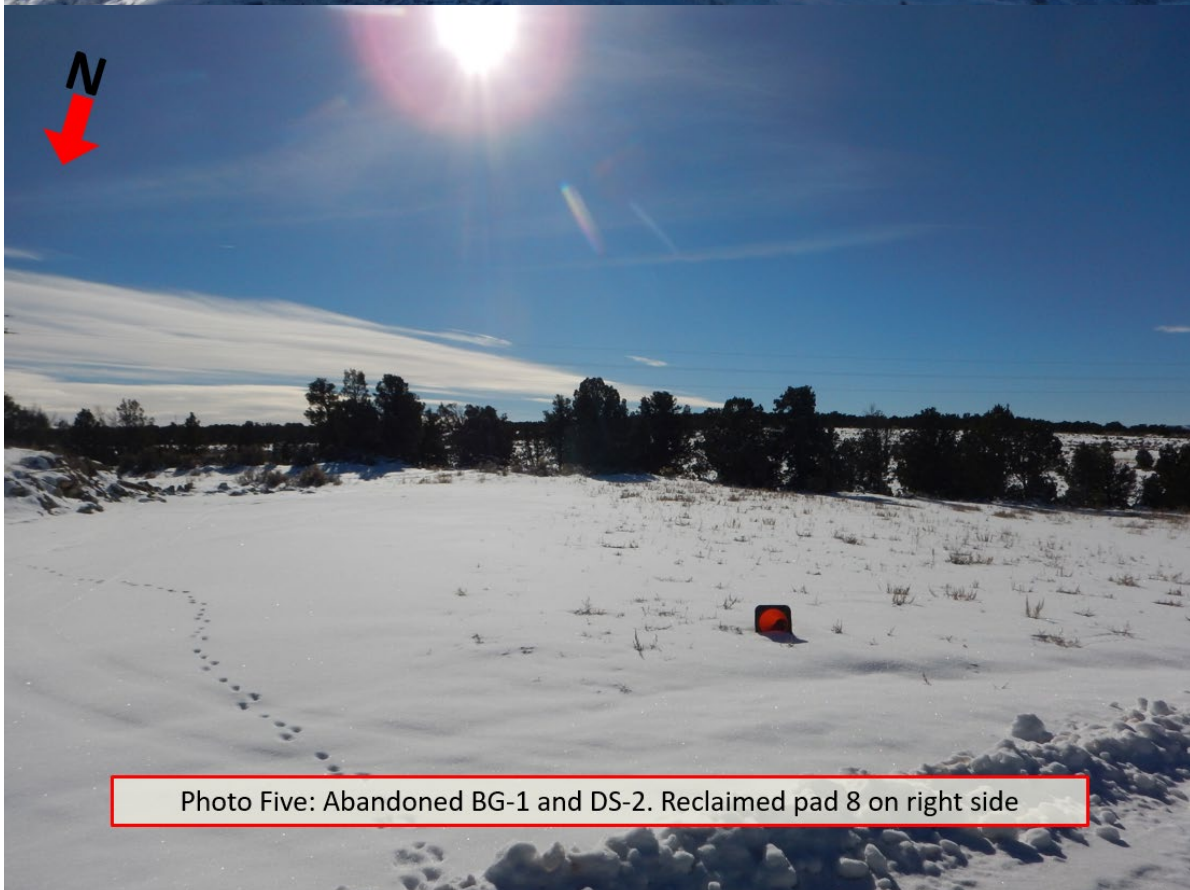
Wells DS-2 and BG-1 were also both plugged. All casing was cut off below the surface. They are located on the corner of the 8 Pad that is reclaimed. Little to no dirt work is necessary. Disturbed areas will be seeded this spring to blend into the 8 Pad.

Photo Five: Abandoned BG-1 and DS-2. Reclaimed pad 8 on right side
