Re: GCC Energy, LLC, King II Mine
CDRMS Permit # C-1981-035
Stoner Engineering: Quarterly Inspection: Water Quality
Improvements 4th Quarter 2022

Date: December 8, 2022

Re: King Coal I – Quarterly Water Quality Improvements Inspection

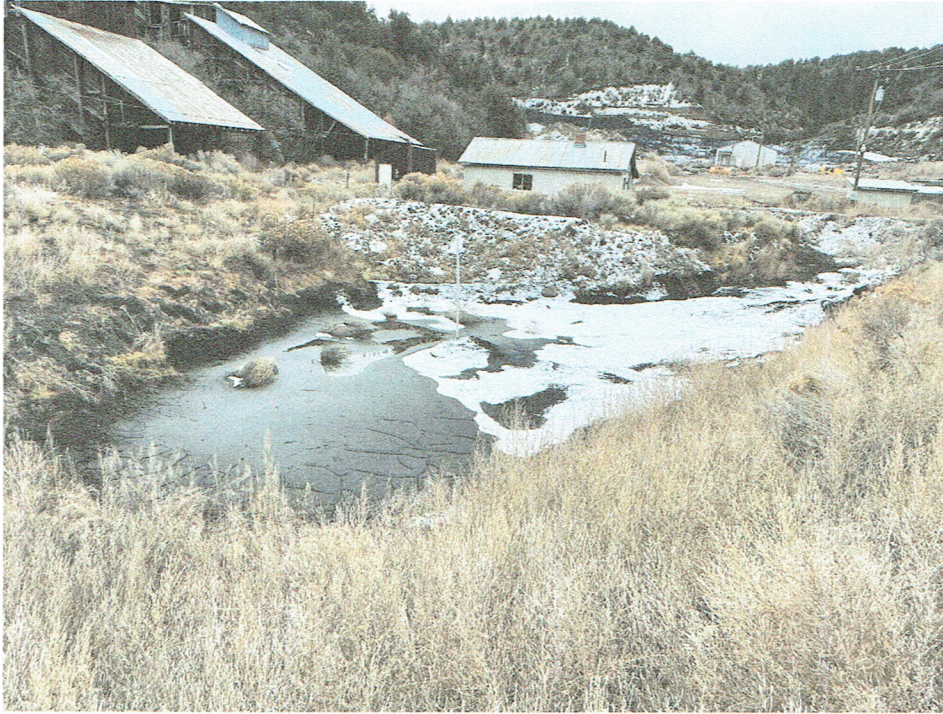
Both ponds held water at the time of the inspection due to recent storms. While the east pond water level had dropped since the previous inspection and was minimal (see Pic. 1), the west pond held roughly the same amount of water (see Pic. 2). The ponds should continue to be monitored after storm events to ensure that excess sediment does not reduce the required storage capacity available for storm water runoff. When conditions permit, the removal of the excess sediment in the west pond should be completed. The sedimentation traps at the entrance to the site are generally in good condition.

Pic. 1 – Water level lower, East pond.

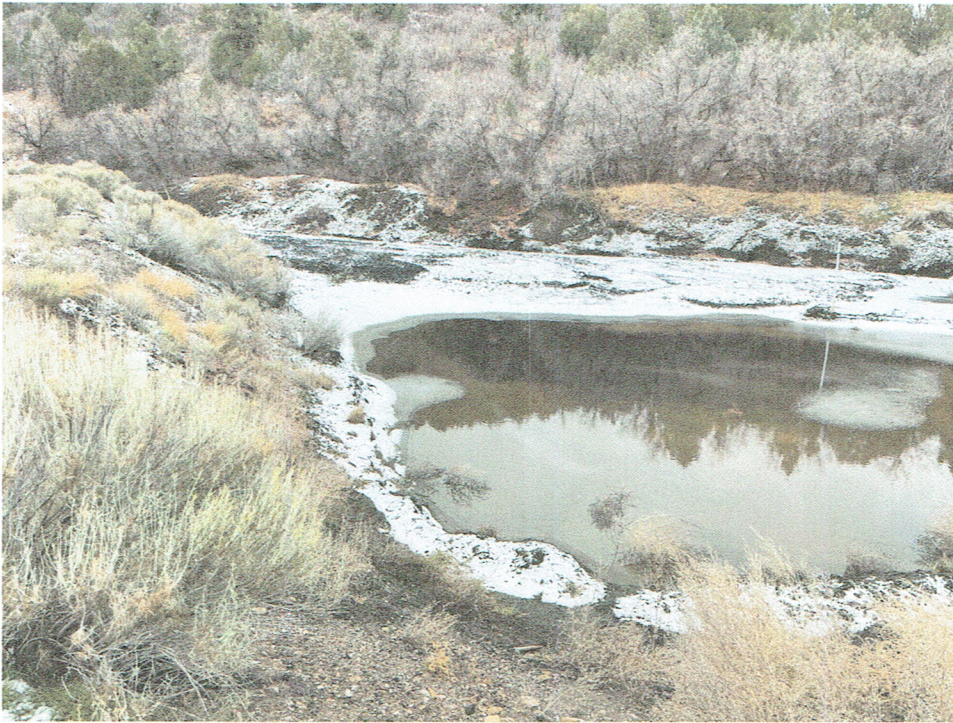
Pic. 2 – Sediment/water levels appear unchanged, West pond.

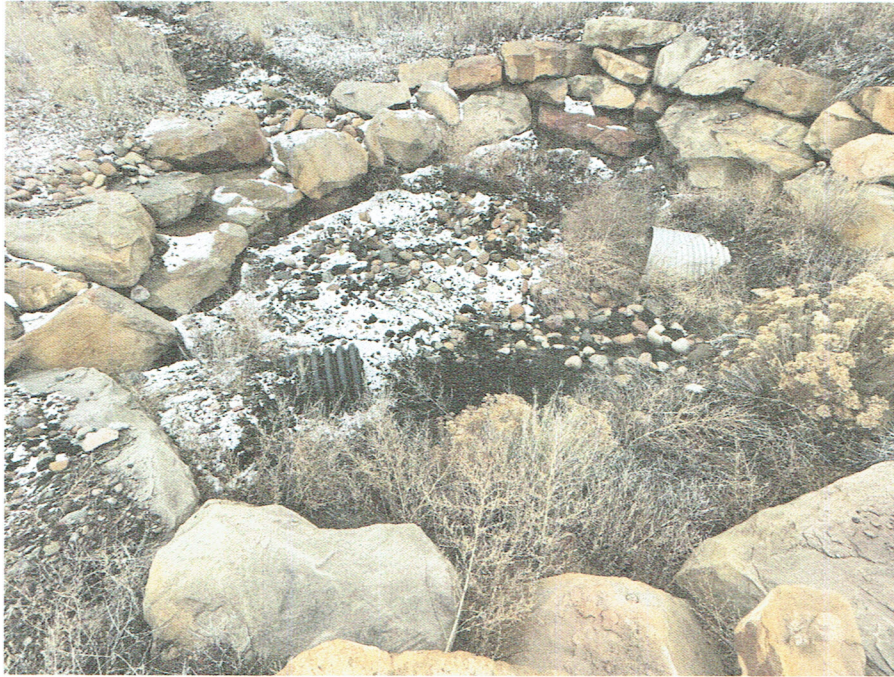
There has been some erosion of the channel for the treated water flows along the west side of the lower pile. This has also resulted in some sedimentation of the inlet basin for the culvert running under the haul road into the west detention pond (see Pic. 3). The sedimentation should be cleaned from the basin and the channel section repaired to prevent additional erosion.

Pic. 3 – Inlet basin, treated water ditch at base of lower waste pile.

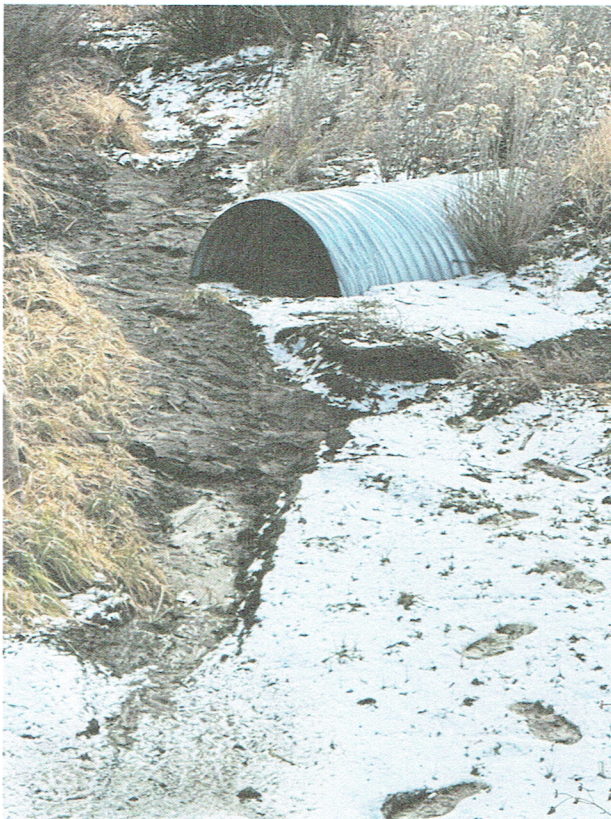
The sedimentation of the clear water ditch (Reach 5) at the outlet of the south clear water ditch (Reach 3 & 4) where it was rerouted to account for the construction of the lower waste embankment pile has not been cleaned (see Pic. 4). This sediment should be cleared to prevent the culvert from backing up and/or reducing the capacity of the north clear water ditch. Reduced outflow of the culvert (Reach 3 & 4) could result in south clear water flows entering the west detention pond during a large storm event. All the culverts located on the site should be checked and any excess sediment cleared/cleaned after seasonal storm events.

Pic. 4 – South clear water ditch (Reach 3& 4) outlet at tie to north clear water ditch (Reach 5).
