Re: GCC Energy, LLC, King II Mine

CDRMS Permit # C-1981-035

Stoner Engineering: Quarterly Inspection: Refuse

King Coal I – Quarterly Waste Pile/Embankment Inspection

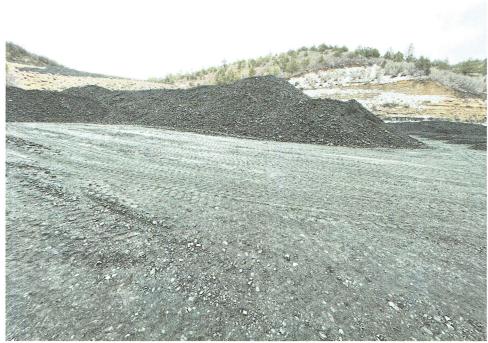
There does not appear to have been any additional waste material placed at the top of the main waste embankment pile since the previous inspection. There has been additional material placed on the lower pile (see Pic. 1). The slope of the top of the existing pile is closer to that defined in the Waste Bank Design produced by Don May, 1997.

Pic. 1 –Waste material stockpiled on lower waste pile.

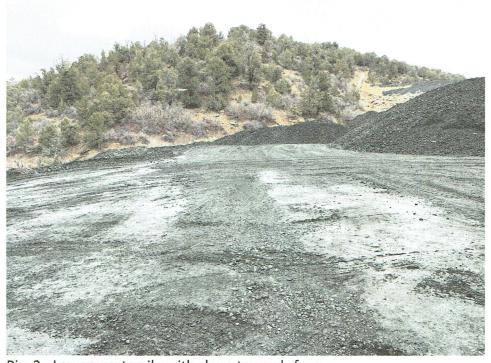
As a result of the stockpiling of waste embankment materials on the lower pile, there is a portion that slope to the north towards the face of the embankment pile. The required berming at the face of the embankment is in place and is preventing runoff from flowing down the face of the embankment pile. The grading should be improved on the lower pile to prevent runoff from flowing towards the face of the waste embankment pile which could result in erosion down the face of the waste pile.

Pic. 2 -Lower waste pile with slope towards face.
