MINERALS PROGRAM INSPECTION REPORT
PHONE: (303) 866-3567

MINE NAME: Doughty's Pit	MINE/PROSPECTING ID#: M-1975-009	MINERAL: Clay (general)	COUNTY: Jefferson
INSPECTION TYPE: Monitoring	WEATHER: Windy	INSP. DATE: December 19, 2022	INSP. TIME: 11:00
OPERATOR: The Lakewood Brick and Tile Company	OPERATOR REPRESENTATIVE: Jim Welte	TYPE OF OPERATION: 110c - Construction Limited Impact	
REASON FOR INSPECTION: Normal I&E Program	BOND CALCULATION TYPE:	BOND AMOUNT: \$8,385.00	
DATE OF COMPLAINT: NA	POST INSP. CONTACTS: None	JOINT INSP. AGENCY: None	
INSPECTOR(S): Eric Scott	INSPECTOR'S SIGNATURE:

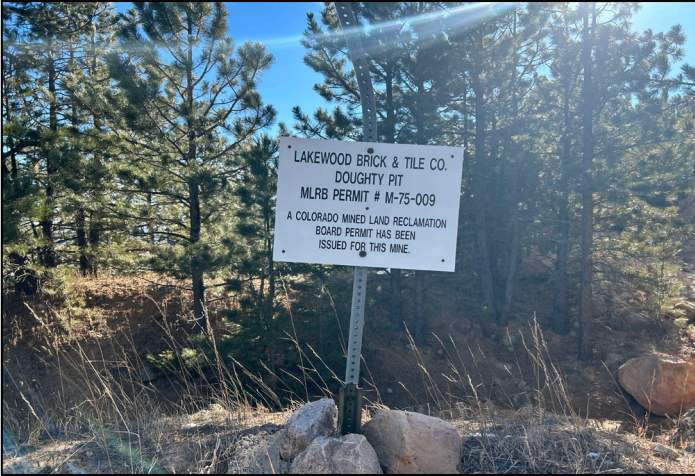
The Doughty's Pit was inspected by Eric Scott with the Division of Reclamation, Mining and Safety as part of the Division's monitoring inspection program. The site was previously inspected by the Division on February 14, 2019. Mr. Jim, and Ms. Julie Weltie with Lakewood Brick and Tile Company in addition to Mr. Steve O'Brian with Environment, Inc. were present during the inspection. The entrance sign and boundary markers were observed during the inspection as required by Rule 3.1.12 (photo 1).

Photo 1 – Site identification sign near site entrance

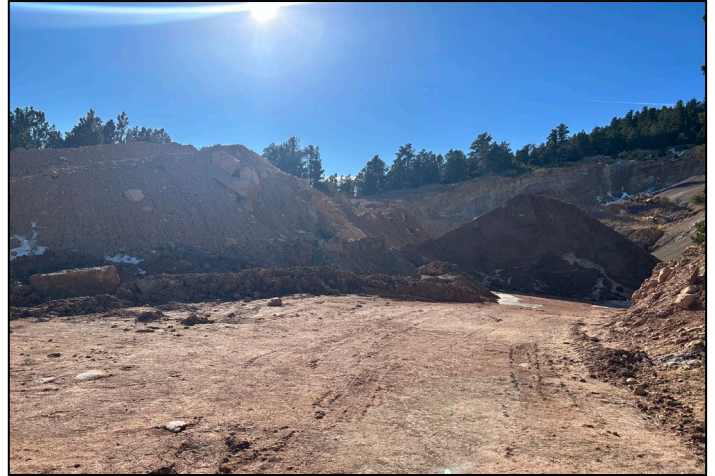
Based on the existing perimeter slopes at the site (photos 2-4), and the extent of the disturbance within the permitted 5 acres, the Division believes that it is unlikely the re-sloping earthwork required to reclaim the site to stable 2:1 slopes within the existing permit area can be completed if additional excavation continues. DRMS recommends that the operator determine the viability of the current reclamation plan and submit a permit revision to address final reclamation, perhaps with slightly steeper 3:1 slopes and erosion control contouring. If the operator is unwilling to address this potential issue in a timely fashion, the Division will implement a surety increase based on the existing conditions and what would be required to achieve stable 2:1 slopes within the existing permit area. This may include costs to import material as needed and construction of benches to facilitate long term stability of the remaining slopes.

Photo 2 – Existing product stockpile on right, overburden for reclamation on left.

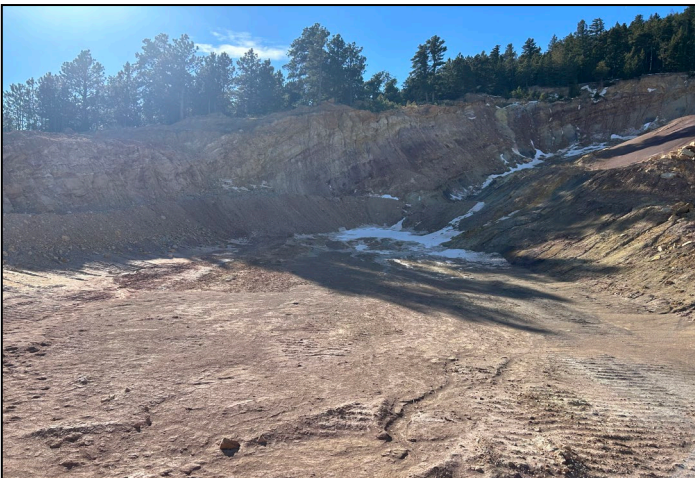
Photo 3 – Photo from top of overburden stockpile looking west.

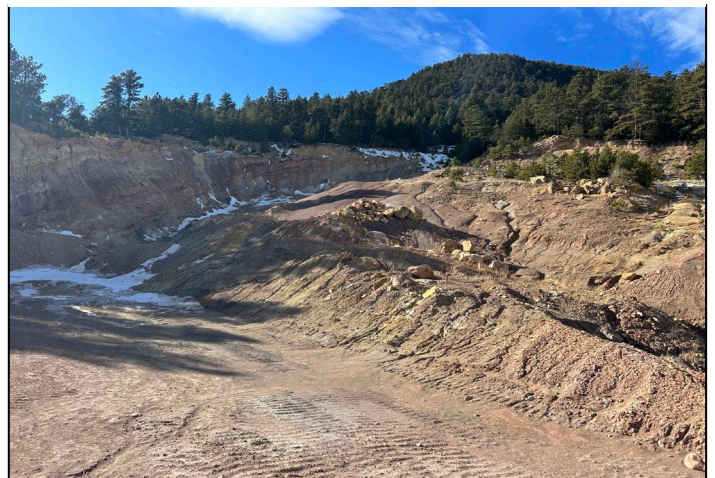
Photo 4 – Photo from top of overburden stockpile looking NW.
