MINERALS PROGRAM INSPECTION REPORT
PHONE: (303) 866-3567

MINE NAME: Church Pit	MINE/PROSPECTING ID#: M-1979-045	MINERAL: Clay (general)	COUNTY: Jefferson
INSPECTION TYPE: Monitoring	WEATHER: Windy	INSP. DATE: December 19, 2022	INSP. TIME: 12:00
OPERATOR: The Lakewood Brick and Tile Company	OPERATOR REPRESENTATIVE: Jim and Julie Welte	TYPE OF OPERATION: 112c - Construction Regular Operation

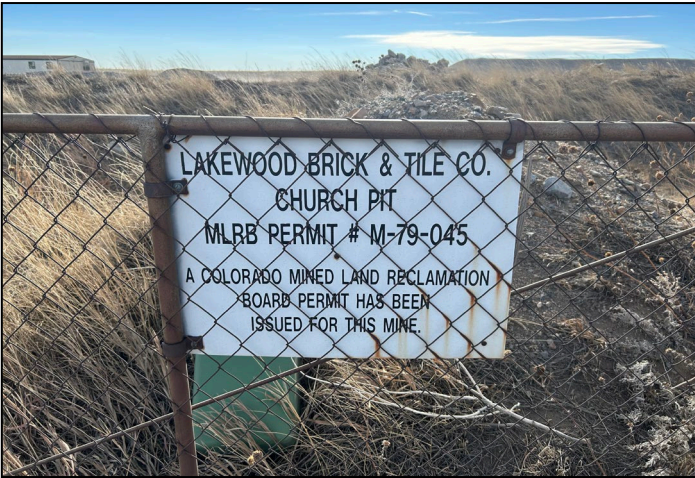
The site is currently permitted for 75.74 acres, and the site identification sign (Photo 1) and boundary markers were present as required by Rule 3.1.12. The Church Pit is mined for sand, gravel and clay. Lakewood Brick and Tile operates the clay extraction from the site, and Bestway Concrete extracts the sand and gravel from the Church Pit, in addition to the adjacent Rocky Flats Pit. An agreement between Bestway and Lakewood Brick exists to allow the joint operations currently taking place at the site.

Photo 1 – Site identification sign at entrance to the permit area.

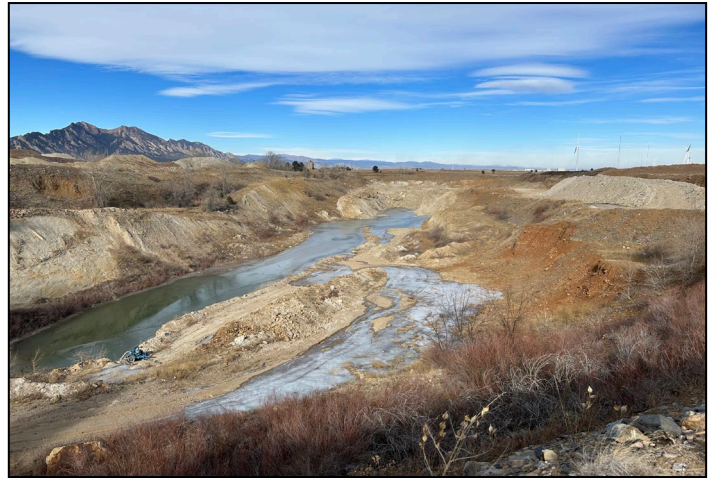
PROBLEM/POSSIBLE VIOLATION: Problem: The site is improperly impounding surface drainage/runoff. All surface drainage/runoff is required by the State Engineer's Office to be discharged within 72 hours.

Photo 2 – Improperly retained runoff in bottom of clay pit will need to be discharged.

CORRECTIVE ACTIONS: Operator is required to pump and discharge water from the site and submit photos or other documentation to demonstrate compliance, or submit documentation from the State Engineer's Office demonstrating that the impoundment of water in this pit is authorized by that office by the corrective action date.

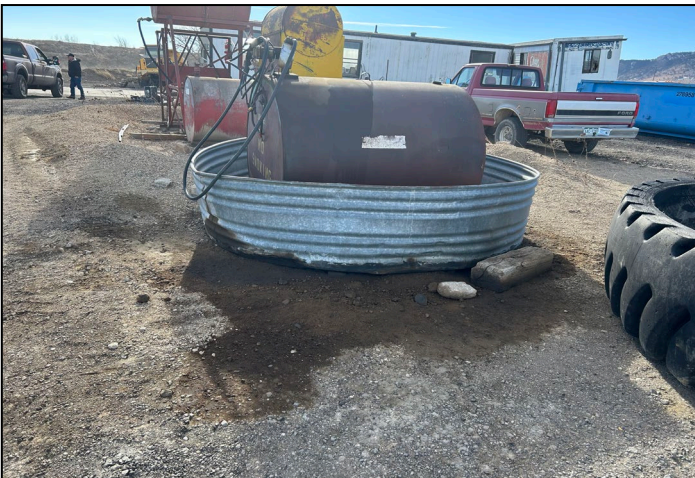
PROBLEM/POSSIBLE VIOLATION: Problem: Improper storage and containment of fuels and/or other hazardous materials was present on site.

Photo 3 – Proper secondary containment will need to be used for on-site fuel storage and all stained soils removed and properly disposed of.

CORRECTIVE ACTIONS: All storage tanks, petroleum and any hazardous materials on site for any period of time shall have appropriate secondary containment. The site will also have to comply with all applicable SPCC requirements. Please supply photo documentation that any fuel or hazardous materials containers are stored properly - including applicable secondary containment structures by the corrective action date. Note that secondary containment structures shall consist of an impermeable containment which could contain all contents of the tanks and various containers (when full) plus 10% of the total capacity. The operator may also provide photo documentation that all containers have been removed from the site on or before the corrective action date.

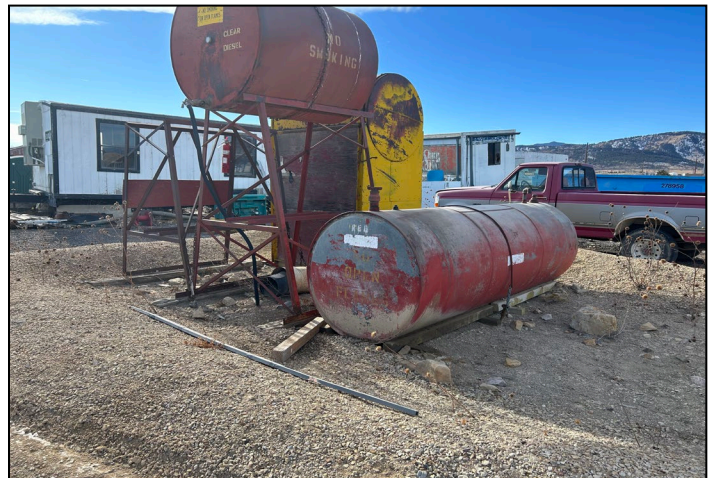
Photo 4 – Proper secondary containment will need to be used for on-site fuel storage. Incomplete gravel berm is not sufficient.

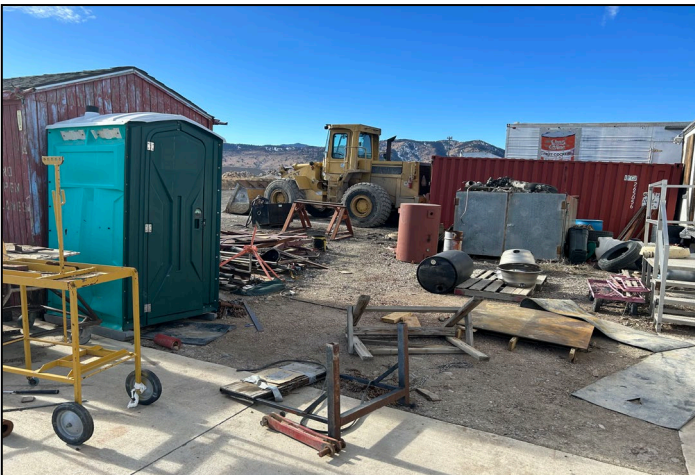
PROBLEM/POSSIBLE VIOLATION: Problem: Trash and refuse was noticed on the site (old tires, scrap steel, stained soils, general refuse). This is a problem at this time for failure to dispose of refuse in a manner that controls unsightliness or deleterious effects of such refuse pursuant to C.R.S. 34-32.5-116(4)(e).

- 1) The presence of refuse/trash such as old tires, scrap steel, stained soils, and general trash (photo 5). These items will need to be removed from the site and properly disposed of by the corrective action date of March 31, 2023 as noted on the first page of this report.
- 2) The presence of impounded runoff/precipitation in the clay pit (Photo 2). As detailed on the first page of this report, any impounded runoff/precipitation captured by the clay pit will need to be discharged within 72 hours.
- 3) Improper Fuel Storage -lack of proper secondary containment (Photo 3-4). As stated above, proper secondary containment for all fuel tanks on site is required. The operator will need to provide documentation (photos) that all tanks on site have proper secondary containment as detailed above by the corrective action date (March 31, 2023).

Photo 5 – Excess trash and refuse should be removed from the site. (scrap, old tires, inoperable vehicles, etc.)

CORRECTIVE ACTIONS: The operator shall submit a written notice to the Division with photo documentation, that the trash has been removed from the site by the corrective action date.
