MINERALS PROGRAM INSPECTION REPORT
PHONE: (303) 866-3567

MINE NAME: Rocky Flats Pit	MINE/PROSPECTING ID#: M-1987-113	MINERAL: Clay, sand, gravel	COUNTY: Jefferson
INSPECTION TYPE: Monitoring	WEATHER: Windy	INSP. DATE: December 19, 2022	INSP. TIME: 13:00
OPERATOR: Bestway Concrete Company	OPERATOR REPRESENTATIVE: Chris Oestreich	TYPE OF OPERATION: 112c - Construction Regular Operation	
REASON FOR INSPECTION: Normal I&E Program	BOND CALCULATION TYPE:	BOND AMOUNT: \$551,431.00	
DATE OF COMPLAINT: NA	POST INSP. CONTACTS: None	JOINT INSP. AGENCY: None	
INSPECTOR(S): Eric Scott	INSPECTOR'S SIGNATURE:

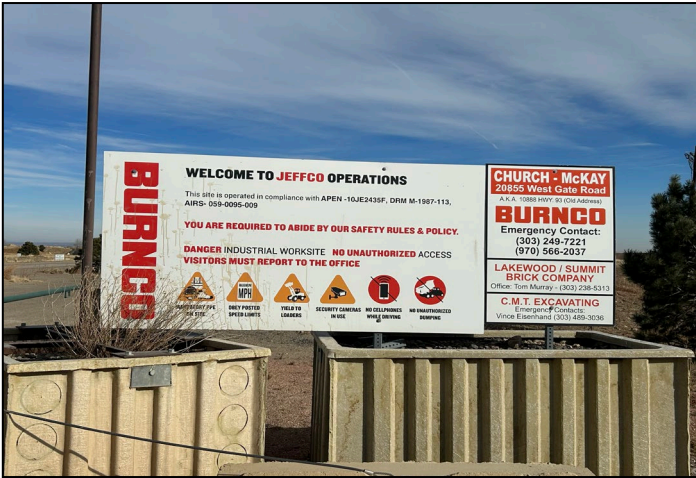
The site is currently permitted for 95.07 acres, although it should be noted that the easternmost portion of the site cannot be mined at this time due to sand and gravel rights ownership issues. The site identification sign and boundary markers were present as required by Rule 3.1.12 (Photo 1). Wind was high during the inspection, but had not yet reached the level of 35 mph sustained of sustained wind which would trigger processing operations shut-down as required by the air permit.

Photo 1 – site identification sign with all operations permits listed, including DRMS

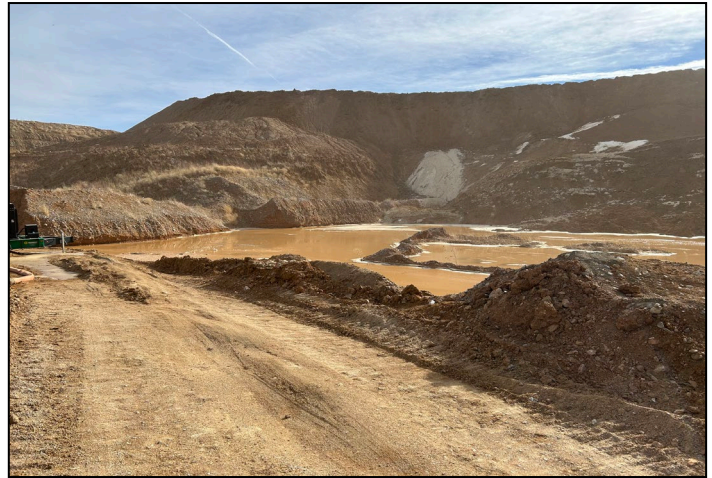
Photo 2 – SE corner of operational mining cell. Water in photo is a process water pond - no groundwater has been exposed at this site.

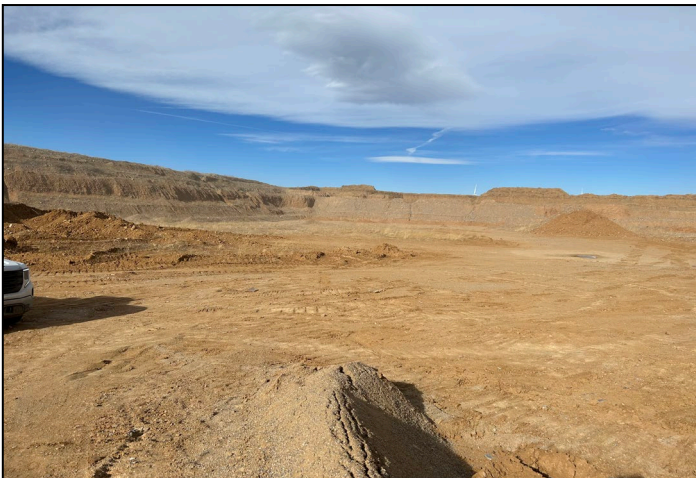
Photo 3 – NW corner of large operational cell on east side of site showing current west and north highwalls.

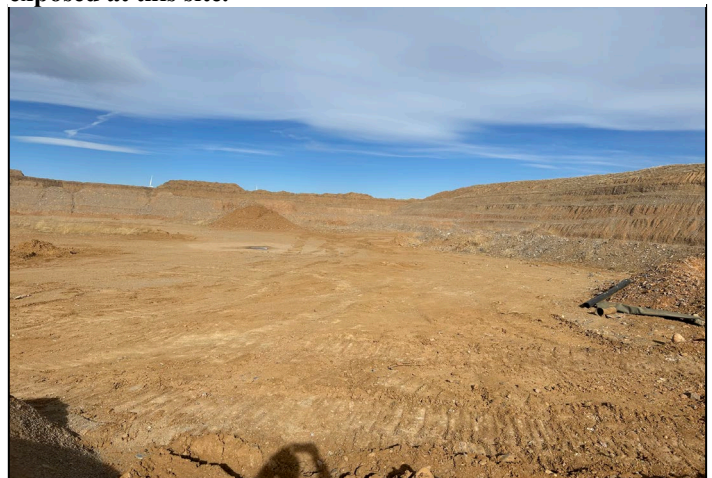
Photo 4 – NE corner of large operational cell on east side of site showing current north and east highwalls.
