MINERALS PROGRAM INSPECTION REPORT
PHONE: (303) 866-3567

MINE NAME: West Farm Reservoirs	MINE/PROSPECTING ID#: M-2022-048	MINERAL: Sand, gravel, borrow	COUNTY: Weld
INSPECTION TYPE: Preoperation Inspection	WEATHER: Windy	INSP. DATE: December 21, 2022	INSP. TIME: 12:00
OPERATOR: L. G. Everist, Incorporated	OPERATOR REPRESENTATIVE: Lynn Shults	TYPE OF OPERATION: 112c - Construction Regular Operation

REASON FOR INSPECTION: Preoperation Inspection	BOND CALCULATION TYPE:	BOND AMOUNT: No Bond Held
DATE OF COMPLAINT: NA	POST INSP. CONTACTS: None	JOINT INSP. AGENCY: None
INSPECTOR(S): Eric Scott Michael Cunningham	INSPECTOR'S SIGNATURE:

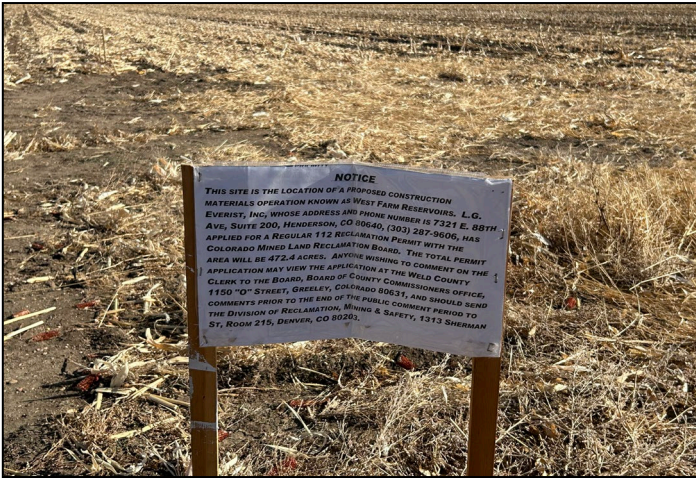
PROBLEM/POSSIBLE VIOLATION: Problem: The required 11"x17" notice of permit applied for sign was present in only one location for a proposed 472 acre permit adjacent to Weld County Roads CR 21 and CR 32.5. The permit boundaries, were not sufficiently marked for the pre-operation inspection.

Two items were noted during the inspection that will require corrective actions by the applicant as described on the first page of this report: insufficient notice signage, and insufficient permit boundary marking at the time of this inspection. These issues will need to be addressed as detailed in the corrective actions section of the first page of this report, and proof provided to DRMS that this has been done by the corrective action dates provided. One permit applied for notice was present adjacent to WCR 21 near the proposed site entrance (Photo 1).

Photo 1 – notice of permit applied for sign at proposed site entrance on east side of WCR 21.

CORRECTIVE ACTIONS: The operator must post notice signs "as required by the Office, and of sufficient number..." In this instance, at least one notice sign meeting the rule requirements for size and content should be posted along each county road adjacent to the site where it is visible from the roadway. All additional notice signs should be posted by no later than 1/6/23.

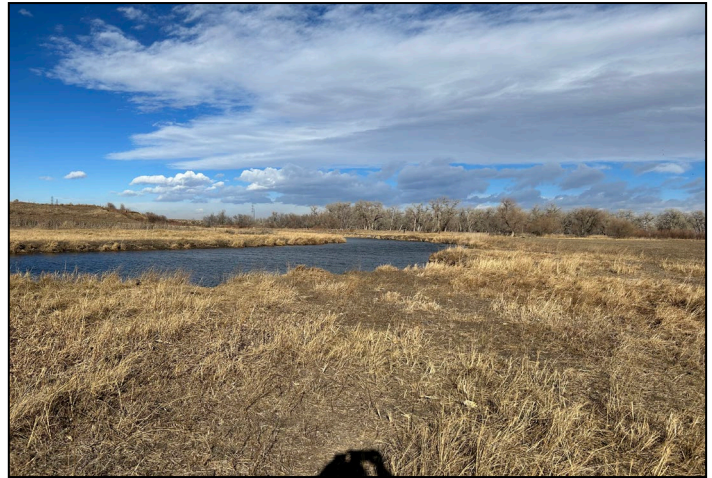
Surface water was present and flowing to the river in the most significant N-S running ditch across the site (Photos 2-3). This is reportedly due to the ditch being excavated at some point in the past into the shallow groundwater at the site. At the time of this inspection (December) there is no irrigation currently active in the area, there has been no recent precipitation, and groundwater on the lower area of the proposed permit is very shallow based on existing monitoring data, so this explanation seems very reasonable.

Photo 2 – area of flowing water in center of northern half of permit area. Taken looking NW from lower (east) side of permit.

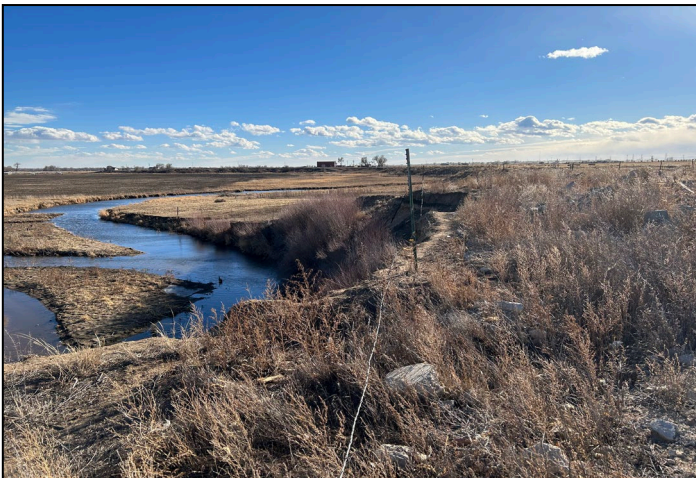
Photo 3 – area of flowing water in center of northern half of permit area. Taken looking SE from upper terrace (west side) of permit.

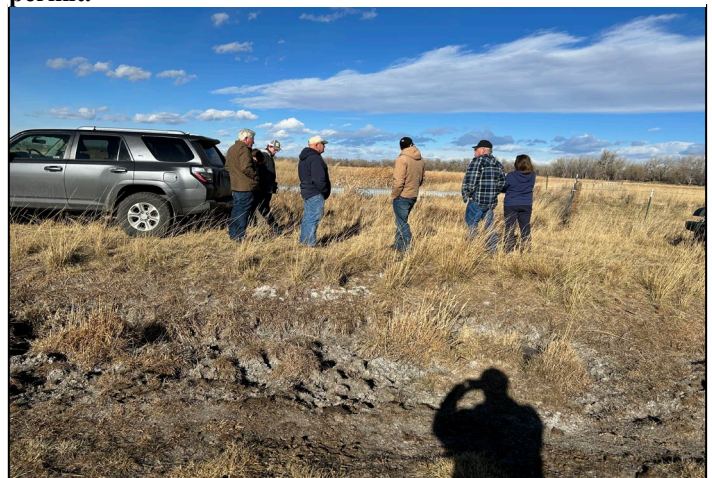
DRMS and the Operator representatives also met with the property caretaker for the adjacent property to the south of the permit. This property is part of the Colorado Open Lands conservatorship, and representatives for Colorado Open Lands, Cheryl Crufre and Chris Hart, were also present for that portion of the inspection. These parties wished to meet with DRMS and the operator to discuss their potential concerns with the application. Two topics were discussed that would be considered to be jurisdictional to DRMS: potential groundwater mounding due to installation of slurry walls within the proposed permit; and preservation of an irrigation return flow pathway for irrigation water leaving the southern adjacent property (Photo 4). When active, this irrigation return flows across the proposed permit area to reach the South Platte River. These issues were also identified in the comment letter provided to DMRS by State Engineer's Office Division of Water Resources, and are also part of the normal permit review process for an application of this type.

Photo 4 – DRMS and Operator meeting with property owner to the south and Colorado Open Lands to discuss preserving irrigation return flow path.

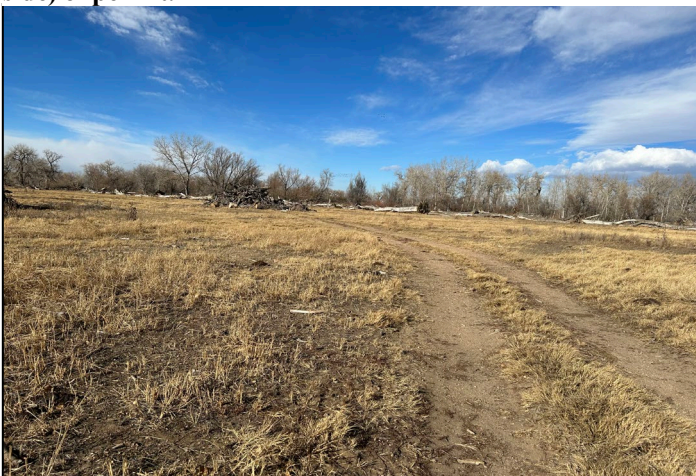
The proposed permit area, along with the included and adjacent features, appear to be accurately shown on the current conditions map provided with the application. The property is currently owned by L.G. Everist, but remains in agricultural use as cropland and pastureland. If the permit is approved, these existing agricultural uses will continue until an area of the permit is ready to be actively mined (Photos 5-6). Representative photos of the pre-mining conditions have been included in this report.

Photo 5 – Pastureland currently in use in NE area (lower area) of proposed permit area.

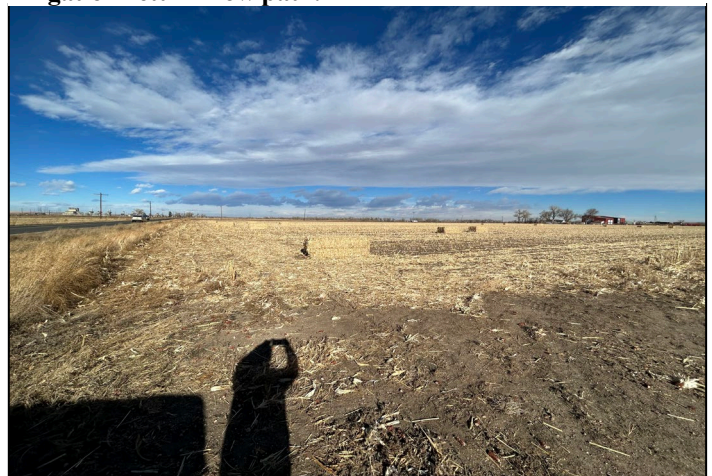
Photo 6 – Cropland (cornfield) currently in use on SW area (upper terrace) of proposed permit area.
