MINERALS PROGRAM INSPECTION REPORT
PHONE: (303) 866-3567

MINE NAME: Caldwell-Nesselhuf Pit No. 1	MINE/PROSPECTING ID#: M-1997-071	MINERAL: Sand and gravel	COUNTY: Crowley
INSPECTION TYPE: Monitoring	WEATHER: Clear	INSP. DATE: December 20, 2022	INSP. TIME: 10:30
OPERATOR: All-Rite Paving & Redi-Mix, Inc.	OPERATOR REPRESENTATIVE: Jodi Schriber	TYPE OF OPERATION: 112c - Construction Regular Operation	
REASON FOR INSPECTION: Normal I&E Program	BOND CALCULATION TYPE: Complete Bond	BOND AMOUNT: \$499,433.00	
DATE OF COMPLAINT: NA	POST INSP. CONTACTS: None	JOINT INSP. AGENCY: None	
INSPECTOR(S): Patrick Lennberg Amber Michels	INSPECTOR'S SIGNATURE:

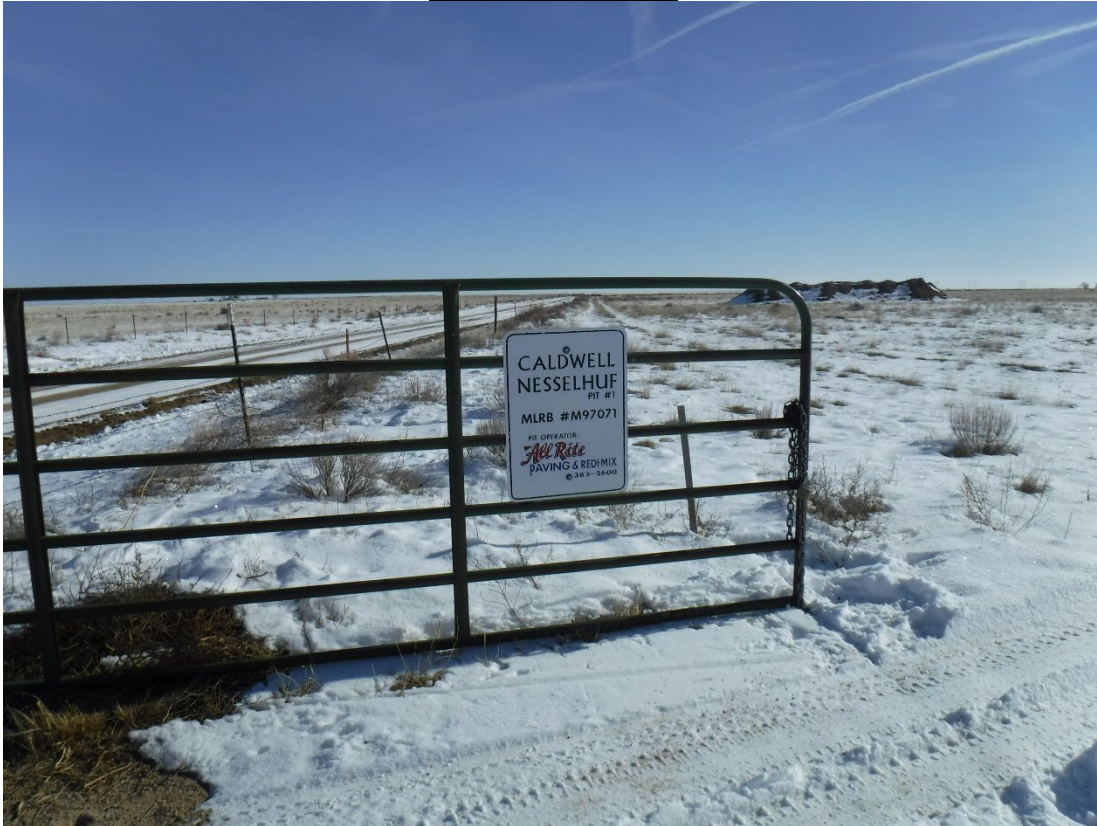
Photo 1: Mine sign at the primary mine entrance

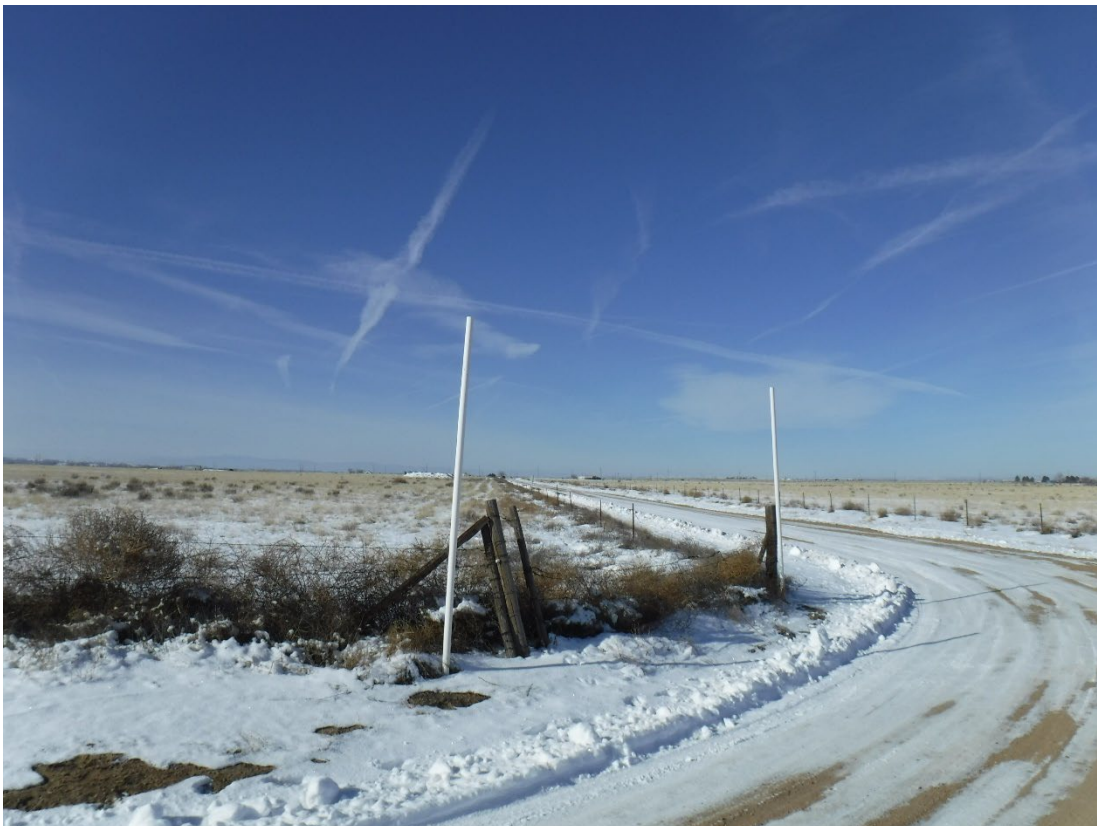
Photo 2: Typical permit boundary markers

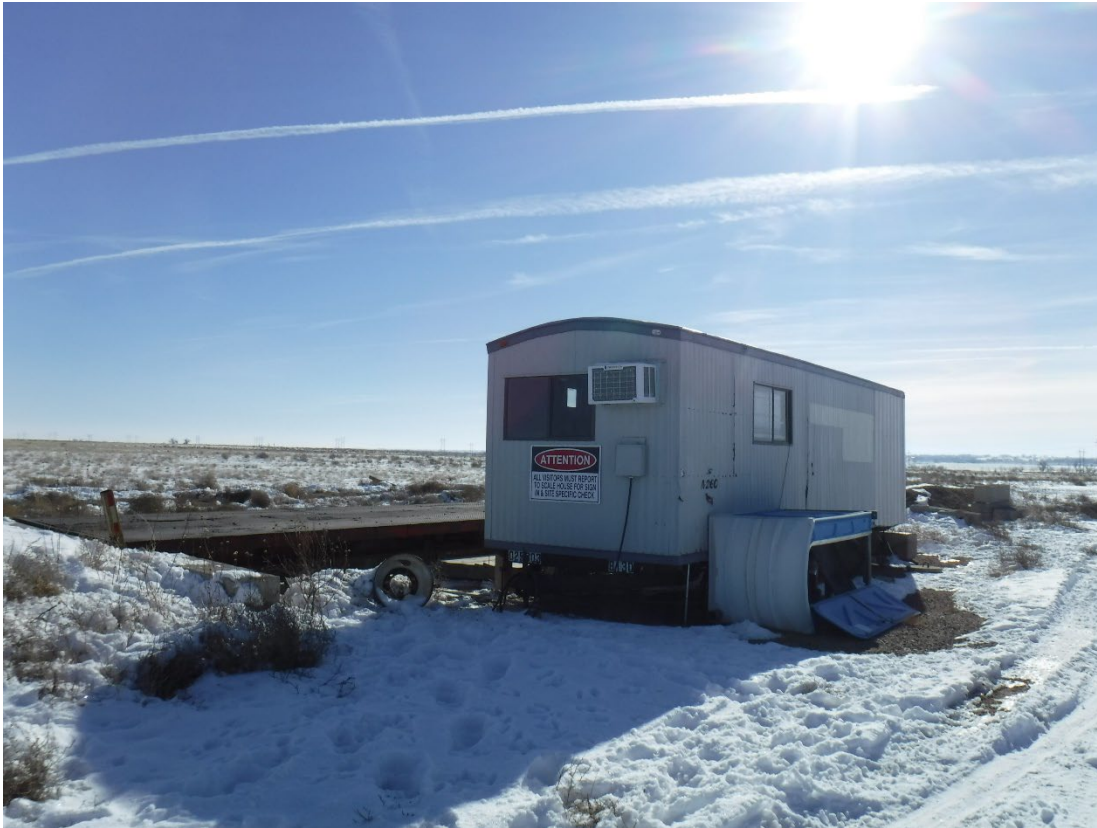
The 2,000 gallon AST that was on-site during the last inspection and noted on the AM-1 Mining Plan Map has been removed from the site. The Operator also informed the Division that the scale house was recently replaced with a newer portable scale house. The scale house is located near the mine entrance along a haul road that is approximately 2.2 acres in size.

Photo 3: Scale house

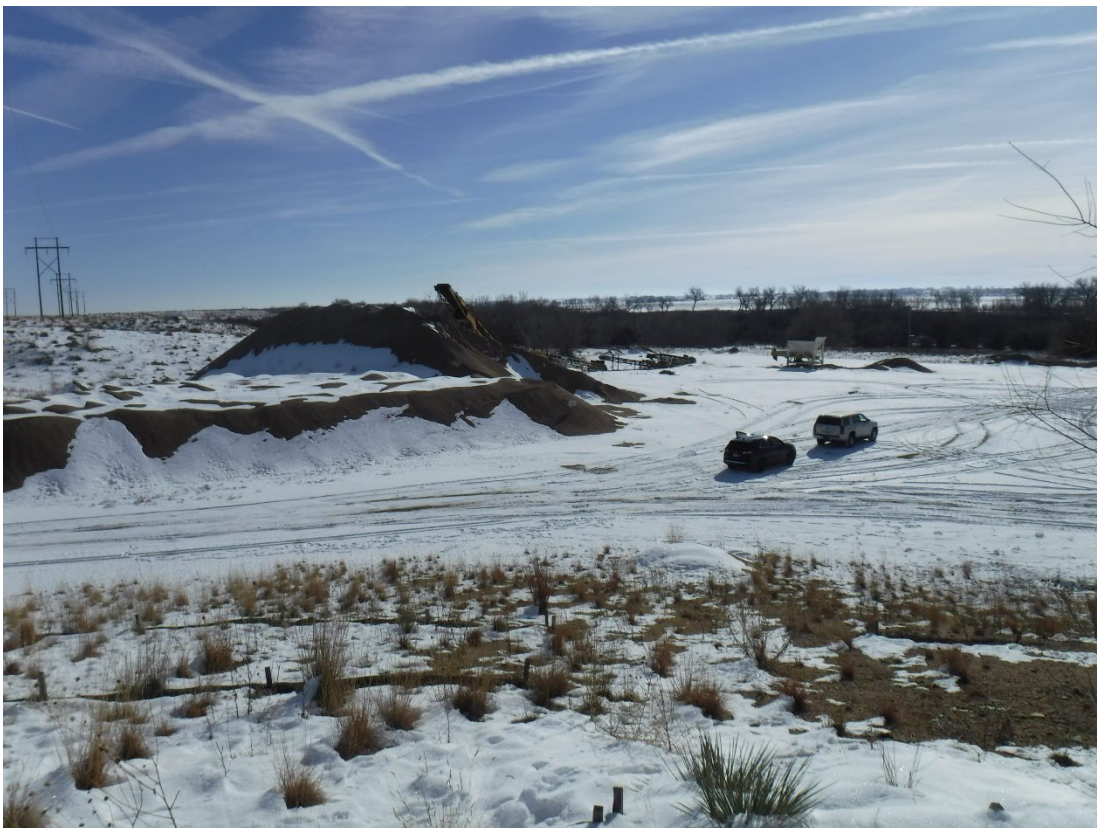
There are three power-poles where the Operator has completed mining or is currently mining around. It appears the Operator is maintaining a 50 foot buffer around the base of the poles as was committed to in AM-1. Around one pole, where the Operator has completed mining, the slopes have been graded to approximately 3H:1V slope and vegetation is becoming established along the slopes. It does not appear that there is more than 100 feet of highwall exposed.

Photo 4: Looking southeast from the base of a power pole across the disturbed area

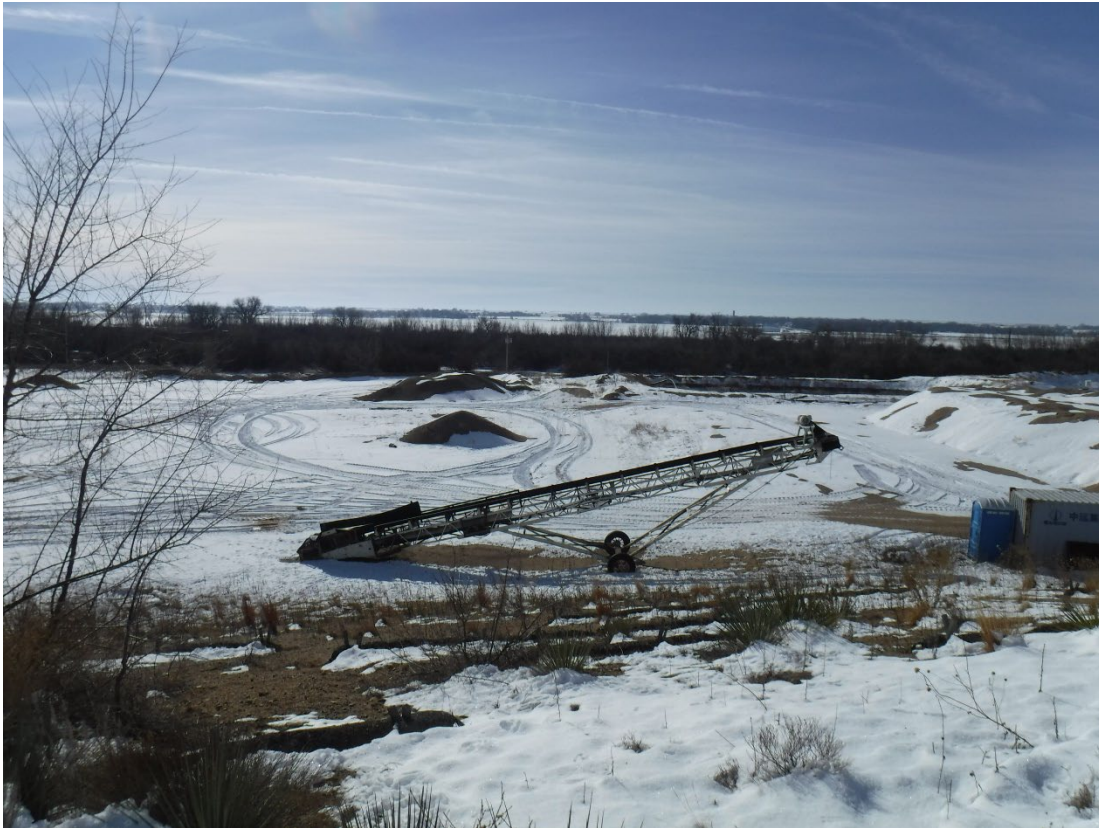
Photo 5: Looking south from the base of a power pole across the disturbed area

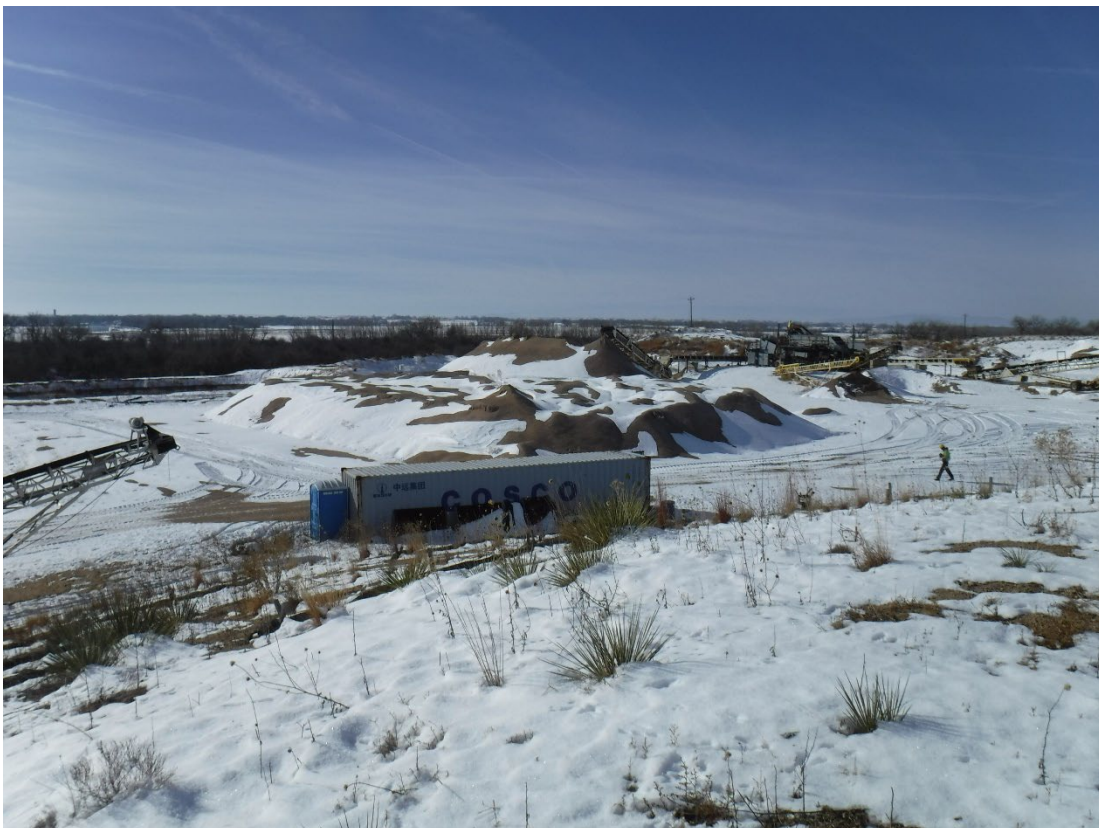
Photo 6: Looking southwest from the base of a power pole across the disturbed area, wash plant to the right of picture

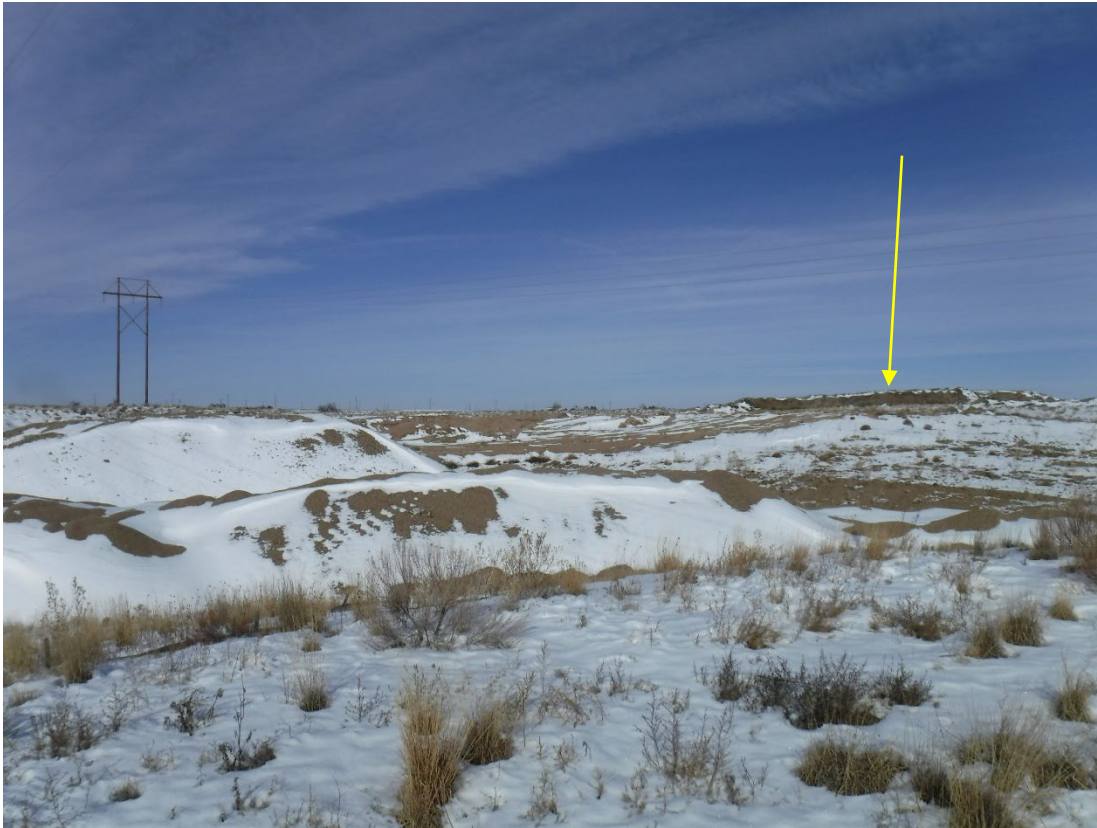
Photo 7: Looking northwest from the base of a power pole across the disturbed area, arrow indicates top soil stockpile

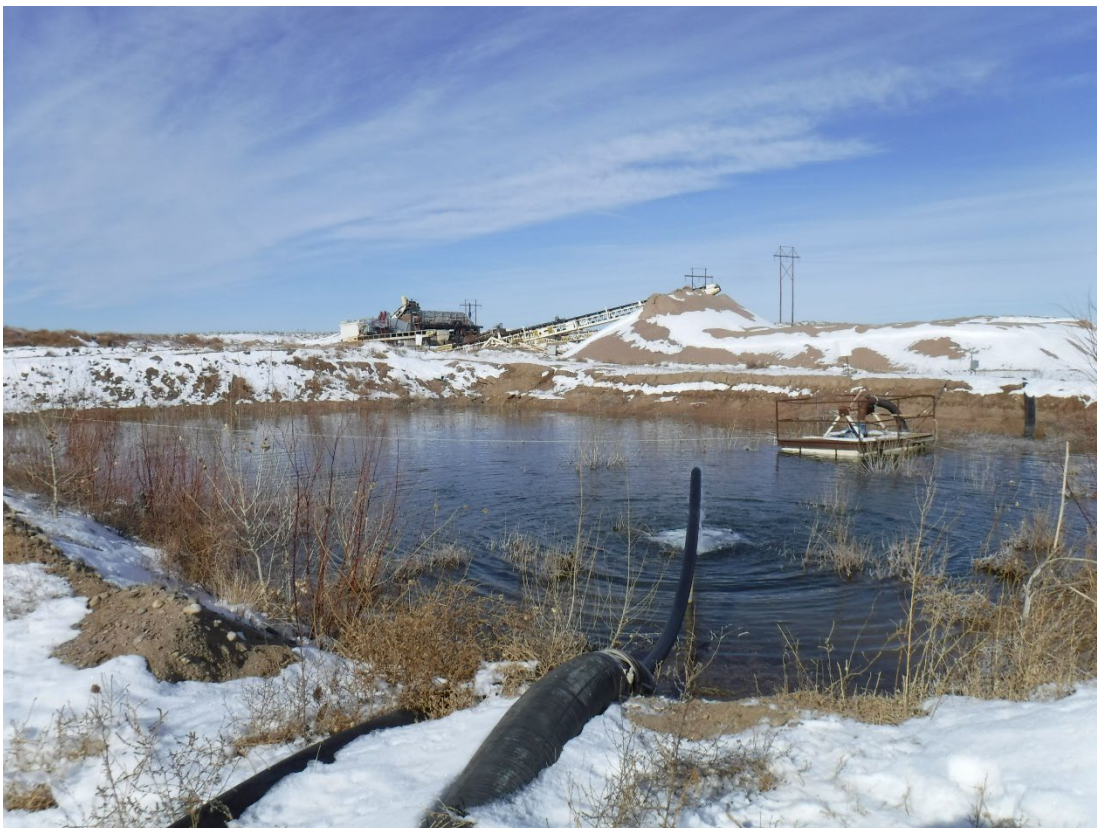
Photo 8: Eastern most wash pond being filled

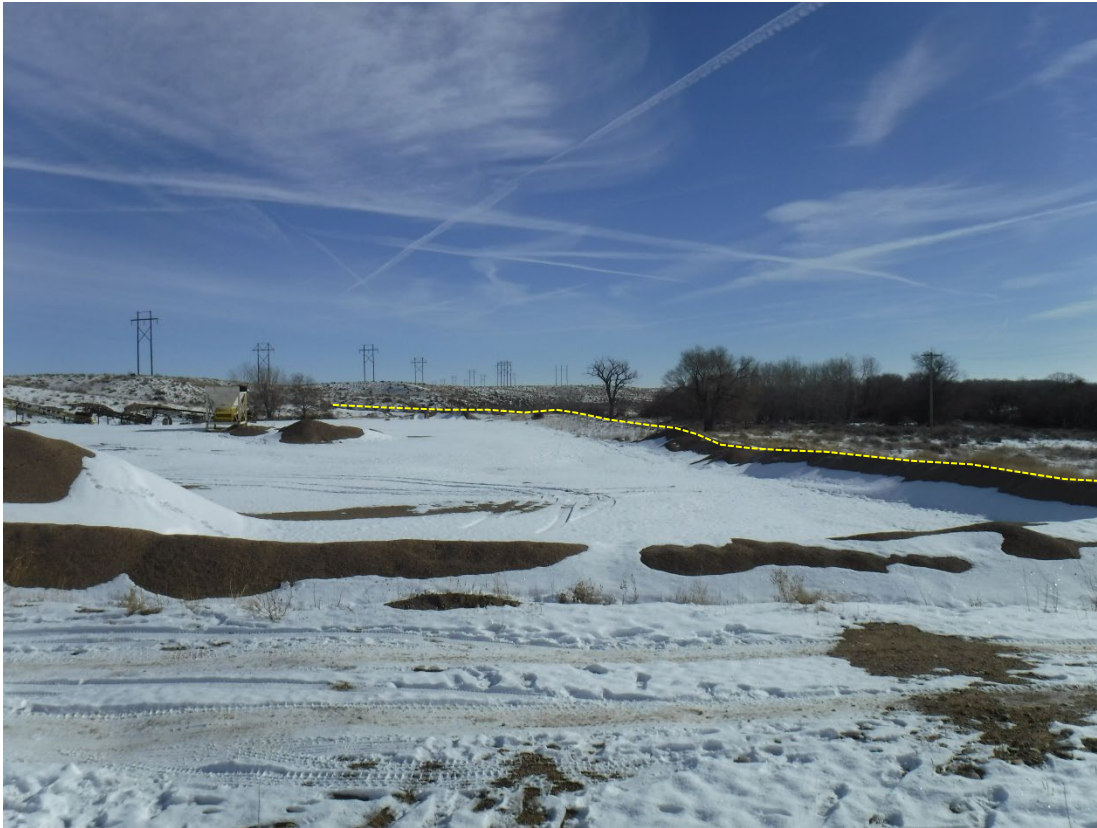
At the southern end of the disturbance area the berm, marking the 200 foot buffer from the Arkansas River, was inspected. The berm appears to be in good condition and stable. The previous disturbed areas that were reclaimed in establishing the 200 foot buffer appear to have vegetation becoming established. Also along the southern disturbance area are three wash ponds. The eastern most pond was being filled during the inspection from water being pumped from an onsite well located approximately 190 feet to the south. The side slopes of the ponds appear to be stable but the Division did note that Tamarisks (Salt Cedar) were growing in each of the ponds. The Operator was informed they should eradicate the plants before they become established.

Photo 9: Looking east near the southern end of disturbed area, line marks top of 200 foot buffer berm

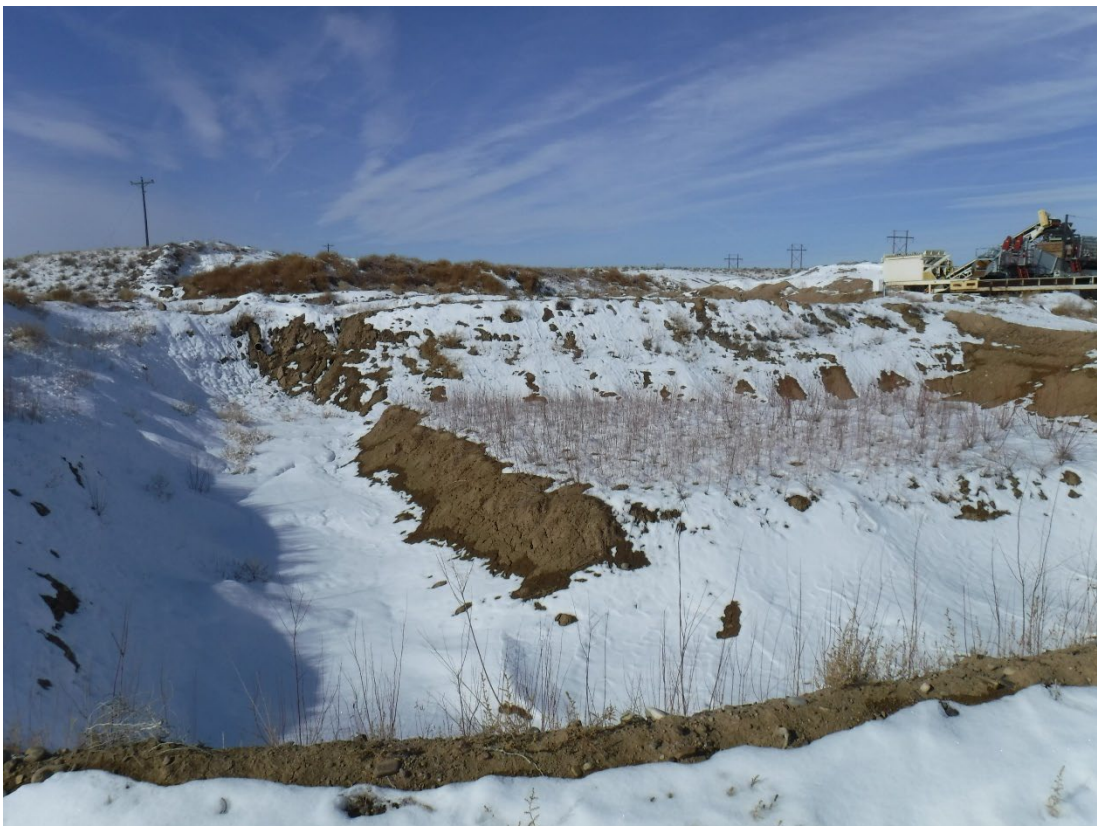
Photo 10: Middle wash pond

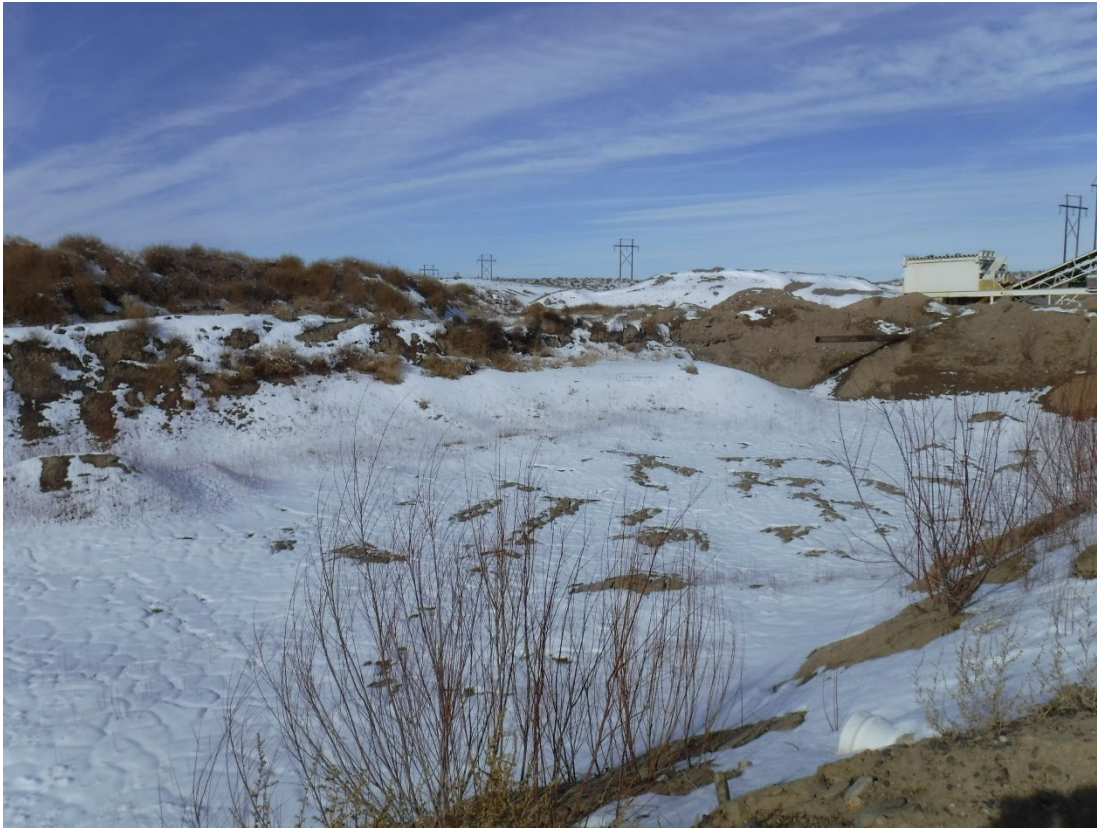
Photo 11: Western wash pond

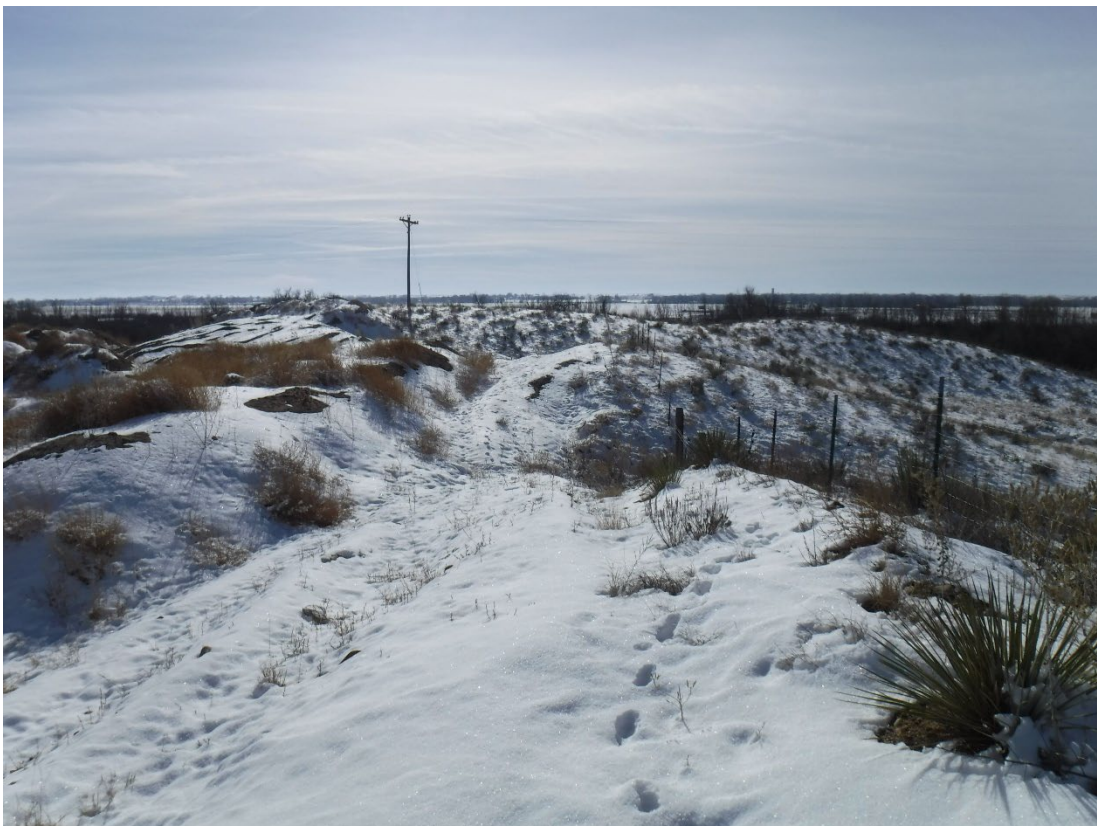
The site was active at the time of inspection. A crew was preparing the site to begin washing operations. Since the last inspection mining disturbance has increased from 12.6 acres to approximately 22 acres. Disturbed areas are approaching the permit boundary along the southwest fence line. The disturbances approaching the permit boundary had some material replaced along the former highwall in an effort to begin reclamation. Topsoil has been stripped and stockpiled in the area located north of the pit area.

Photo 12: Mined areas, left of picture, approaching permit boundary (fence line to right)

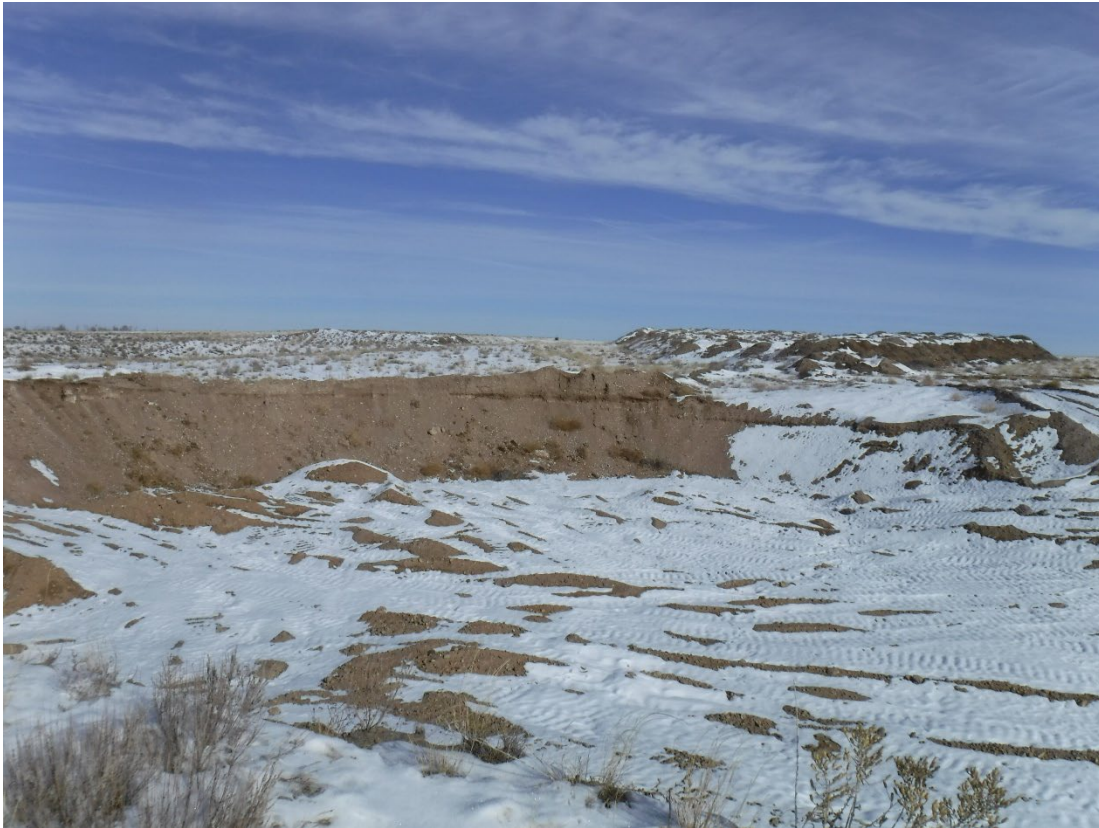
Photo 13: Mining highwall center and left of picture with top soil stockpile right background

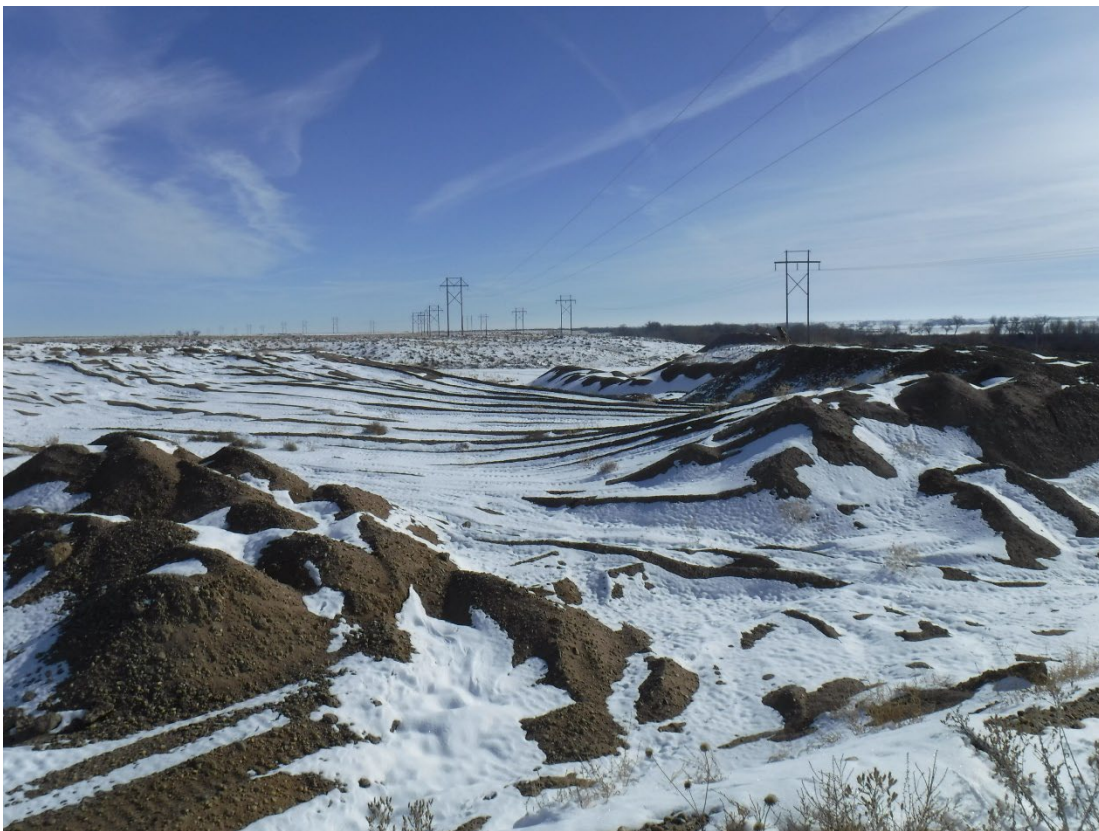
Photo 14: Area stripped ahead of mining

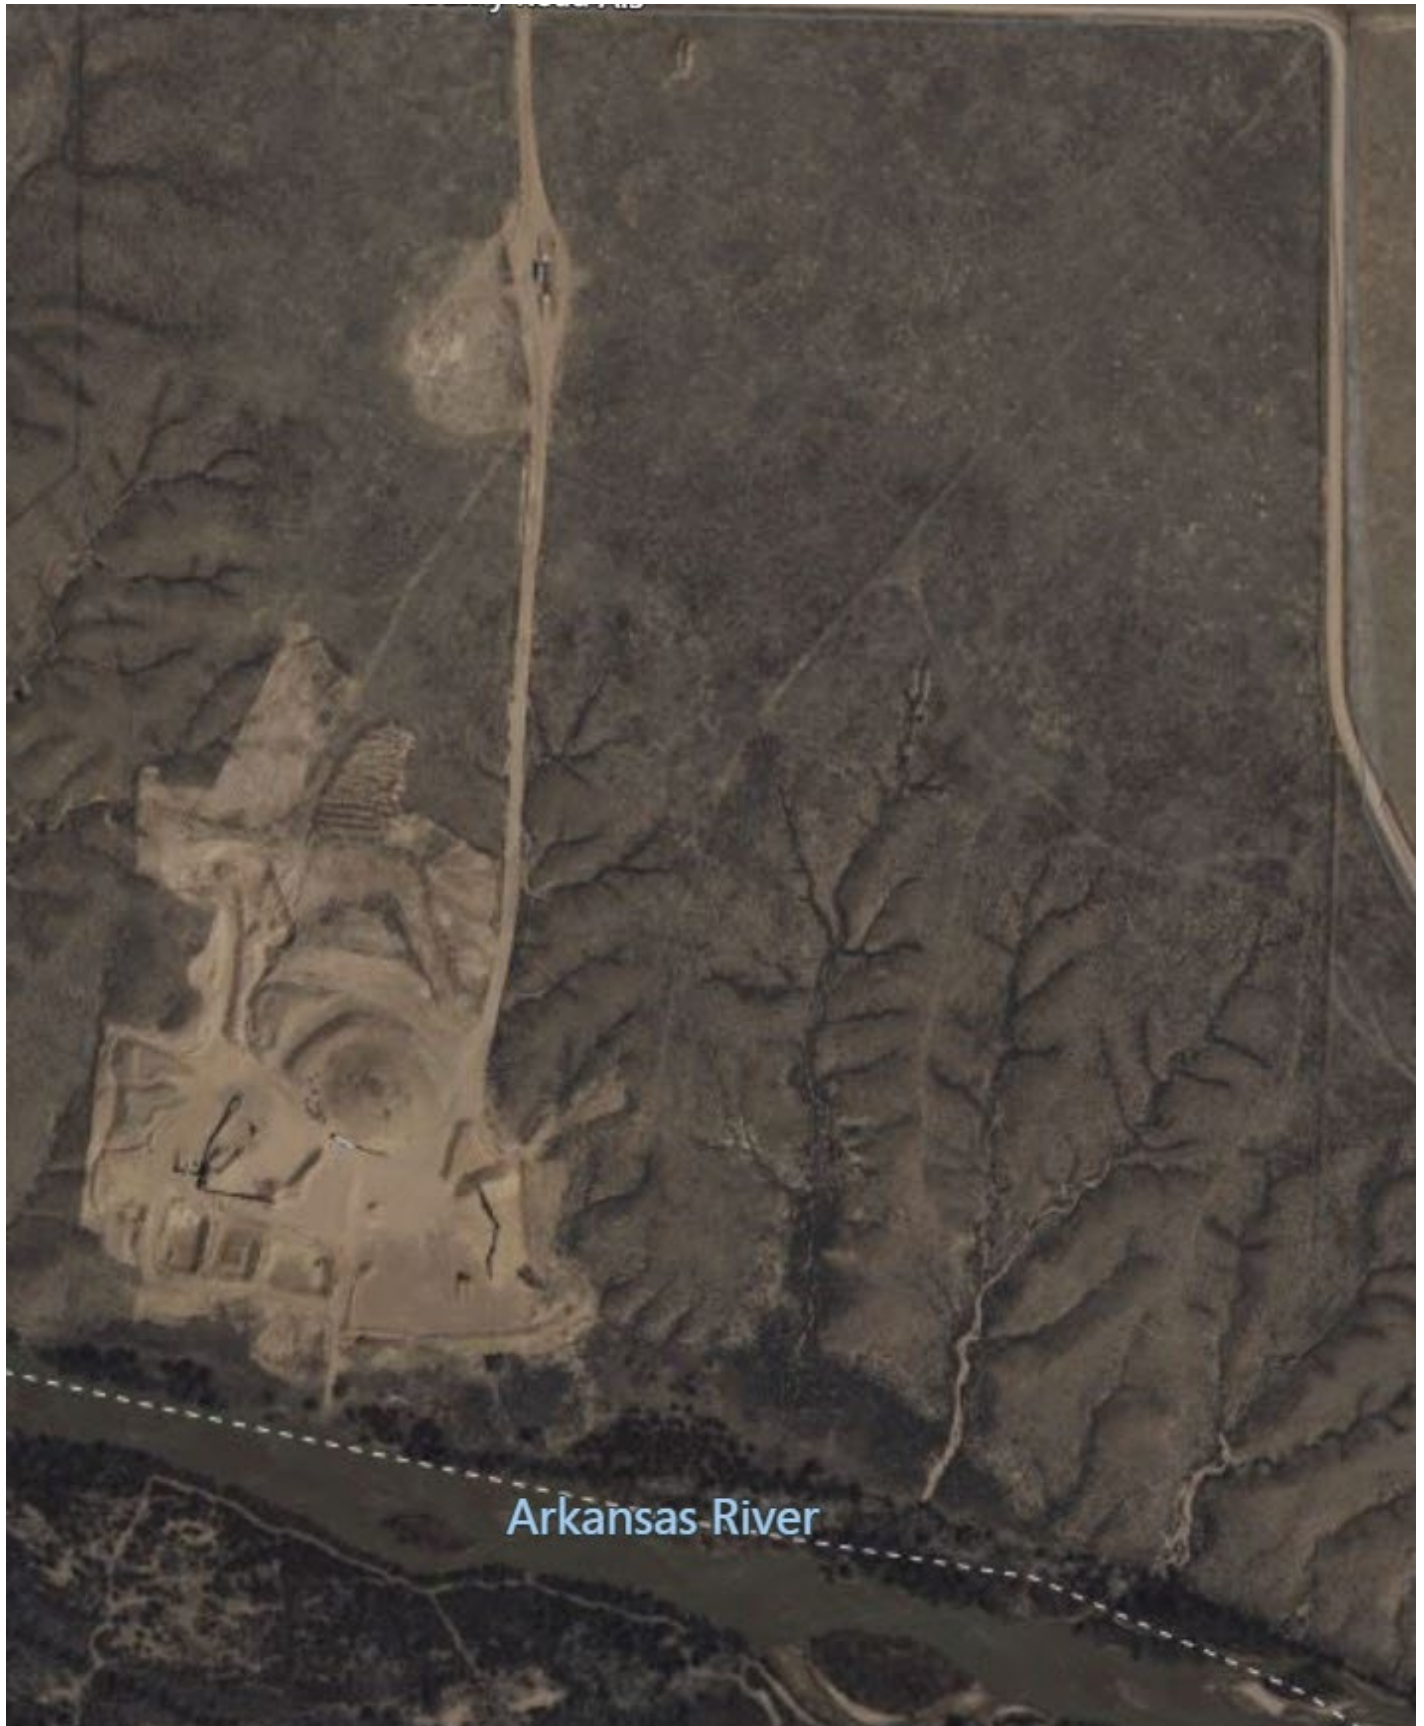
A more recent aerial image of permit area that accurately depicts the level of disturbance observed during the inspection
