MINERALS PROGRAM INSPECTION REPORT
PHONE: (303) 866-3567

MINE NAME: Wattenberg Lakes	MINE/PROSPECTING ID#: M-2004-051	MINERAL: Aggregate	COUNTY: Weld
INSPECTION TYPE: Monitoring	WEATHER: Clear	INSP. DATE: December 20, 2022	INSP. TIME: 10:00
OPERATOR: Holcim - WCR, Inc.	OPERATOR REPRESENTATIVE: Wyatt Webster	TYPE OF OPERATION: 112c - Construction Regular Operation	
REASON FOR INSPECTION: Normal I&E Program	BOND CALCULATION TYPE: Complete Bond	BOND AMOUNT: \$520,000.00	
DATE OF COMPLAINT: NA	POST INSP. CONTACTS: None	JOINT INSP. AGENCY: None	
INSPECTOR(S): Peter Hays Hunter Ridley	INSPECTOR'S SIGNATURE:

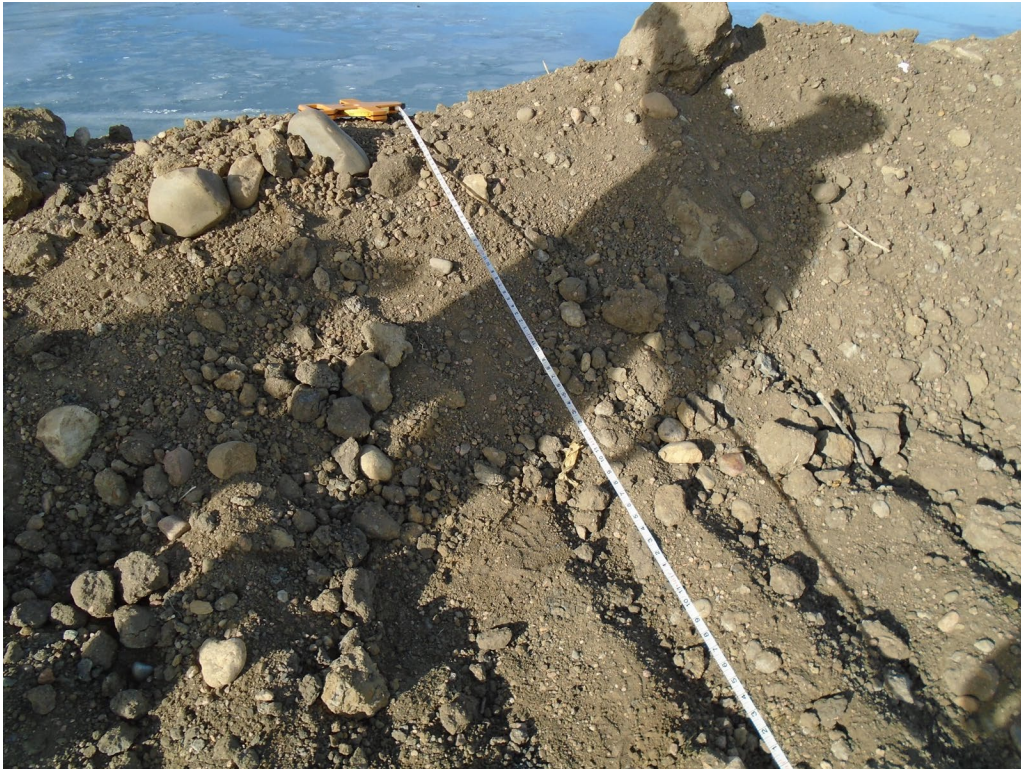
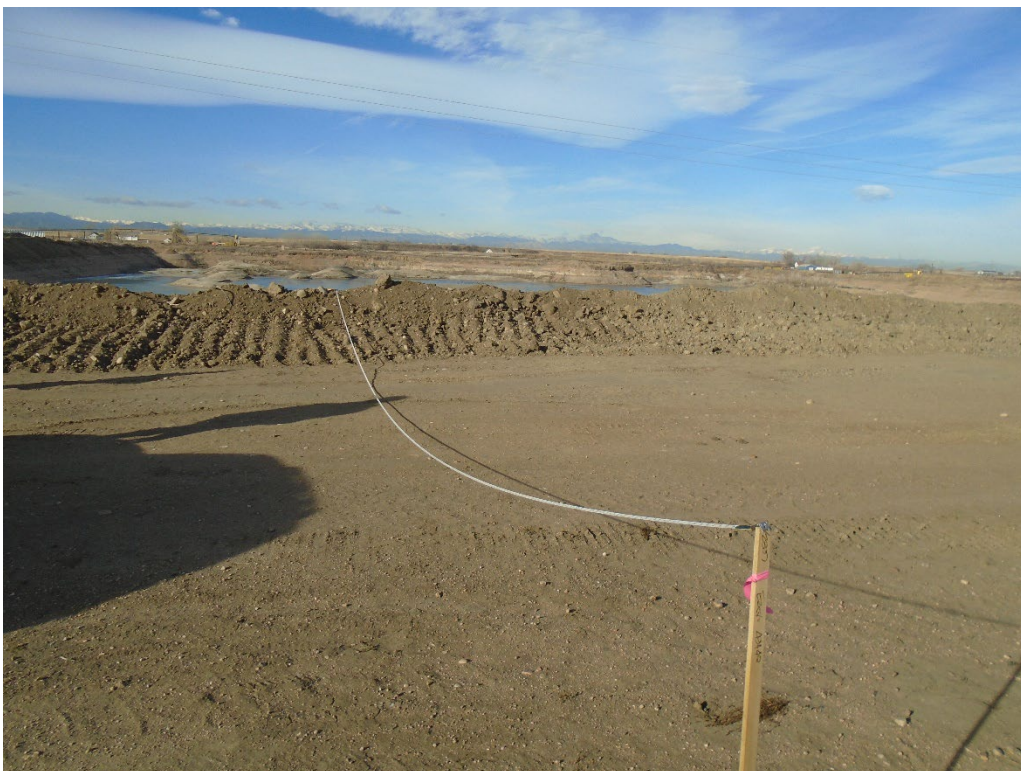
The offset from the permit boundary markers to the top of the eastern highwall for the Phase 2 / Pond 1 Mining Area was measured at six (6) locations by the Division. The offsets measured forty four (44) feet, forty two (42) feet, forty six (46) feet, forty eight (48) feet, fifty (50) feet and fifty four (54) feet from south to north from the southeast permit boundary corner.

Photograph of the first measured offset distance

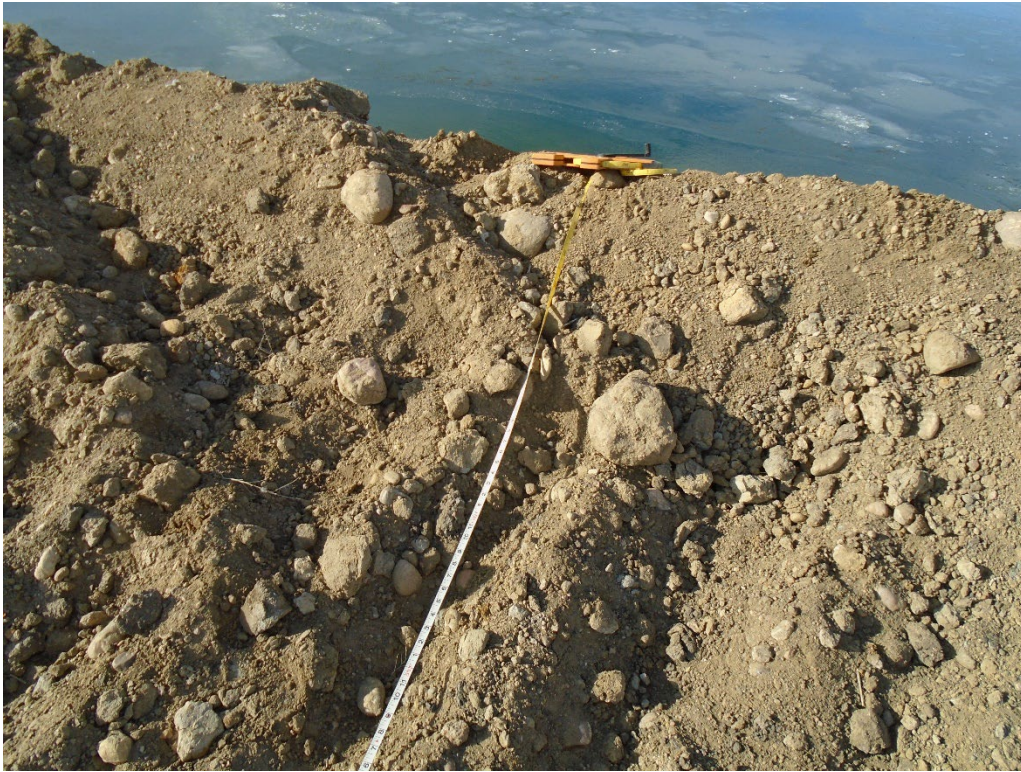
Photograph of the second measured offset distance

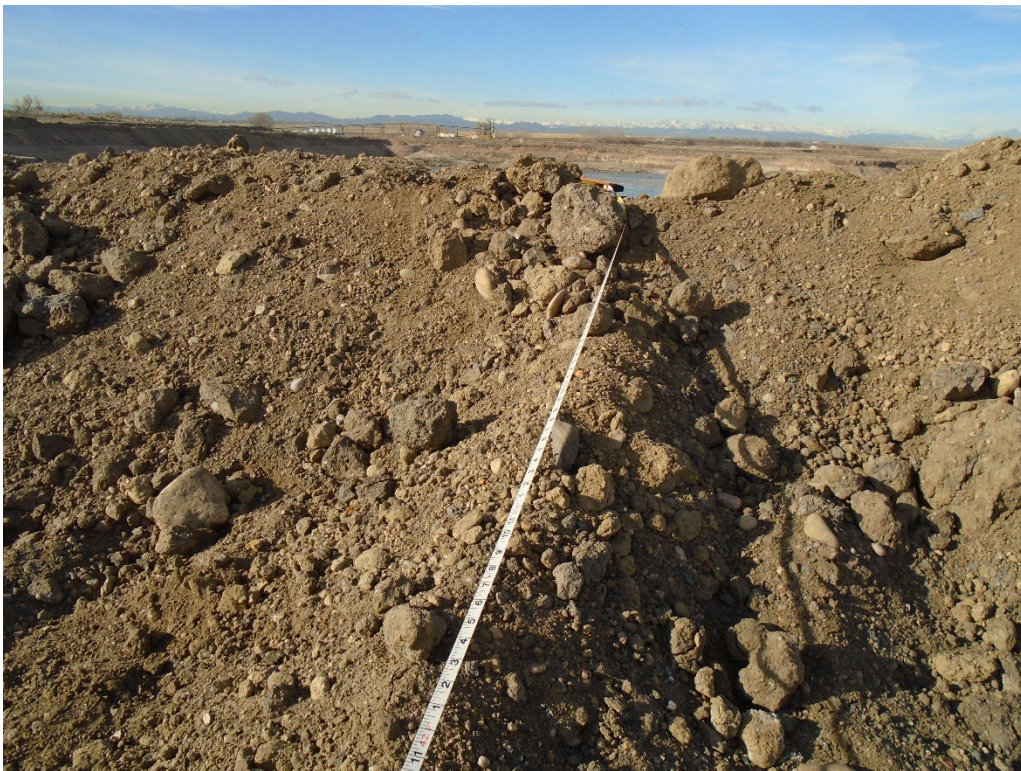
Photograph of the third measured offset distance

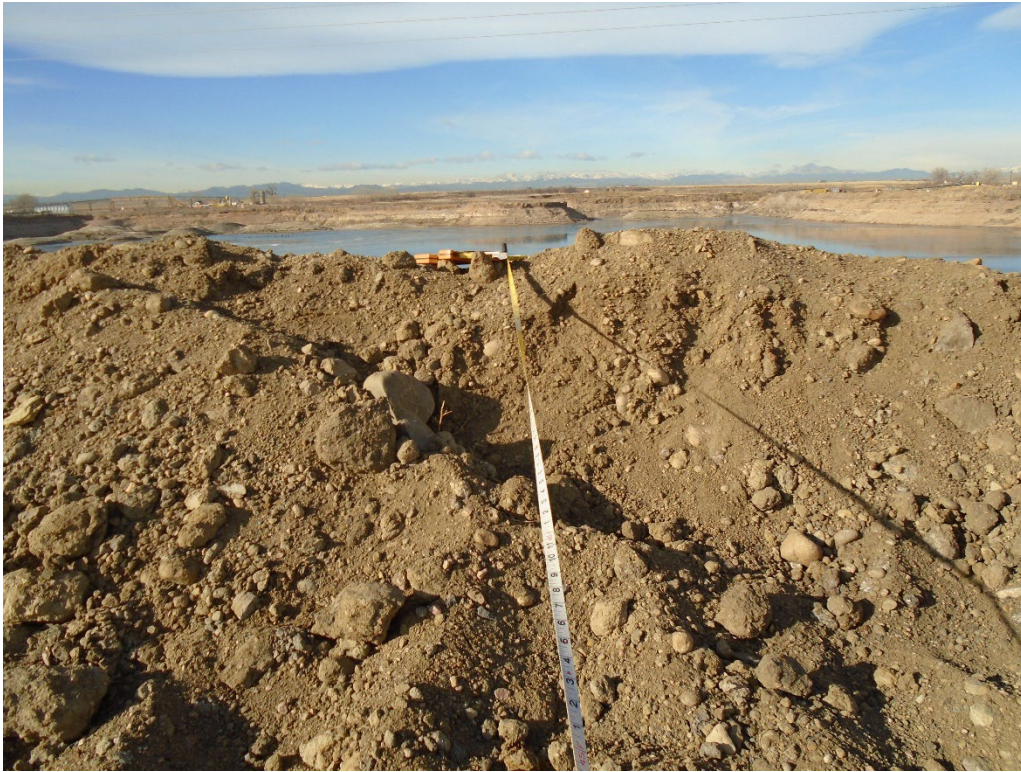
Photograph of the fourth measured offset distance

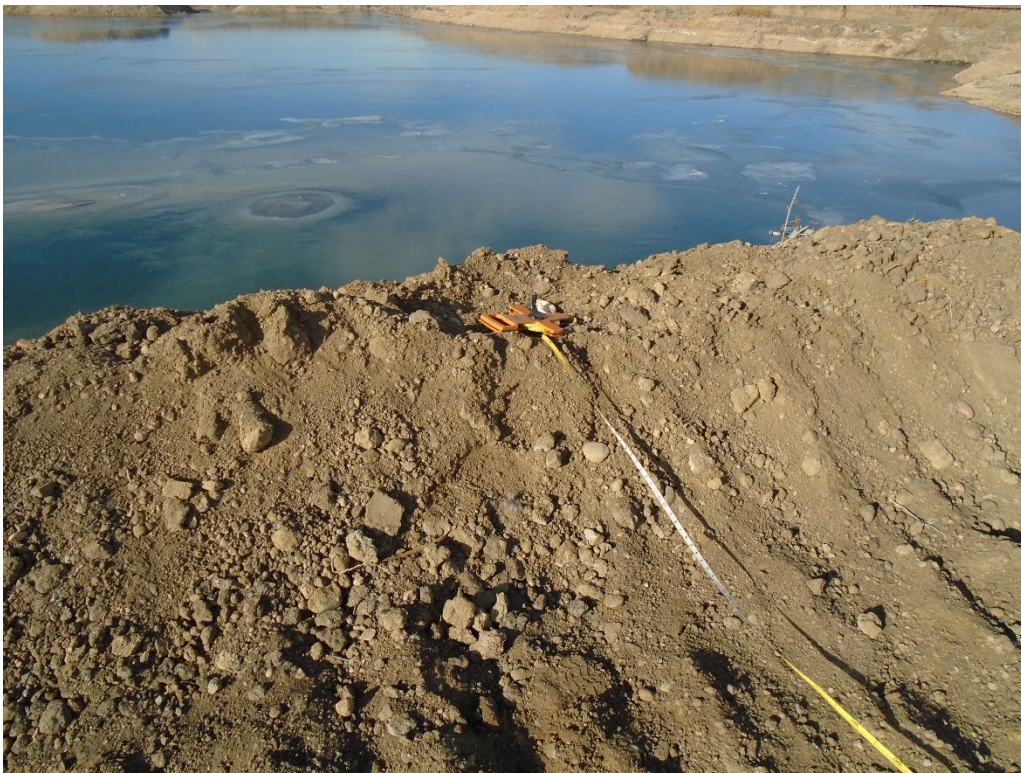
Photograph of the fifth measured offset distance

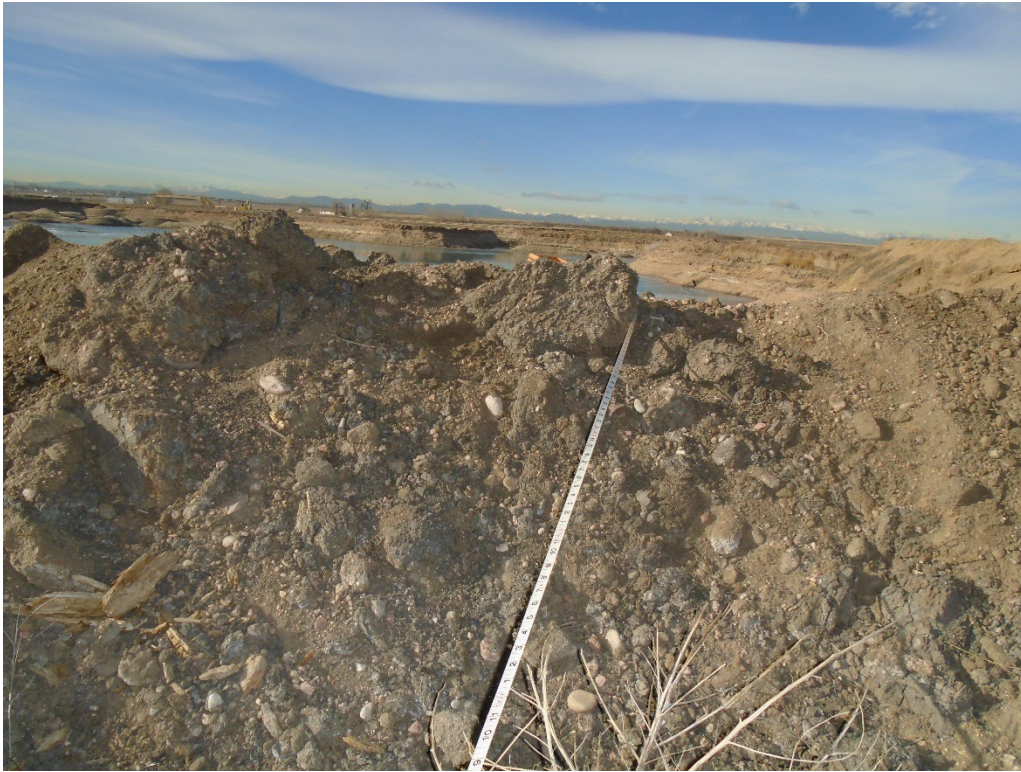
Photograph of the sixth measured offset distance

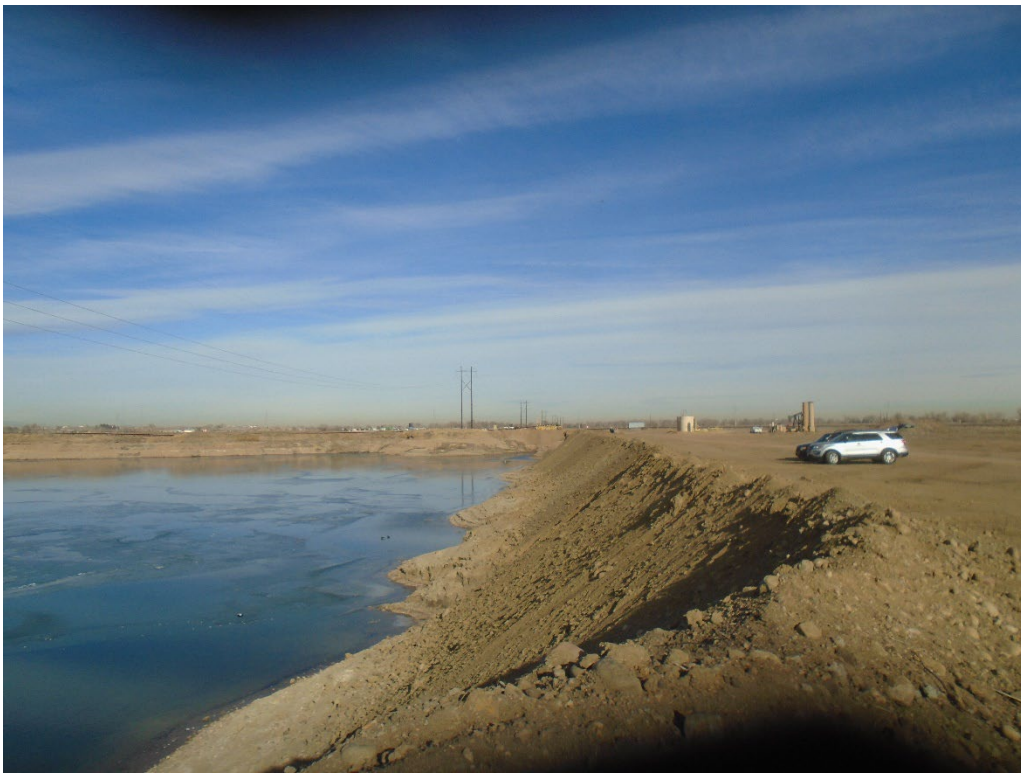
The backfilled portion of the eastern highwall for the Phase 2 / Pond 1 Mining Area is in compliance with the approved Mining Plan which requires at least a 40 foot offset from the permit boundary from county roads. The problem is considered abated by the Division based on the observations from this inspection. No further corrective actions are required to be performed by the Operator for this problem.

View of the backfilled slope from the southwest corner of Phase 2 / Pond 1 Mining Area looking north
