Geotechnical Addendum

2022 Annual Report

Aggregate Industries Deer Creek Quarry

Permit M1977-014 Jefferson County, Colorado

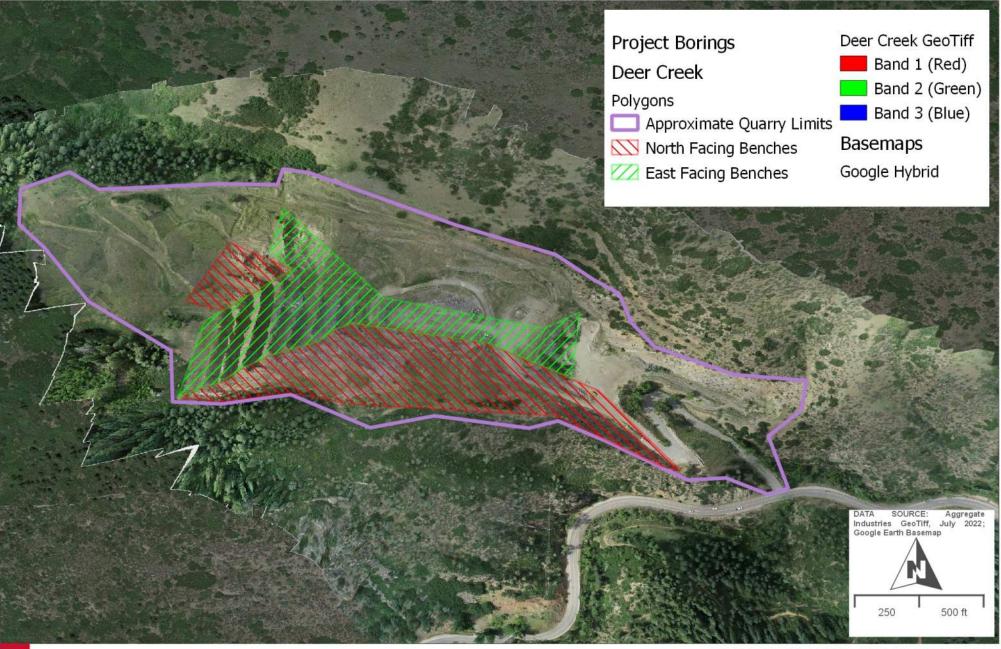
QUARRY EXTENTS AND BENCH TYPE DEER CREEK QUARRY JEFFERSON COUNTY, COLORADO FIGURE 2

The quarry consists of two dominant highwalls, to the west and to the south. East facing highwall extends from approximately elevation (El.) 6820 above mean sea level (msl) to El. 6380. The north facing highwall begins at approximately El. 6650. Both highwalls have been unmined since approximately 2003, with limited mining activities including moving stockpiled materials and material storage occurring along the floor of the pit and the lower bench at approximately El. 6420. An access/haul road is present to the north of the pit and provides access to the benches of the east facing highwall. Refer to Figures 2 and 3, Quarry Extents and Bench Type and Quarry Aerial Map and Bench View, respectively, for additional information.

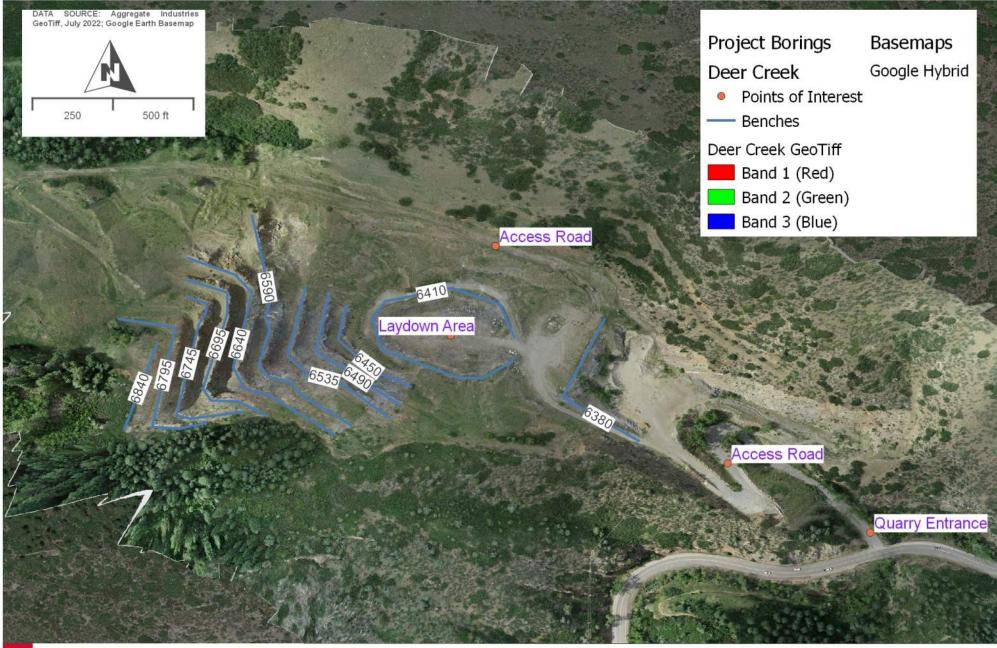
QUARRY AERIAL MAP AND BENCH VIEW DEER CREEK QUARRY JEFFERSON COUNTY, COLORADO FIGURE 3

The following section includes observations of mine conditions made by HDR staff on September 12 and November 6, 2022. Joint and foliation orientations, highwall trends, and rock mass rating (RMR) classification estimates were not included in this task order, as this effort was limited to evaluating conditions resulting from the work done in the current year. Therefore, historical aerial imagery through Google Earth and imagery provided through the Propellor online portal were reviewed for changes relevant to the mine conditions and any reclamation activities. The historical background information was then considered while evaluating the conditions at the site. The following sections detail the findings for the 2022 mining year. Refer to Figure 3 for additional information regarding the quarry feature locations.

Site reclamation has been performed at the quarry prior to HDR's involvement. The upper benches have developed vegetation on the slopes, and historical rockfall has continued to fill the benches. East facing benches have continued to perform well, with little to no significant rockfall. The north facing bench, specifically at approximately elevation El. 6625 experienced a significant rockfall event within approximately the last two (2) years, based on historical imagery. The volume of the slide appeared to be approximately 100 cubic yards and was contained within the lower bench. Similarly, continued development of rockfall at the corner of the east and north facing highwalls has continued. Various benches appear to be at near capacity, resulting in some rockfall likely to fall beyond the next lower bench. Particularly, Benches 6695, 6640, and 6490. During the site evaluation performed by HDR, noted recent rockfall was identified along the lower access road leading to the laydown area.

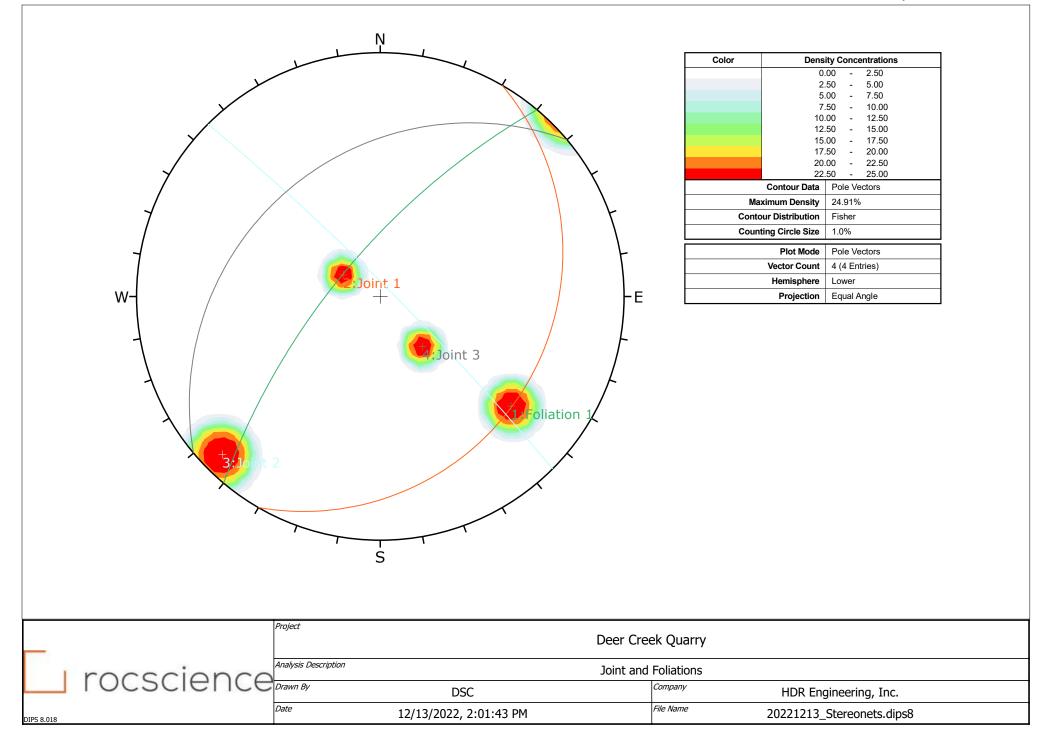
Joints and Foliations

In general, three (3) joint sets were noted. Set 1 (J1) was identified as being oriented at 20°,120° using the dip/dip direction notation. Set 2 (J2) was approximately 85°,45° and Set 3 (J3) was approximately 30°,320°. Foliation throughout the site varied locally; however, a prominent foliation feature (F1) noted throughout was identified at approximately 70°,310°.
