RE: Potts Pit #2; DRMS File No. M-2006-013; Notice of Outstanding Corrective Action

MINERALS PROGRAM INSPECTION REPORT
PHONE: (303) 866-3567

MINE NAME: Potts Pit #2	MINE/PROSPECTING ID#: M-2006-013	MINERAL: Gravel, sand and borrow material for construction	COUNTY: Huerfano
INSPECTION TYPE: Monitoring	INSPECTOR(S): Connor Drinkard, Jared Ebert	INSP. DATE: April 13, 2022	INSP. TIME: 10:15
OPERATOR: Eastern Colorado Aggregates, R.L.L.L.P.	OPERATOR REPRESENTATIVE: Mr. Joe Baxter	TYPE OF OPERATION: 112c - Construction Regular Operation	
REASON FOR INSPECTION: Normal I&E Program	BOND CALCULATION TYPE: Complete Bond	BOND AMOUNT: \$103,200.00	
DATE OF COMPLAINT: NA	POST INSP. CONTACTS: None	JOINT INSP. AGENCY: None	
WEATHER: Clear	INSPECTOR'S SIGNATURE:

April 13, 2022 DRMS Inspection

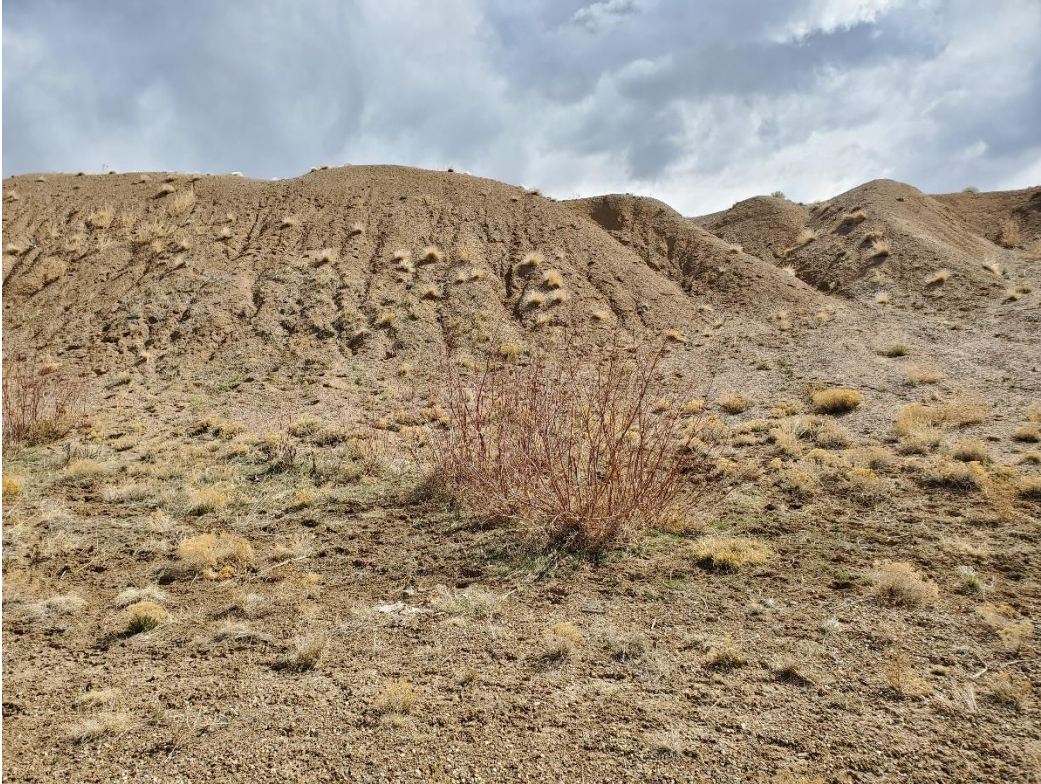
Figure 3. Looking east at stockpile from west side of affected area. Tamarisk present.

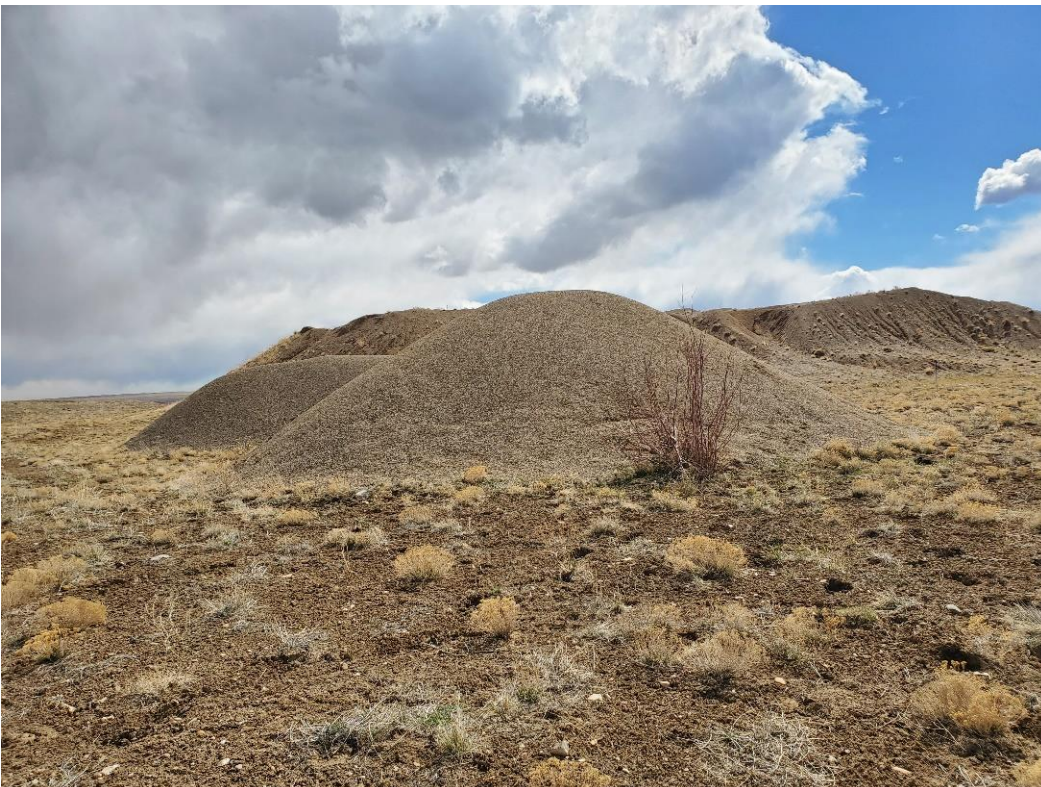
Figure 4. Looking east at stockpiles from west side of affected area. Tamarisk present.

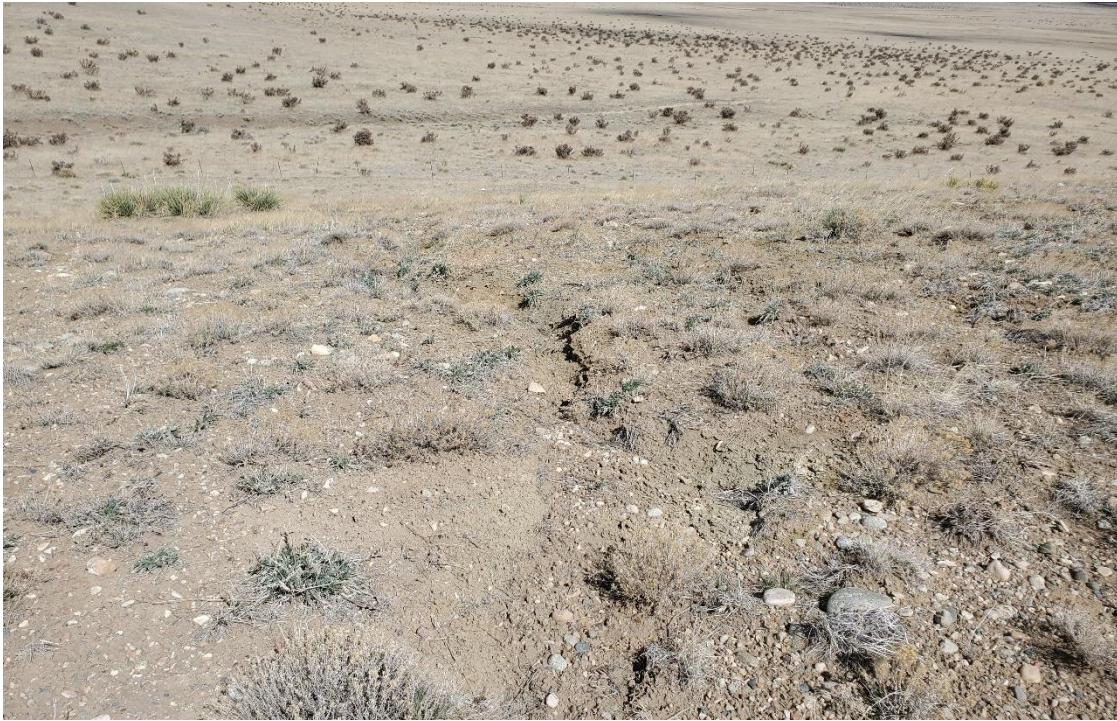
Erosion gullies and ruts were observed on-site. Figures 9, 11, 12, and 19 show specific problem areas. The northwest portion of the active mining area has substantial erosion which is especially concerning. This is a problem at this time for failure to protect the affected land from erosion pursuant to C.R.S. 34-32.5-116(4)(j). **The operator shall provide photo documentation to the Division verifying erosion gullies and ruts have been repaired, and that the site has have been reconstructed and stabilized to prevent erosion damage by 7/4/22.**

Figure 9. Rill north of topsoil stockpile.

CORRECTIVE ACTIONS: The operator shall provide photo documentation to the Division verifying erosion gullies and ruts have been repaired, and that the site has have been reconstructed and stabilized to prevent erosion damage by the corrective action date.

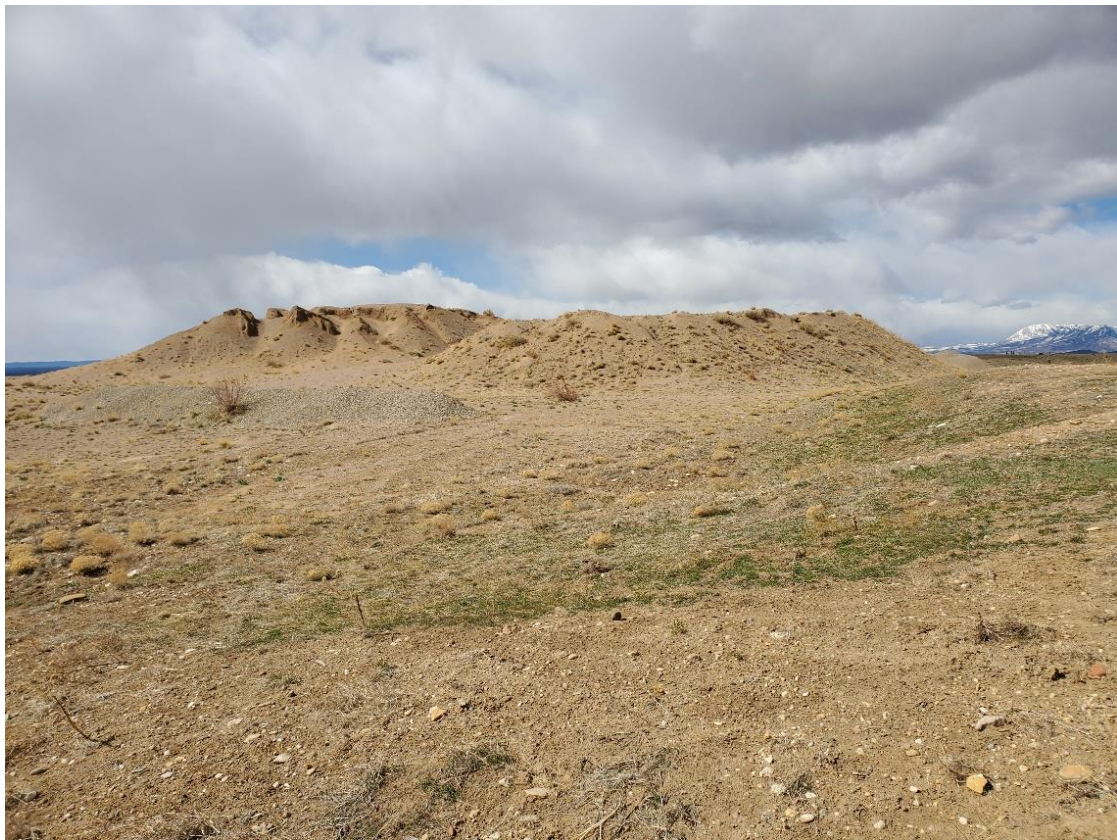
Figure 10. Looking west from eastern side of affected area. Tamarisk present.

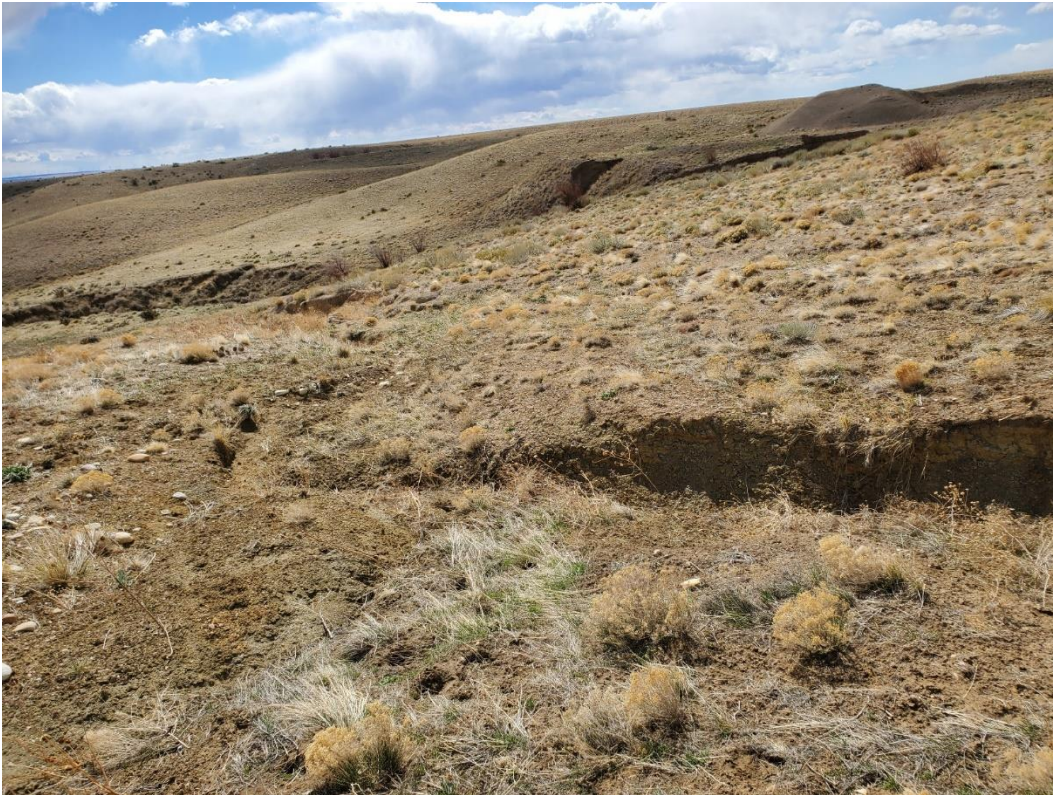
Figure 11. Looking southeast from eastern side of affected area. Prominent rill.

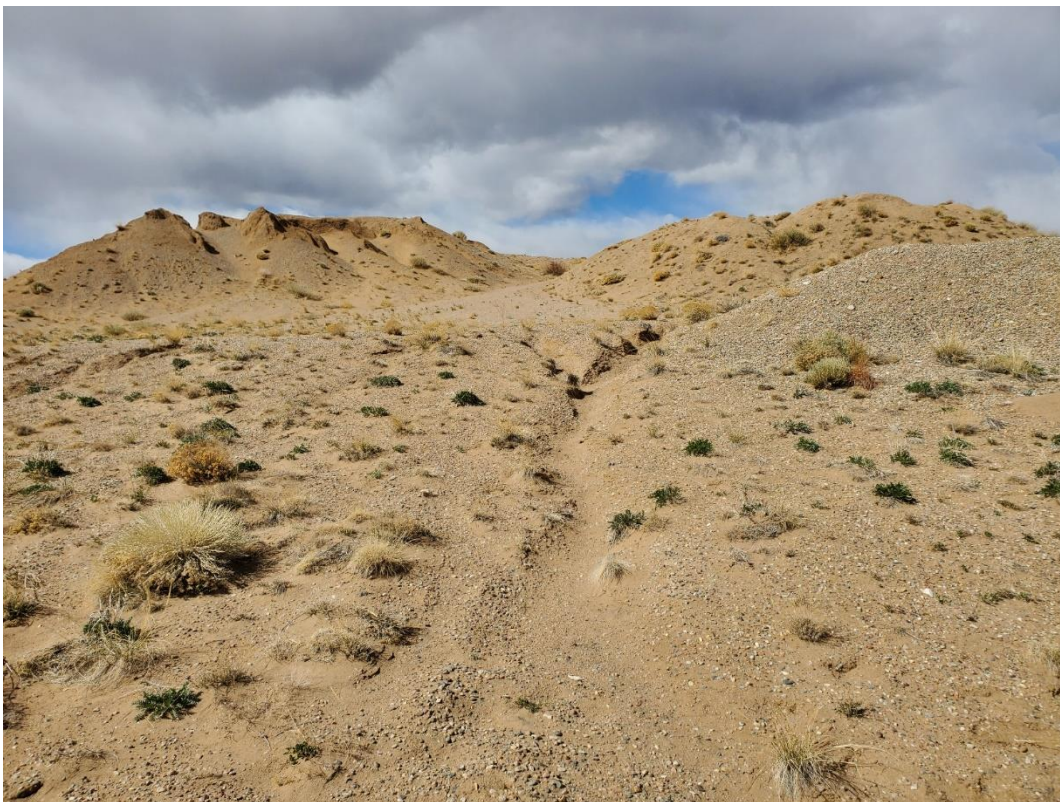
Figure 12. Looking west from eastern side of affected area. Prominent rill coming from stockpiles.

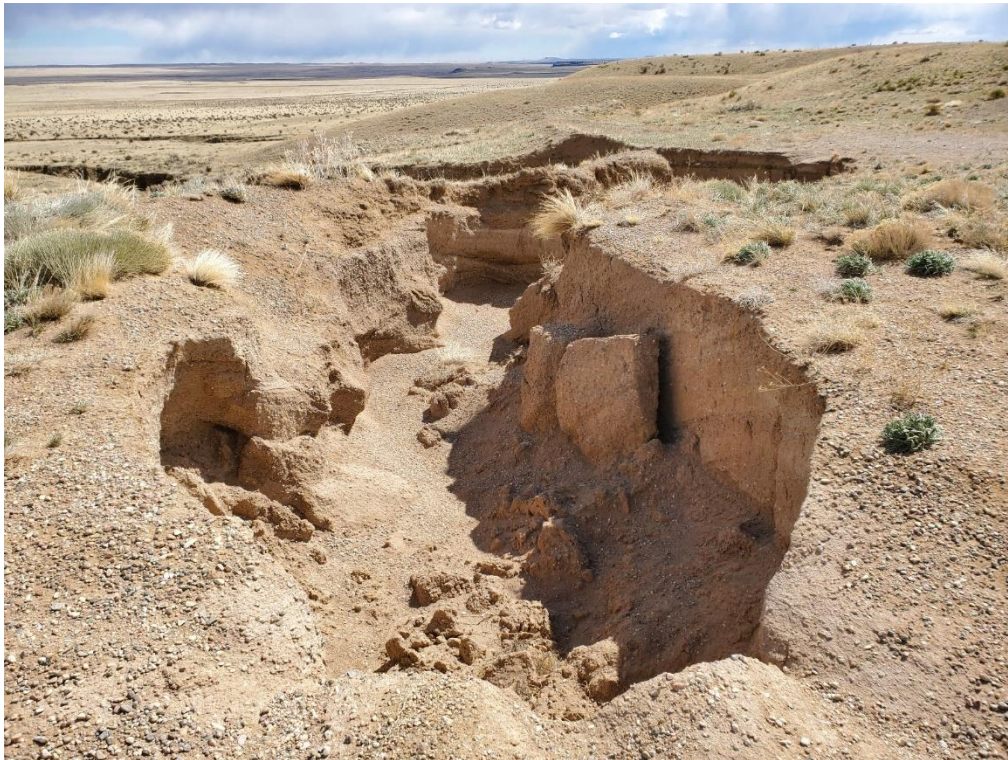
Figure 14. Looking southeast from east side of affected area. Major gully forming at the head of this drainage.

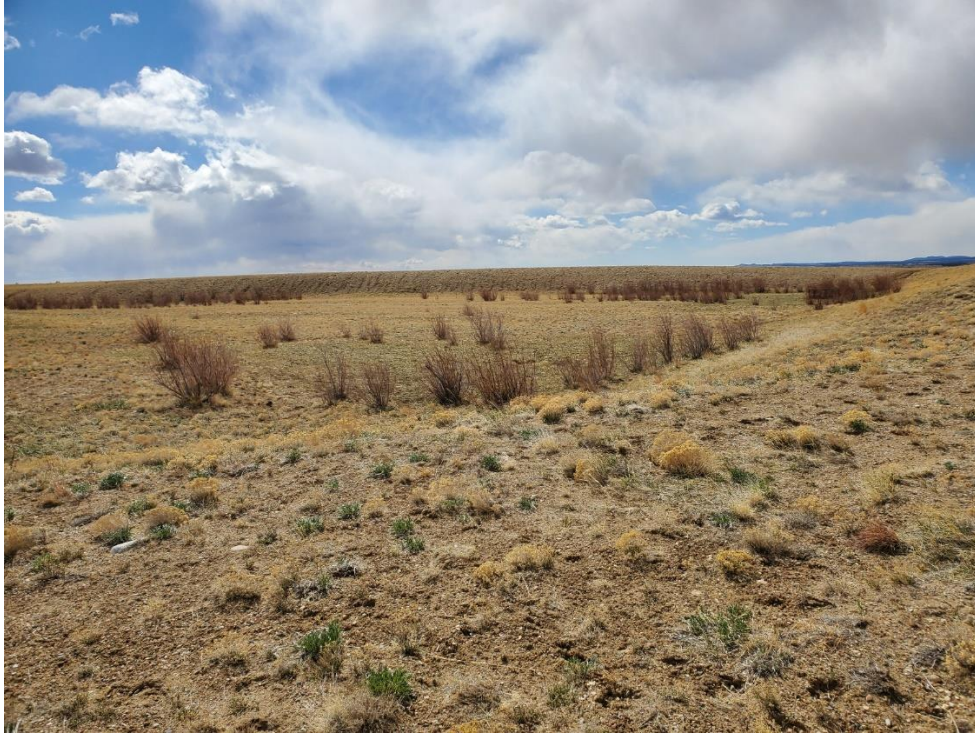
Figure 15. Looking southeast into previous affected area from east side of affected area. Established tamarisk.

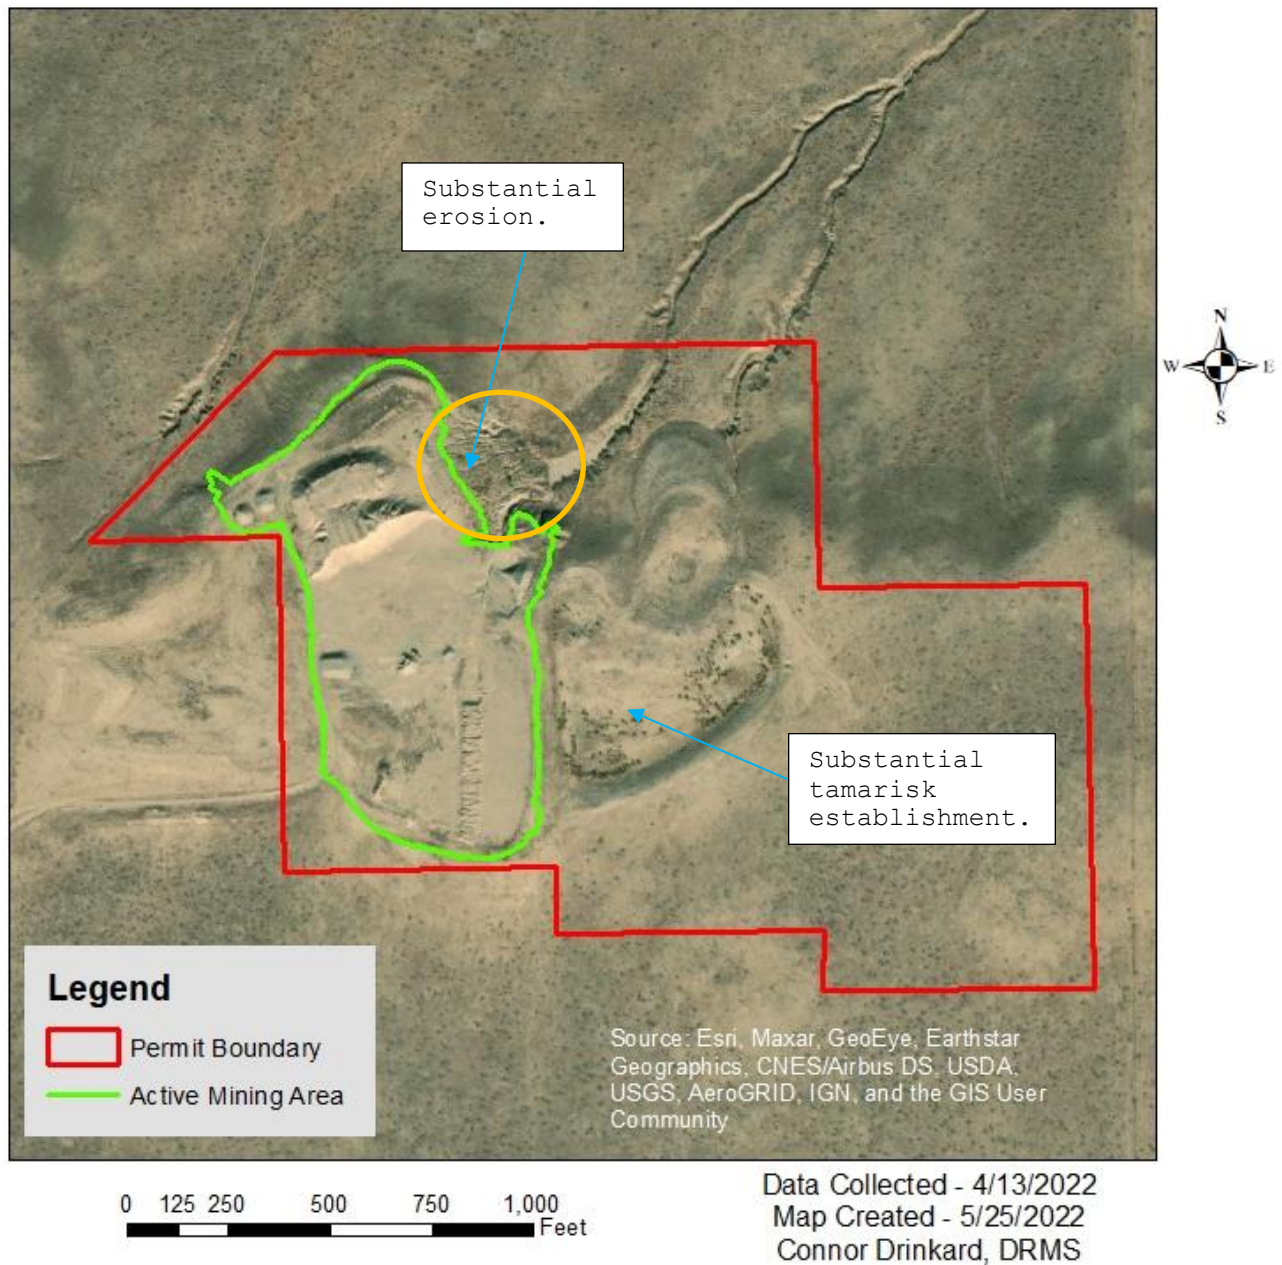
Figure 19. Map of Potts Pit #2. Active Mining Area approx. 13.3 acres.
