**NEW ELK MINE**  
**Permit No. C-1981-012**

**QUARTERLY COAL WASTE BANK INSPECTION REPORT**  
**December 11, 2022**

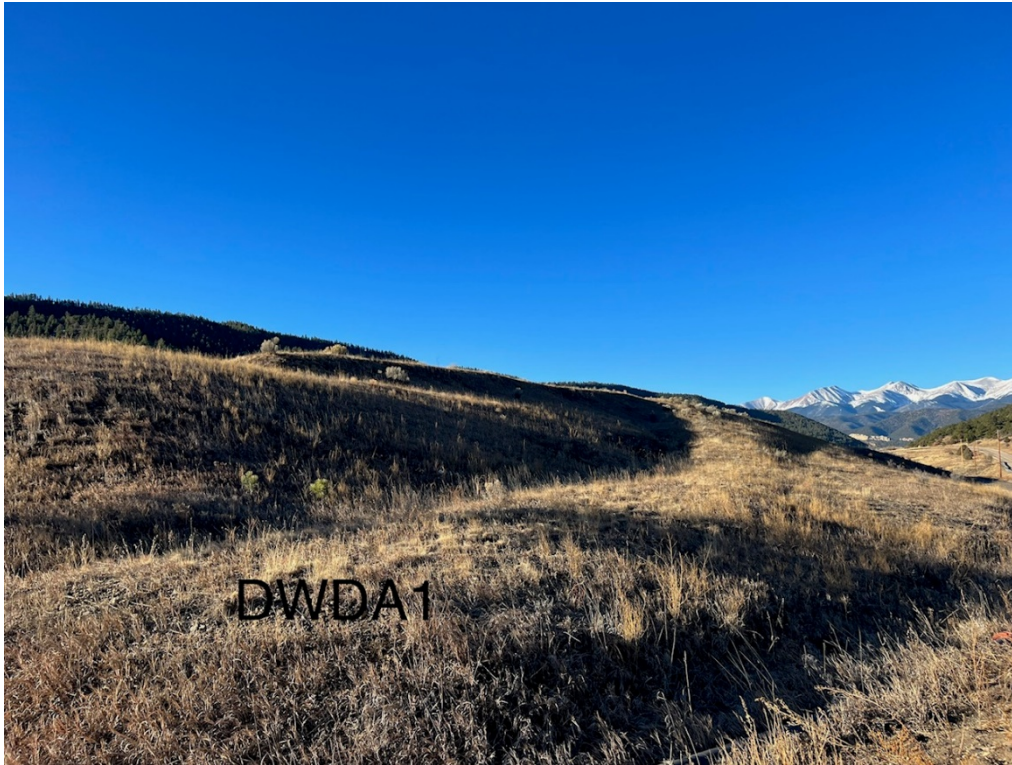
**DWDA #1**

Surface and out slopes of the pile were inspected for visible signs of potential failure or instability. None were observed.

Overall the disposal area is in good condition.

None at this time.

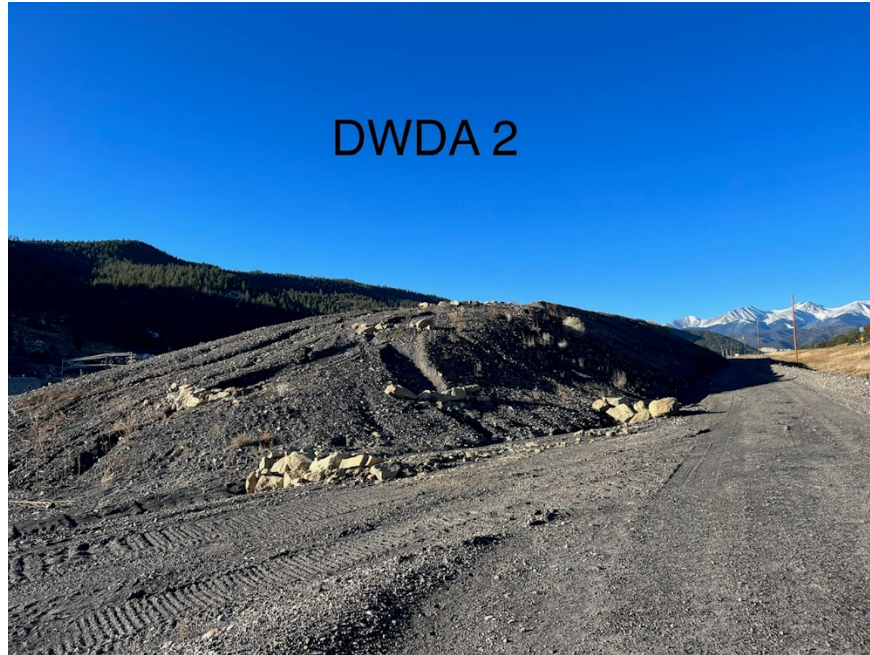
**DWDA #2**

Positive Drainage is maintained on the surface of the DWDA. Sump on East end of pile was being cleaned at time of inspection. Rills on the disposal area are being monitored. No evidence of springs nor seeps were observed.

Surface and out slopes of the pile were inspected for visible signs of potential failure or instability. There was some surface erosion but not enough to make the area unstable. In all no signs of failure or instability were observed.

Overall the disposal area is in good condition.

Ditch and sumps on North side of pile needs to be cleaned. Rills are being monitored. Sump at East end of pile has recently been cleaned.

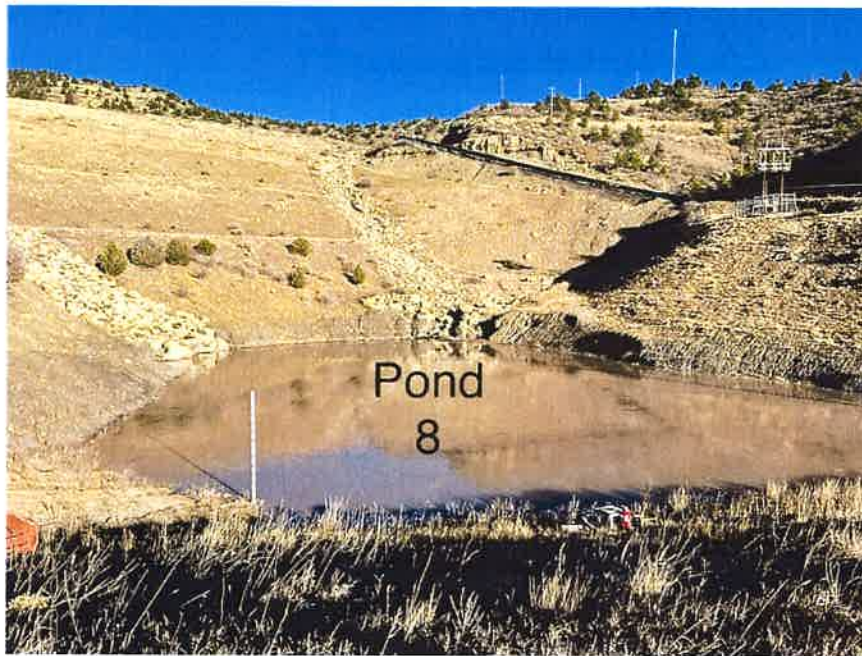
**Pond at base of Refuse Disposal Area**

Positive Drainage is maintained on the surface of the RDA. Sumps on top of the RDA have been recently cleaned. There is no ponding on the top of the pile. No evidence of springs nor seeps were observed.

Overall the site is in good condition. Compaction test from this quarter is attached. Compaction tests came back at 95%, 96%, and 97%.

None required at this time.
