QUARTERLY SEDIMENTATION POND INSPECTION REPORT

Mine: New Elk

Inspection Period: Fourth Quarter 2022

Inspection Date: 12/11/2022

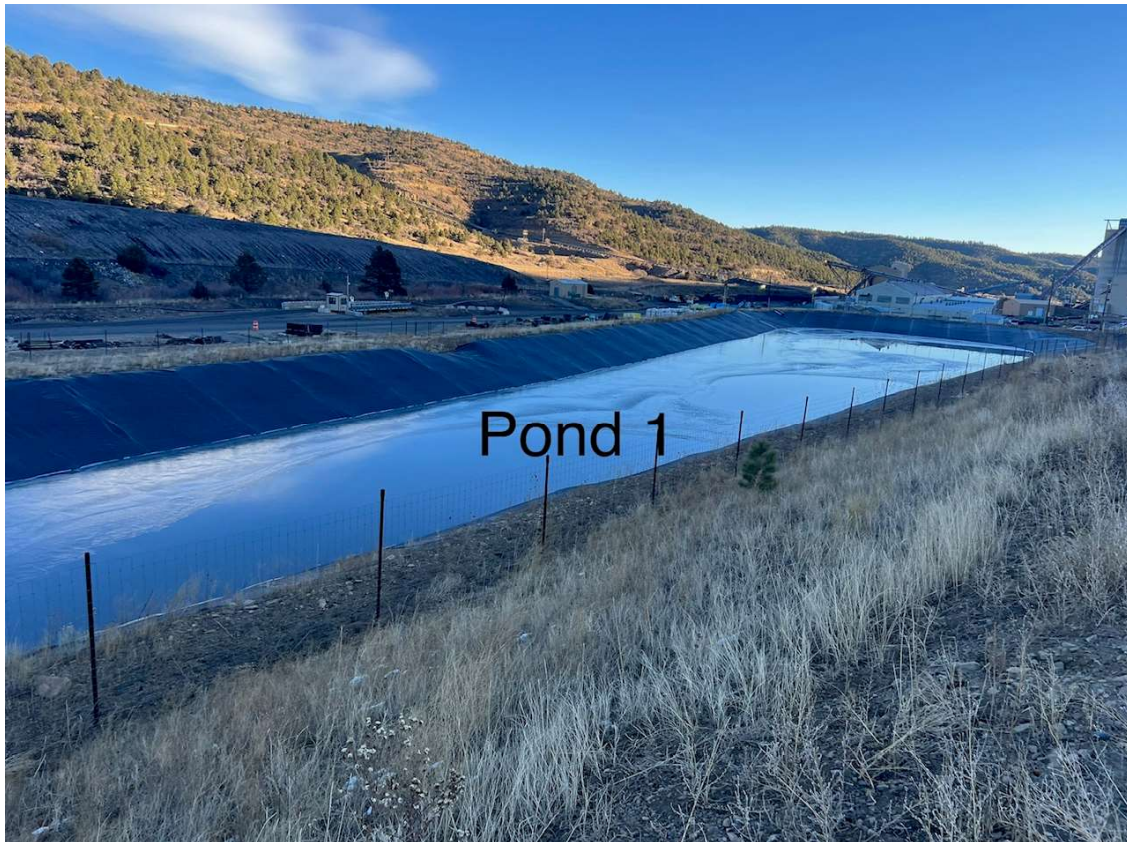
Pond 1

Pond liner is visibly in good working condition at time of inspection. Pond was about 1/2 full at time of
Inspection. No issues

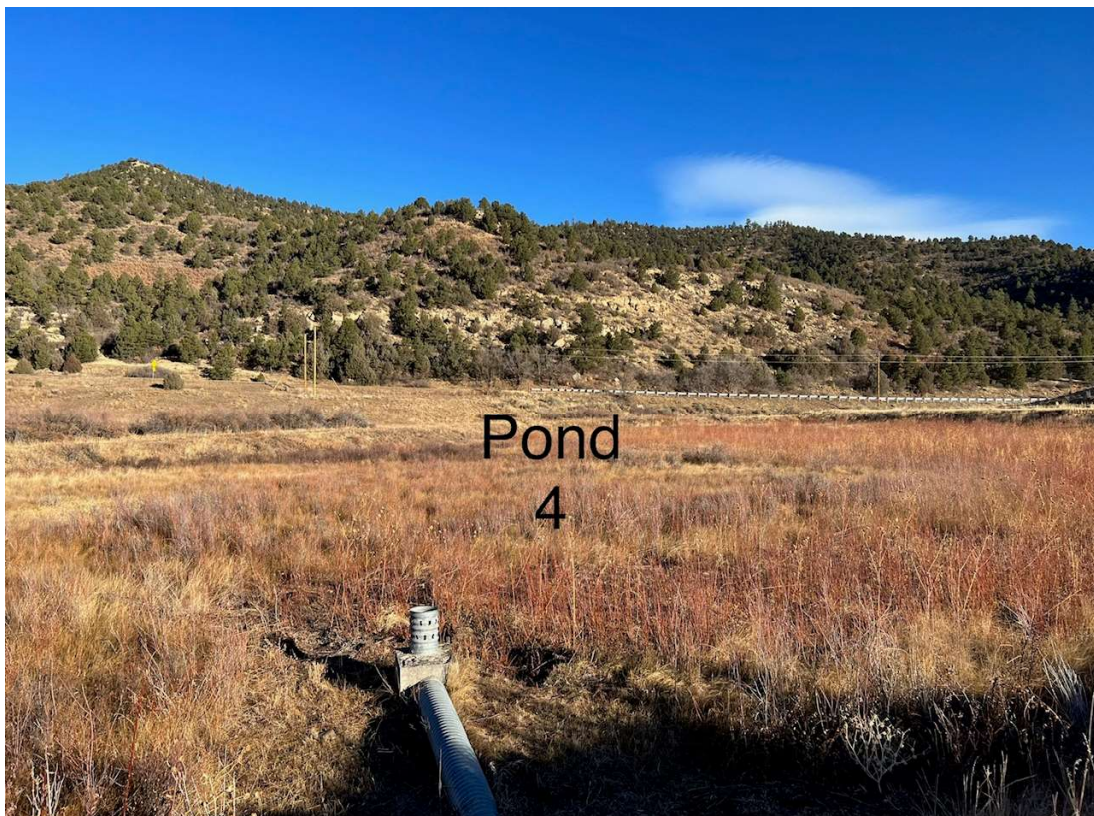
Pond 4

Pond was dry and no issues found.

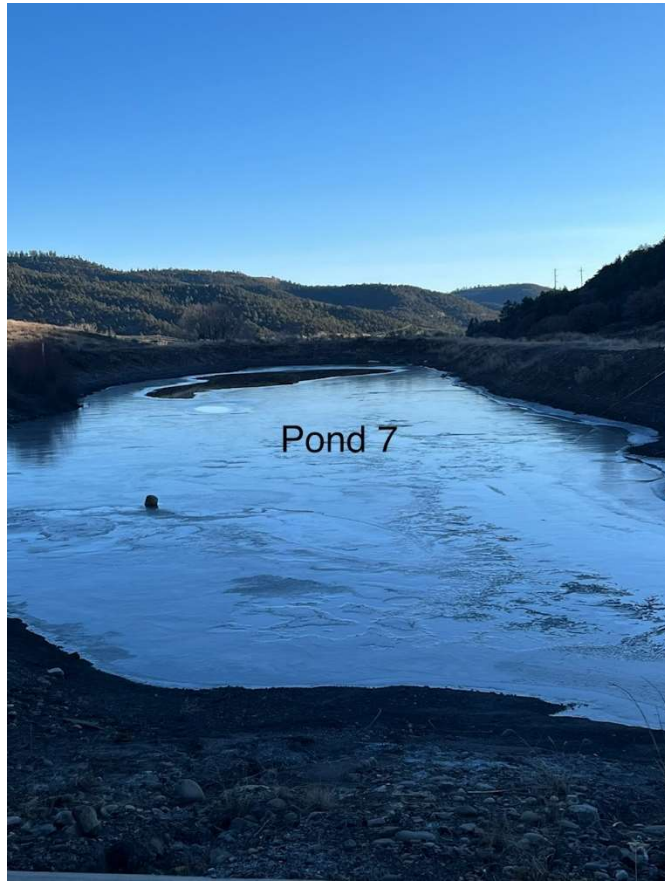
Pond 7

Pond is holding water at time of inspection. Not discharging and no issues found.

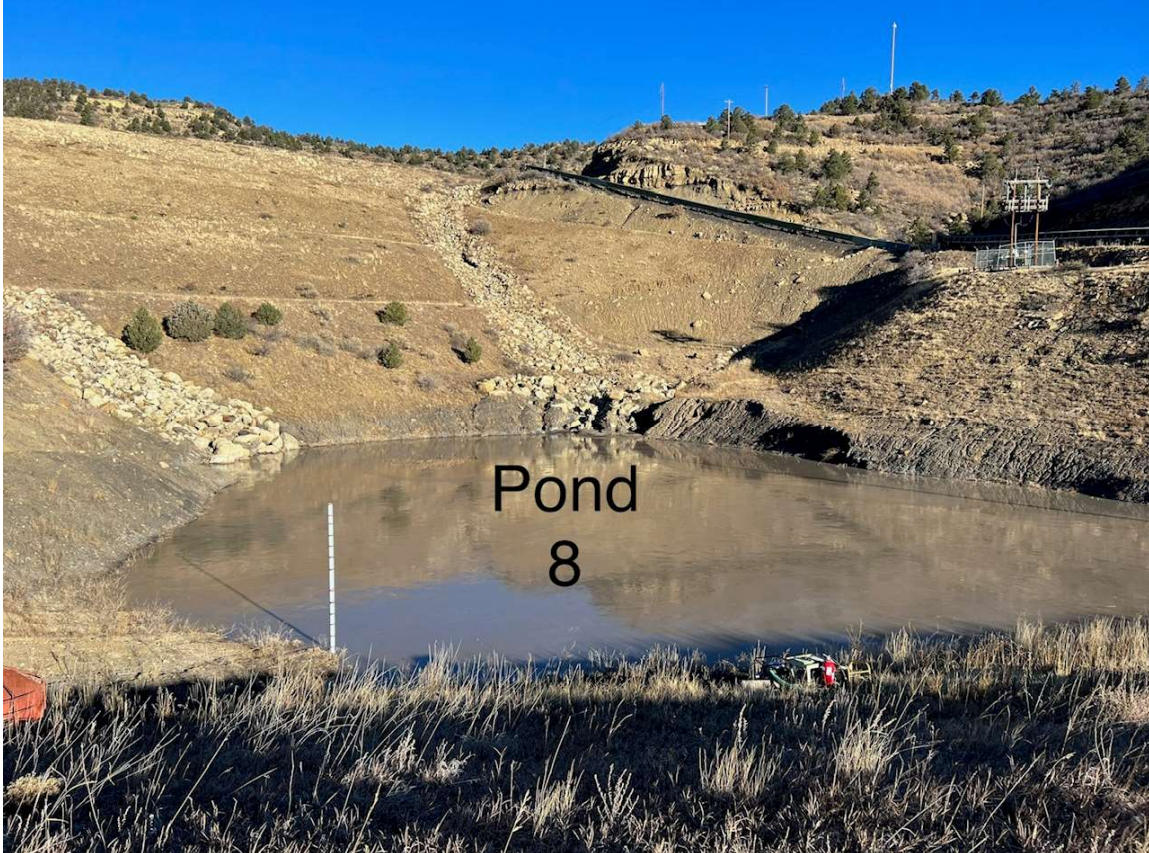
Pond 8

Water is at bottom of the gauge. No issues found at time of inspection.

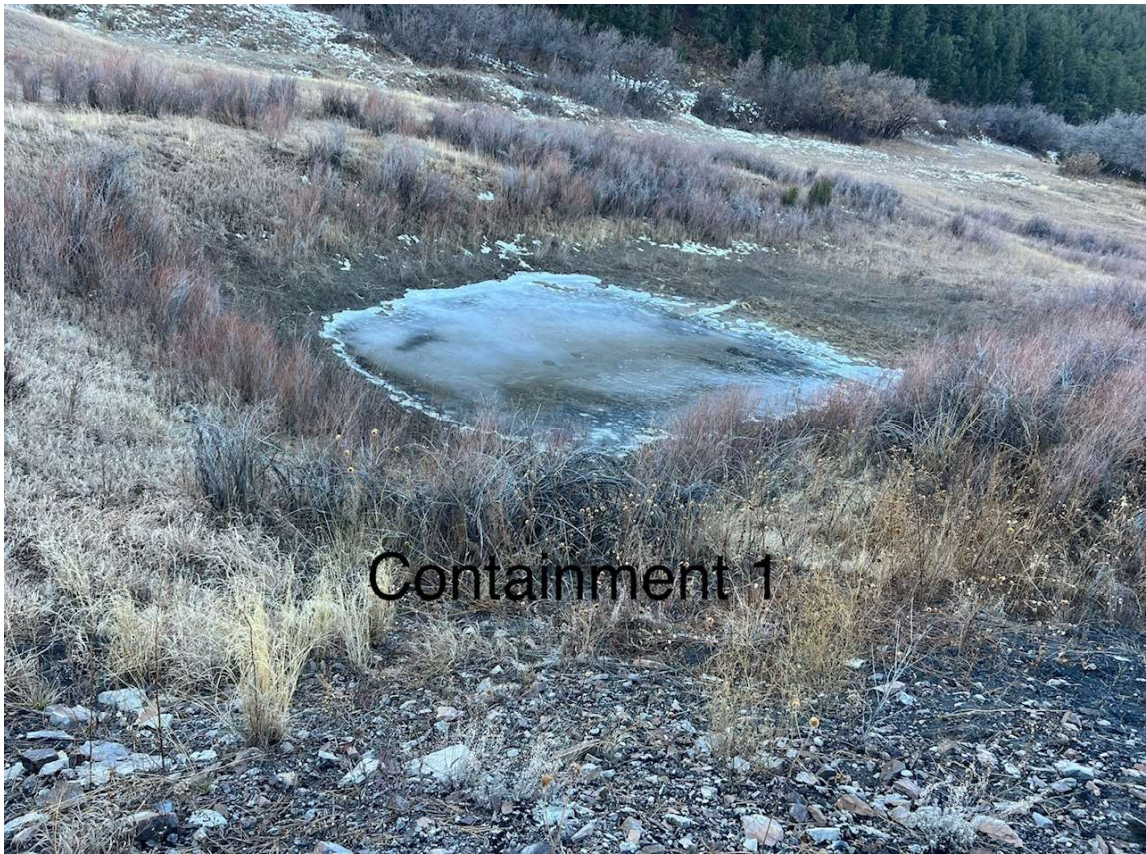
Containment Area #1

Containment was holding a small amount of water at time of inspection. In good shape.

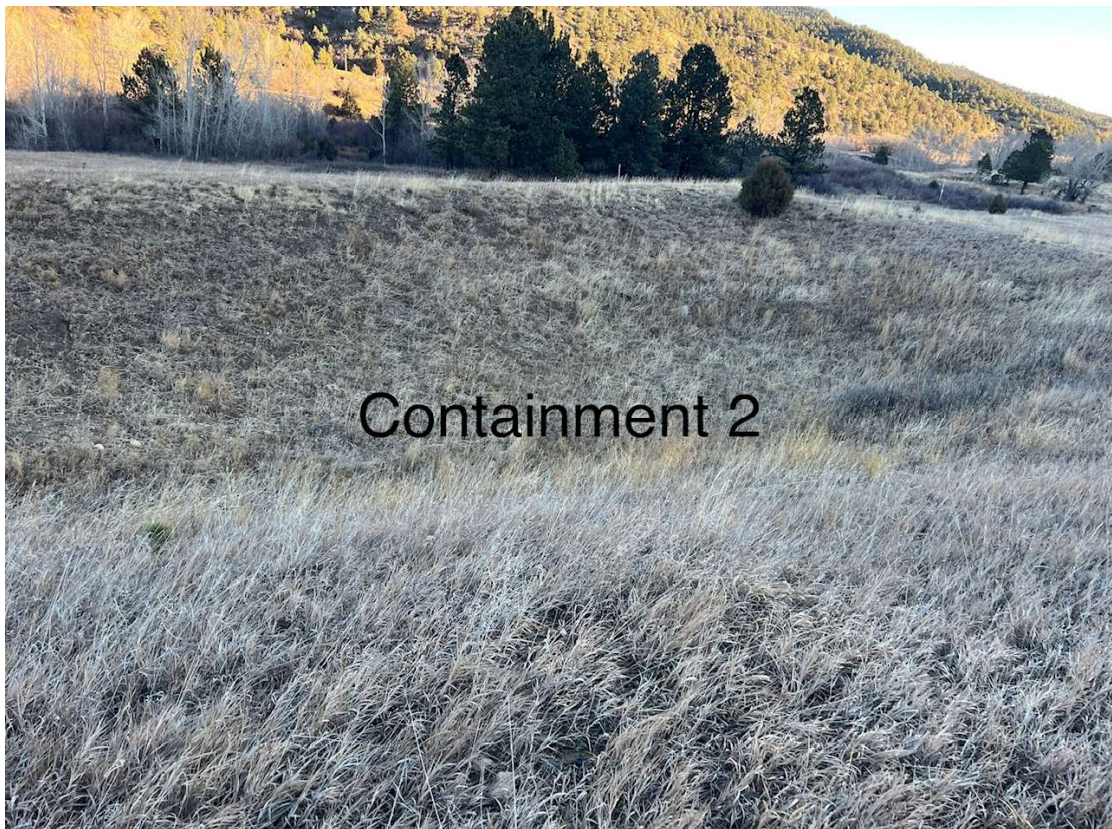
Containment Area #2

The containment was dry at time of inspection. In good shape.

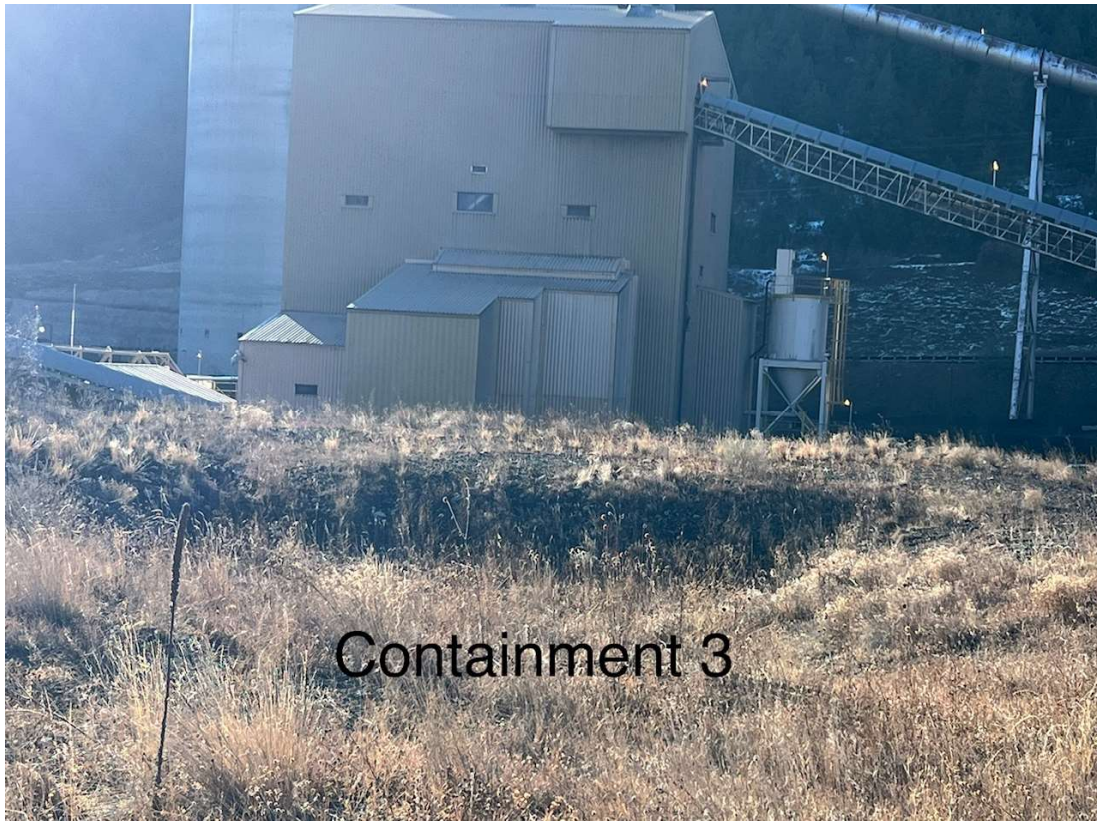
Containment Area #3

Containment Area was dry at time of inspection. No issues

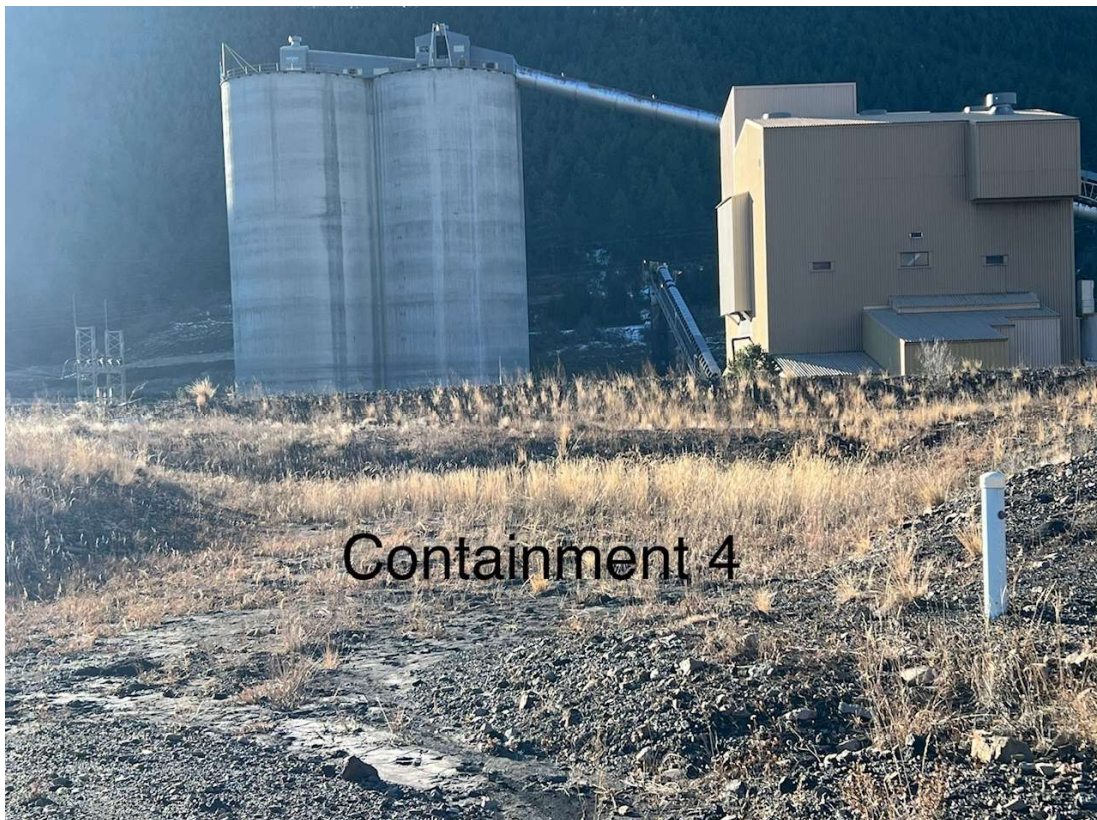
Containment Area #4

Containment Area was dry at time of inspection. In good shape

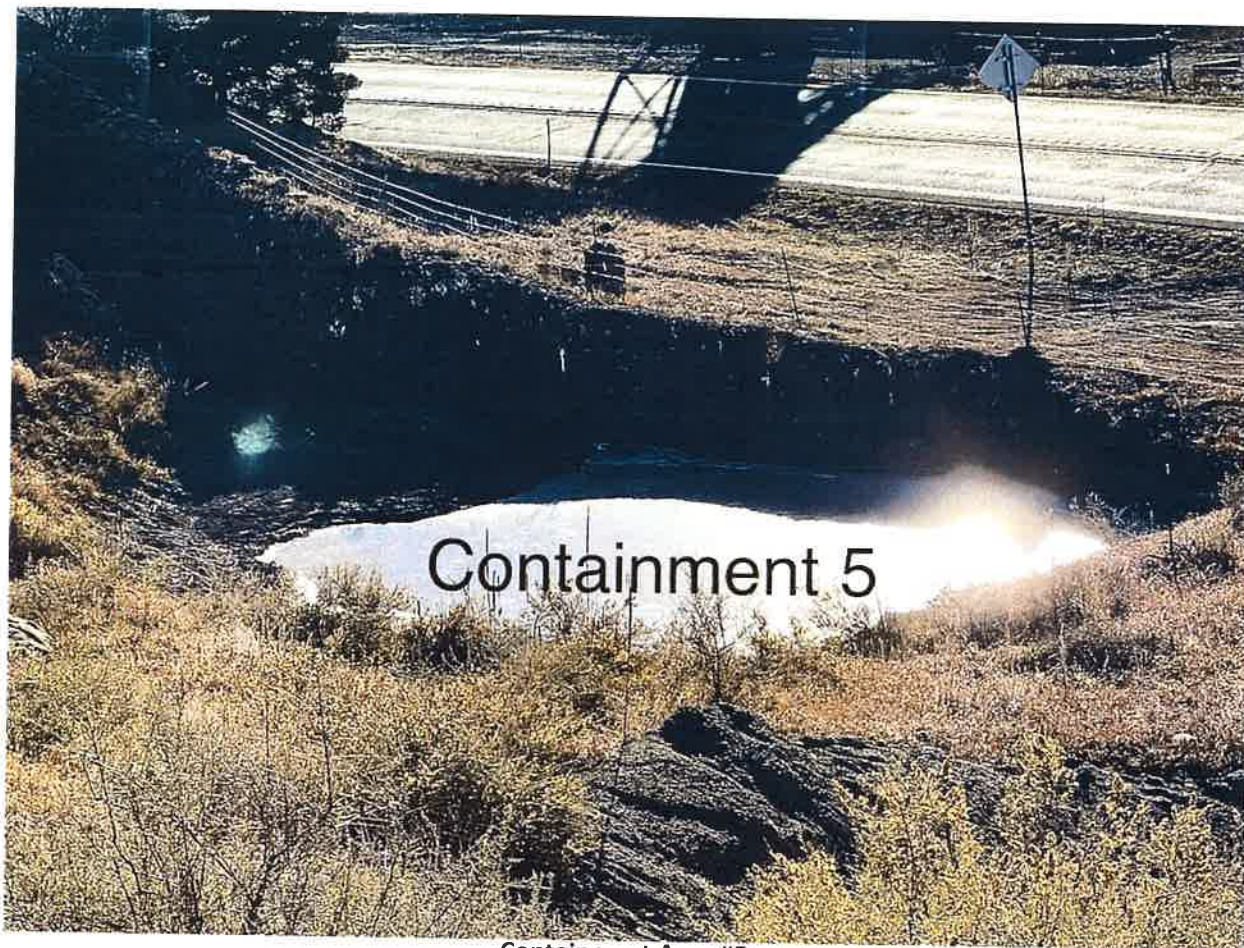
Containment Area #5

Containment Area was holding water at time of inspection. Has recently been pumped. No issues.
