LORENCITO CANYON MINE
Permit No. C-1996-084

INSPECTION OF EXCESS SPOIL-FILLS 7, 8, & 9
December 11, 2022

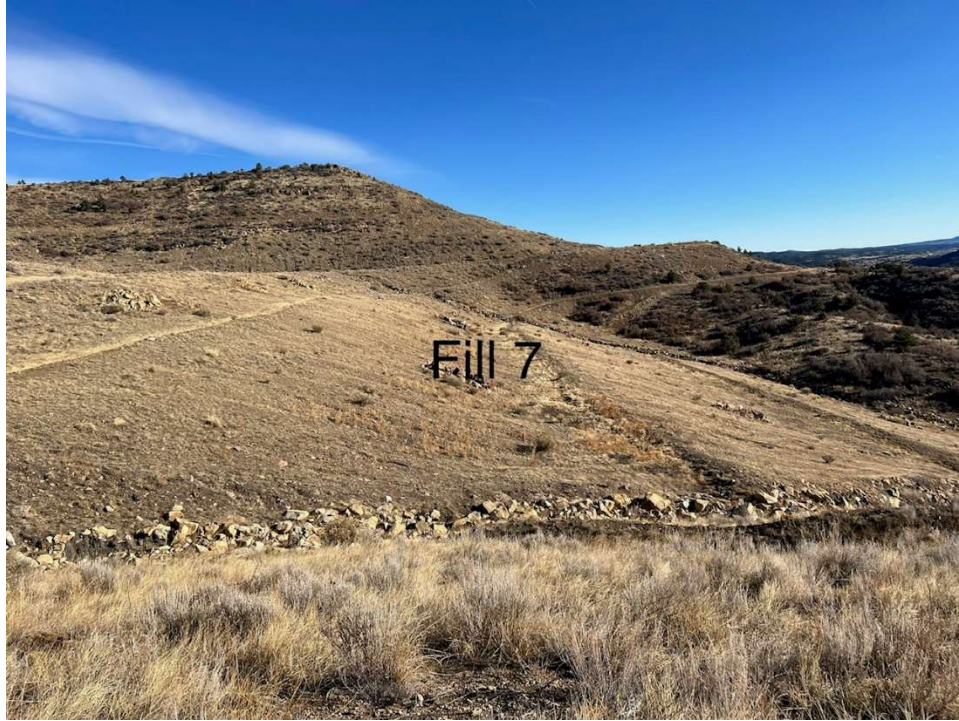
Fill #7

The entire excess spoil fill facility was examined for signs of failure and instability such as tension cracks, ground movement, springs and seeps, and standing water. There was no indication of potential instability at time of inspection.

Overall the site is in good condition. The vegetation on the fill is encouraging.

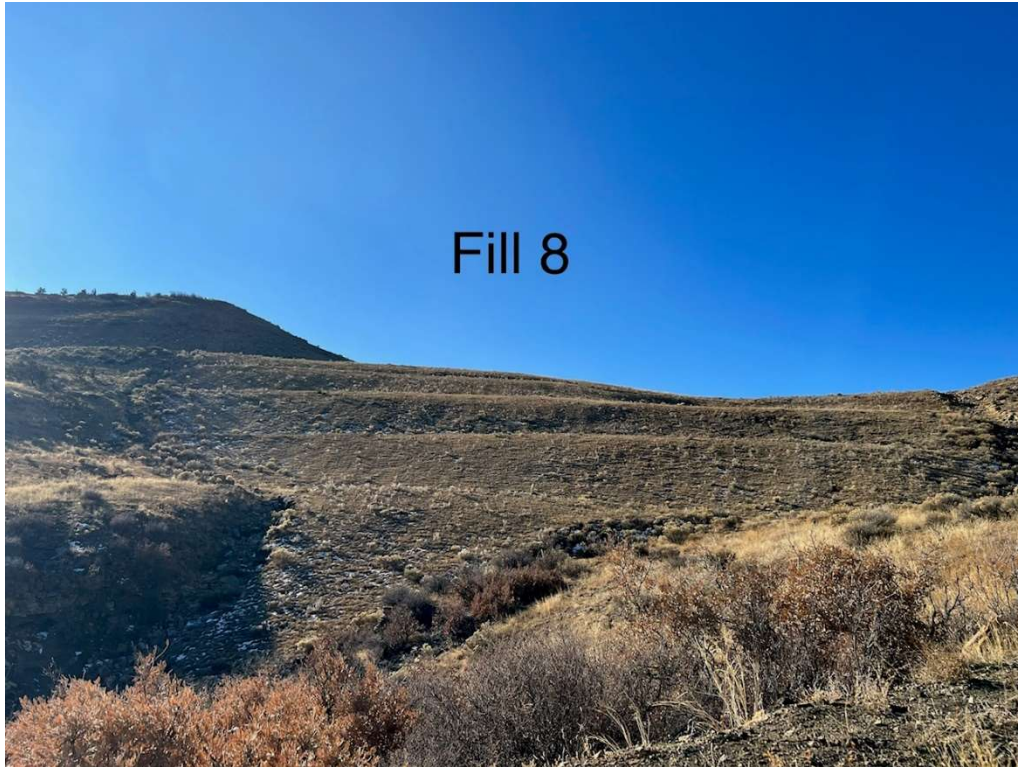
Fill #8

The entire excess spoil fill facility was examined for signs of failure and instability such as tension cracks, ground movement, springs and seeps, and standing water. There was no indication of potential instability at time of inspection.

Overall the site is in good condition. Vegetation is very good on the fill.

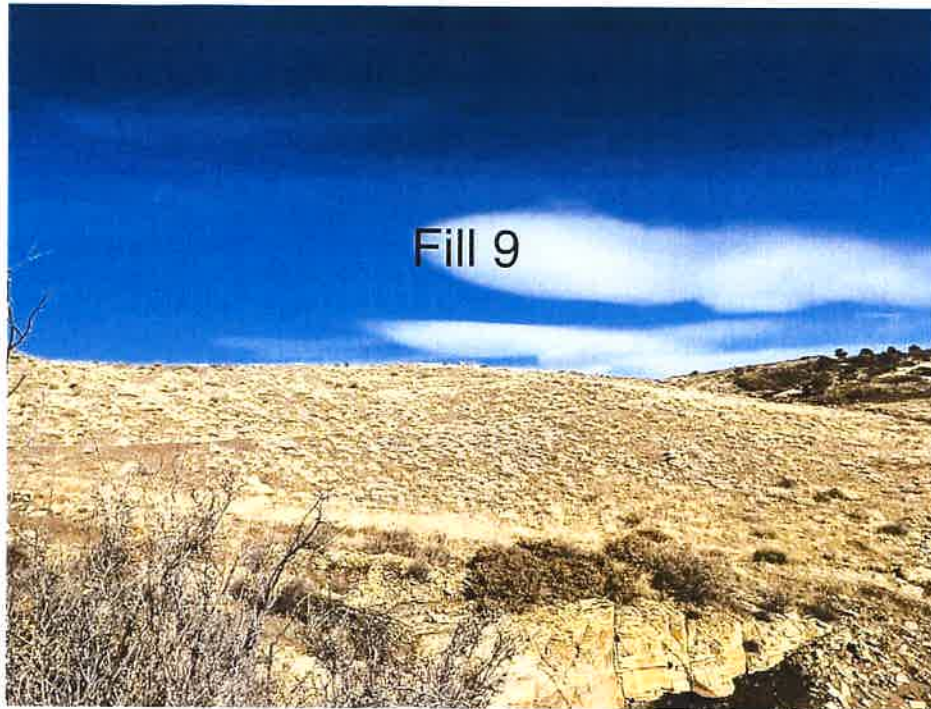
Fill #9

The entire excess spoil fill facility was examined for signs of failure and instability such as tension cracks, ground movement, springs and seeps, and standing water. There was no indication of potential instability at time of inspection.

Overall the site is in good condition.
