QUARTERLY SEDIMENTATION POND INSPECTION REPORT

Mine: Lorencito

Inspection Period: Fourth Quarter 2022

QUARTERLY SEDIMENTATION POND INSPECTION REPORT
Lorencito Canyon Mine- December 11, 2022

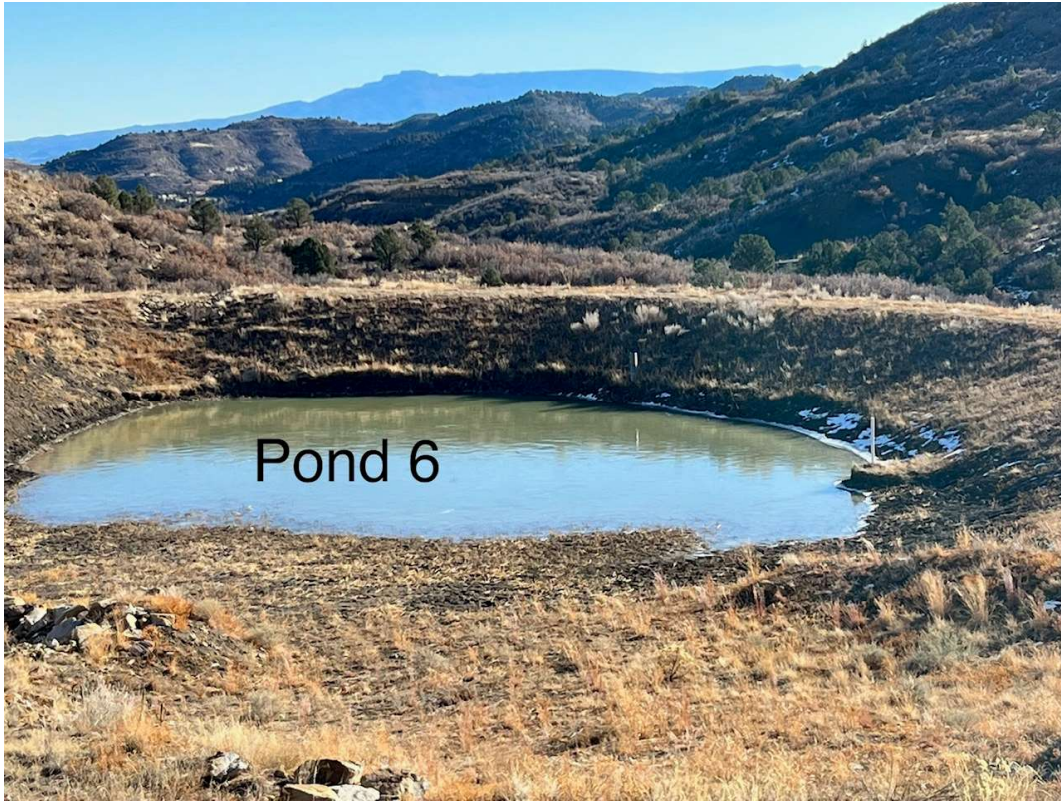
Pond 6

Pond was holding water but not discharging at time of inspection. No Issues

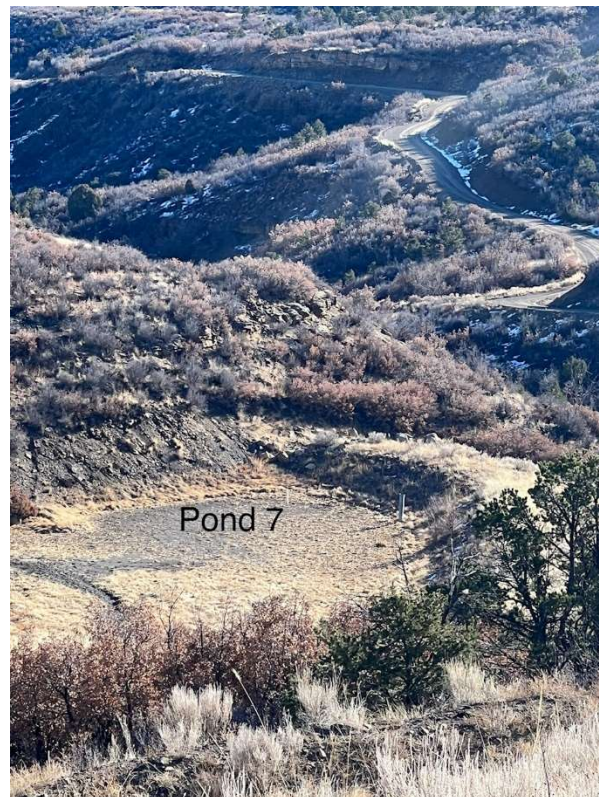
Pond 7

Pond was empty at time of inspection.

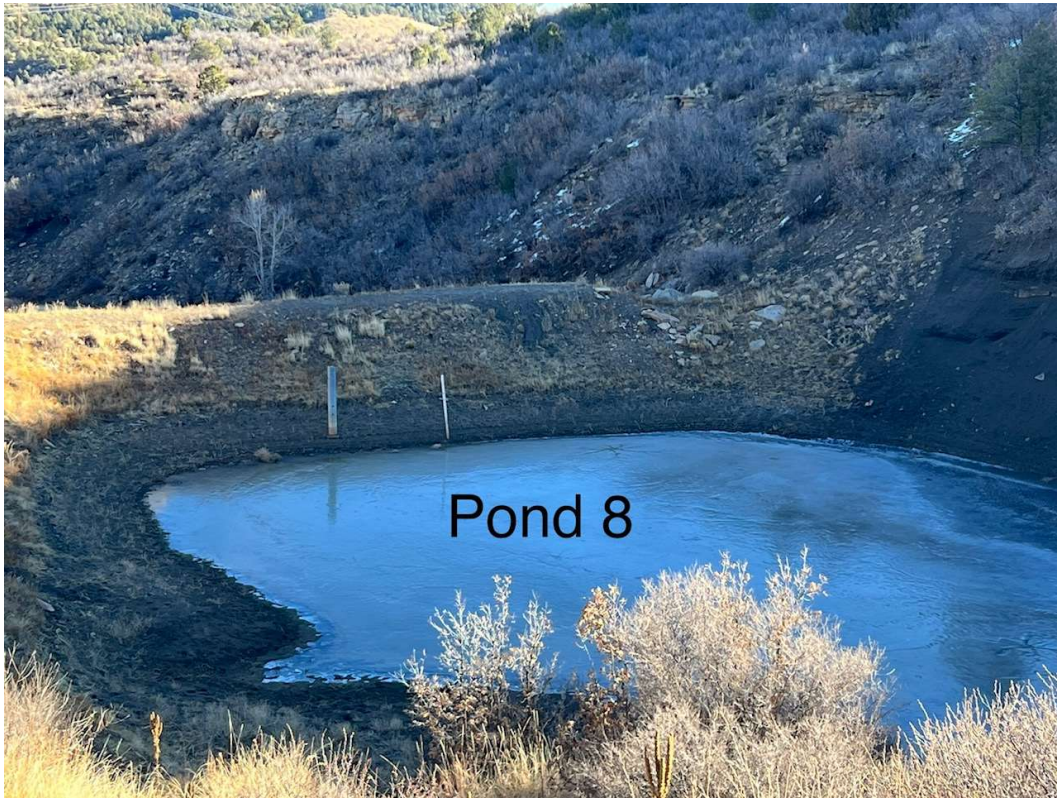
Pond 8

Pond was holding a small amount of water at time of inspection.

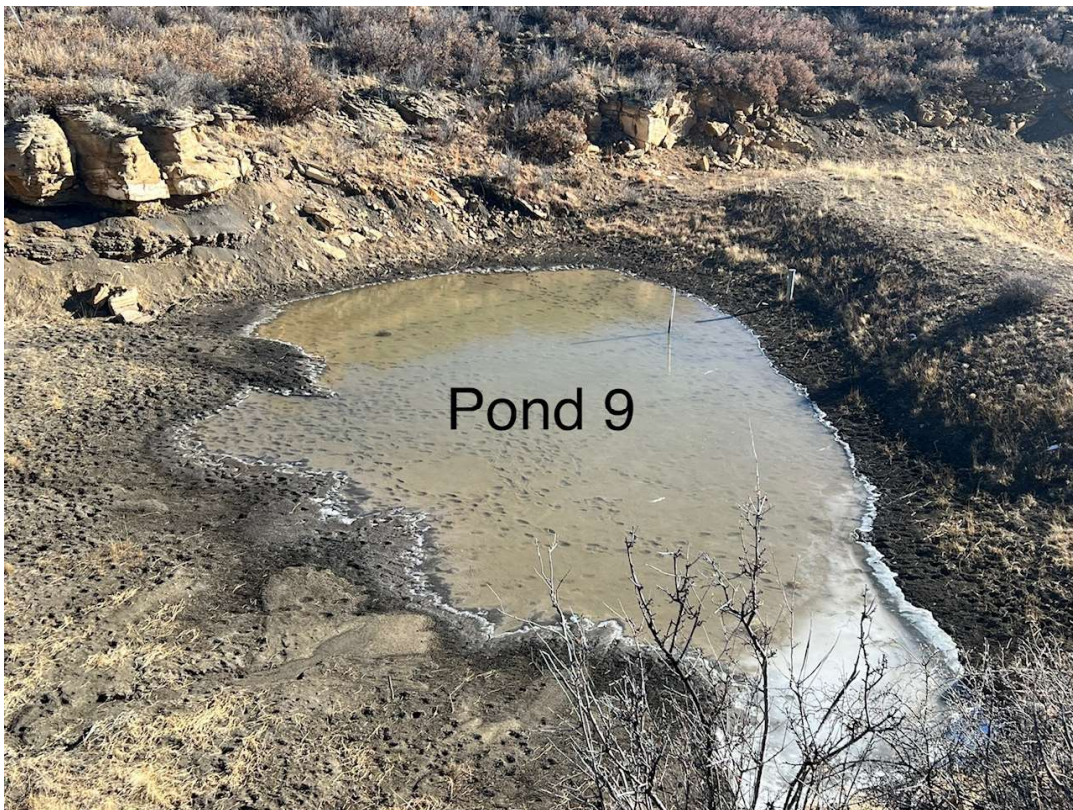
Pond 9

Pond was a small amount holding water at time of inspection.

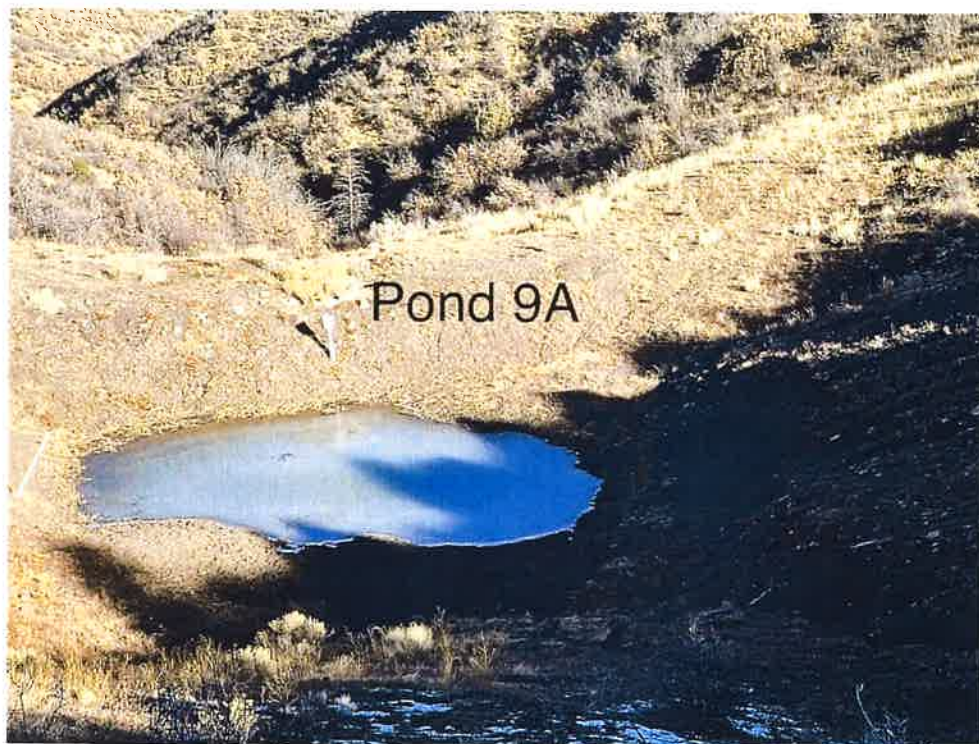
Pond 9A

Pond was holding a small amount of frozen water. No issues.
