To: Jerald Schnabel  
Continental Materials Corp.  
File: November 2022 Monitoring Summary

**Reference: November 2022 Geotechnical Monitoring Summary Pikeview Quarry**

Client/Project  
CONTINENTAL MATERIALS  
CORP.  
PIKEVIEW QUARRY SLOPE  
MONITORING

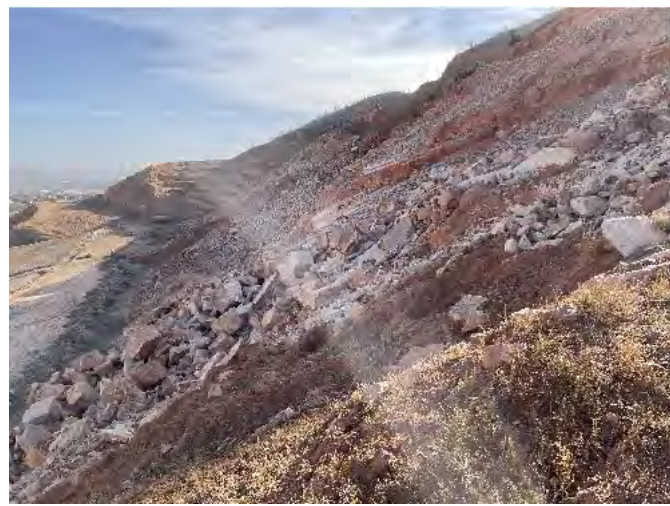
- No cracking was observed on the native granite slopes above the extents of the disturbed area. (Photo 6)
- Operators continue to place compacted material in the buttress zone. The fill material was primarily excavated from the North Borrow Area and the Shop Borrow Area. Note that the North Borrow Area is a separate project associated with the City's plans for the property; this grading was permitted by El Paso County. (Photo 7)

6. View south of granite slopes above disturbed area.

NOTE 1:  
NO  
CRACKS  
6.

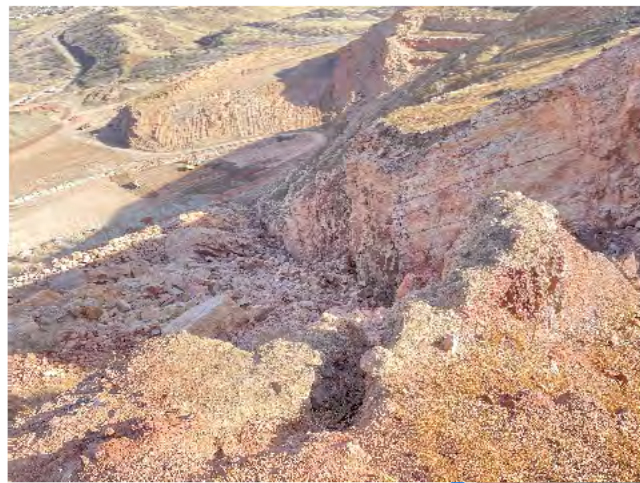
5. View southeast from haul road down to pit floor.

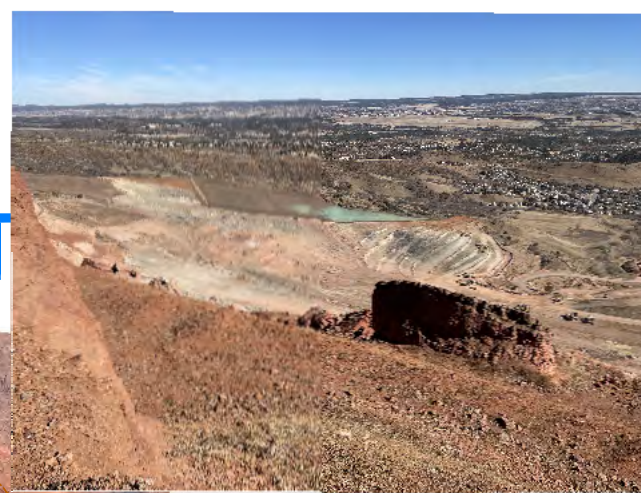
4. View northeast of NBA benches and slide slope.

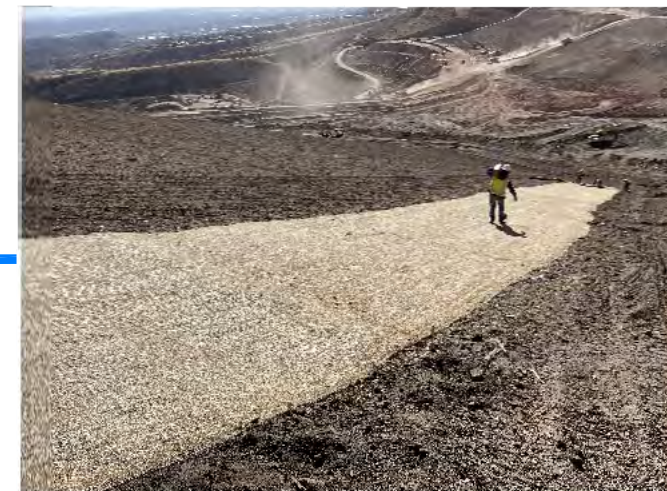
3. Erosion control installed on north borrow slope.

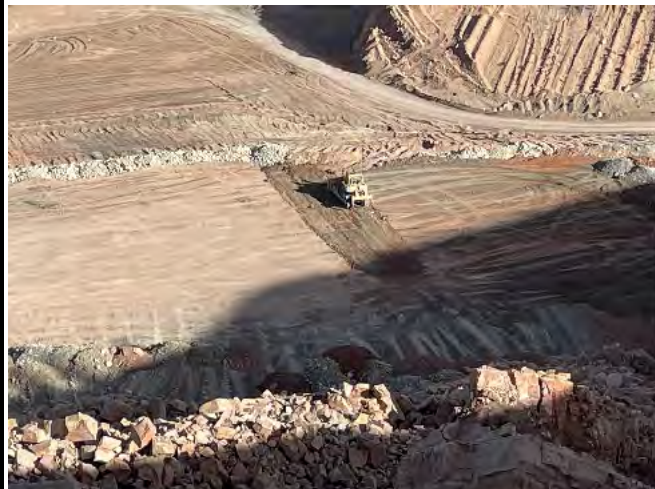
7. Compacted area in the buttress zone.

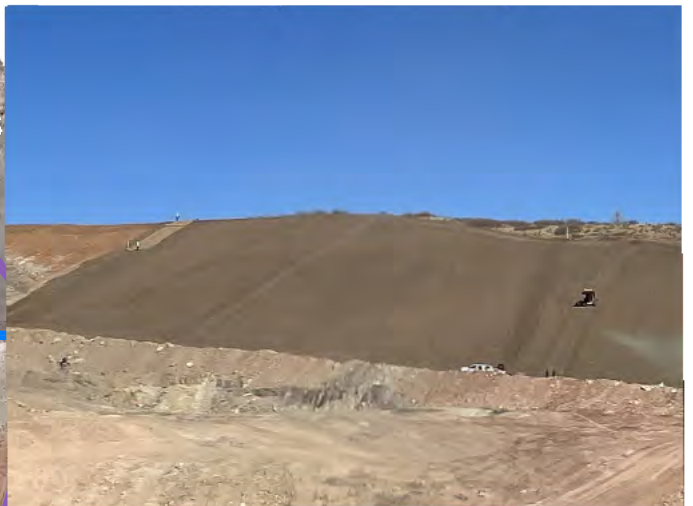
2. Graded slopes in the north borrow area.

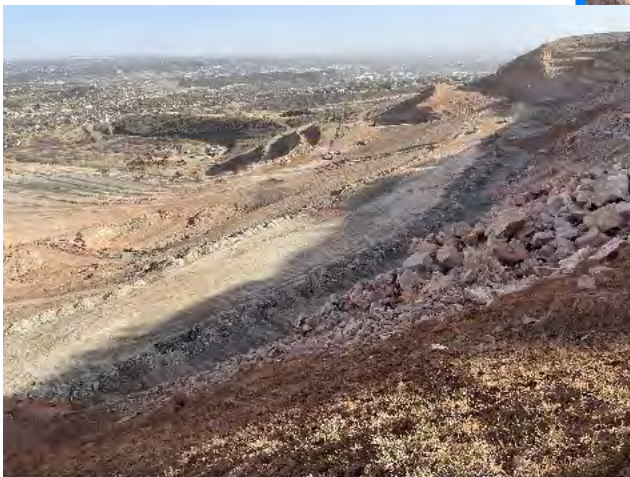
- A safety buffer zone is being kept between the active work areas and the toe of the slide to stop any rocks that might come loose during grading operations. Compacted fill is placed in the buffer zone as the buttress fill is placed. (Photo 8)

8. Buffer zone on pit floor along toe of slide.

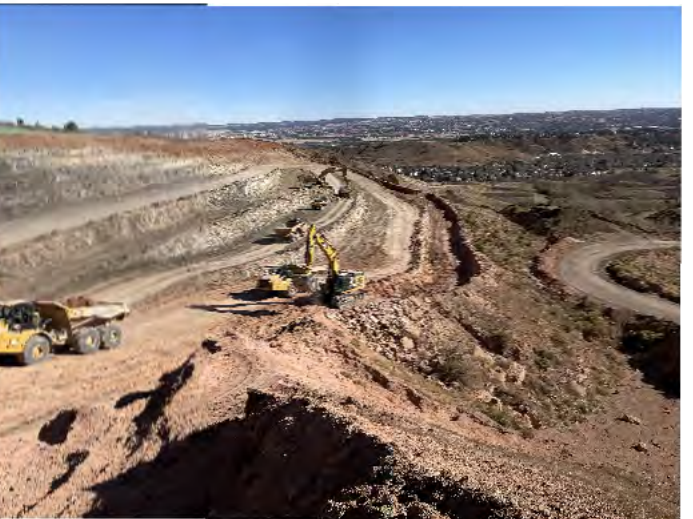
1. Benches in the north borrow area.

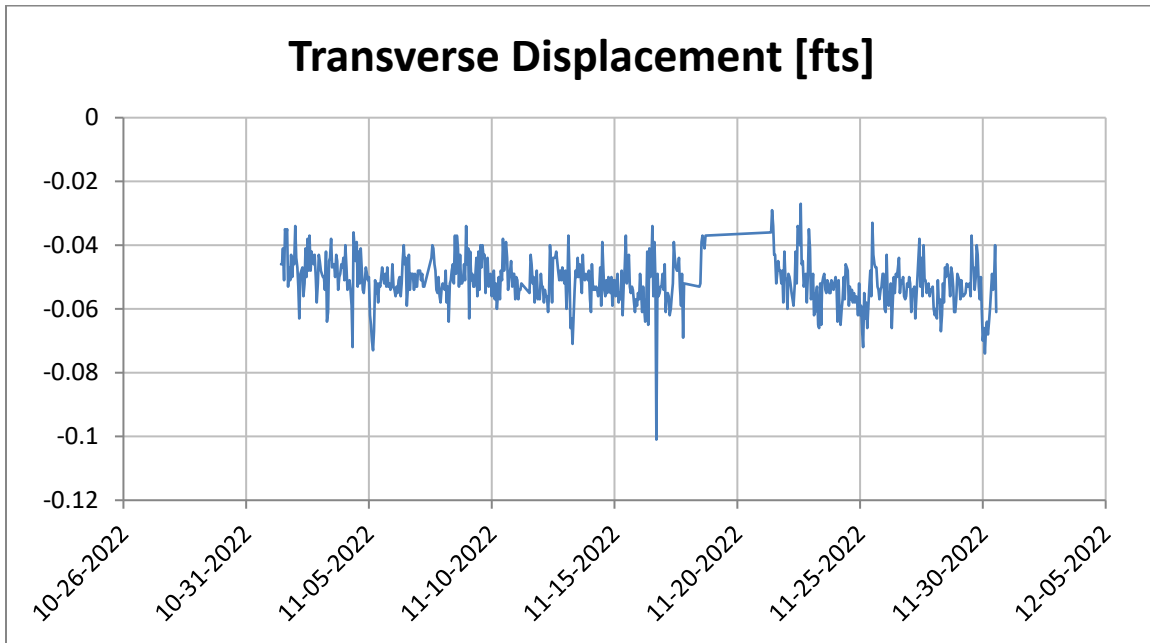
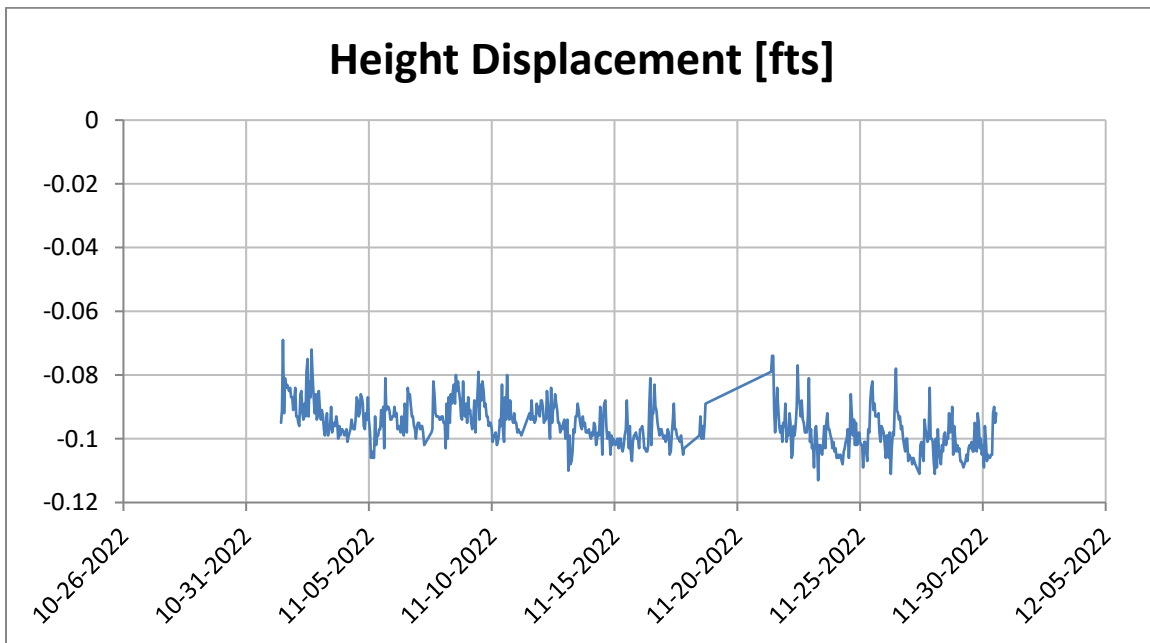
## Prism BR1

| Prism ID | Cumulative Transverse Displacement (ft) | Cumulative Height Displacement (ft) | Monthly Delta (ft) | Cumulative Delta (ft) | Notes / Recommendations |
|---|---|---|---|---|---|
| BR1 | -0.061 | -0.092 | 0.0105 | 0.1573 | Slope creep movements. |

1. Survey accuracy is  $\pm 0.016$  feet.
2. Alarm threshold is  $\pm 0.35$  feet.
3. Transverse displacement is in the horizontal direction. Positive direction means closer to the robotic station.
4. Height displacement is in the vertical direction. Positive direction means higher in elevation.
5. Prism records slope creep movements with slow velocity.

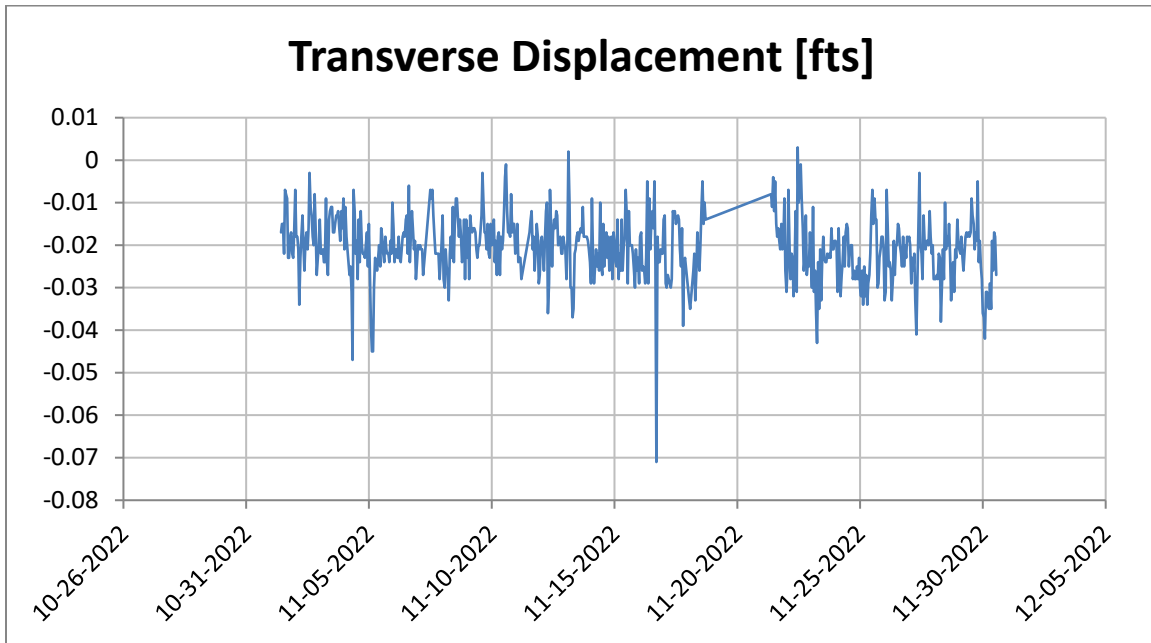
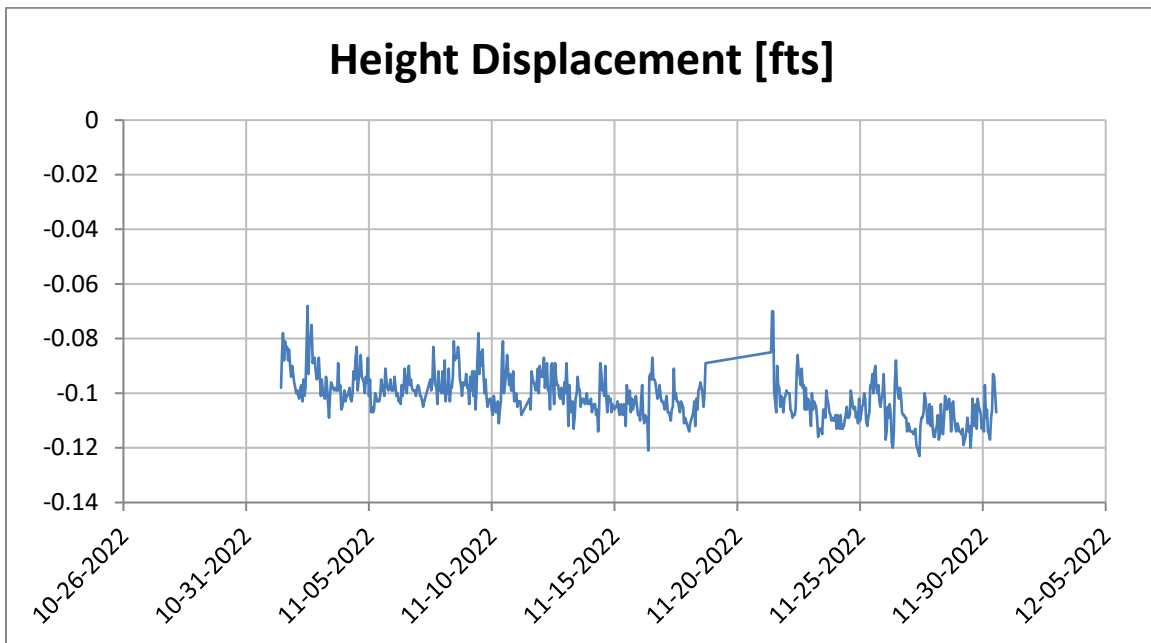
## Prism BR2

| Prism ID | Cumulative Transverse Displacement (ft) | Cumulative Height Displacement (ft) | Monthly Delta (ft) | Cumulative Delta (ft) | Notes / Recommendations |
|---|---|---|---|---|---|
| BR2 | -0.027 | -0.107 | 0.0204 | 0.1572 | Slope creep movements. |

1. Survey accuracy is  $\pm 0.016$  feet.
2. Alarm threshold is  $\pm 0.35$  feet.
3. Transverse displacement is in the horizontal direction. Positive direction means closer to the robotic station.
4. Height displacement is in the vertical direction. Positive direction means higher in elevation.
5. Prism records slope creep movements with slow velocity.

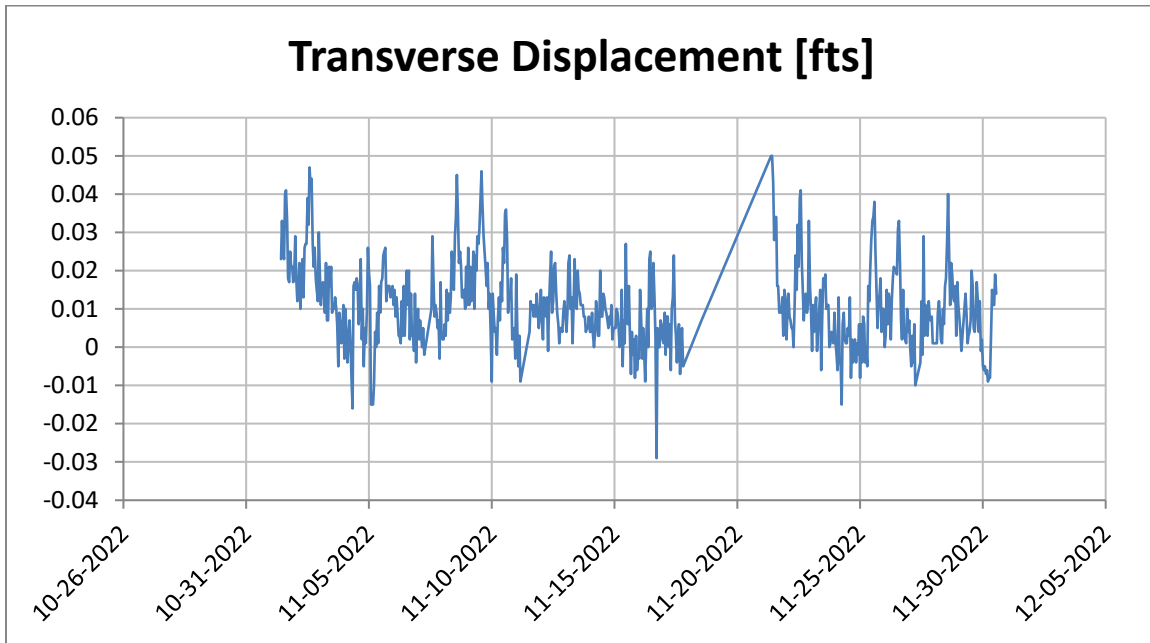
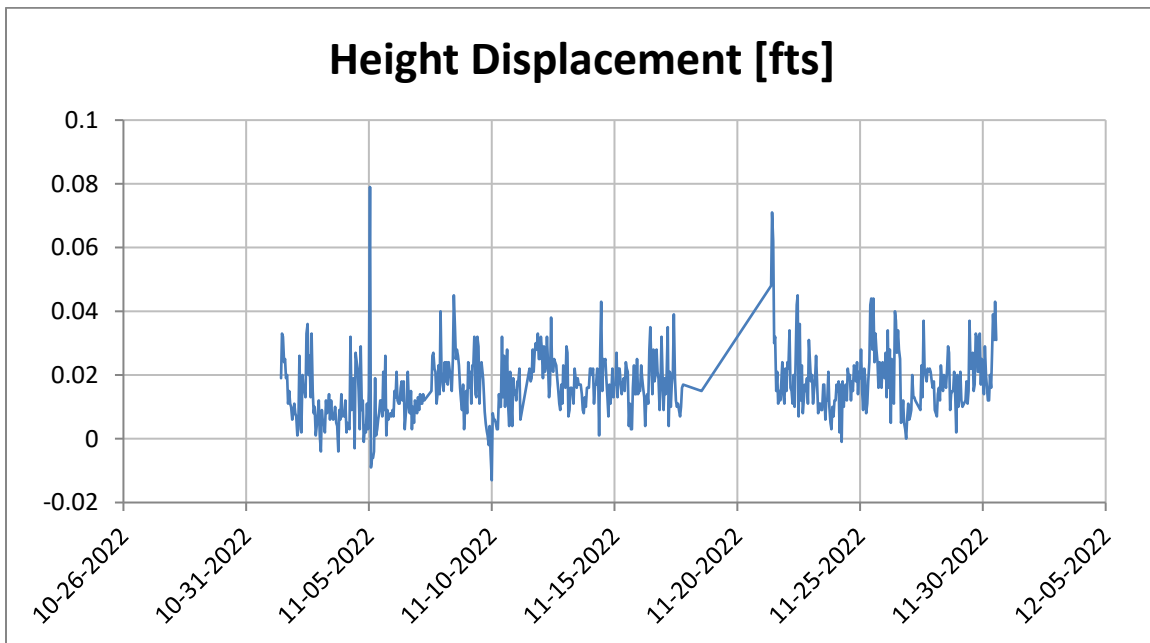
## Prism NP2

1. Survey accuracy is  $\pm 0.016$  feet.
2. Alarm threshold is  $\pm 0.35$  feet.
3. Transverse displacement is in the horizontal direction. Positive direction means closer to the robotic station.
4. Height displacement is in the vertical direction. Positive direction means higher in elevation.
5. Regression limit alert received on November 5.

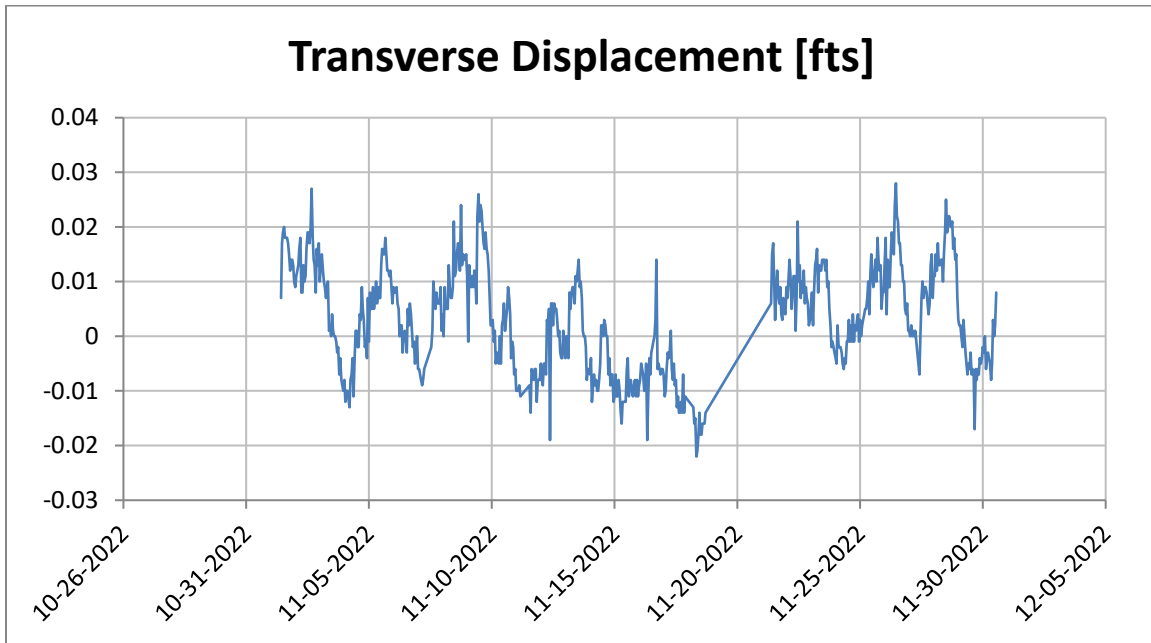
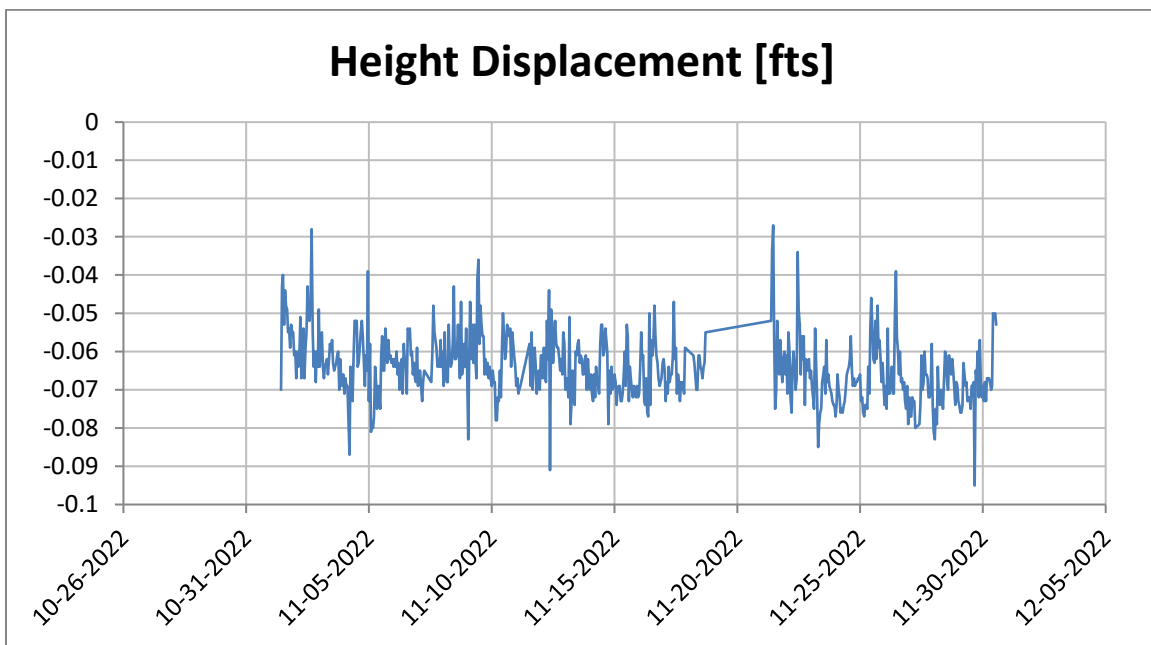
## Prism NP66

| Prism ID | Cumulative Transverse Displacement (ft) | Cumulative Height Displacement (ft) | Monthly Delta (ft) | Cumulative Delta (ft) | Notes / Recommendations |
|---|---|---|---|---|---|
| NP66 | 0.008 | -0.053 | -0.0141 | 0.0624 | Slope creep movements. |

1. Survey accuracy is  $\pm 0.016$  feet.
2. Alarm threshold is  $\pm 0.35$  feet.
3. Transverse displacement is in the horizontal direction. Positive direction means closer to the robotic station.
4. Height displacement is in the vertical direction. Positive direction means higher in elevation.
5. Prism records slope creep movements with slow velocity.

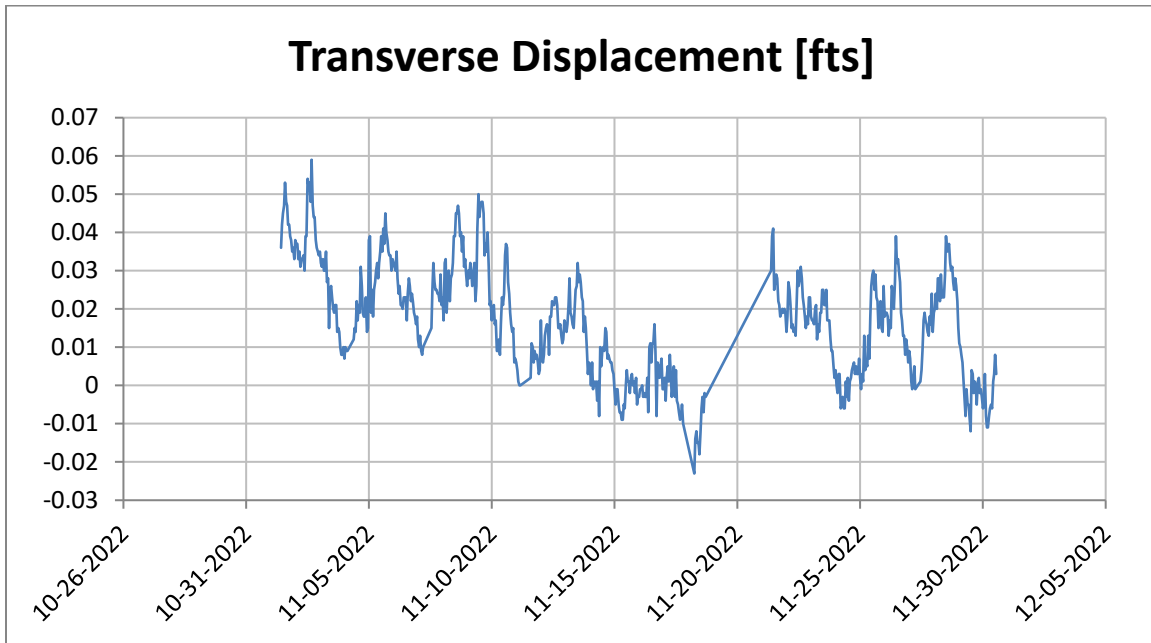
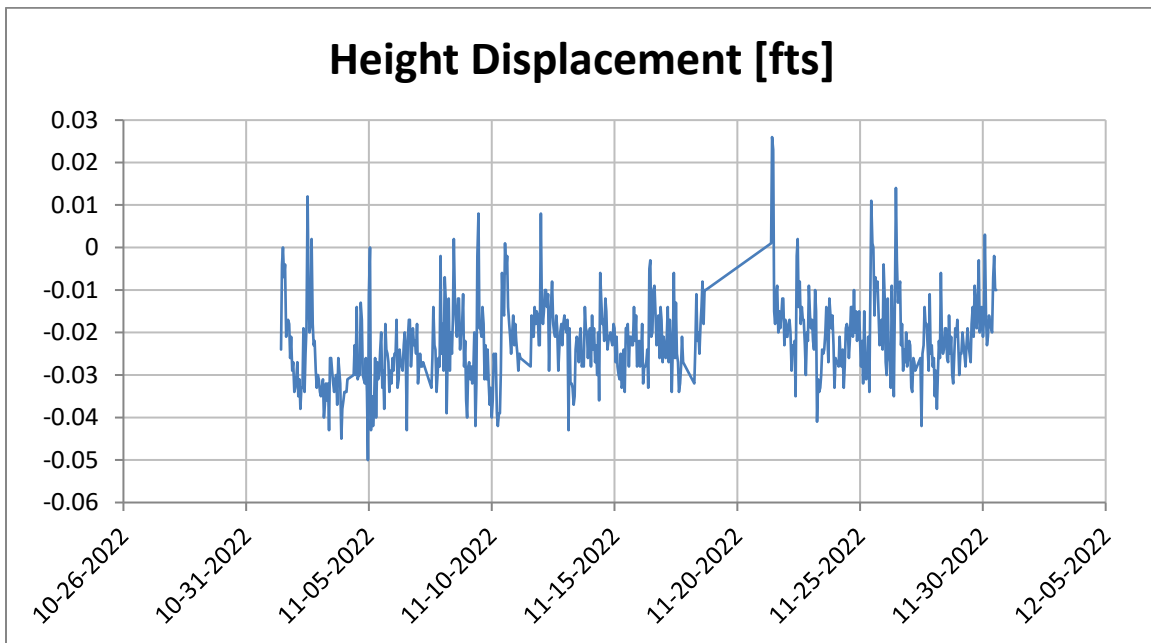
## Prism P33

1. Survey accuracy is  $\pm 0.016$  feet.
2. Alarm threshold is  $\pm 0.35$  feet.
3. Transverse displacement is in the horizontal direction. Positive direction means closer to the robotic station.
4. Height displacement is in the vertical direction. Positive direction means higher in elevation.
5. Regression limit alert received on November 5.
