Division of Reclamation,
Mining and Safety

Permit Number: C-1981-012 Mine Name: New Elk Mine Operator: New Elk Coal Company, LLC Operator Address: Mr. Mark Gray 12250 Highway 12 Weston, CO 81091	County: Las Animas Operation Type: Underground Permit Status: Active Ownership: Private
	Operator Representative Present: John Terry
Operator Representative Signature: (Field Issuance Only)

Inspection Start Date: December 20, 2022 Inspection Start Time: 08:00 Inspection End Date: December 20, 2022 Inspection End Time: 11:30		Inspection Type: Coal Partial Inspection Inspection Reason: Normal I&E Program Weather: Clear	
Joint Inspection Agency: None		Joint Inspection Contacts:	
Post Inspection Agency: None		Post Inspection Contacts:	
Inspector(s): Brock Bowles	Inspector's Signature:

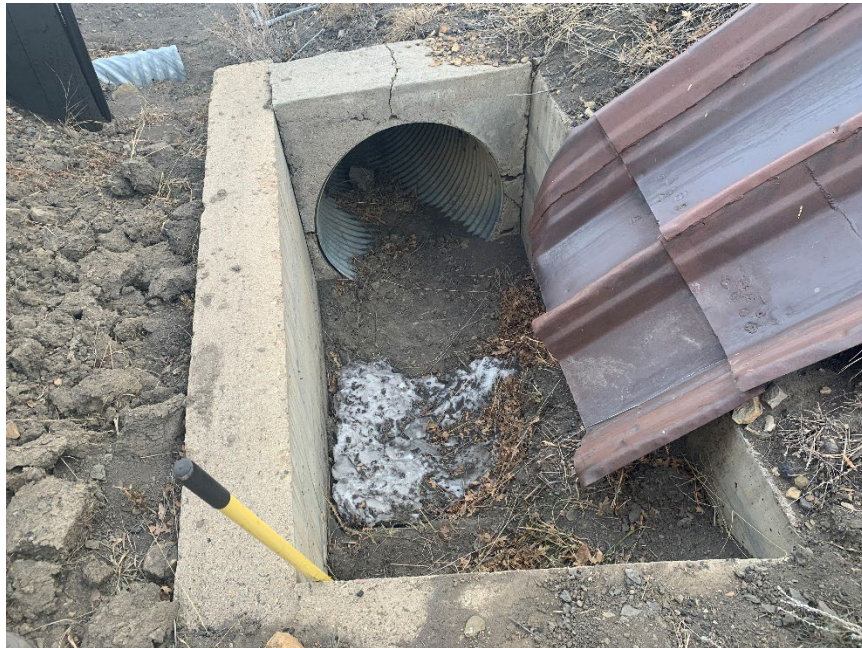
The concrete box at the bottom of the clean water flume by the Bates Portals has been partially cleaned. The remaining debris needs to be removed (photo 1).

Photo 1 – Clean water diversion box needs to be cleaned

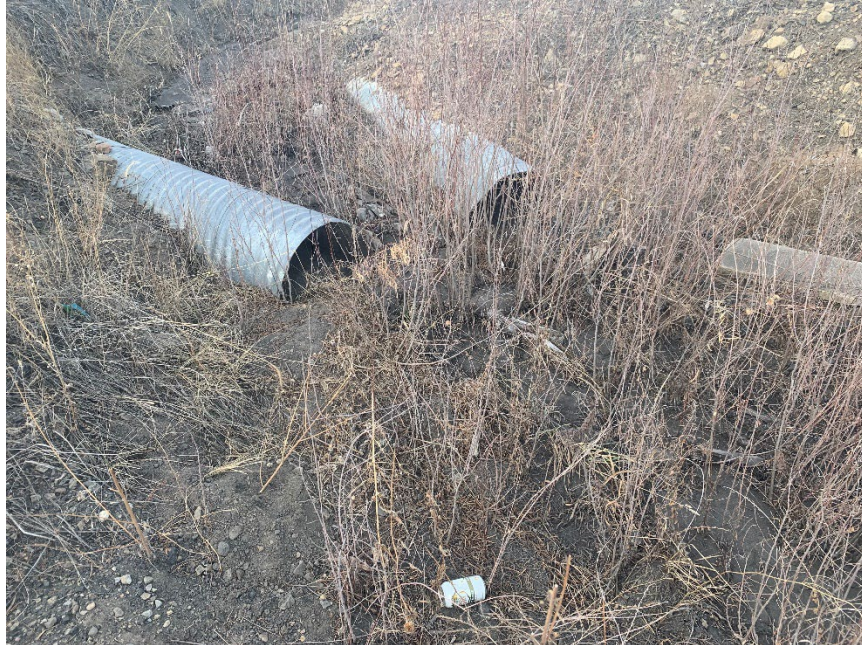
Culverts C34 and C46 located southeast of the clean coal storage area need to be cleaned. The willows on the outlet side of the culverts need to be removed. The willows are preventing the sediment from moving down Ditch D24 resulting in the culverts being half full of sediment (photo 2).

Photo 2 – Willows need to be removed and culverts cleaned

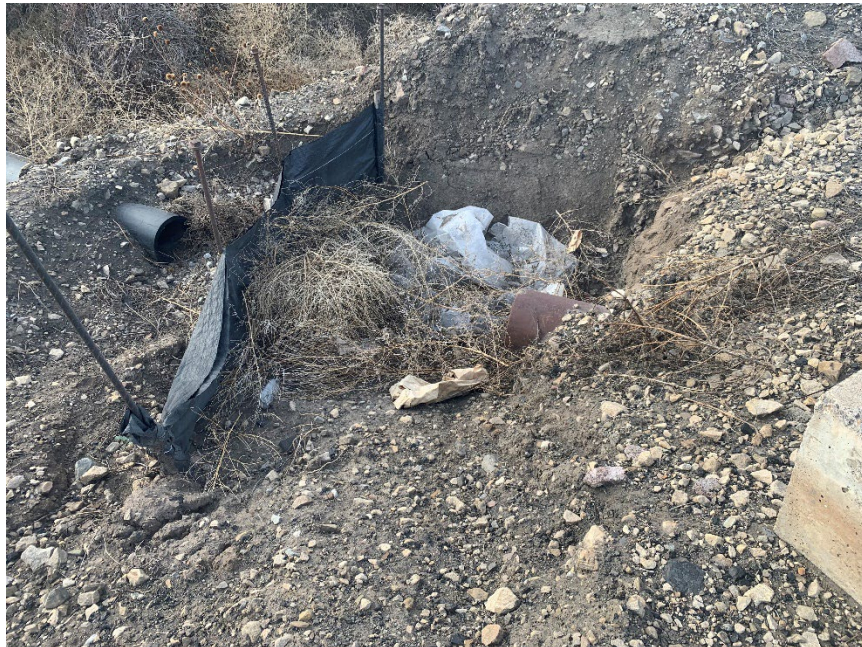
The S.A.E. area south of Pond 7 was in good condition. The silt fences were in good condition. The last silt fence by the flume needs to have the debris removed to ensure proper operation (photo 3).

Photo 3 – Debris needs to be removed from sediment trap

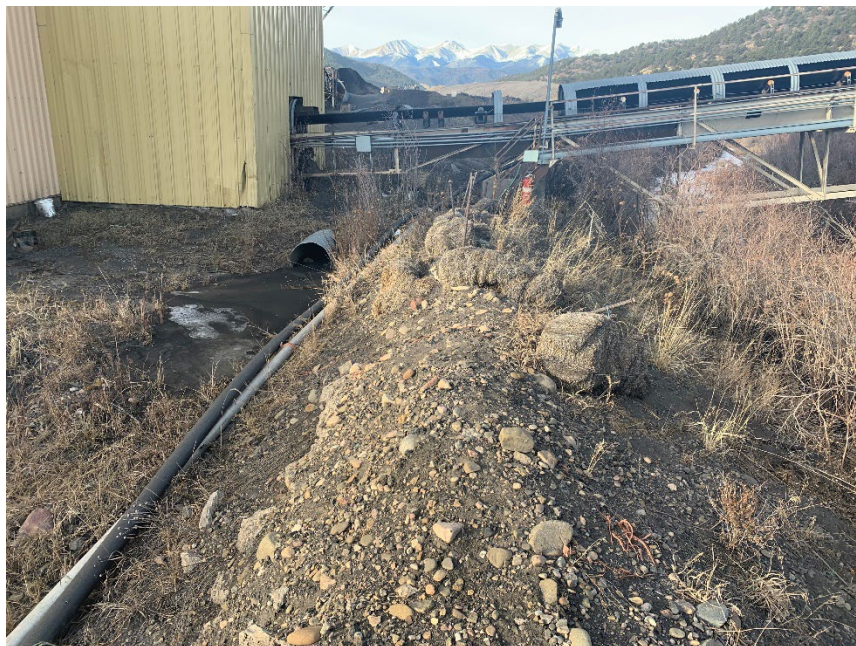
Ditch 32A and the berm between the wash plant and the Purgatory River were in good condition (photo 4).

Photo 4 – Berm between Ditch 32A and Purgatory River

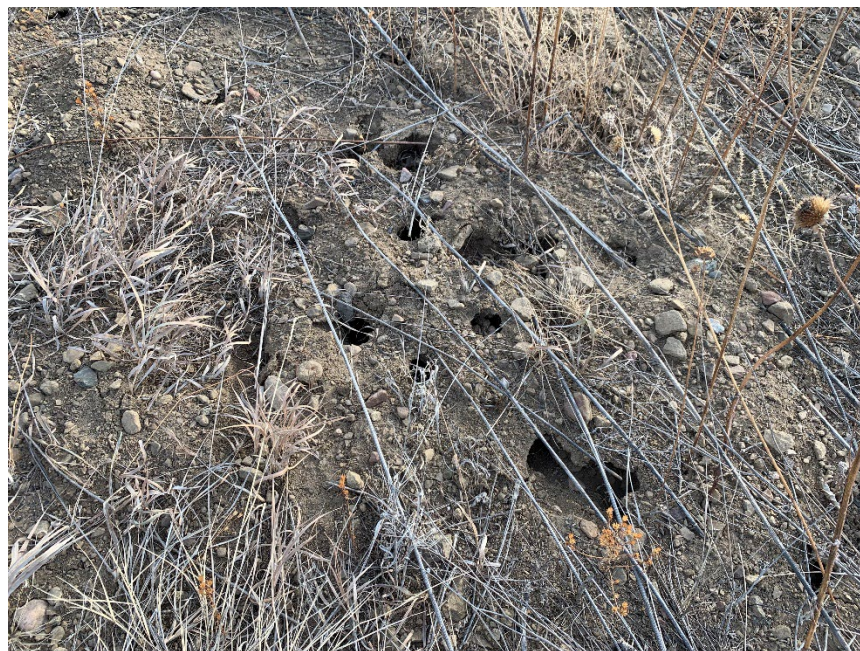
Pond 1 contained water and was frozen. No water was being discharged. The liner appeared to be in good condition and the embankment was well vegetated. Rodent holes were seen on the north side of the embankment (photo 5). The holes are about 1.5 inches in diameter and were seen in several groups. A treatment plan needs to be created and implemented to remove the rodents and ensure the stability of the embankment. Please address the rodent holes, potential damage and mitigation measures in the next Quarterly Sediment Pond Inspection Report.

Photo 5 – Rodent holes on the embankment of Pond 1

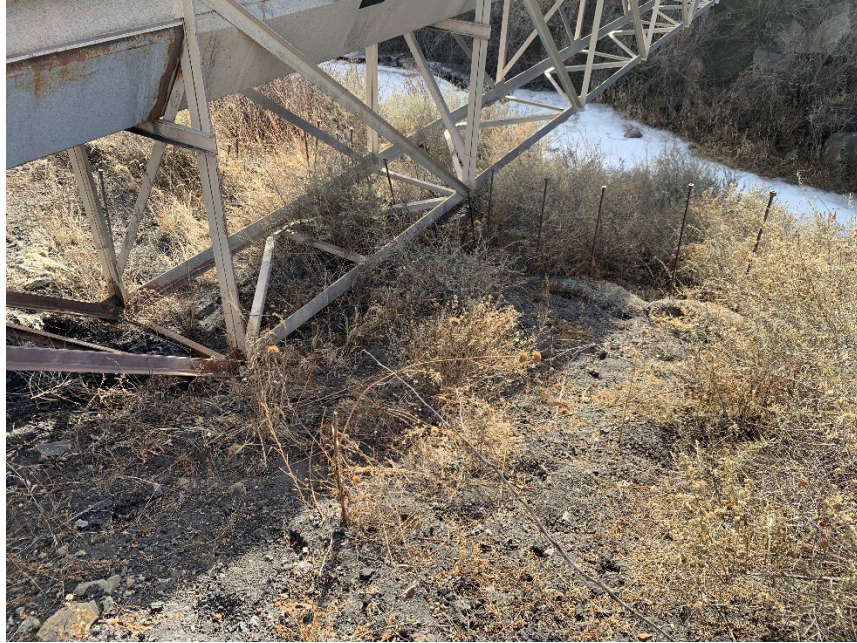
Containment Area 4 is situated west of the coal waste conveyor. The southeast corner of the containment area, next to the conveyor belt, needs to have the slope re-established to ensure positive drainage away from the river and towards the containment area. The silt fence under the conveyor between containment areas 3 and 4 needs to be repaired (photo 6). This area controls the sediment that falls off the last 2 rollers before the belly pan starts on the conveyor.

Photo 6 – Silt fence under conveyor that needs to be repaired

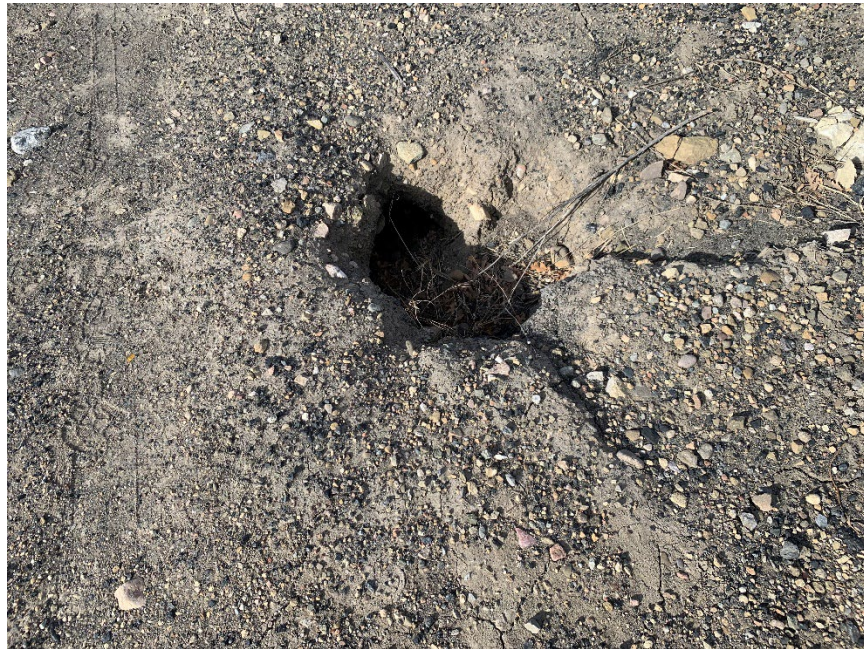
Two culverts convey the discharge from Pond 8, under Hwy 12 to the Purgatory River (culverts are not named on Map 13). A hole developed in the access road, south of Hwy 12, above the culverts. The soil appears to have collapsed inward forming the hole (photo 7). This should be investigated to determine the cause and if there is any damage to the culverts.

Photo 7 – Hole in access road over the Pond 8 discharge culverts

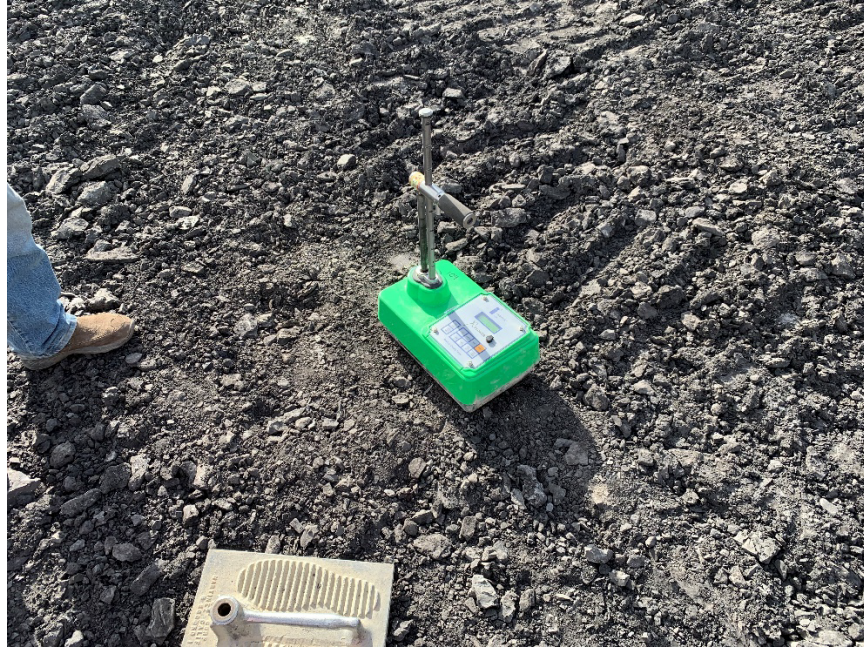
CTL-Thompson was onsite doing the compaction test on the Refuse Disposal Area (photo 8). The RDA was tested in 3 locations. Soil samples were taken to determine moisture content back at the lab. Test results will be published and submitted to DRMS at a later date.

Photo 8 – CTL-Thompson compaction testing on RDA
