MINERALS PROGRAM INSPECTION REPORT
PHONE: (303) 866-3567

MINE NAME: Tucson South Resource	MINE/PROSPECTING ID#: M-2004-044	MINERAL: Sand and gravel	COUNTY: Adams
INSPECTION TYPE: Monitoring	WEATHER: Clear	INSP. DATE: December 9, 2022	INSP. TIME: 11:00
OPERATOR: Holcim - WCR, Inc.	OPERATOR REPRESENTATIVE: Wyatt Webster	TYPE OF OPERATION: 112c - Construction Regular Operation	
REASON FOR INSPECTION: Normal I&E Program	BOND CALCULATION TYPE: Full	BOND AMOUNT: \$834,000.00	
DATE OF COMPLAINT: NA	POST INSP. CONTACTS: None	JOINT INSP. AGENCY: Adams County	
INSPECTOR(S): Nikie Gagnon	INSPECTOR'S SIGNATURE:

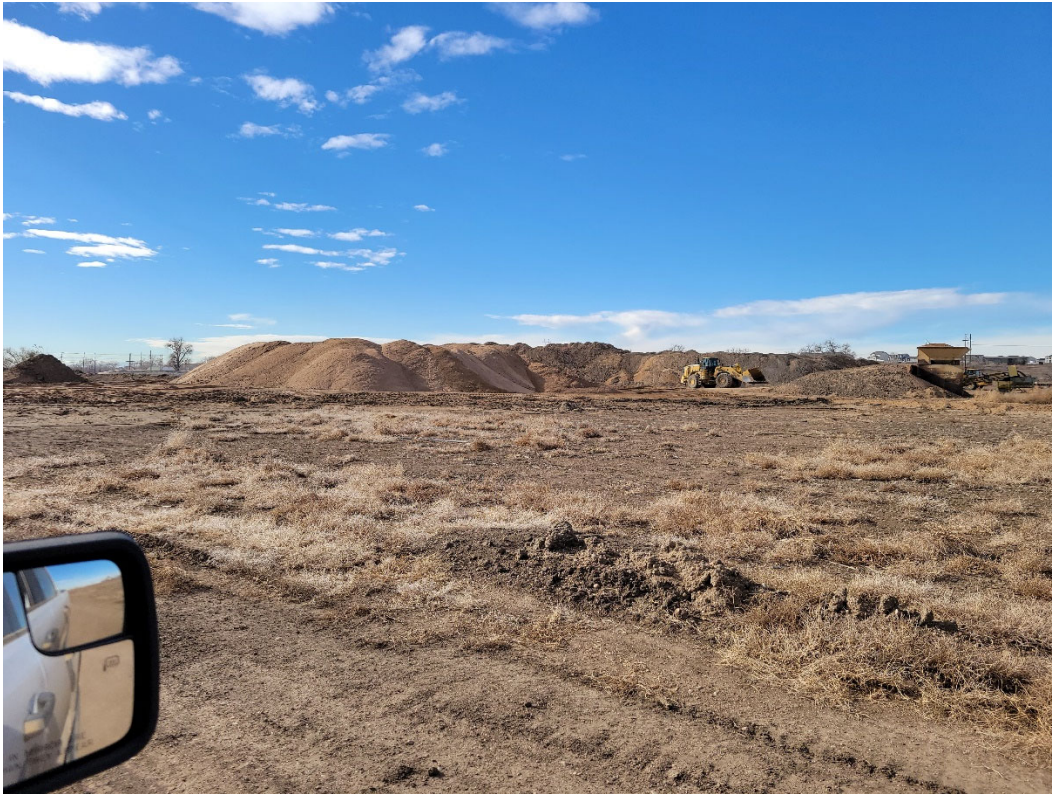
Looking west at overburden and stockpiles in the west side mining area.

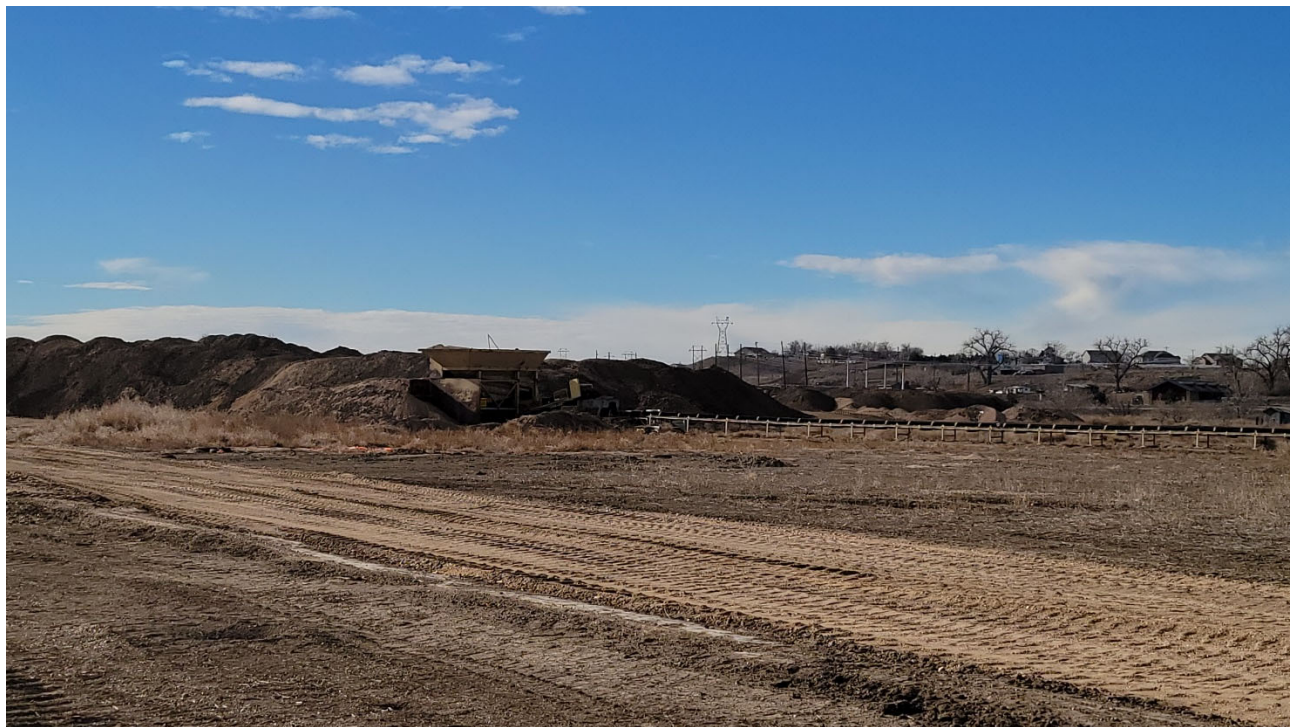
Conveyor loading area in the west side mining area.

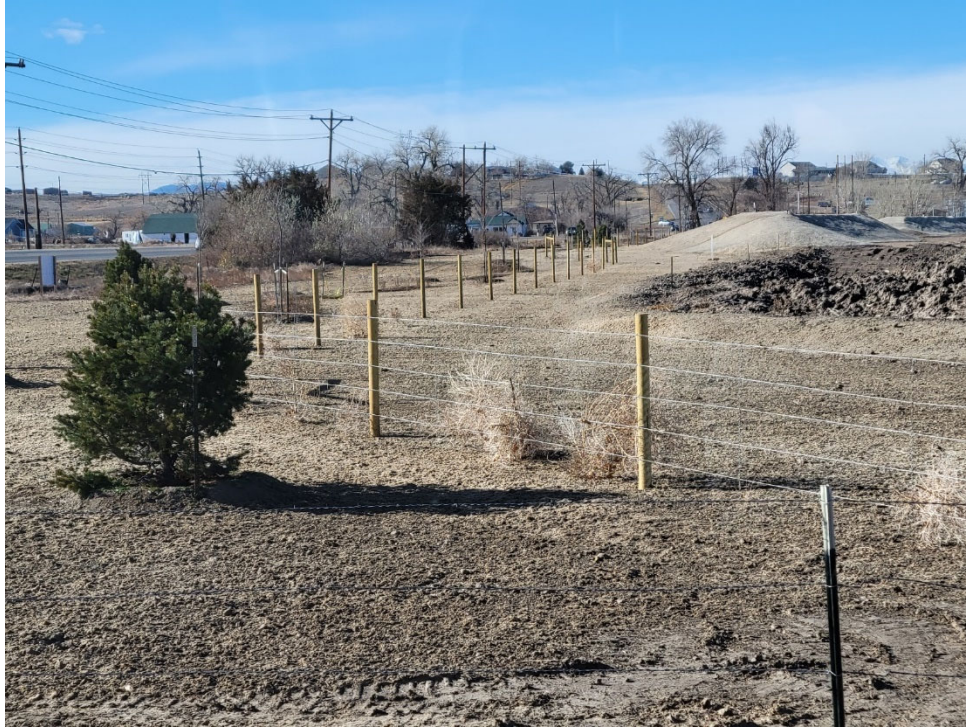
Southwest corner of the west mining area.
Topsoil berm and trees planted by operator. Barbed wire fencing along the permit boundary.

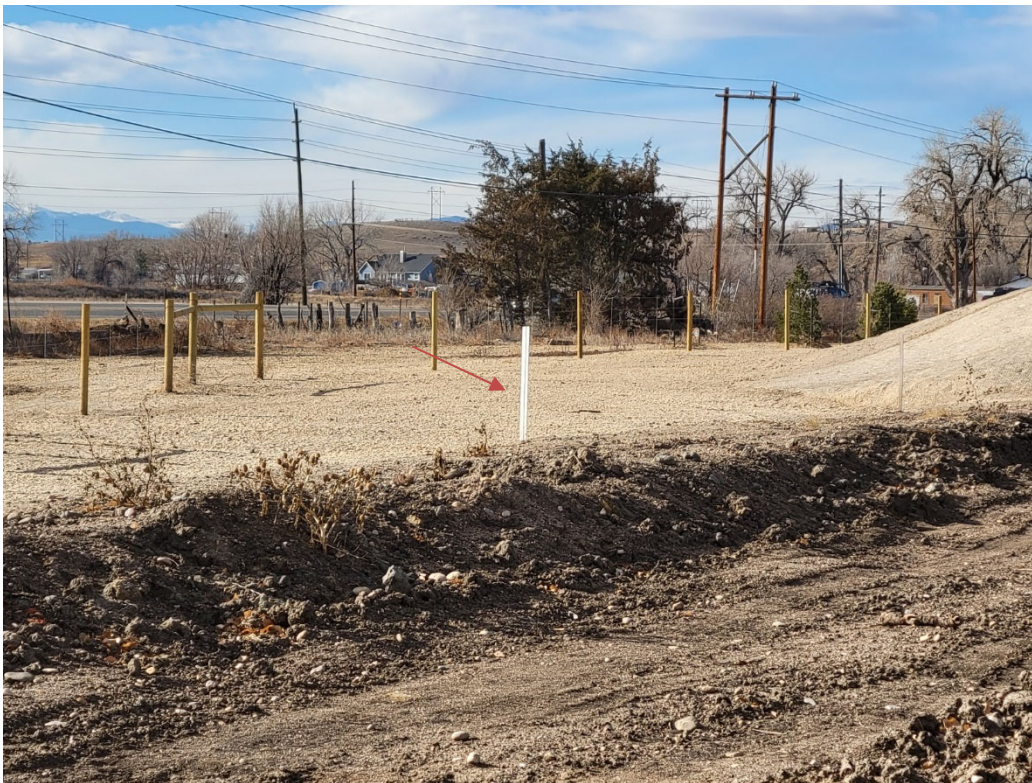
Southwest corner of the west mining area. Slurry wall marked by white post.

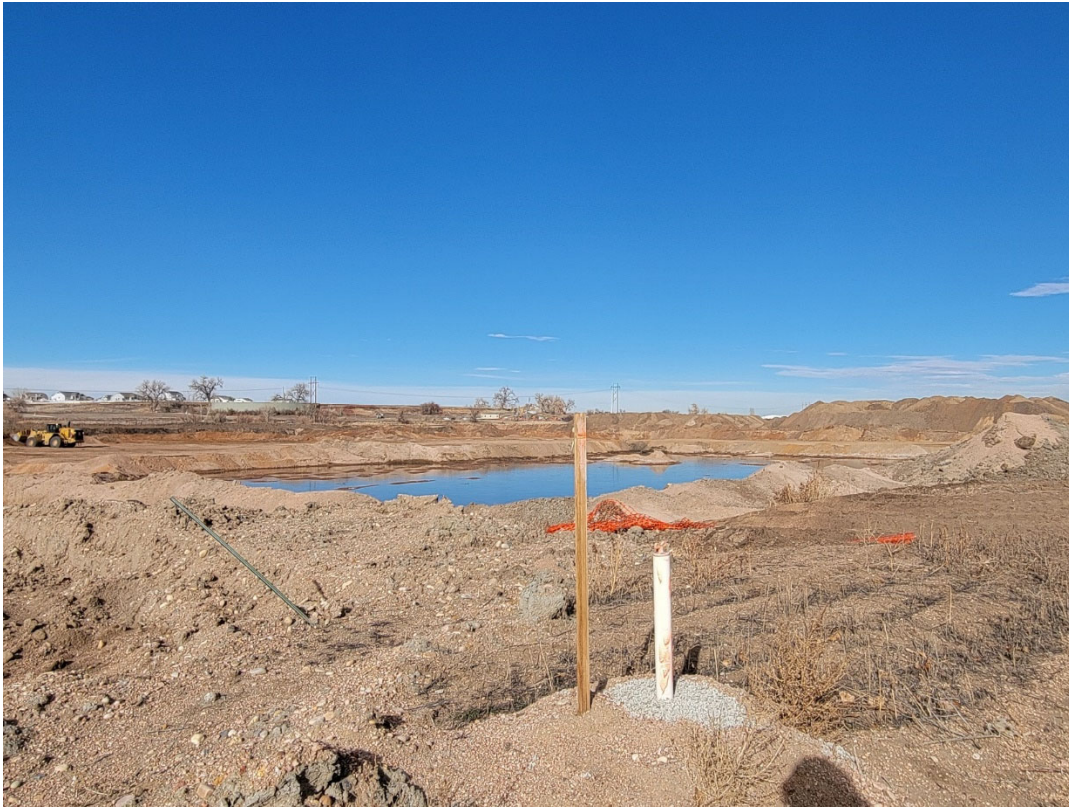
Looking north across the pit area. Groundwater is pumped out of pit to settling pond in the east mining area.

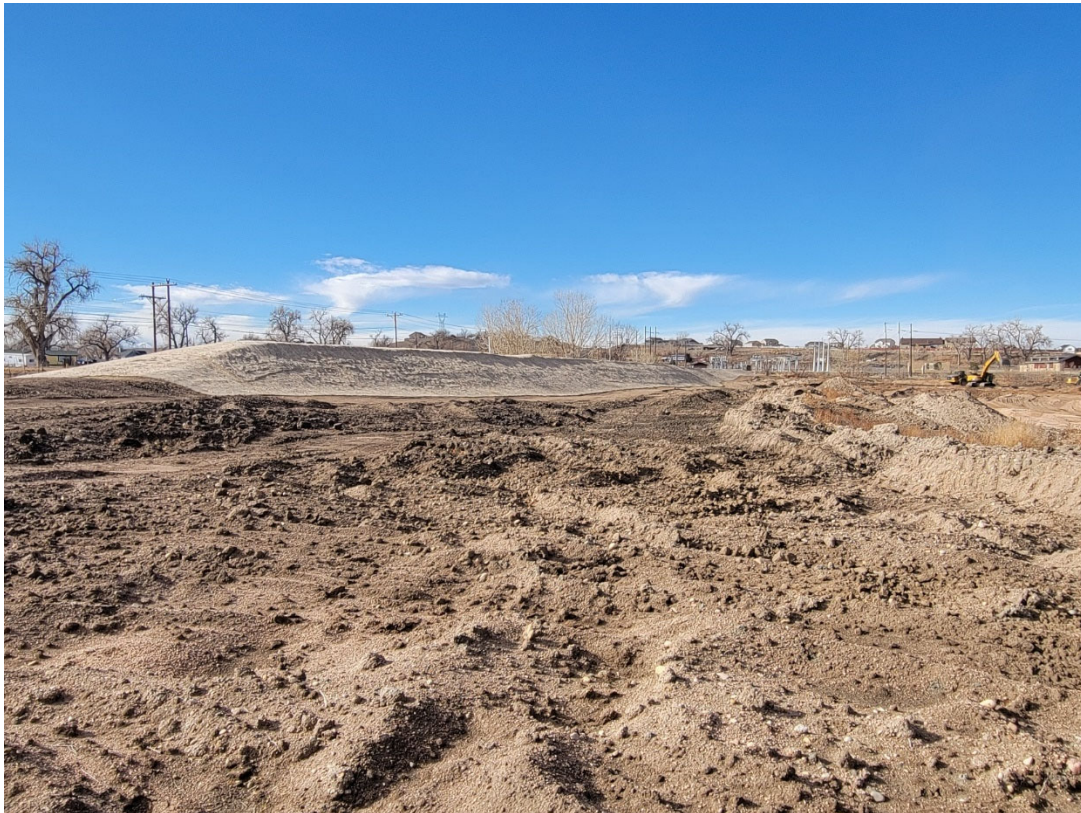
Looking south at the topsoil berm from the active mine side.

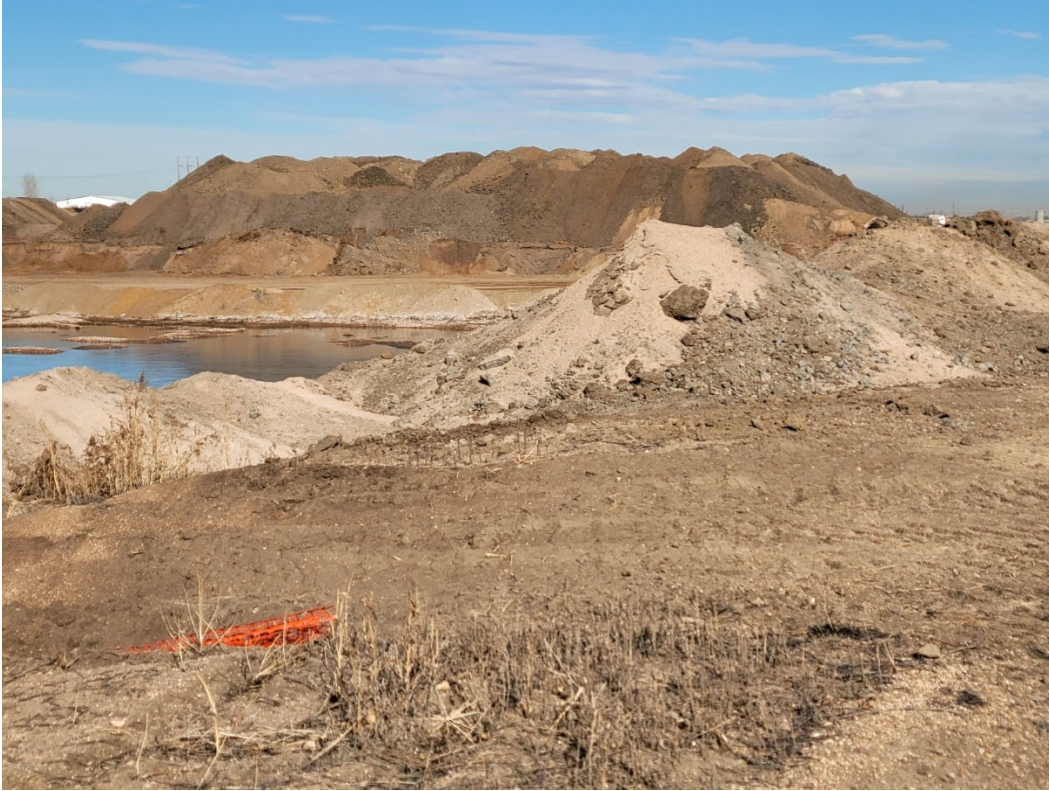
Overburden pile north of the active mining area.

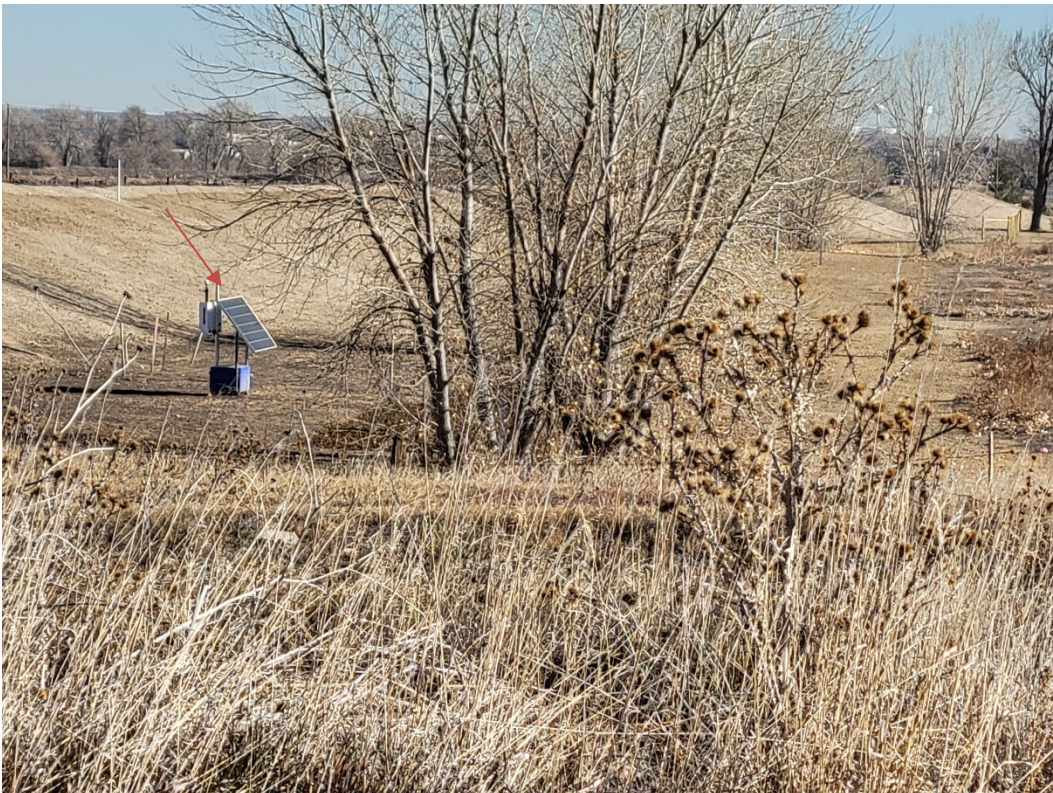
Looking east from the southwest corner of the west mining area. Arrow points to wind sensor.

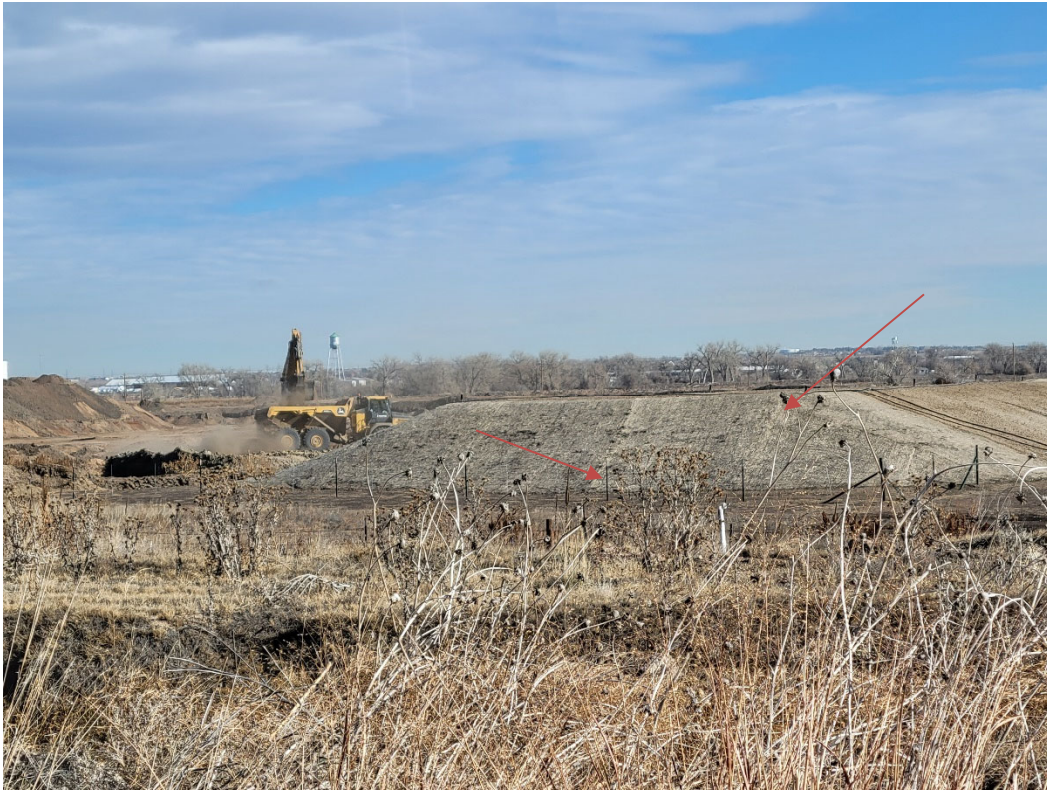
Looking east from the west side. Arrows point to perimeter fence and topsoil berm.

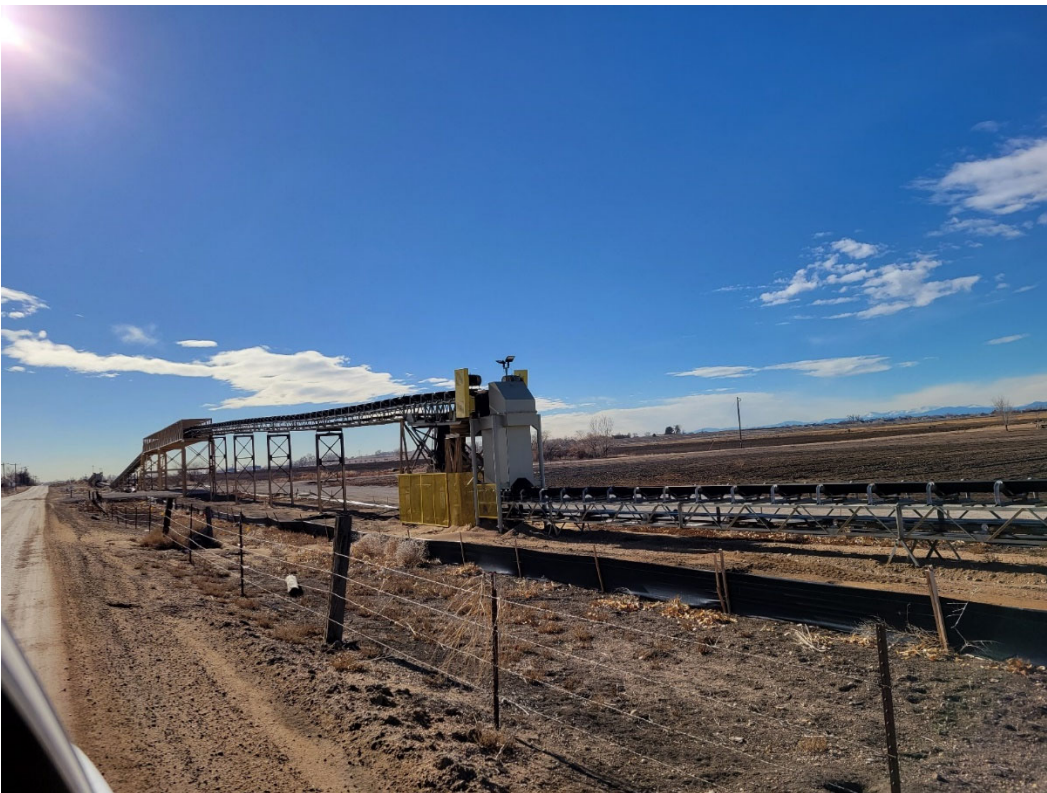
Looking south at conveyor system.

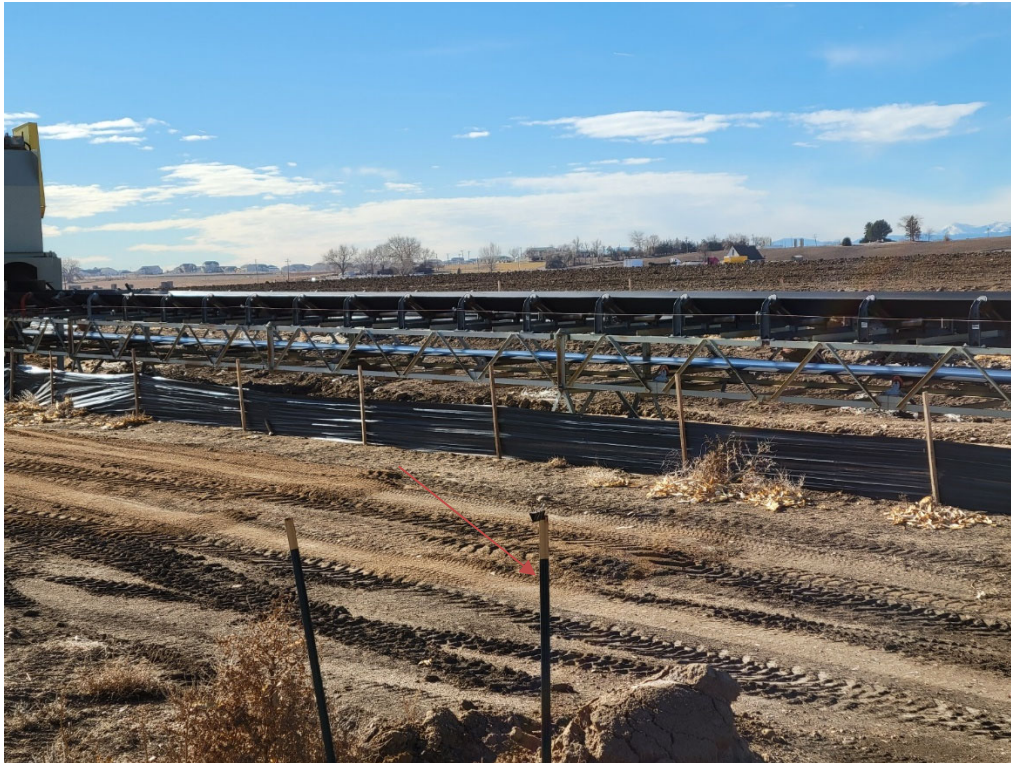
Looking west at conveyor system. Silt fence runs along both sides of conveyor.
Post in foreground marks permit boundary.

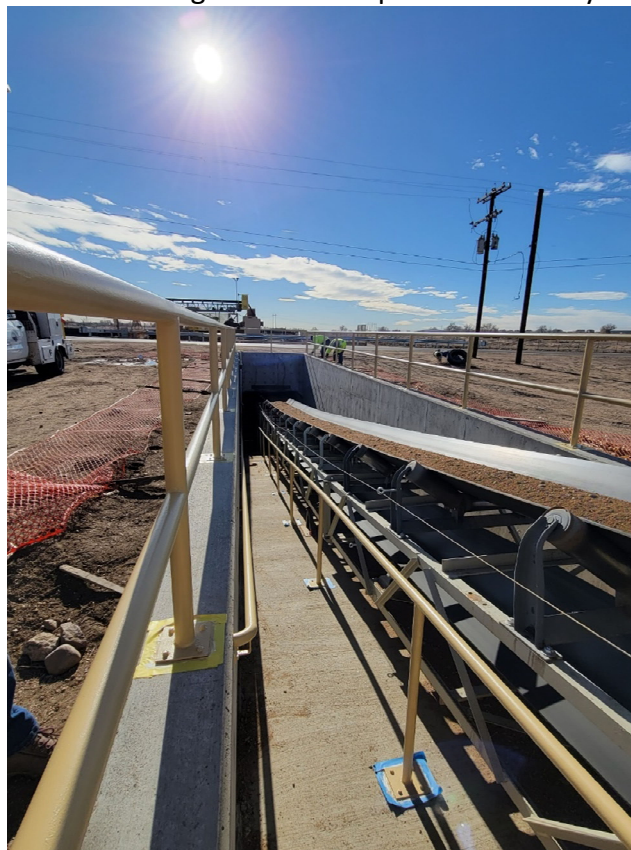
Looking south at tunnel where conveyor runs under the County road.

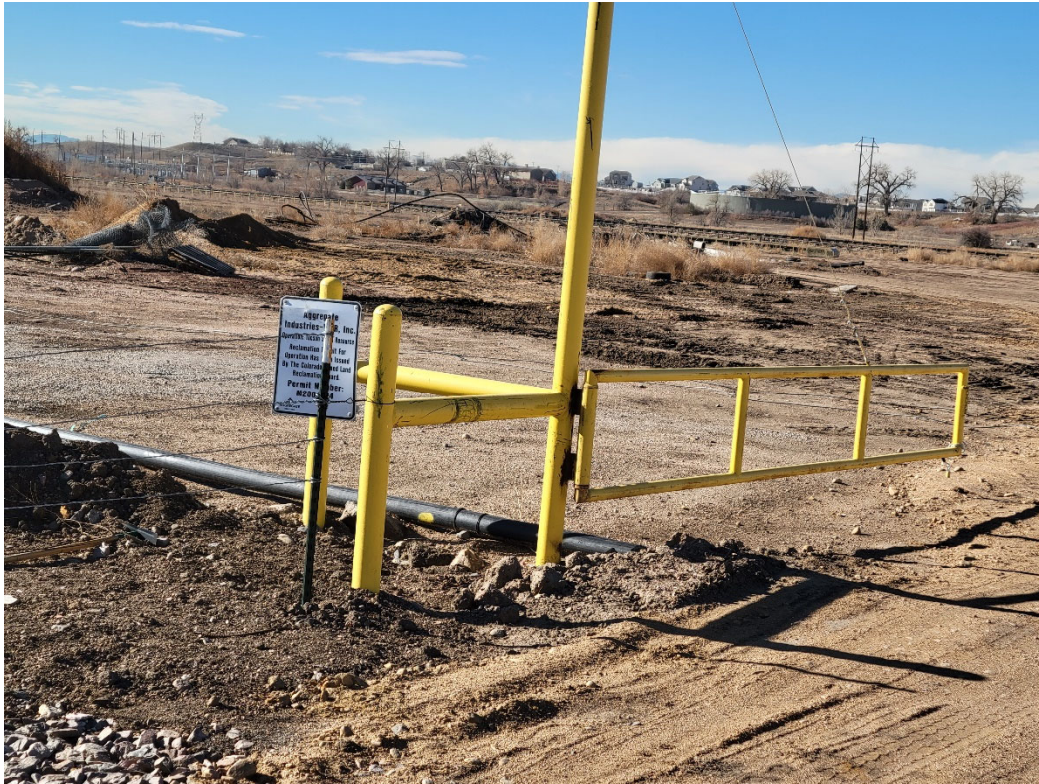
Entrance to the east side mining area.

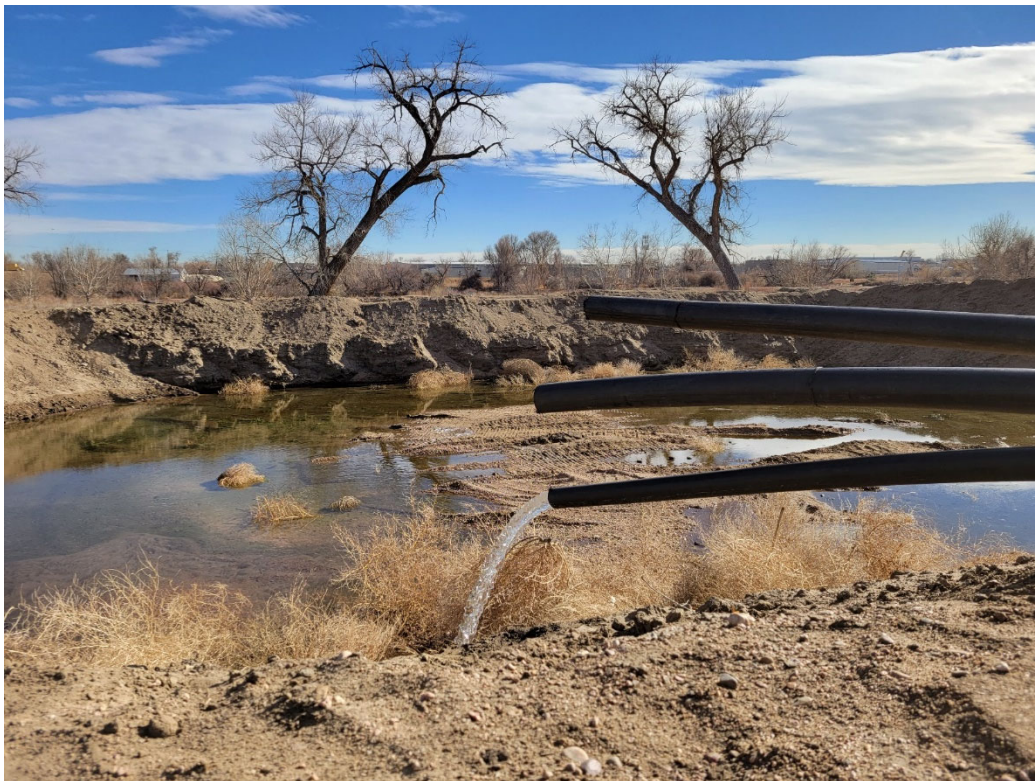
Settling pond in the northeast corner of the east side mining area. South Platte in the background.

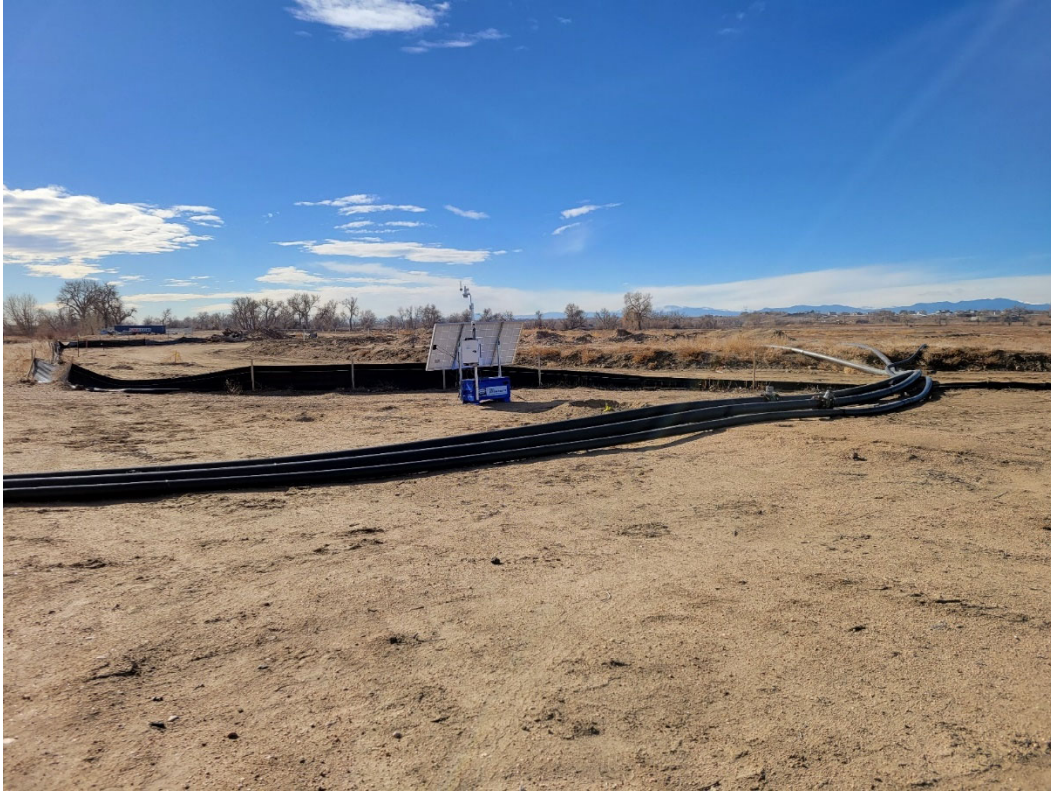
Dust sensor located in the northeast corner of the east side mining area. Piping running to the settling pond.

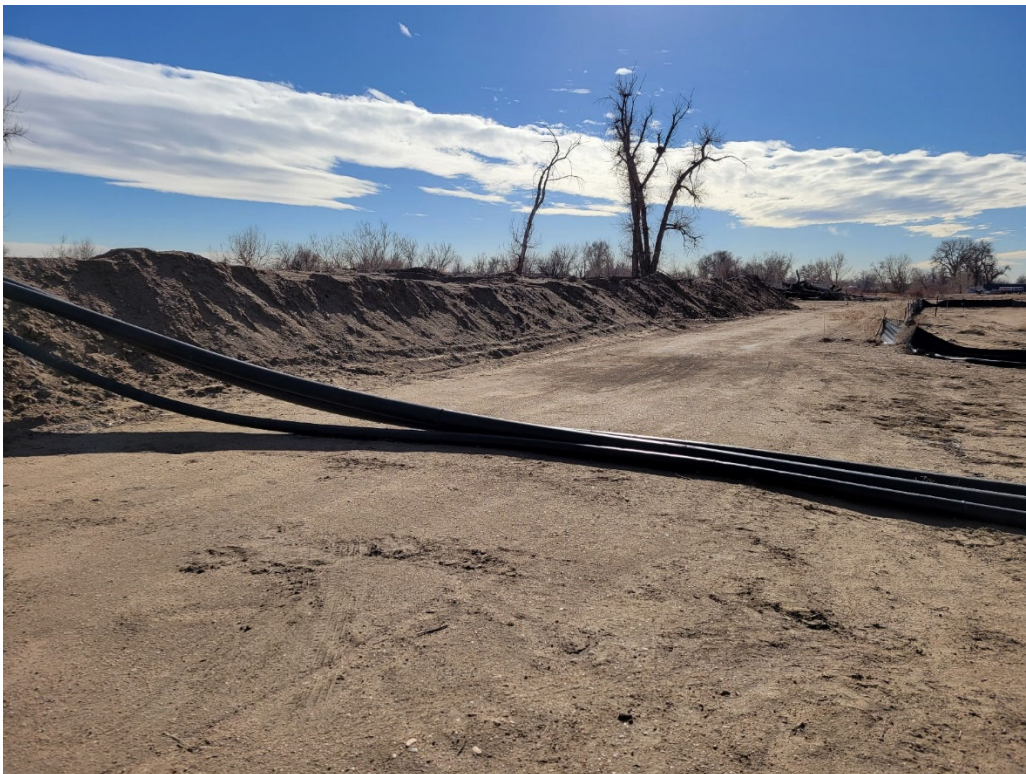
Topsoil berm along the eastern boundary of the east mining area.
Piping running over the top to the settling pond.

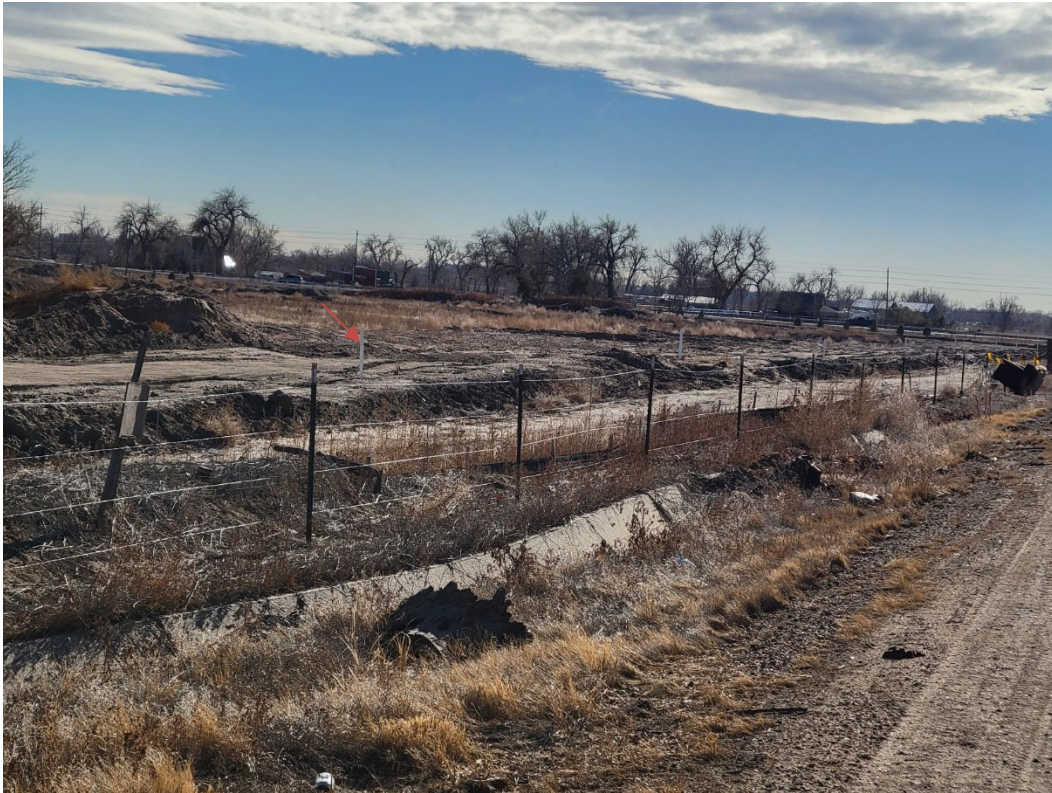
Barbed wire fence along Tucson Street surrounds the east mining area. Slurry wall marked by white post.

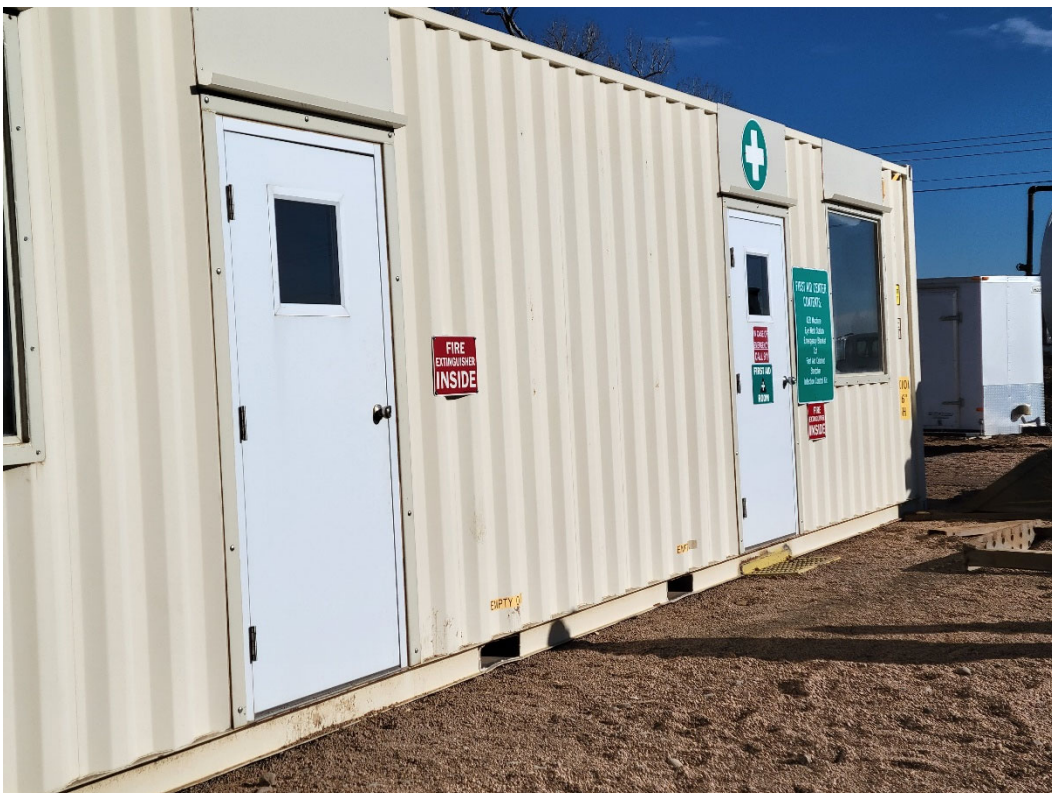
Main office at the entrance to the west mining area.

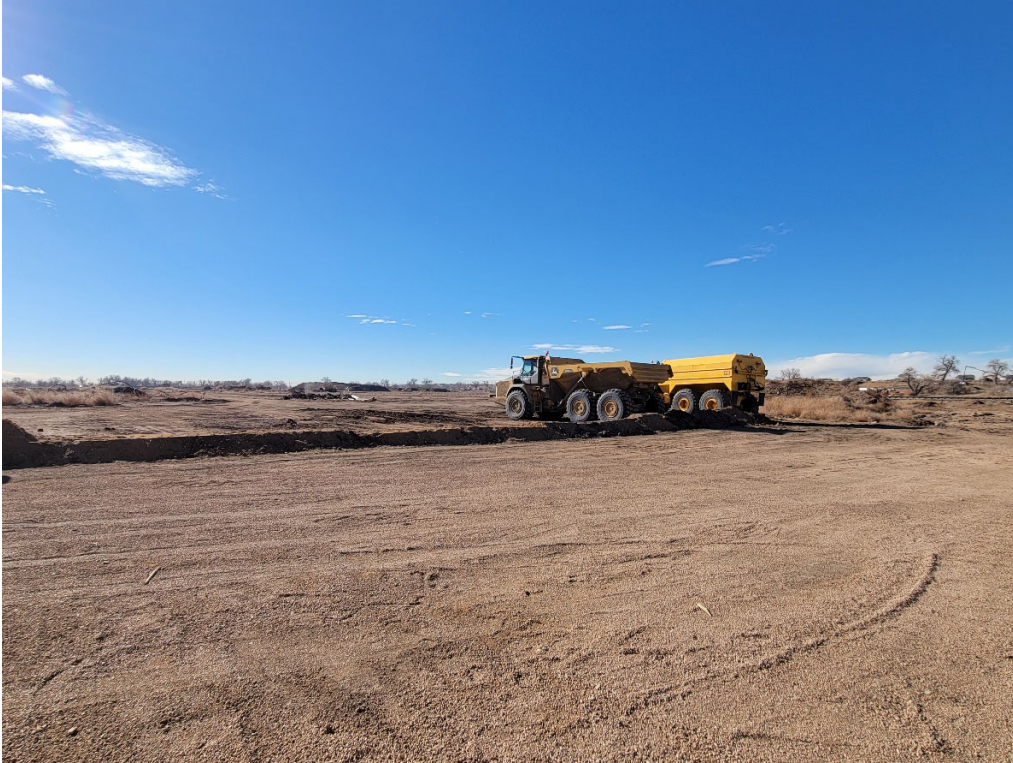
Parking area adjacent to the main office in the west mining area.
