MINERALS PROGRAM INSPECTION REPORT
PHONE: (303) 866-3567

MINE NAME: Hazeltine Mine	MINE/PROSPECTING ID#: M-2004-031	MINERAL: Sand and gravel	COUNTY: Adams
INSPECTION TYPE: Surety Release Inspection	WEATHER: Clear	INSP. DATE: December 9, 2022	INSP. TIME: 10:00
OPERATOR: Holcim - WCR, Inc.	OPERATOR REPRESENTATIVE: Wyatt Webster	TYPE OF OPERATION: 112c - Construction Regular Operation	
REASON FOR INSPECTION: Surety Release Requested	BOND CALCULATION TYPE: None	BOND AMOUNT: \$670,602.00	
DATE OF COMPLAINT: NA	POST INSP. CONTACTS: None	JOINT INSP. AGENCY: None	
INSPECTOR(S): Nikie Gagnon	INSPECTOR'S SIGNATURE:

OBSERVATIONS

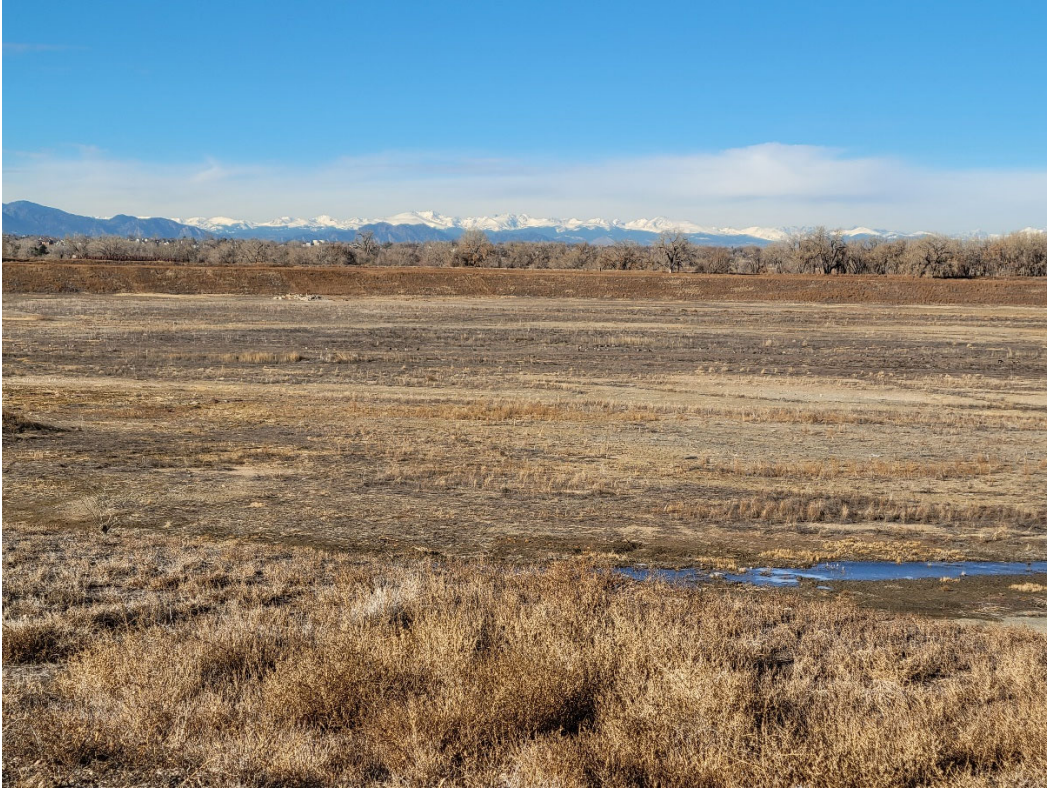
Looking west across Hazeltine Reservoir, former mining pit area.

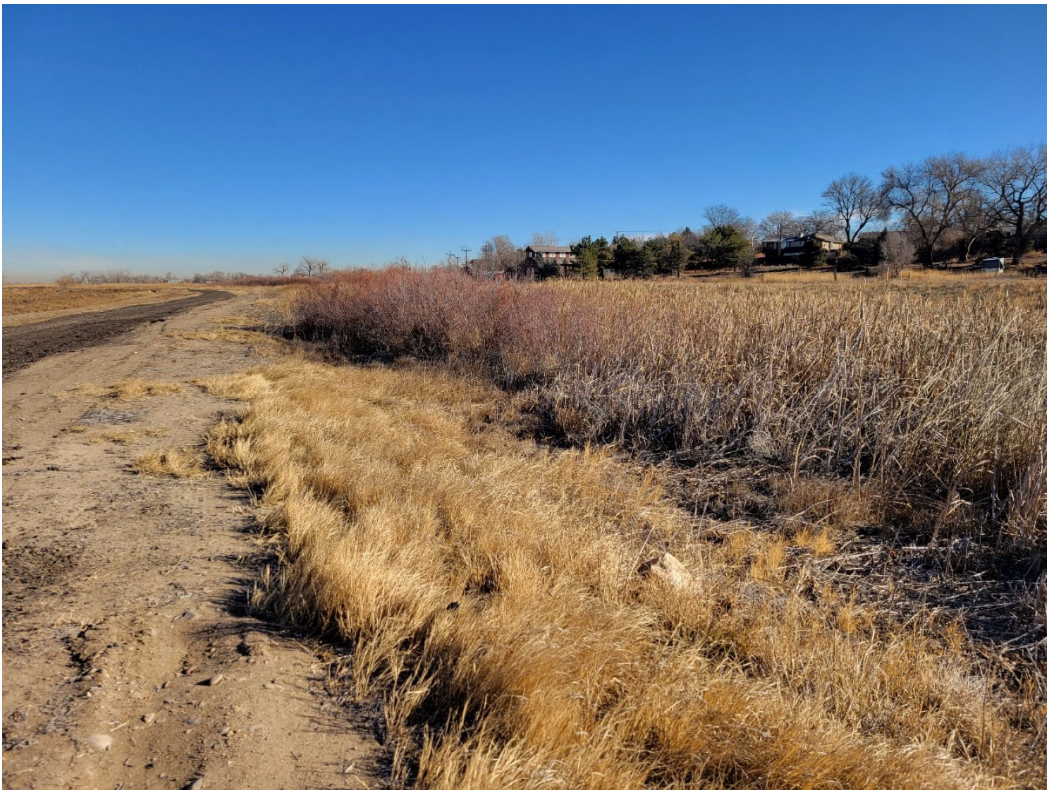
Bull Seep wetland adjacent to access road. Area treated for noxious weeds and Russian olive trees removed.

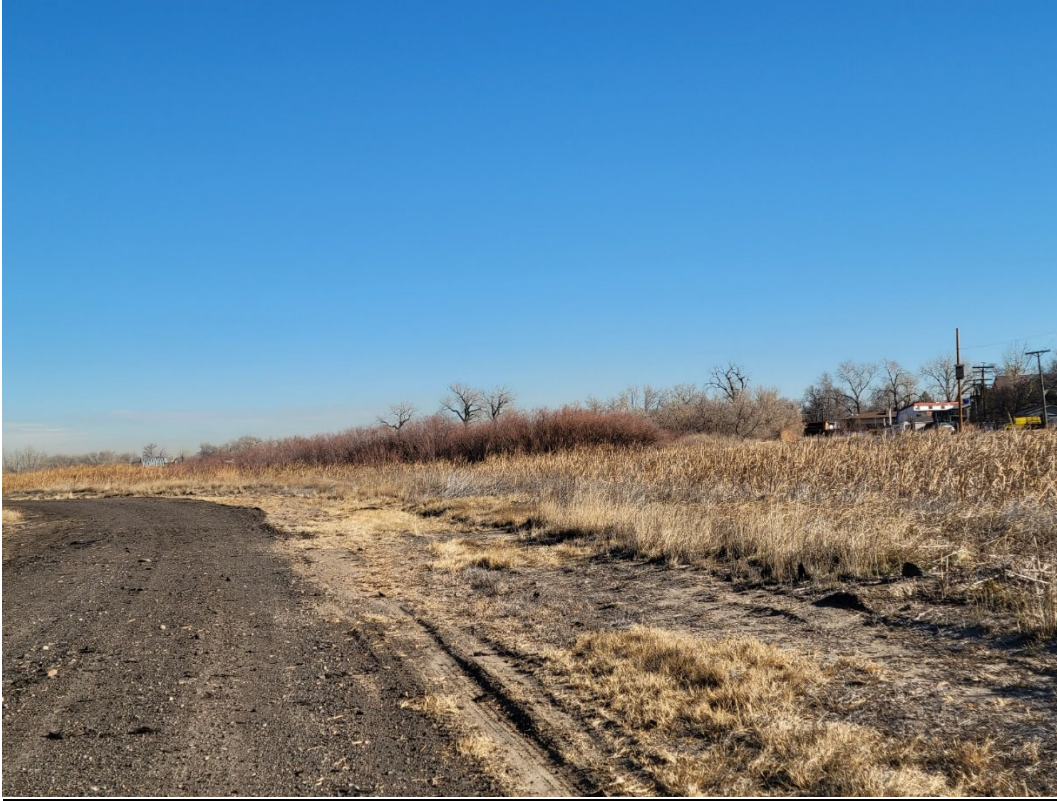
Northern end of Bull Seep wetland area adjacent to access road. Area treated for noxious weeds and Russian olive trees removed.

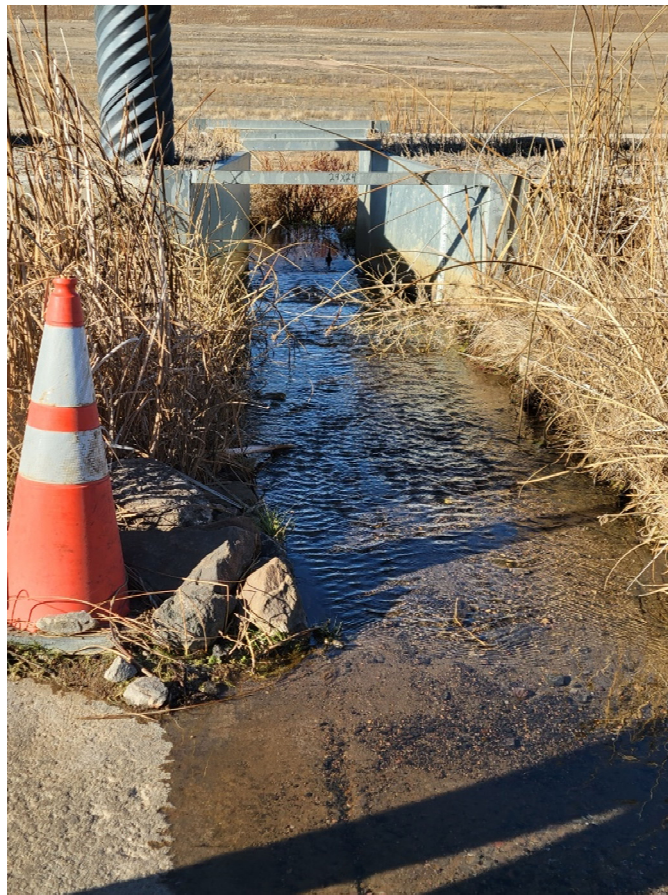
The Orr drain, which was installed as part of a permanent mitigation plan, was open and discharging at the time of inspection. Water flows into the pit and pools in the northeastern section of the former pit (Hazeltine Reservoir). A pump was operating and pumping water out of the reservoir and discharging into the Bull Seep along the northern edge of the property. The Bull Seep is a tributary to the South Platte River. According to a revised comment received on December 21, 2022 from the Division of Water Resources, 97 percent of all lagged depletions from past operations, including dewatering before the pit was lined, will have affected the South Platte River by the end of December 2022 and would have been replaced under the current Aggregate Industries South Platte combined substitute water supply plan (SWSP). The current combined SWSP will expire on December 31, 2022. The Applicant intends to replace the remaining 3 percent of lagged depletions in one lump sum during the next SWSP approval period for 2023. The City of Thornton has a decreed plan for augmentation in Case No. 18CW3158 which will replace all out-of-priority seepage depletions from the Orr

Orr drain on the eastern side of the reservoir. Water flowing into the reservoir.

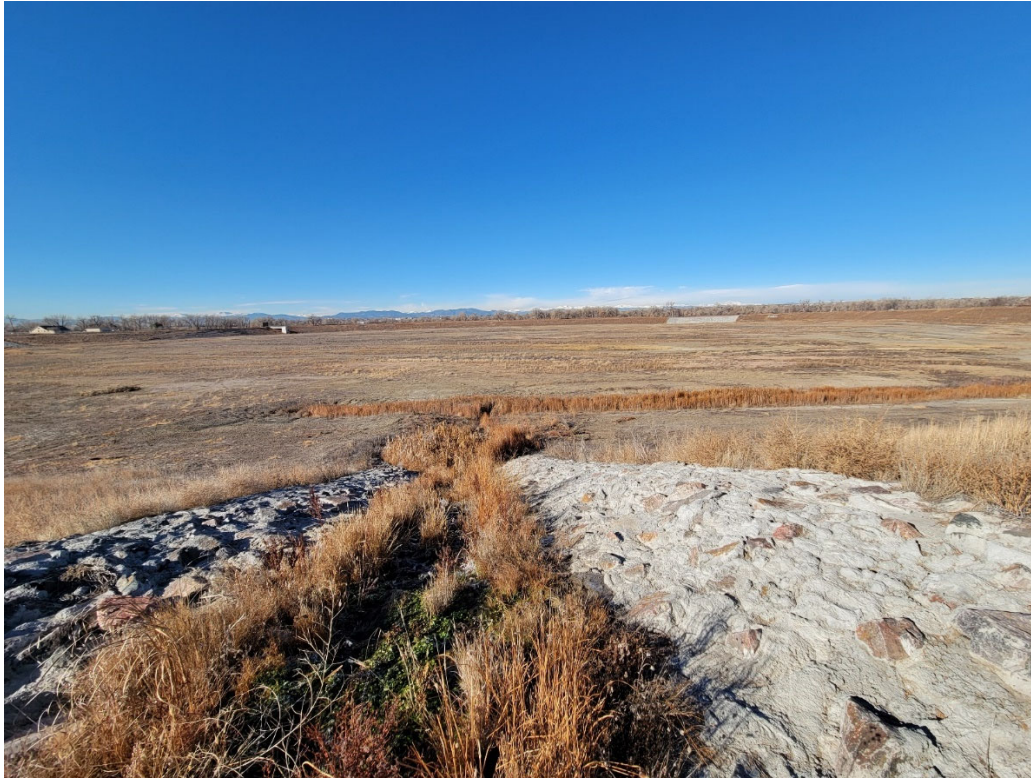
Run-down channel from the Orr drain into the pit.

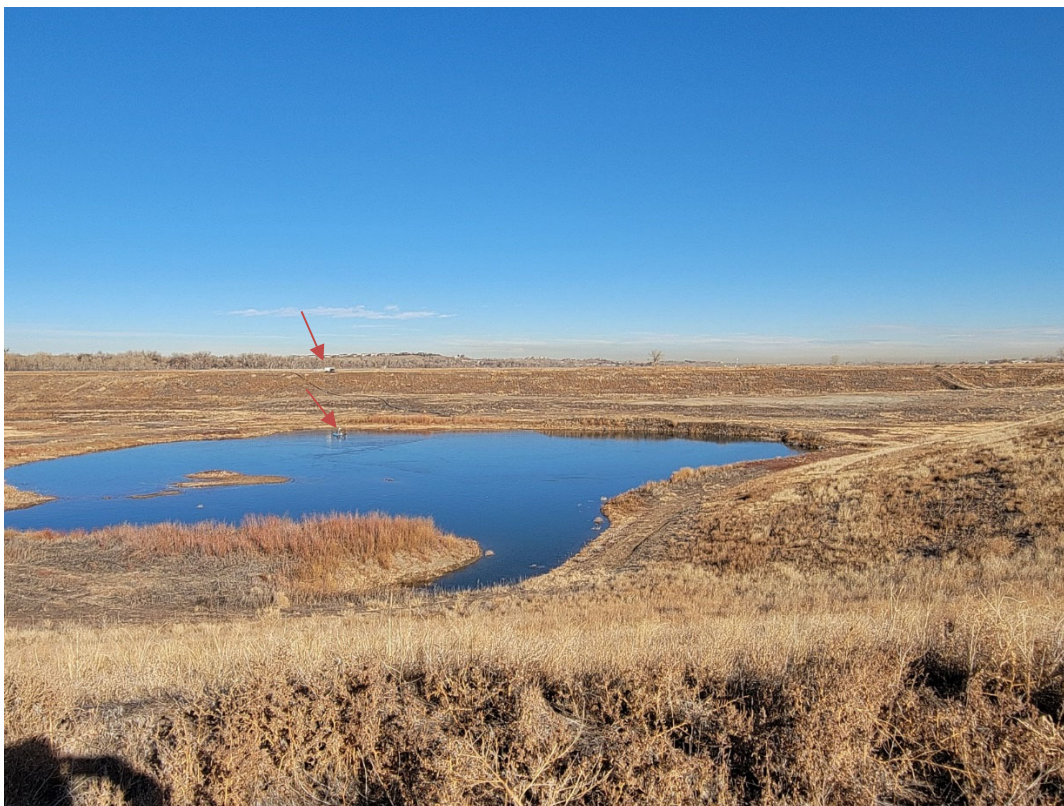
Looking northwest at pool of water from the Orr drain. Arrows point to pump and generator on north side of reservoir.

During the comment period, the City of Thornton requested that Holcim remove the piping, pump, generator and all related materials used for pumping water from the pit. In an email response to the City on December 21, 2022, Holcim confirmed that the pump, generator and piping will be removed once the Division approves the full release of the acres.

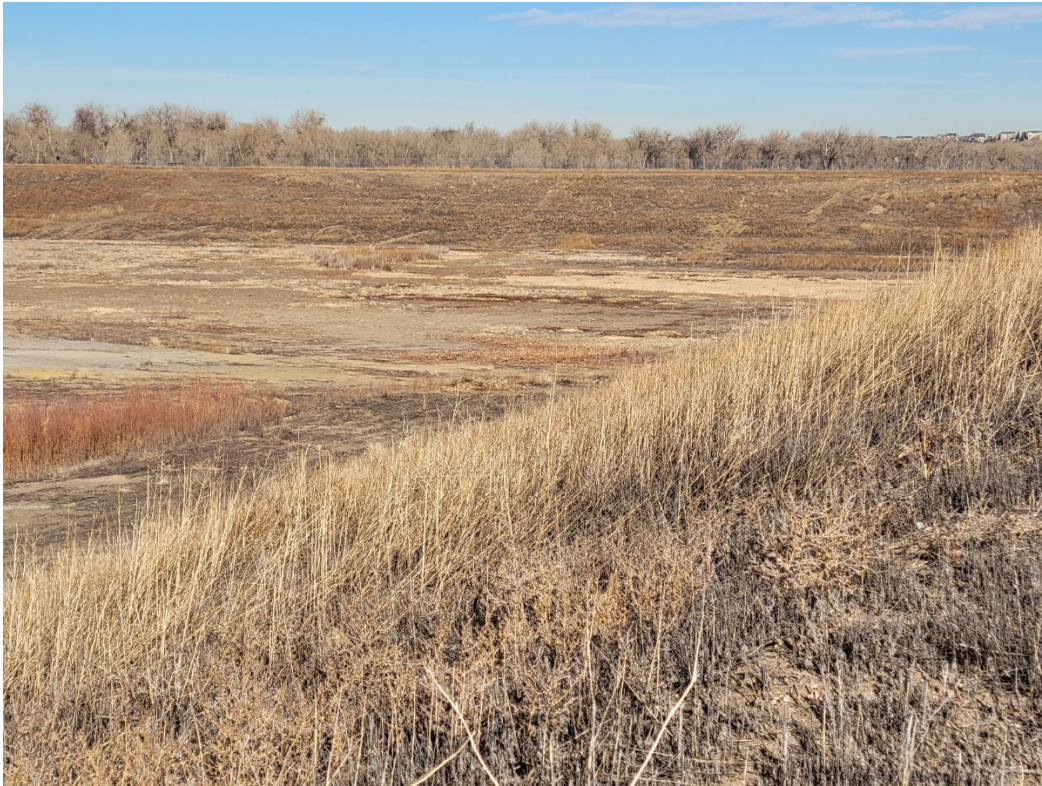
Northeast corner of reservoir – side slopes stabilized by grasses.

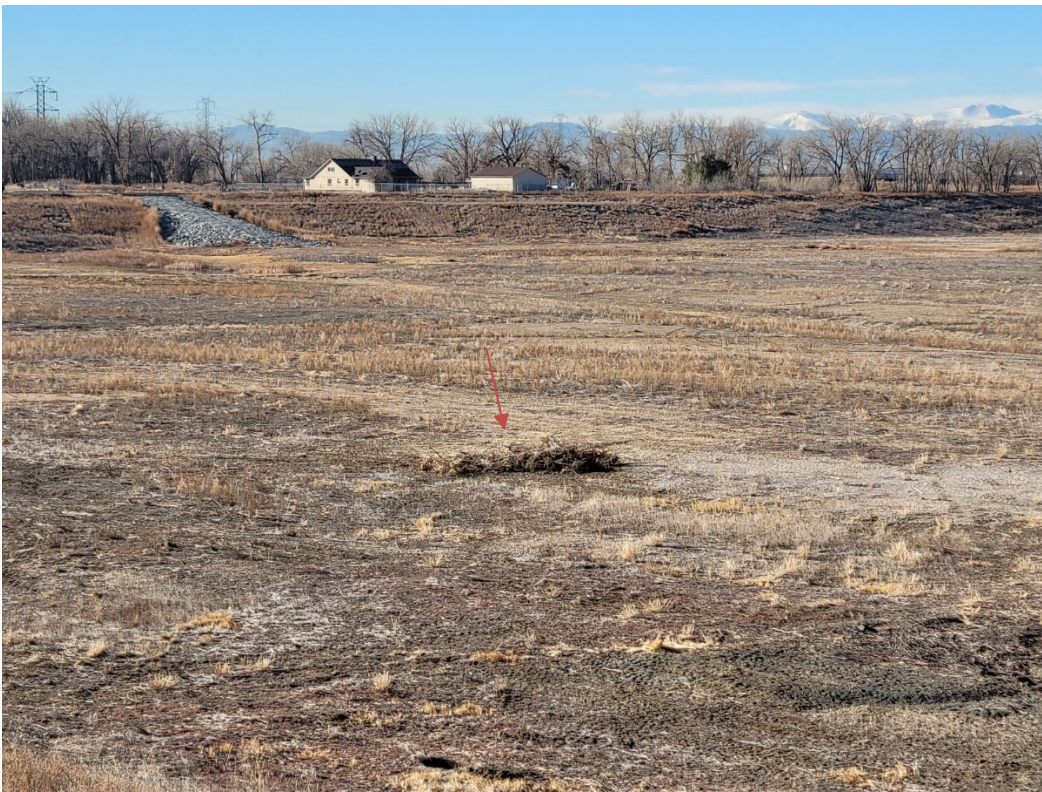
Overflow structures in northwest corner of reservoir near the South Platte,
Arrow points to woody debris pile left over from tree removal.

During the comment period, the City of Thornton expressed concern over woody debris piles left in the bottom of the reservoir from tree removal activity. In response, the Operator removed the piles on December 21, 2022.

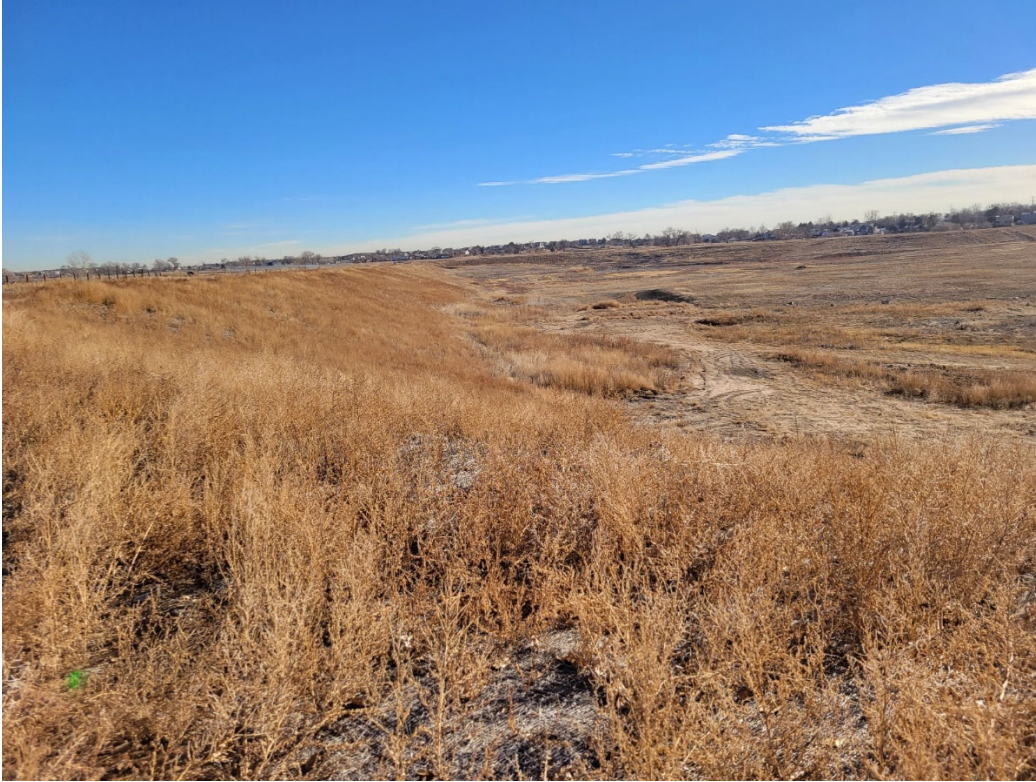
Looking east along northern side. Area reseeded in 2021, Annual weeds and grasses filling in bare areas.

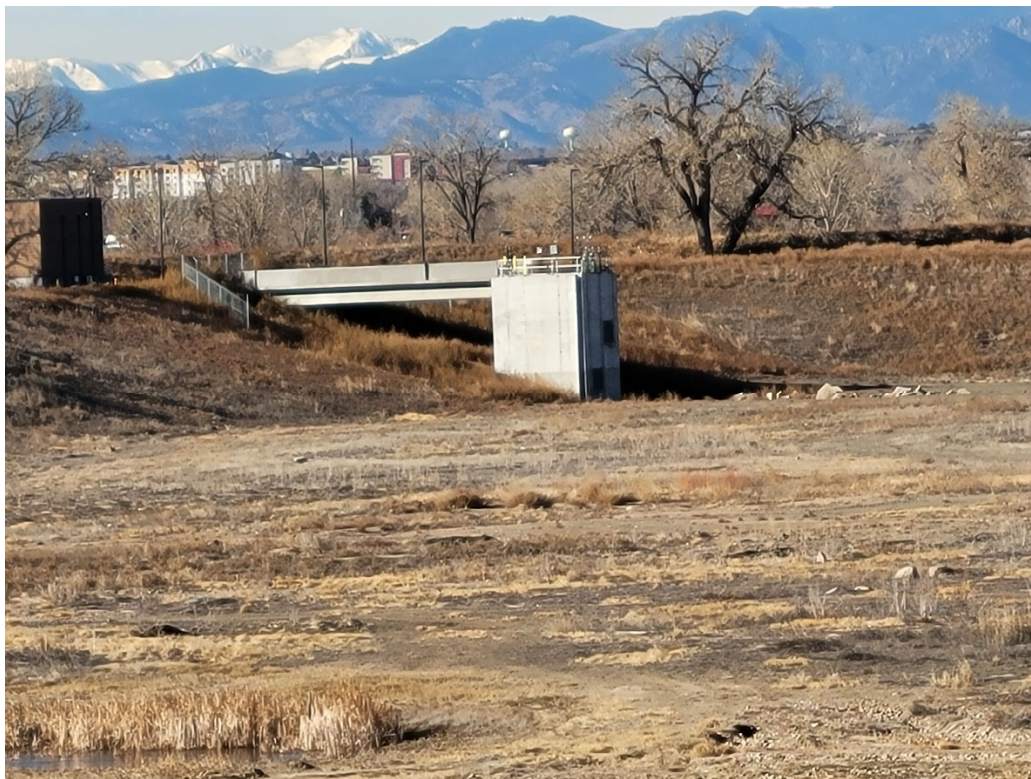
Cooley East Pump station constructed in the southwest corner of the reservoir.

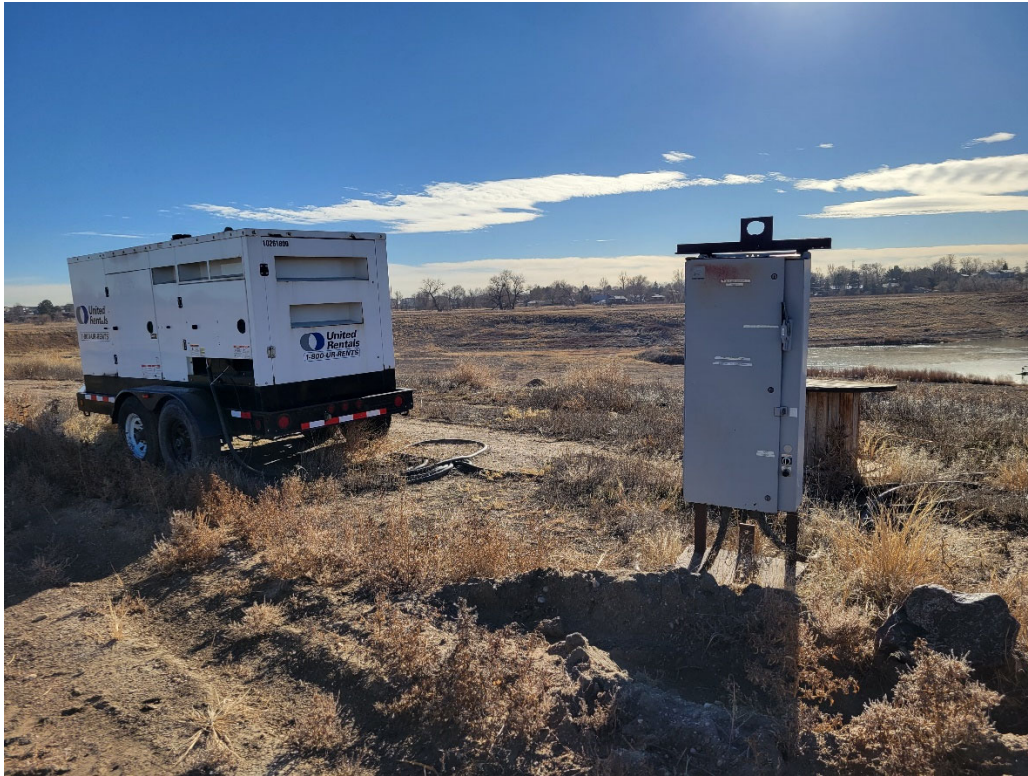
Generator and power supply on north side of reservoir. These will be removed once the Division approves the release.

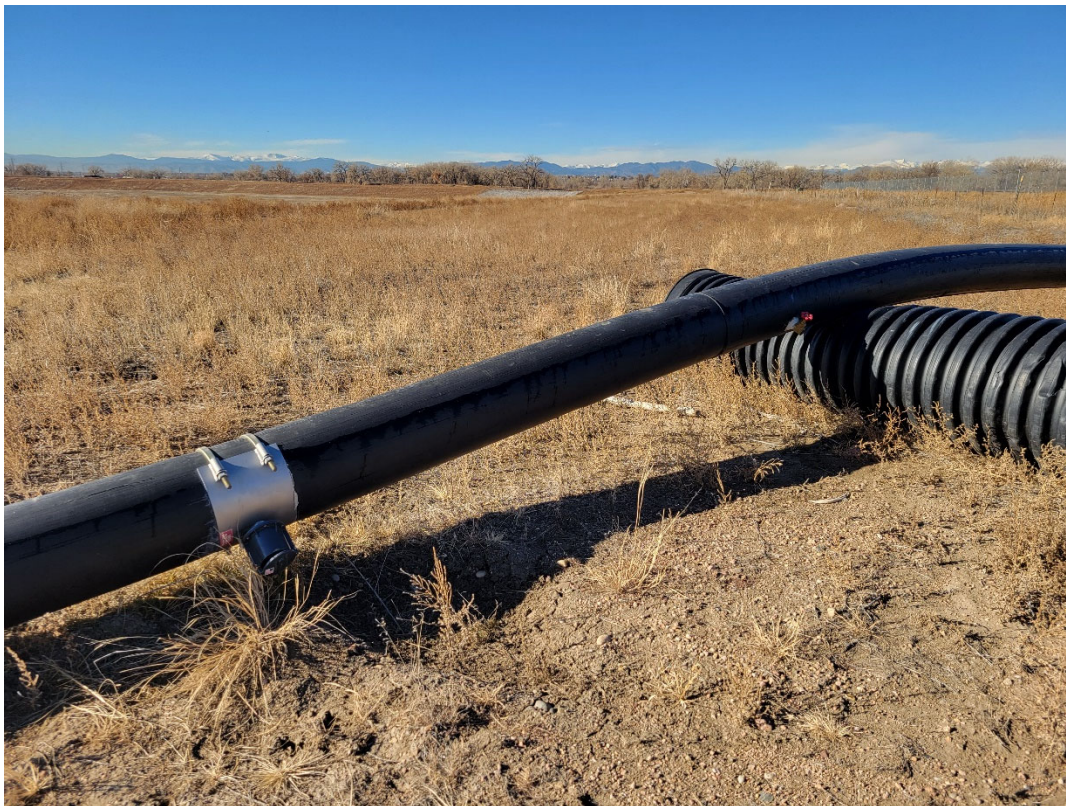
Piping to the Bull Seep on the north side of the reservoir. Piping will be removed once the Division approves the release.
