PERMIT INFORMATION

Permit Number: C-1981-028 Mine Name: Keenesburg Strip Mine Operator: Coors Energy Company Operator Address: Mr. Ben Moline P.O. Box 4030 Golden, CO 80402	County: Weld Operation Type: Surface Permit Status: Permanent Cessation Ownership: Private
	Operator Representative Present: None
Operator Representative Signature: (Field Issuance Only)

INSPECTION INFORMATION

Inspection Start Date: January 6, 2023 Inspection Start Time: 14:00 Inspection End Date: January 6, 2023 Inspection End Time: 14:45	Inspection Type: Coal Partial Inspection Inspection Reason: Normal I&E Program Weather: Clear
Joint Inspection Agency: None	Joint Inspection Contacts:
Post Inspection Agency: None	Post Inspection Contacts:
Inspector(s): Robert Zuber, P.E.	Inspector's Signature: <i>Robert D. Zuber</i> Signature Date: 1/6/2023

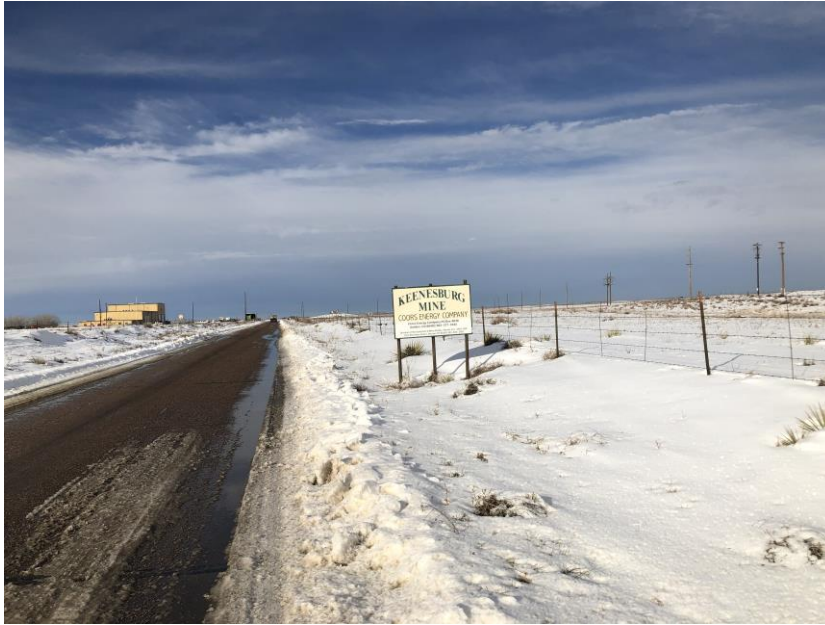
Entrance sign

The entrance sign was in place and contained all necessary information.

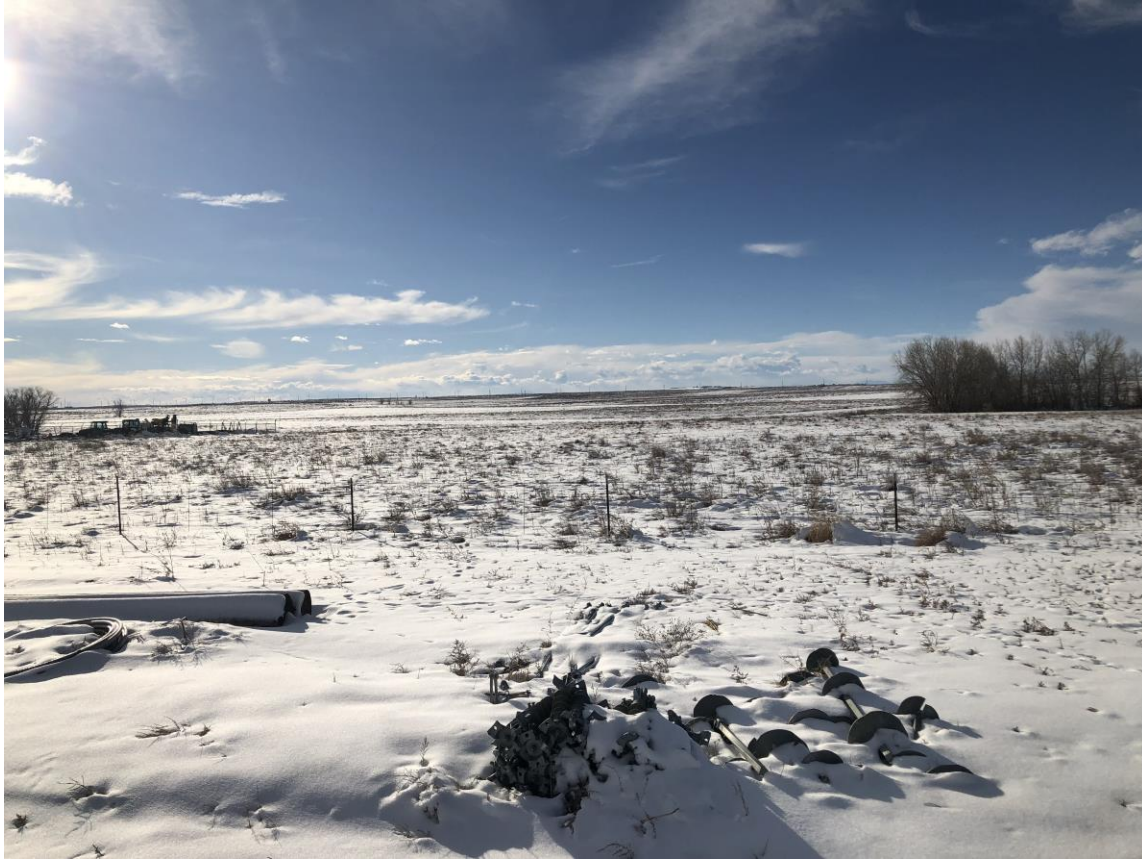
Northeast portion of site, photo taken from adjacent property (foreground is not within permit boundary)
