January 10, 2023
Project No.: 19125

Regarding: Daniels Sand Pit 2, Permit No. M-1973-007-SG
Slope Stability Monthly Monitoring Report

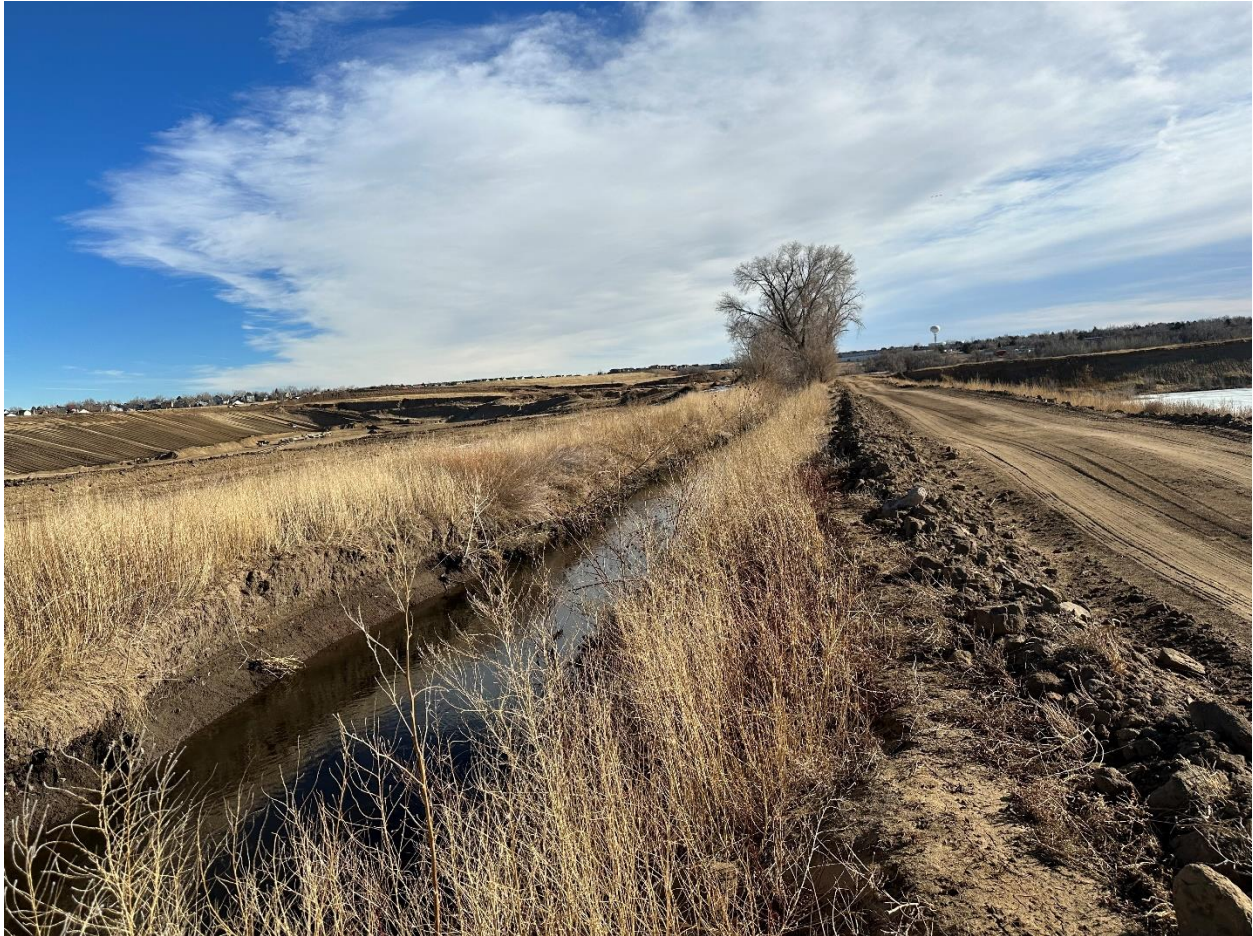
Photo 1. Fountain Mutual Ditch looking east with berm

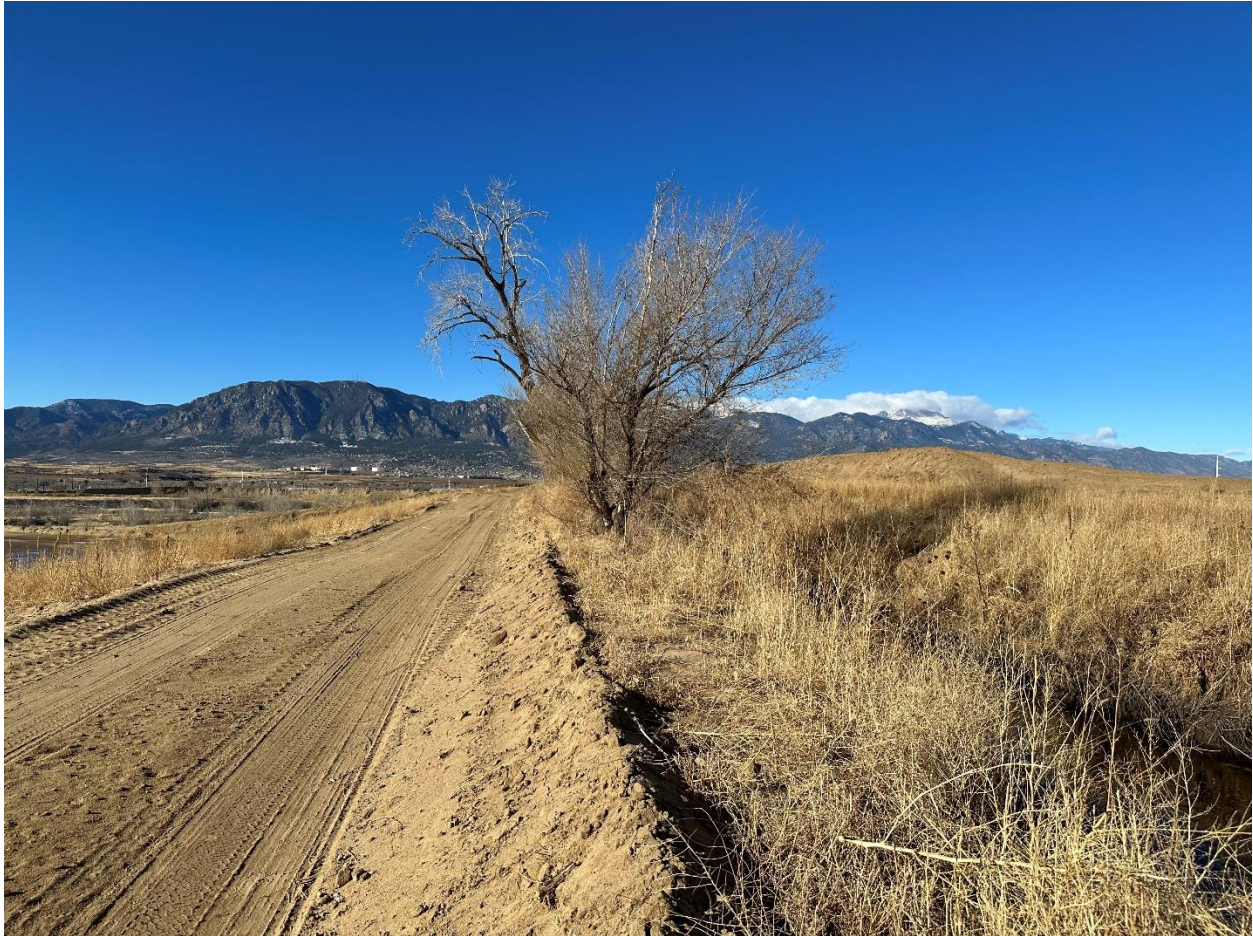
Photo 2. Fountain Mutual Ditch looking west with berm

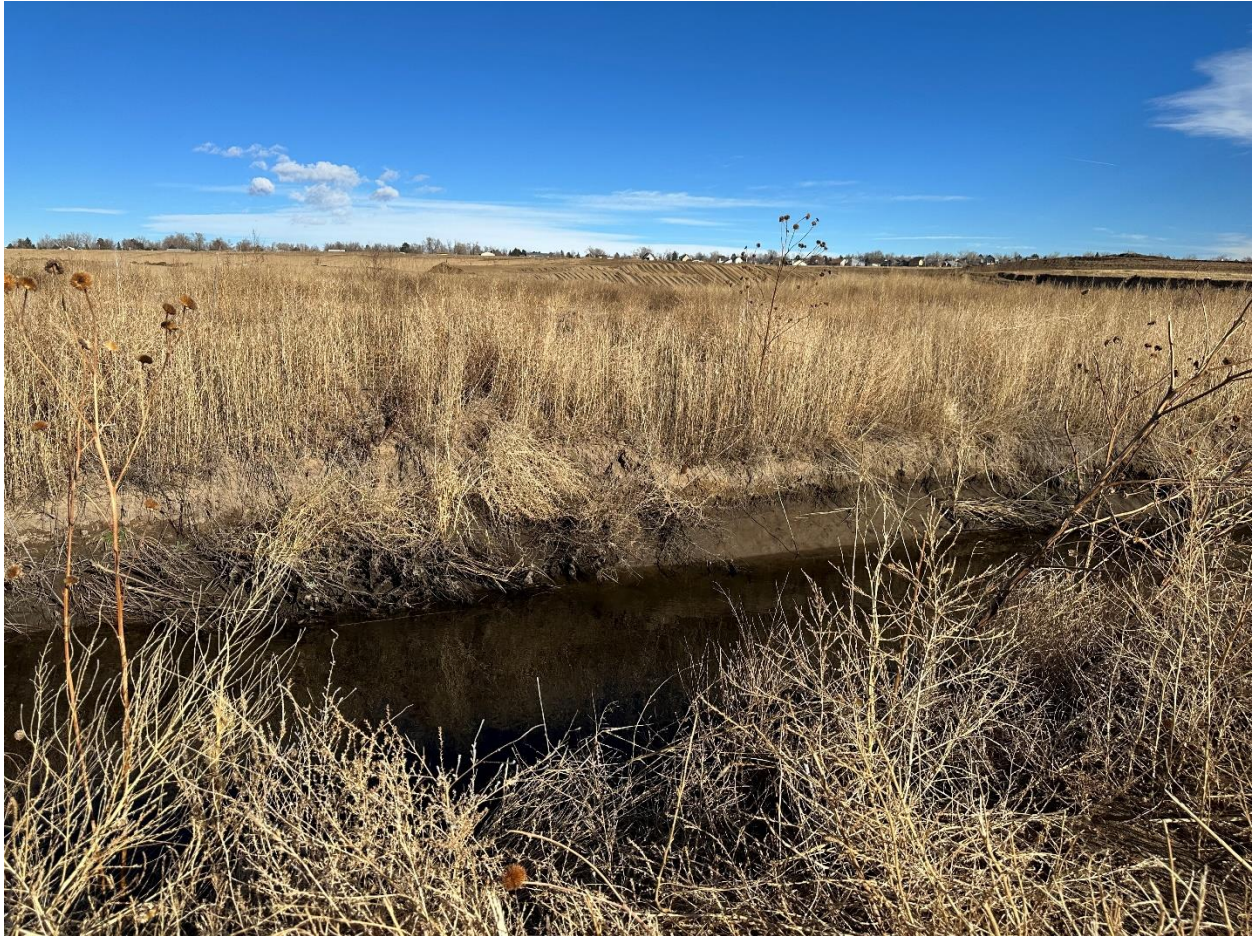
Photo 3. Fountain Mutual Ditch invert

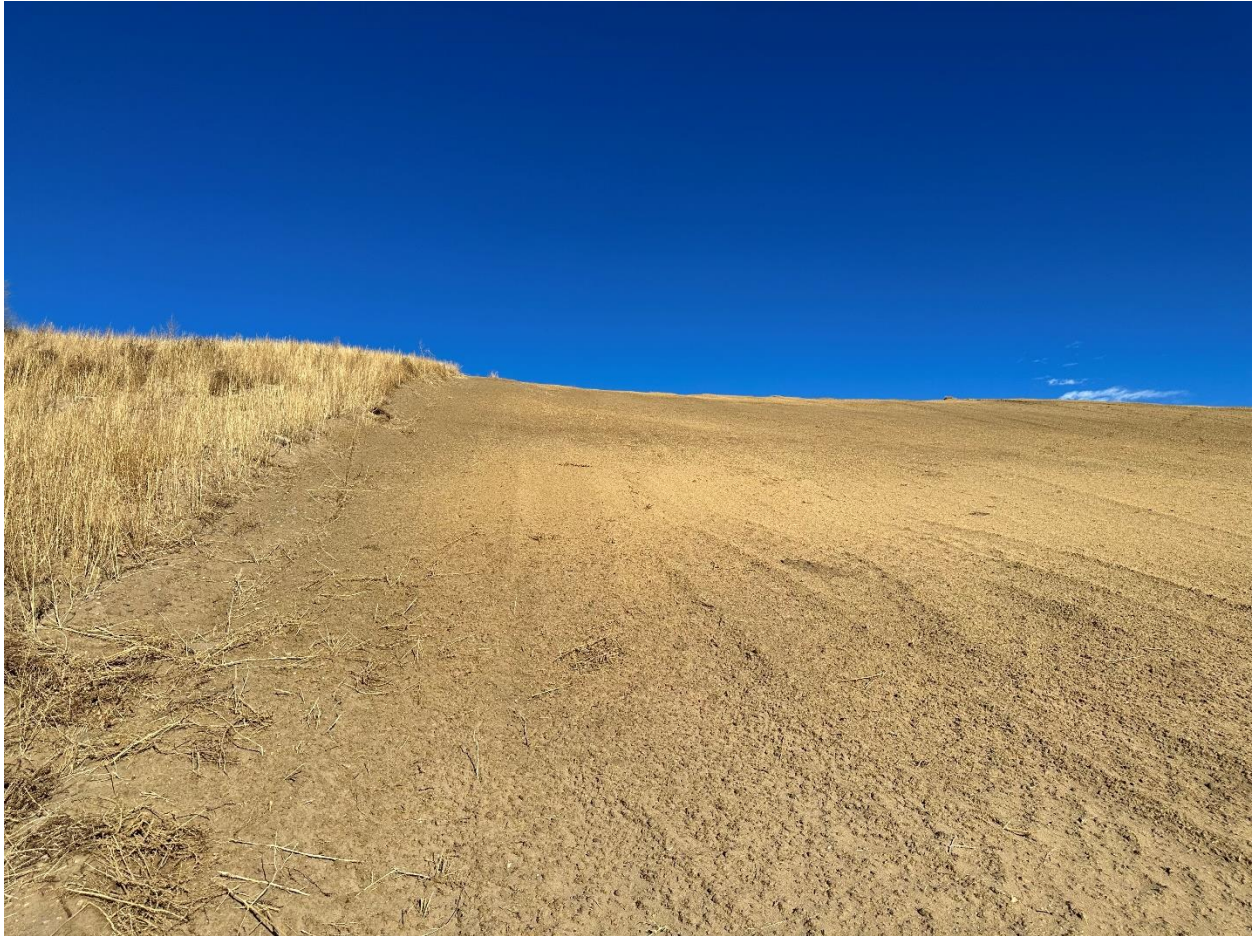
Photo 4. Buttress slope looking north (eastern slope)

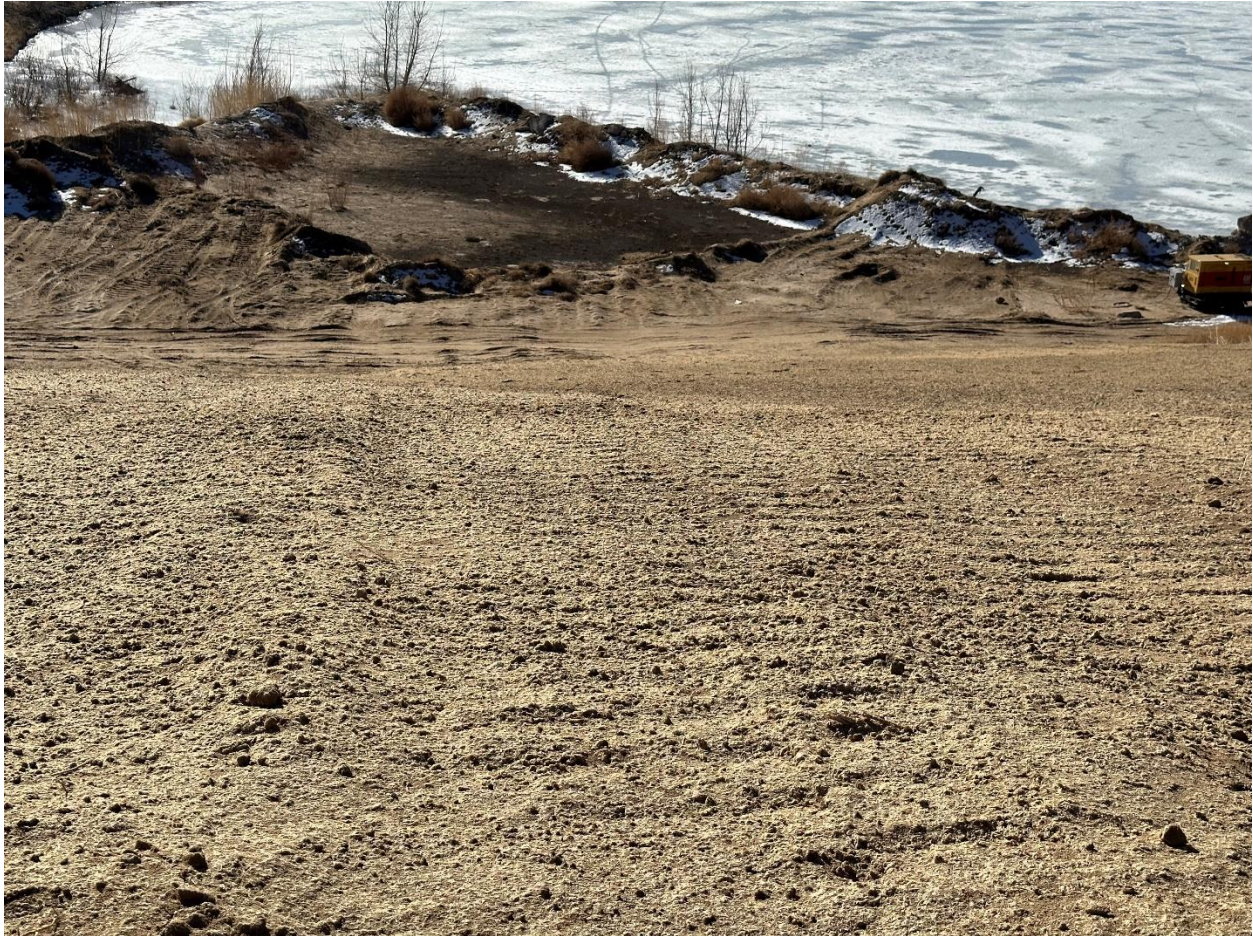
Photo 5. Buttress slope eastern portion with seed

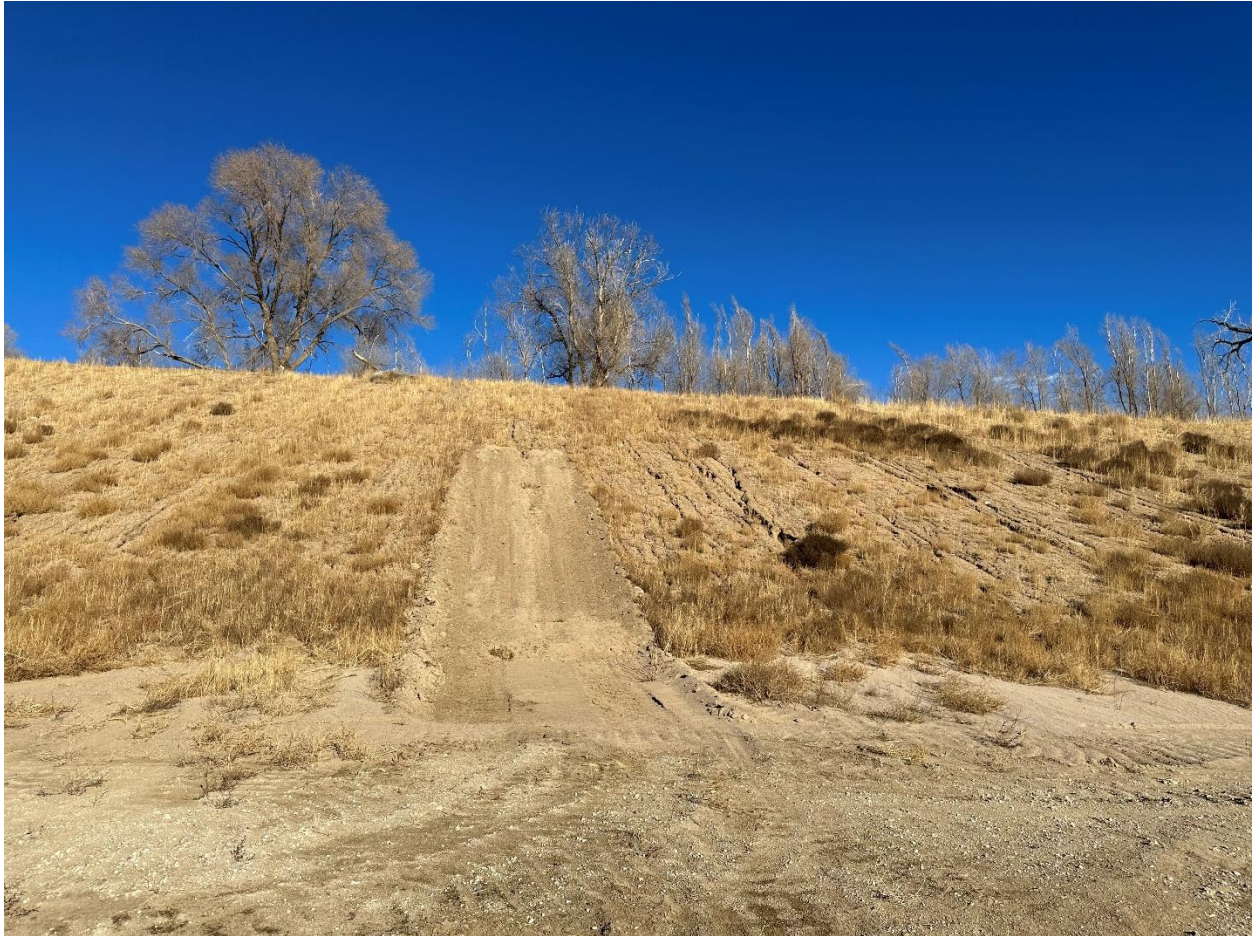
Photo 6. Buttress slope repair looking north from toe, erosion occurring around repair

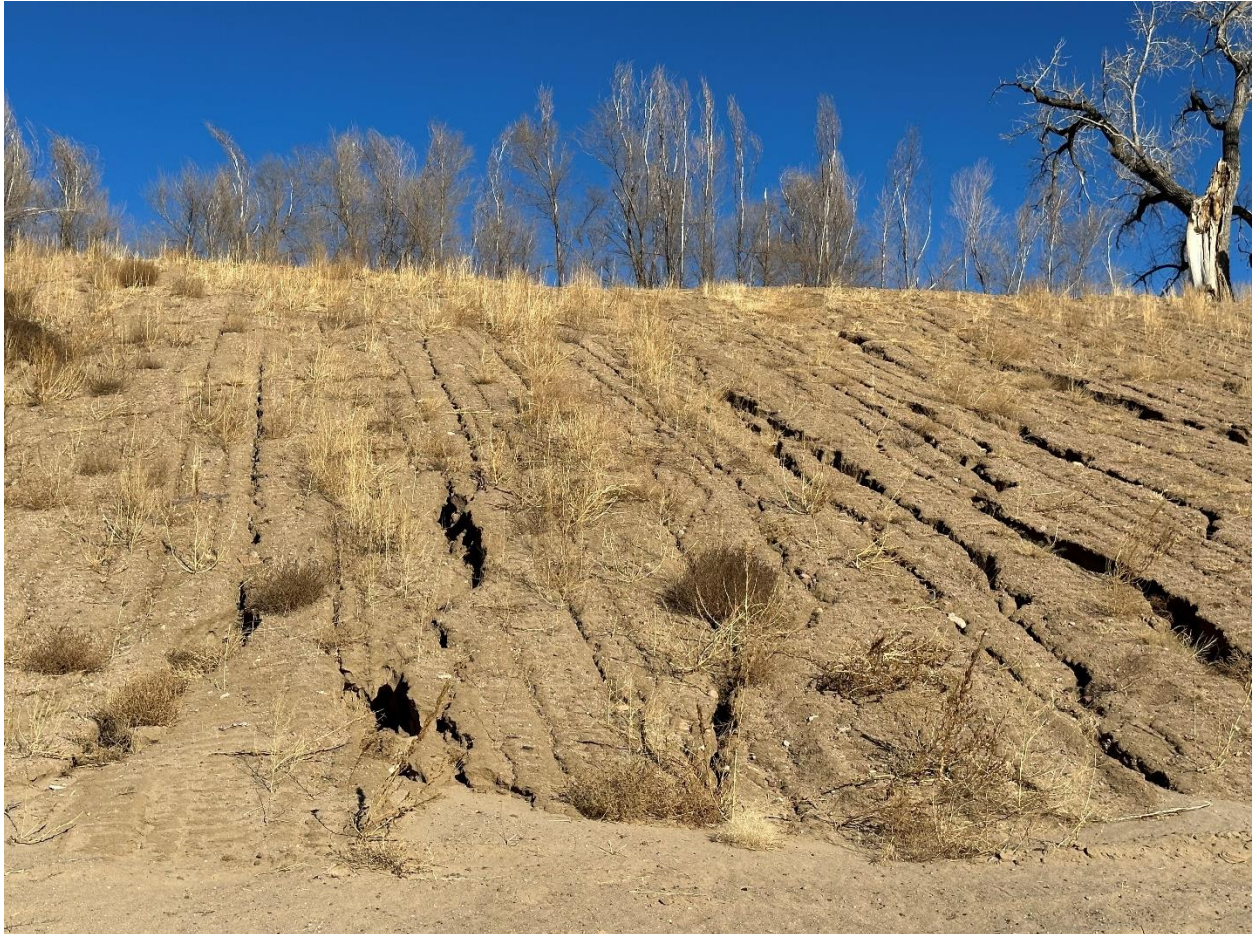
Photo 7. Buttress slope looking north, note evidence of drainage/erosion gullies forming. More sediment near toe
