MINERALS PROGRAM INSPECTION REPORT
PHONE: (303) 866-3567

MINE NAME: #2 Verhoeff Pit	MINE/PROSPECTING ID#: M-2008-013	MINERAL: Sand and gravel	COUNTY: Bent
INSPECTION TYPE: Surety Release Inspection	WEATHER: Cloudy, snow on the ground	INSP. DATE: December 14, 2022	INSP. TIME: 10:00
OPERATOR: Riverside Aggregates, LLC	OPERATOR REPRESENTATIVE: Mark Carrigan	TYPE OF OPERATION: 110c - Construction Limited Impact	
REASON FOR INSPECTION: Surety Release Requested	BOND CALCULATION TYPE: Complete Bond	BOND AMOUNT: \$21,603.00	
DATE OF COMPLAINT: NA	POST INSP. CONTACTS: None	JOINT INSP. AGENCY: None	
INSPECTOR(S): Nikie Gagnon	INSPECTOR'S SIGNATURE:

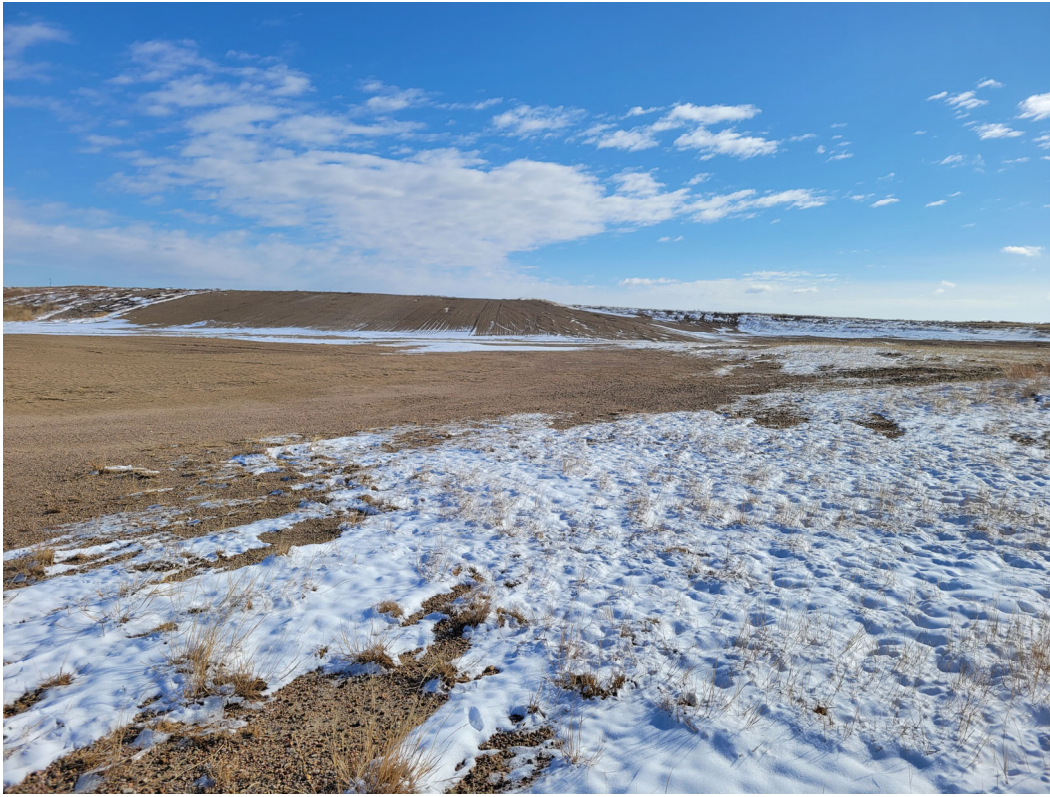
According to the Operator, the site was recently graded and four inches of topsoil was spread across the pit. Seeding occurred in the late fall of 2022. During the inspection, little suitable vegetation growth was observed on the slopes or within the pit area. The majority of the site is bare earth. The site looks as expected for a gravel pit recently graded and seeded. A buffer of undisturbed vegetation surrounds the former mining pit within the permit boundary.

Looking east at recently graded pit area.

Based on observations made during this inspection the request for an acreage release of 9.9 acres will be denied at this time. Once the vegetation fills in across the pit, the Operator can resubmit a release request. Notice of the Division's decision regarding the release request will be sent under a separate cover letter.

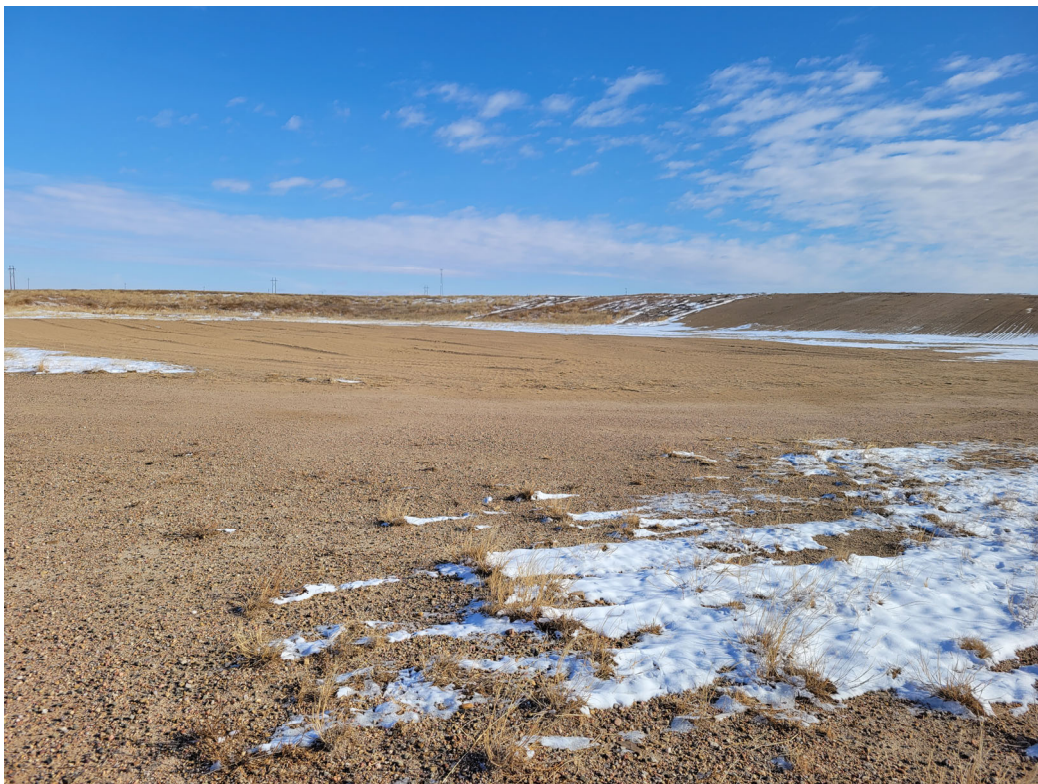
Looking north/northeast across the pit.

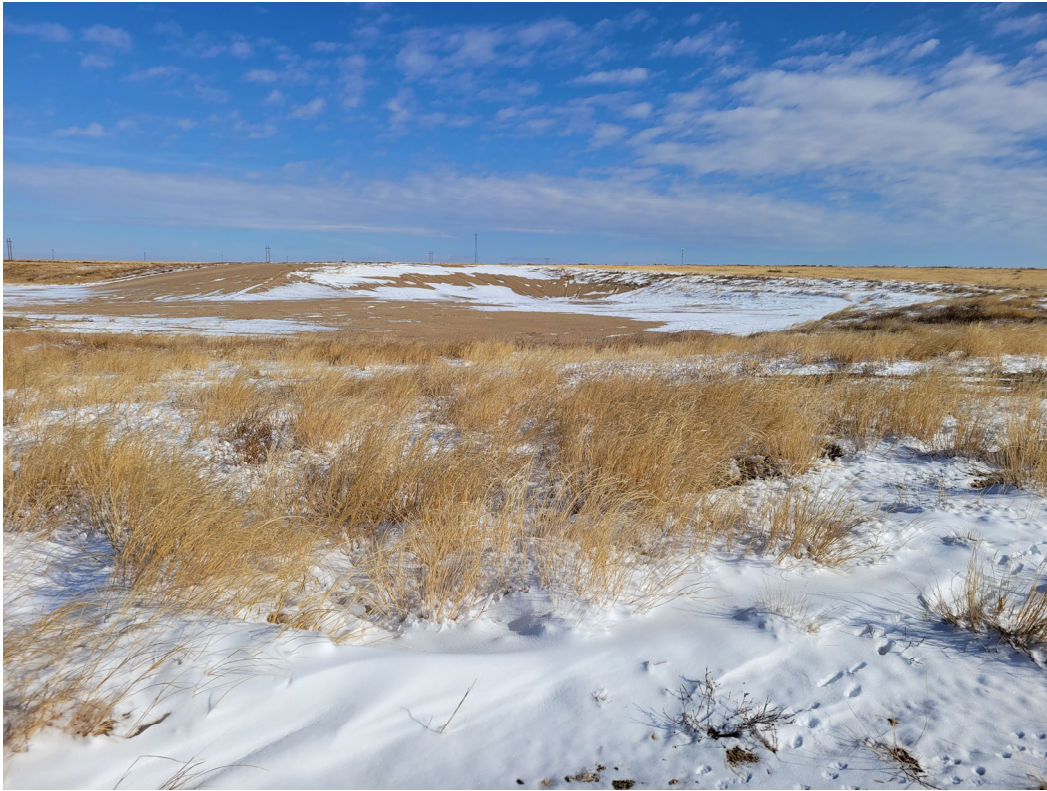
Southwest corner looking east.

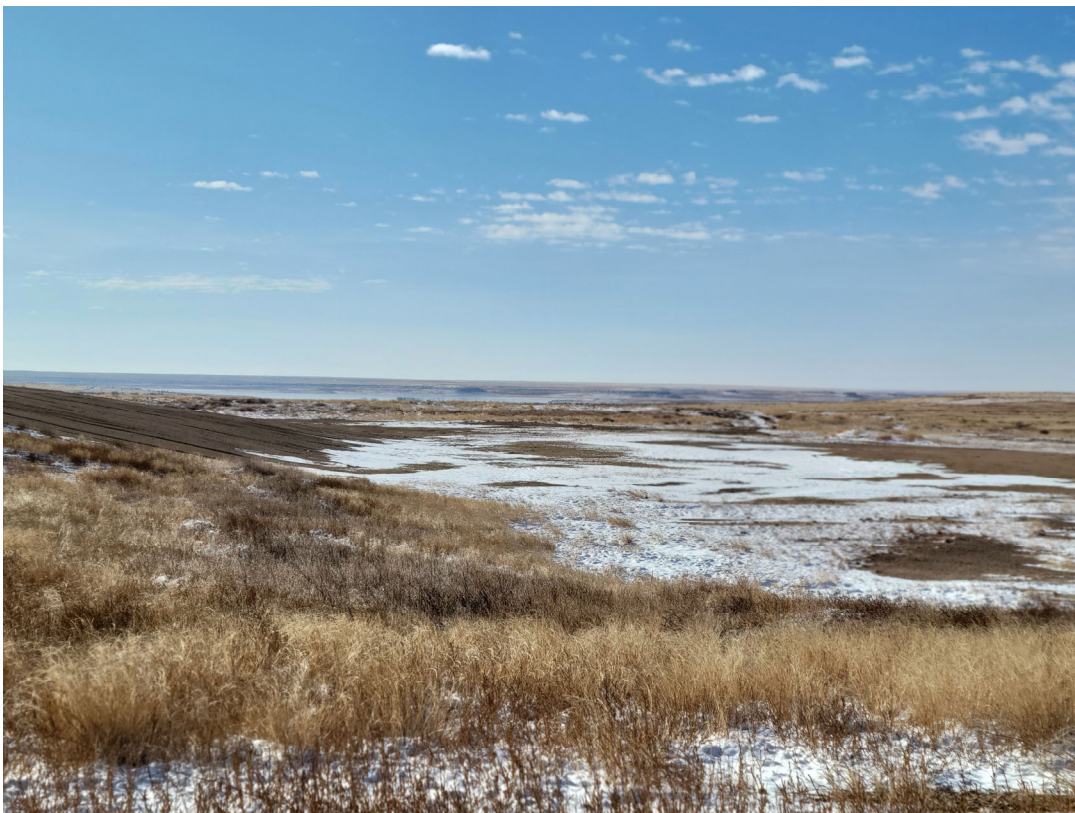
Looking south from the northern boundary.

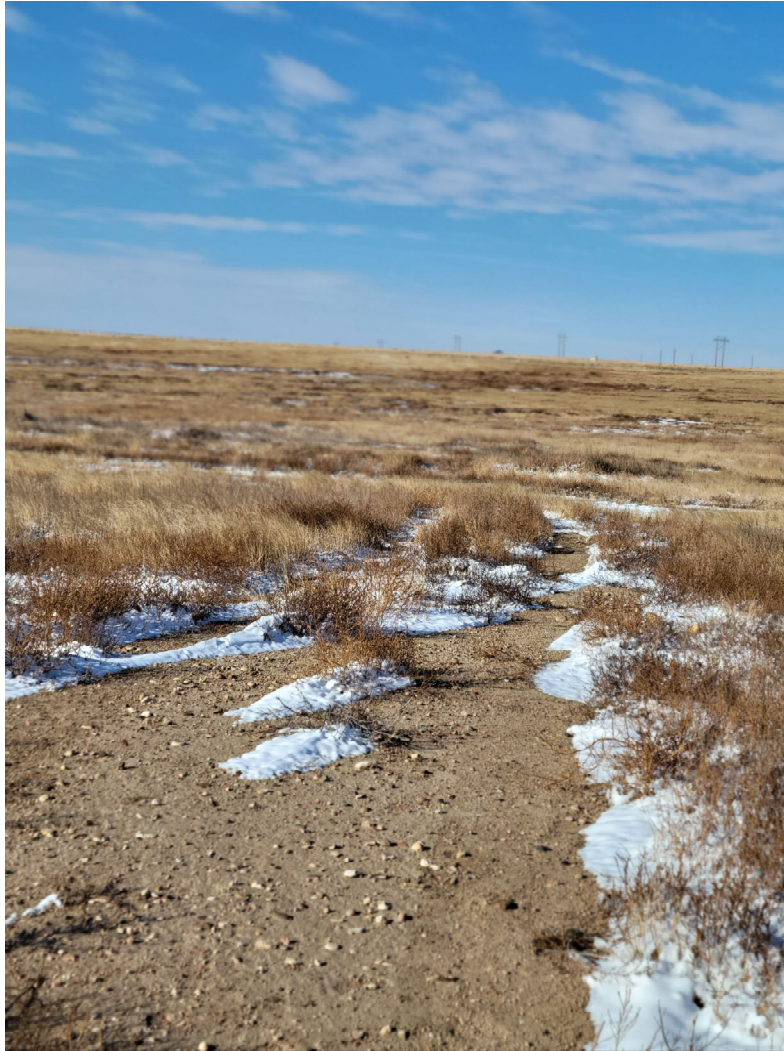
An access/haul road is located on the northwestern side of the pit. The operator indicated the landowner would like this road to remain after reclamation. According to the mining and reclamation maps, the access road from the county road to the pit was existing and is outside the permit boundary. However, it appears an interior access road goes around the perimeter of the pit, within the permit boundary. The access road around the pit should be ripped to reduce compaction and seeded.

Interior access road goes around the pit.

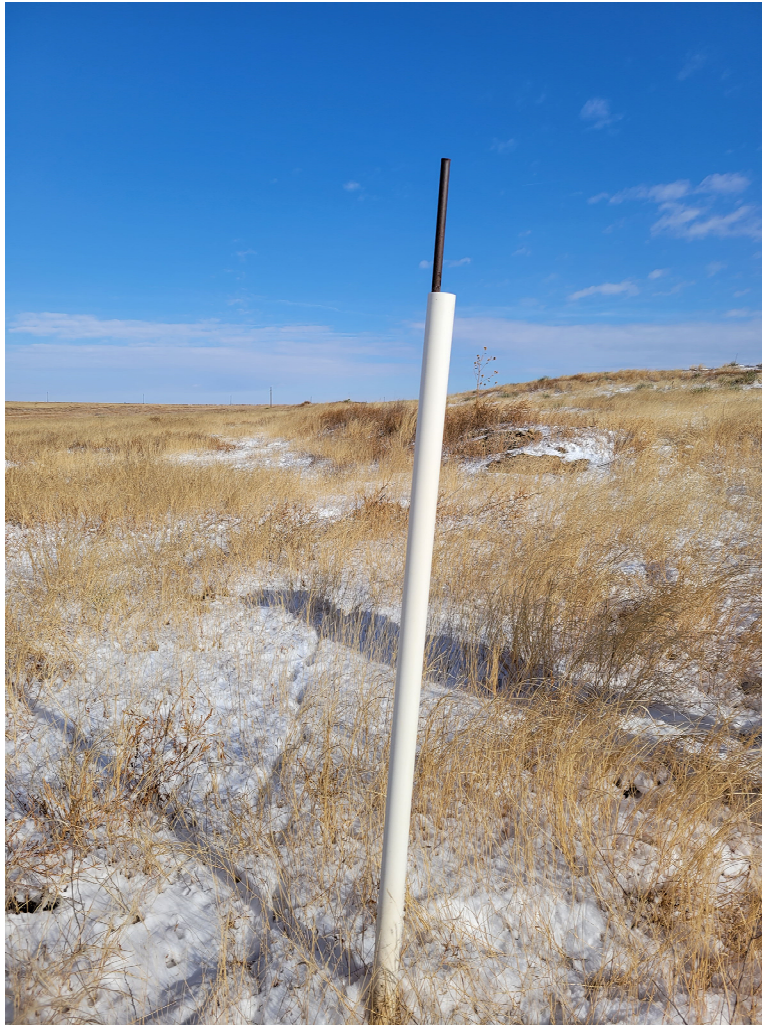
Permit boundary marker in the southwest corner, undisturbed vegetation.
