MINERALS PROGRAM INSPECTION REPORT

MINE NAME: San Luis Project	MINE/PROSPECTING ID#: M-1988-112	MINERAL: Gold and silver	COUNTY: Costilla
INSPECTION TYPE: Monitoring	WEATHER: Clear	INSP. DATE: December 27, 2022	INSP. TIME: 11:30
OPERATOR: Battle Mountain Resources, Inc.	OPERATOR REPRESENTATIVE: Julio Madrid, Steve Carino	TYPE OF OPERATION: 112d-3 - Designated Mining Operation	
REASON FOR INSPECTION: Normal I&E Program	BOND CALCULATION TYPE:	BOND AMOUNT: \$7,400,000.00	
DATE OF COMPLAINT: NA	POST INSP. CONTACTS: None	JOINT INSP. AGENCY: None	
INSPECTOR(S): Lucas West	INSPECTOR'S SIGNATURE:

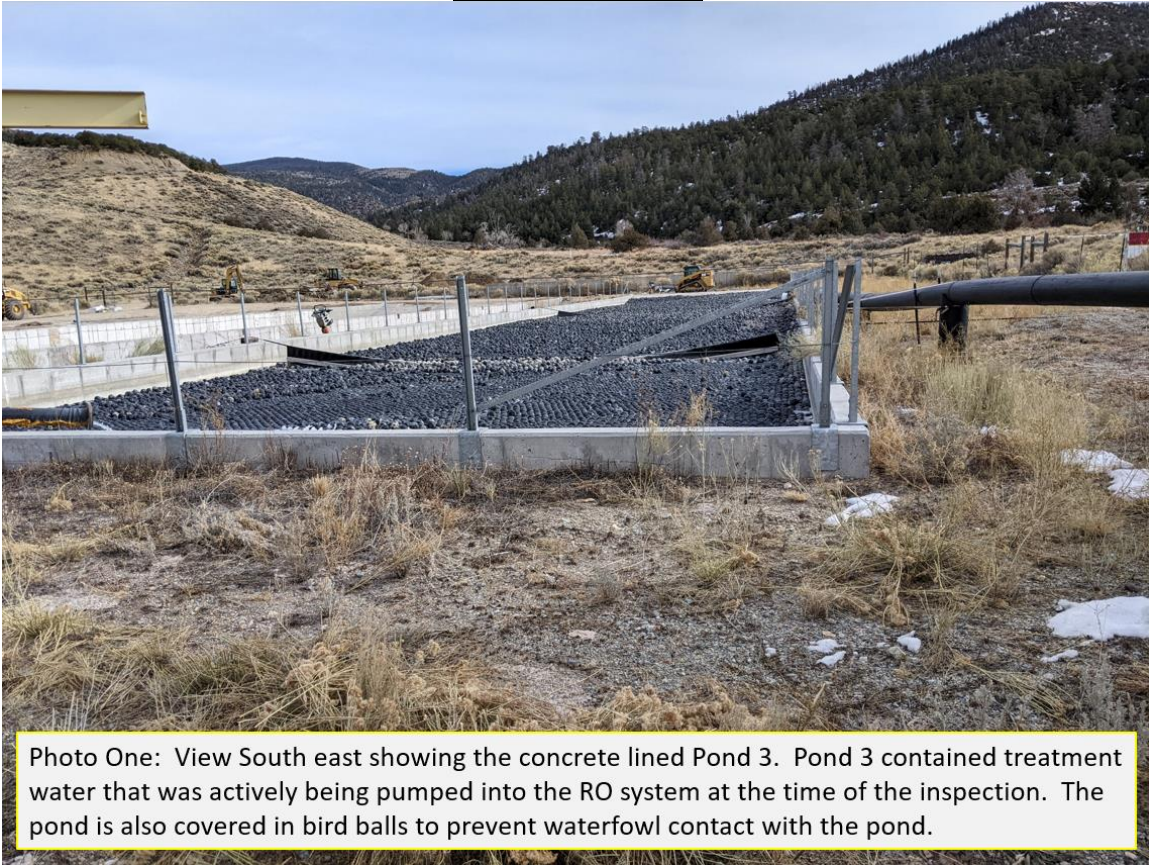
The main focus of this inspection was the final construction inspection of Ponds 2 and 3 which were the focus of Technical Revision 36. Under TR-36 the Operator proposed to convert the two holding ponds for water treatment operations to a concrete lined system to replace the aging HDPE liners in the ponds. The two lined ponds are Environmental Protection Facilities (EPF) as part of the Environmental Protection Plan (EPP). Pursuant to Hard Rock and Metals Mining Rule 7.4 construction or modifications to EPF's require incremental inspections and certification. At the time of the inspection all concrete work on both ponds had been completed. Pond 3, shown in Photos One and Two had been completed previously and all QA/QC documentation has been received. The pond contained water that was actively being pumped into the RO treatment system. All concrete and backfilling work appears to meet the design specifications and the QA/QC documentation shows all parameters were achieved. The pond is covered with bird balls in accordance with their permit.

Photo One: View South east showing the concrete lined Pond 3. Pond 3 contained treatment water that was actively being pumped into the RO system at the time of the inspection. The pond is also covered in bird balls to prevent waterfowl contact with the pond.

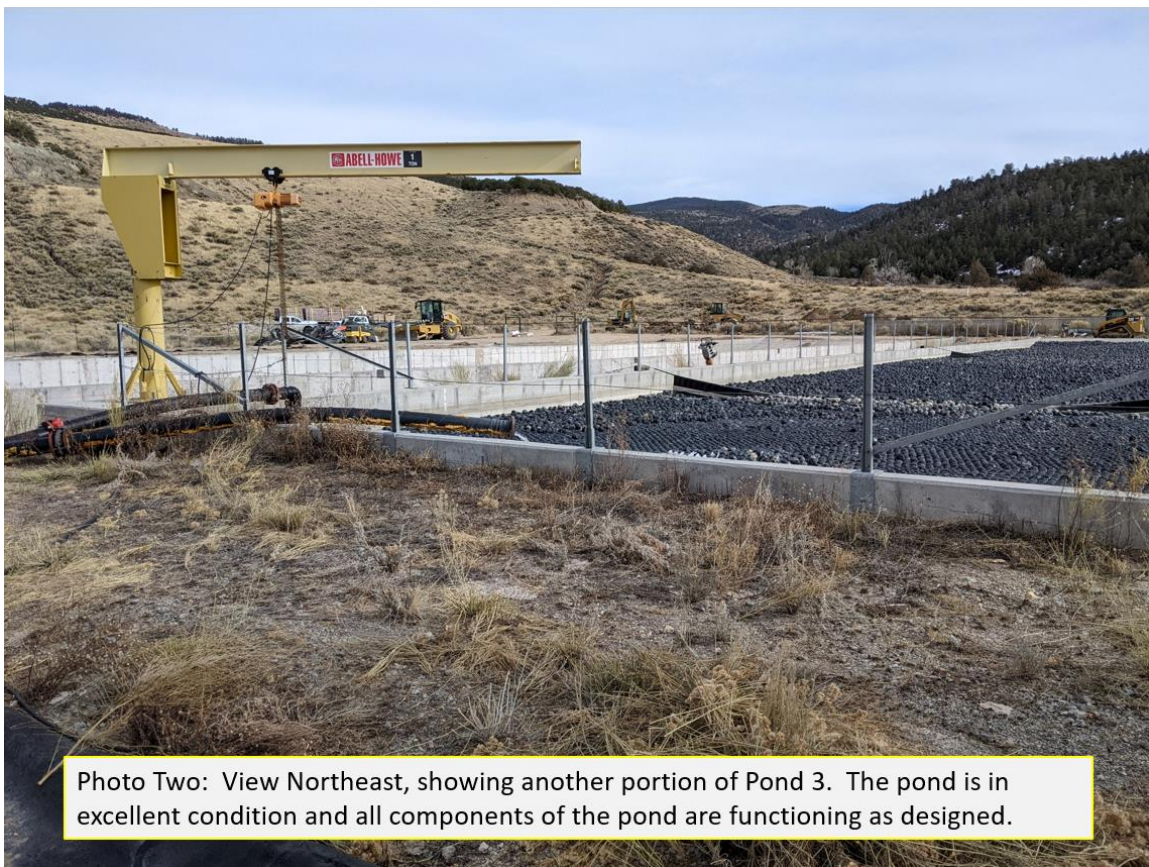
Both ponds are in excellent condition and appear to be constructed in compliance with the design specifications. Once the Division receives the as-build package from the Operator, including all QA/QC documentation the EPF's can be certified. In addition to the ponds, the overall footprint of the site that was observed was in excellent condition. No problems or possible violations were noted. All responses to this report should be directed to Lucas West at the Colorado Division of Reclamation, Mining and Safety's Active Mines Program, Room 215, 1001 E. 62nd Ave, Denver CO, 80216. Direct contact can be made at the Division's Grand Junction Field Office, by phone at 303-866-3567 Ext. 8187 or by email at lucas.west@state.co.us.

Photo Two: View Northeast, showing another portion of Pond 3. The pond is in excellent condition and all components of the pond are functioning as designed.

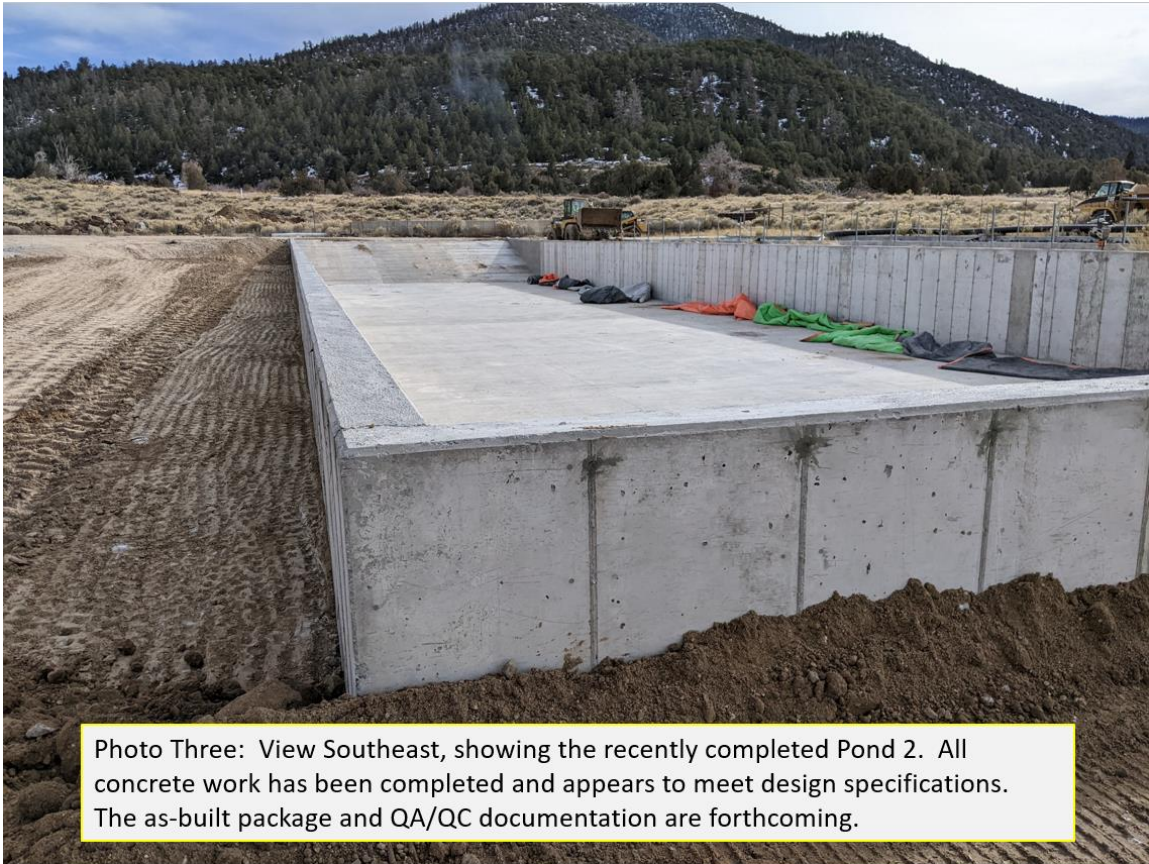
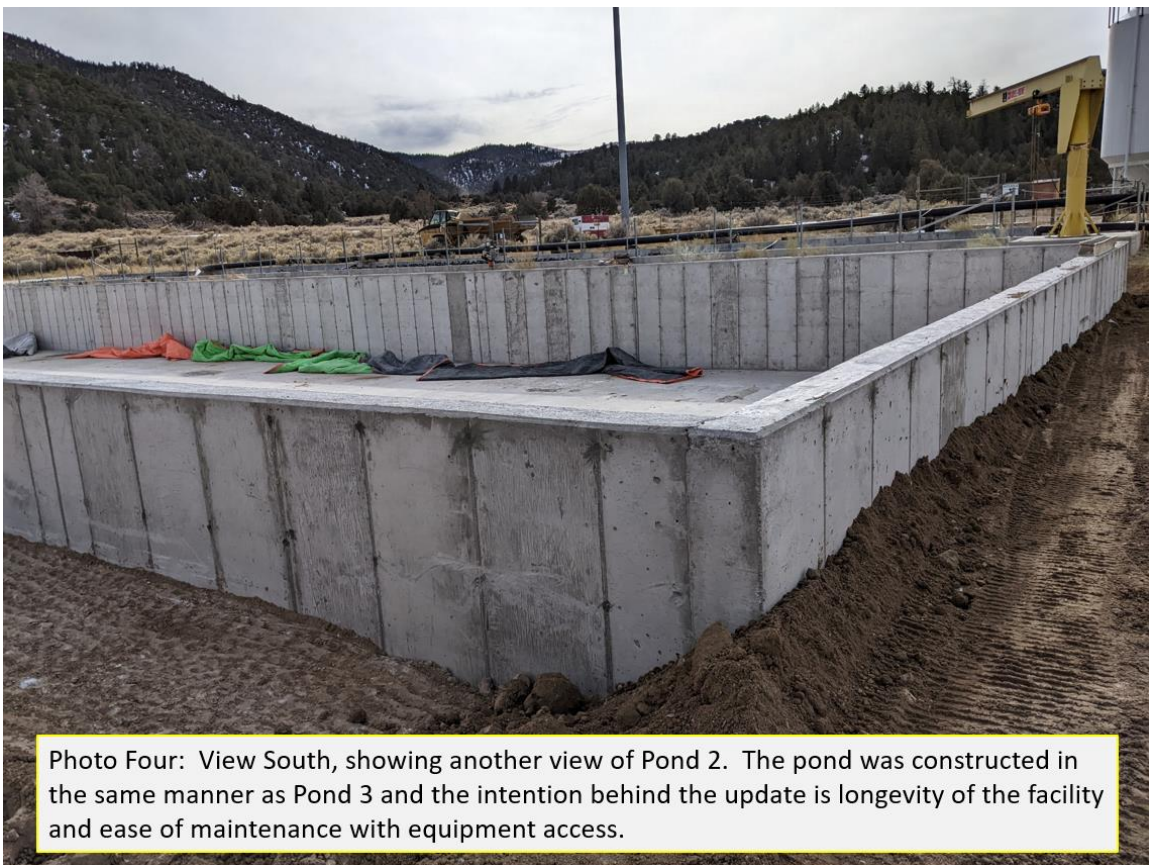
Pond 2, Shown in Photos Three and Four, has had the concrete work completed. The QA/QC documentation is forthcoming, however all tests were completed during construction and the Operator confirmed that all specifications were achieved. The areas around the pond were actively being backfilled at the time of the inspection. The area around the pond can be seen in Photos Five and Six. The area between Pond 2 and 3 was being excavated down to be backfilled and compacted in lifts. During the inspection, winter temperatures had frozen the ground and it was agreed that the excavation, backfill and compaction work could wait until conditions allowed.

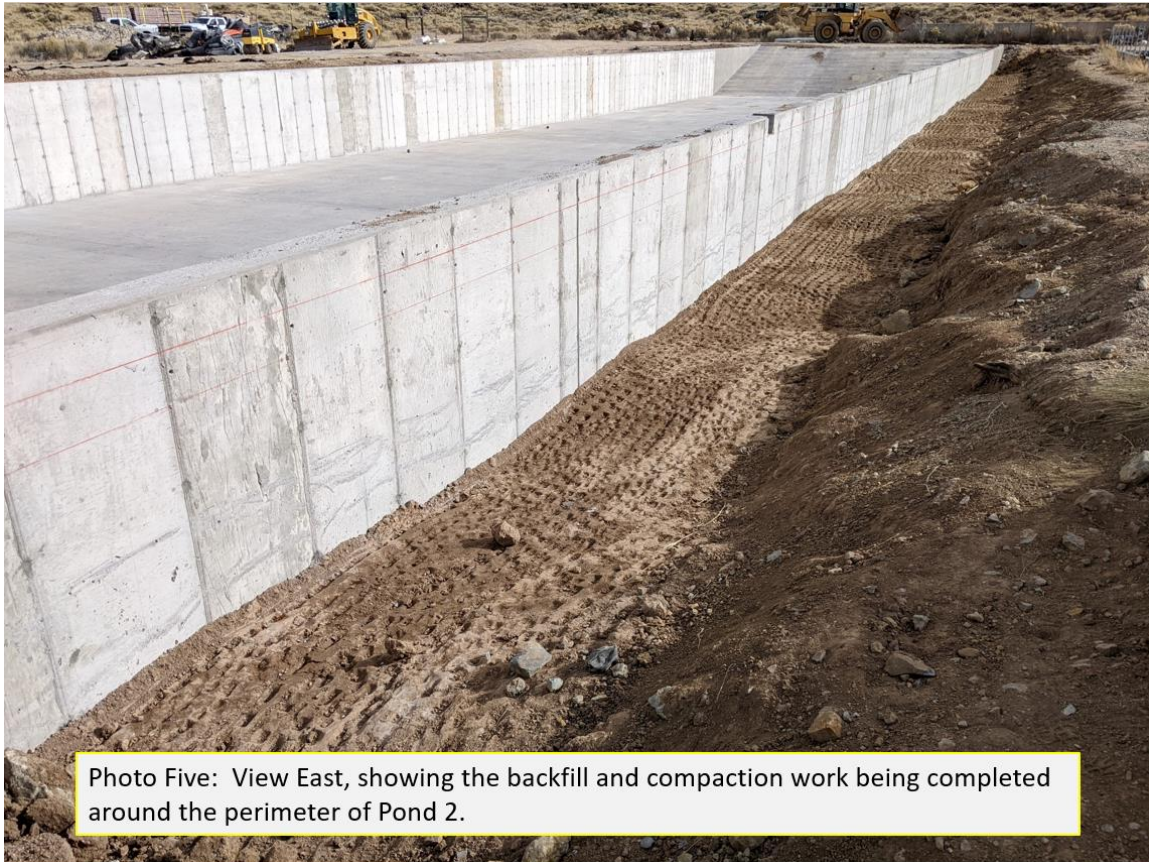
Photo Five: View East, showing the backfill and compaction work being completed around the perimeter of Pond 2.

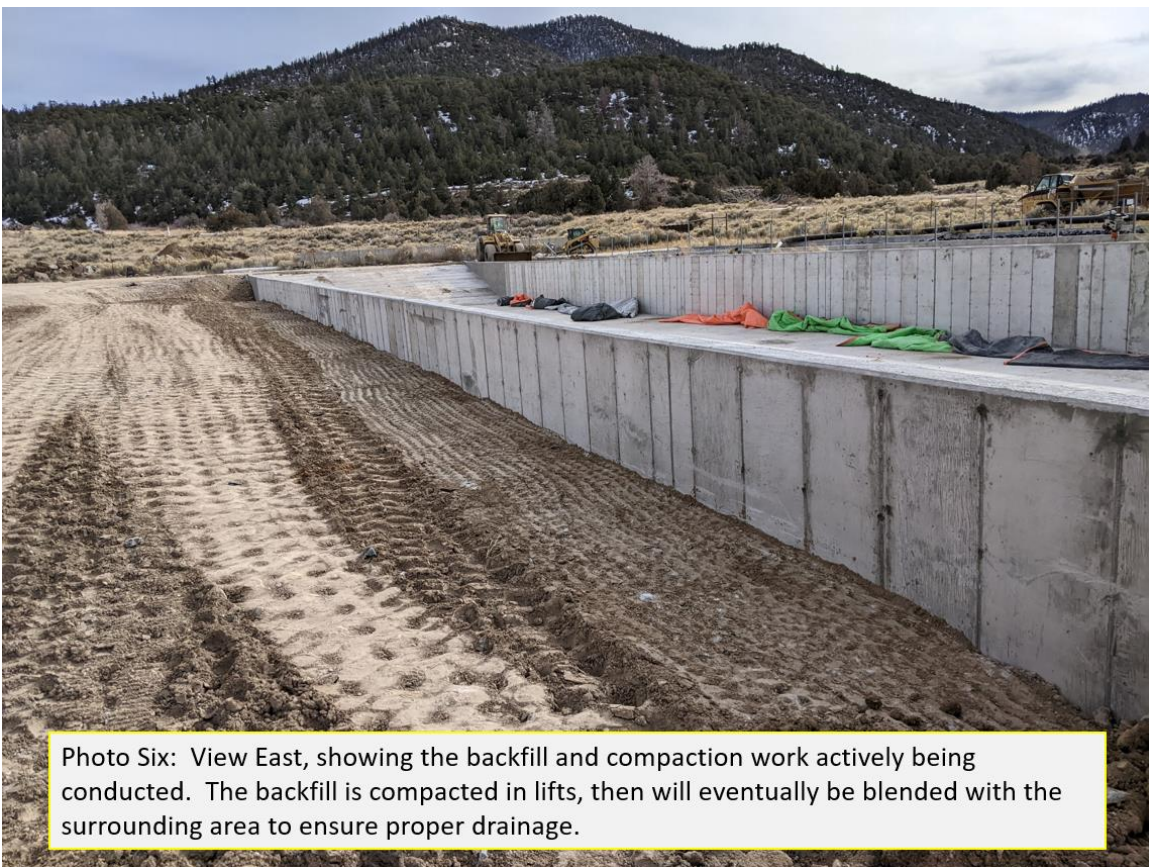
Photo Six: View East, showing the backfill and compaction work actively being conducted. The backfill is compacted in lifts, then will eventually be blended with the surrounding area to ensure proper drainage.
