### MINERALS PROGRAM INSPECTION REPORT

<b>MINE NAME:</b> Verhoeff Gravel Pit #1	<b>MINE/PROSPECTING ID#:</b> M-2014-025	<b>MINERAL:</b> Sand and gravel	<b>COUNTY:</b> Bent
<b>INSPECTION TYPE:</b> Monitoring	<b>WEATHER:</b> Clear and chilly	<b>INSP. DATE:</b> December 14, 2022	<b>INSP. TIME:</b> 11:00
<b>OPERATOR:</b> All-Rite Paving & Redi-Mix, Inc.	<b>OPERATOR REPRESENTATIVE:</b> Jodi Schreiber	<b>TYPE OF OPERATION:</b> 112c - Construction Regular Operation

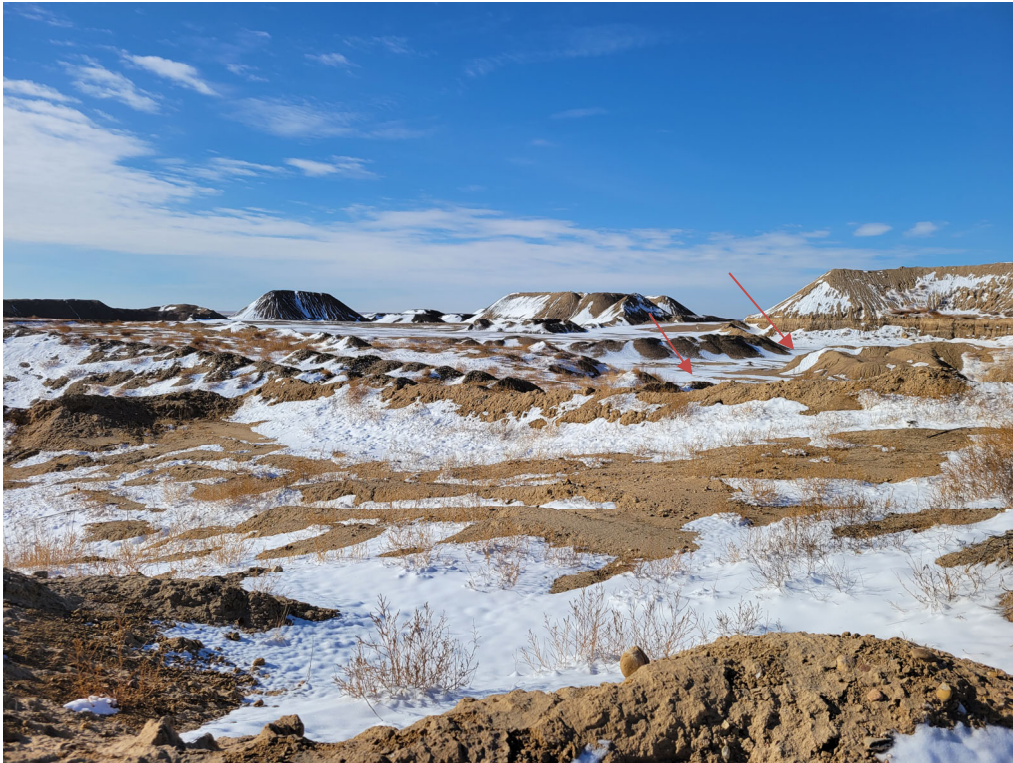
Looking west from the access road at Phase 1 area. Bottom of pit is marked by red arrow.

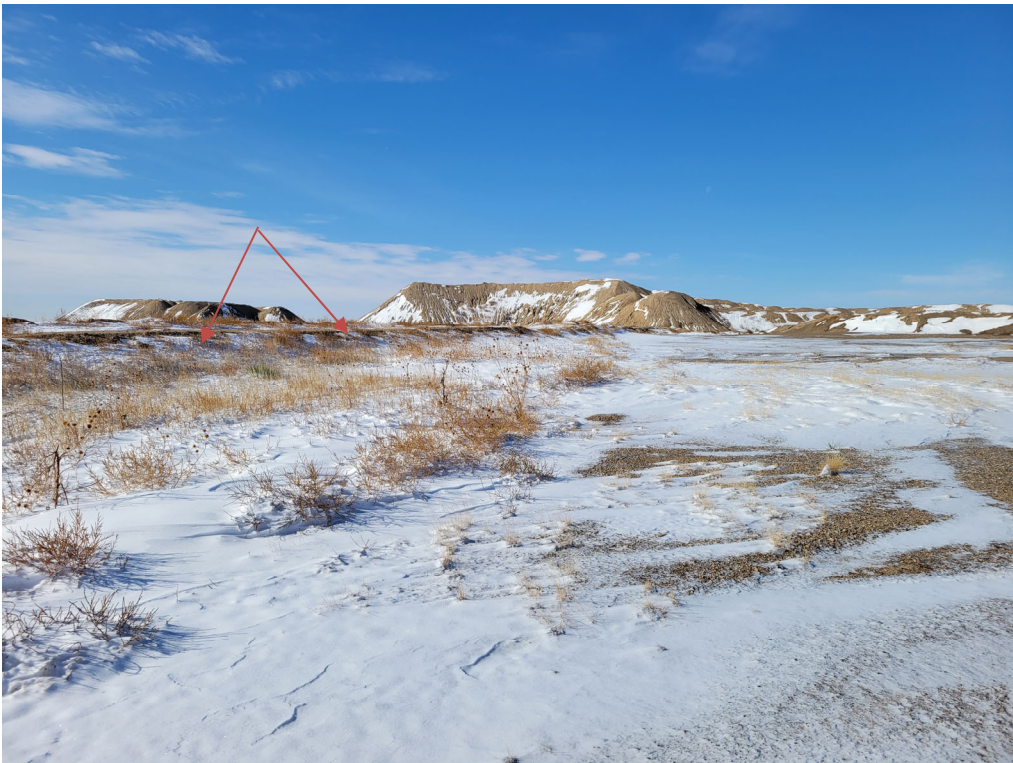
Looking west. Berm marked by red arrow is the dividing line between Phase 1 and Phase 2 areas.

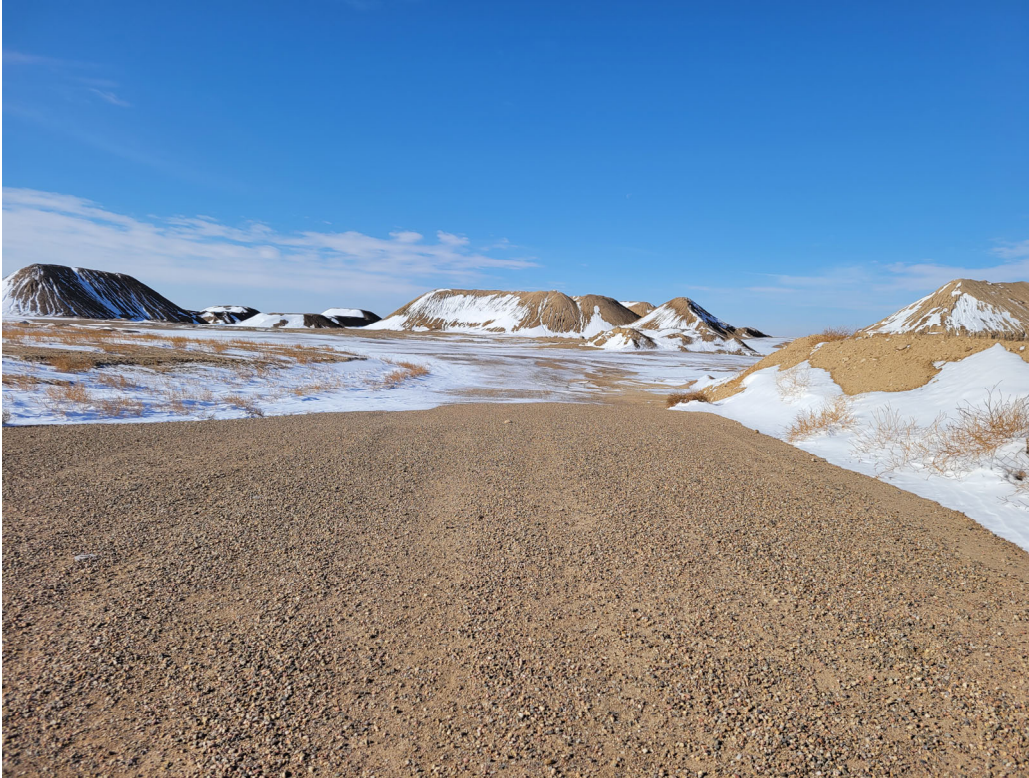
Looking west in to Phase 1. Overburden stripped and stored around the mining area.

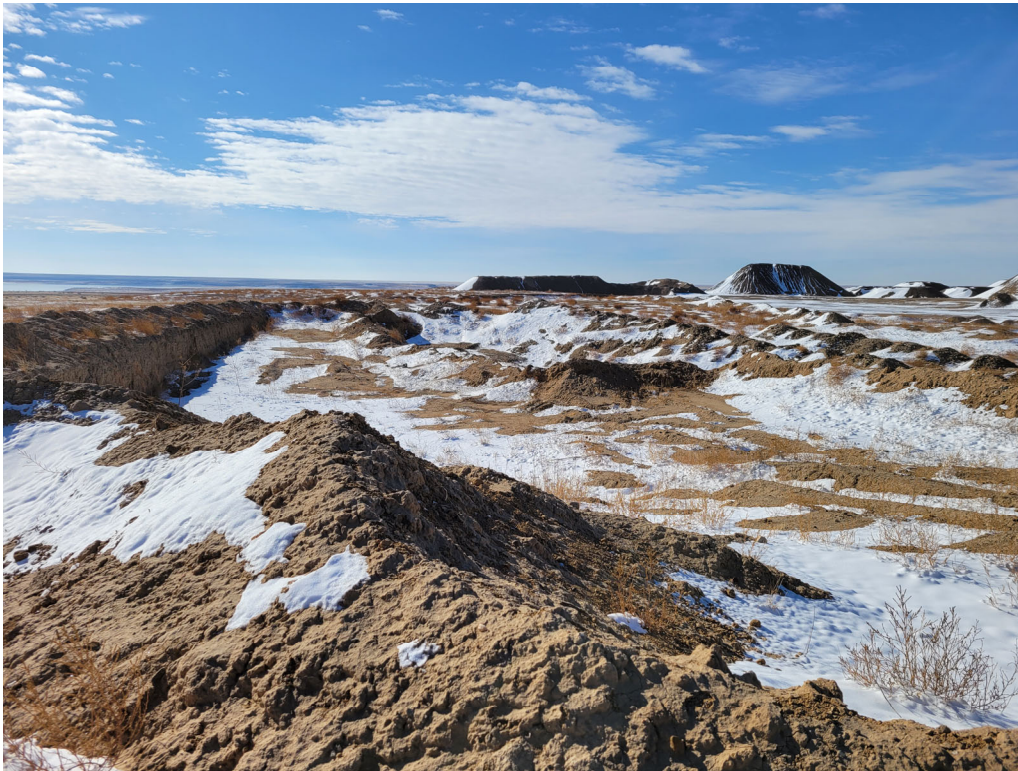
Looking south into mining area from the boundary between Phase 1 and Phase 2.

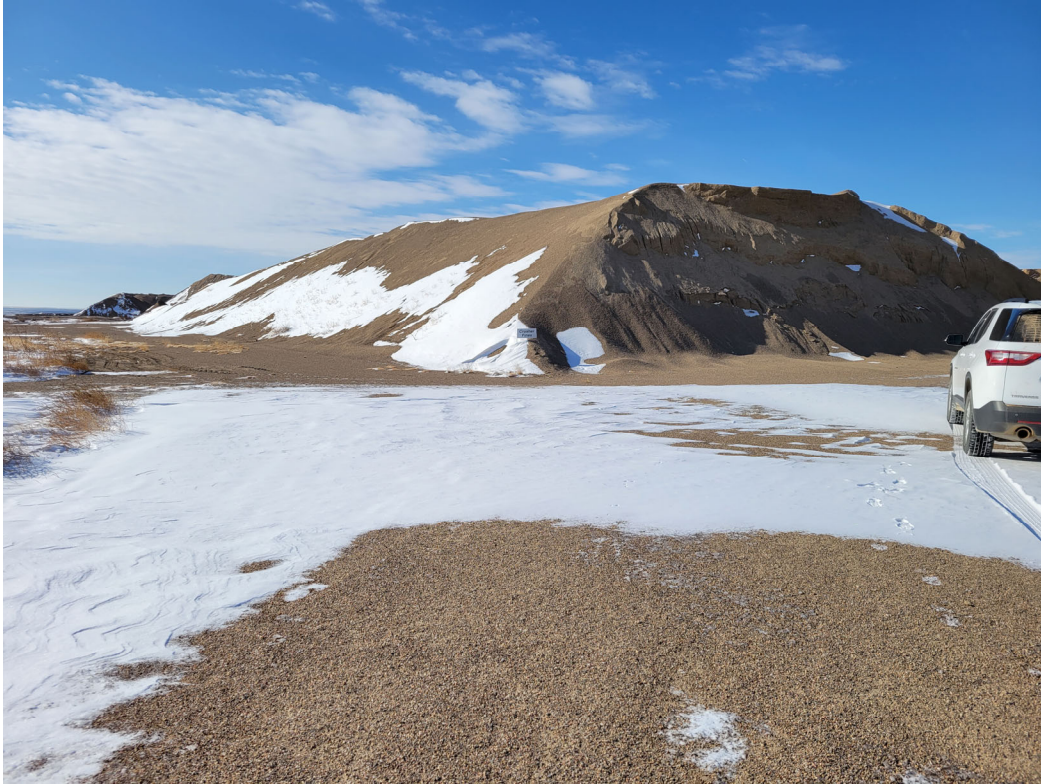
Material stockpile stored in Phase 2 area.

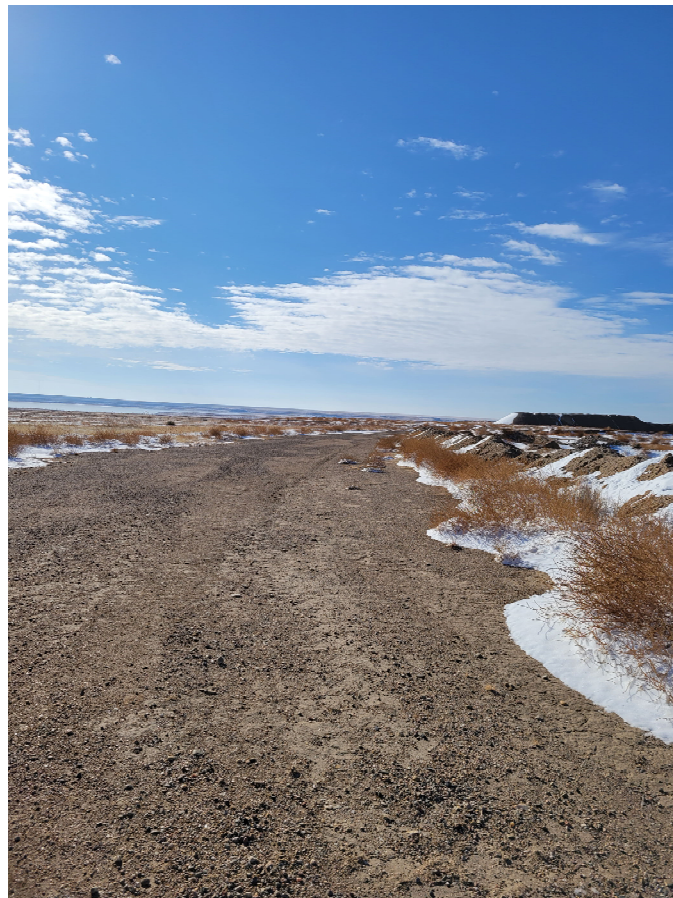
An existing gravel ranch road runs down the eastern edge of the permit area, which has been improved/widened for use by the operation.

Looking south down the improved gravel access road.
