MINERALS PROGRAM INSPECTION REPORT
PHONE: (303) 866-3567

| MINE NAME: Pikeview Quarry | MINE/PROSPECTING ID#: M-1977-211 | MINERAL: Limestone (general), granite gneiss and do | COUNTY: El Paso |
| INSPECTION TYPE: Monitoring | WEATHER: Cloudy | INSP. DATE: January 11, 2023 | INSP. TIME: 10:00 |

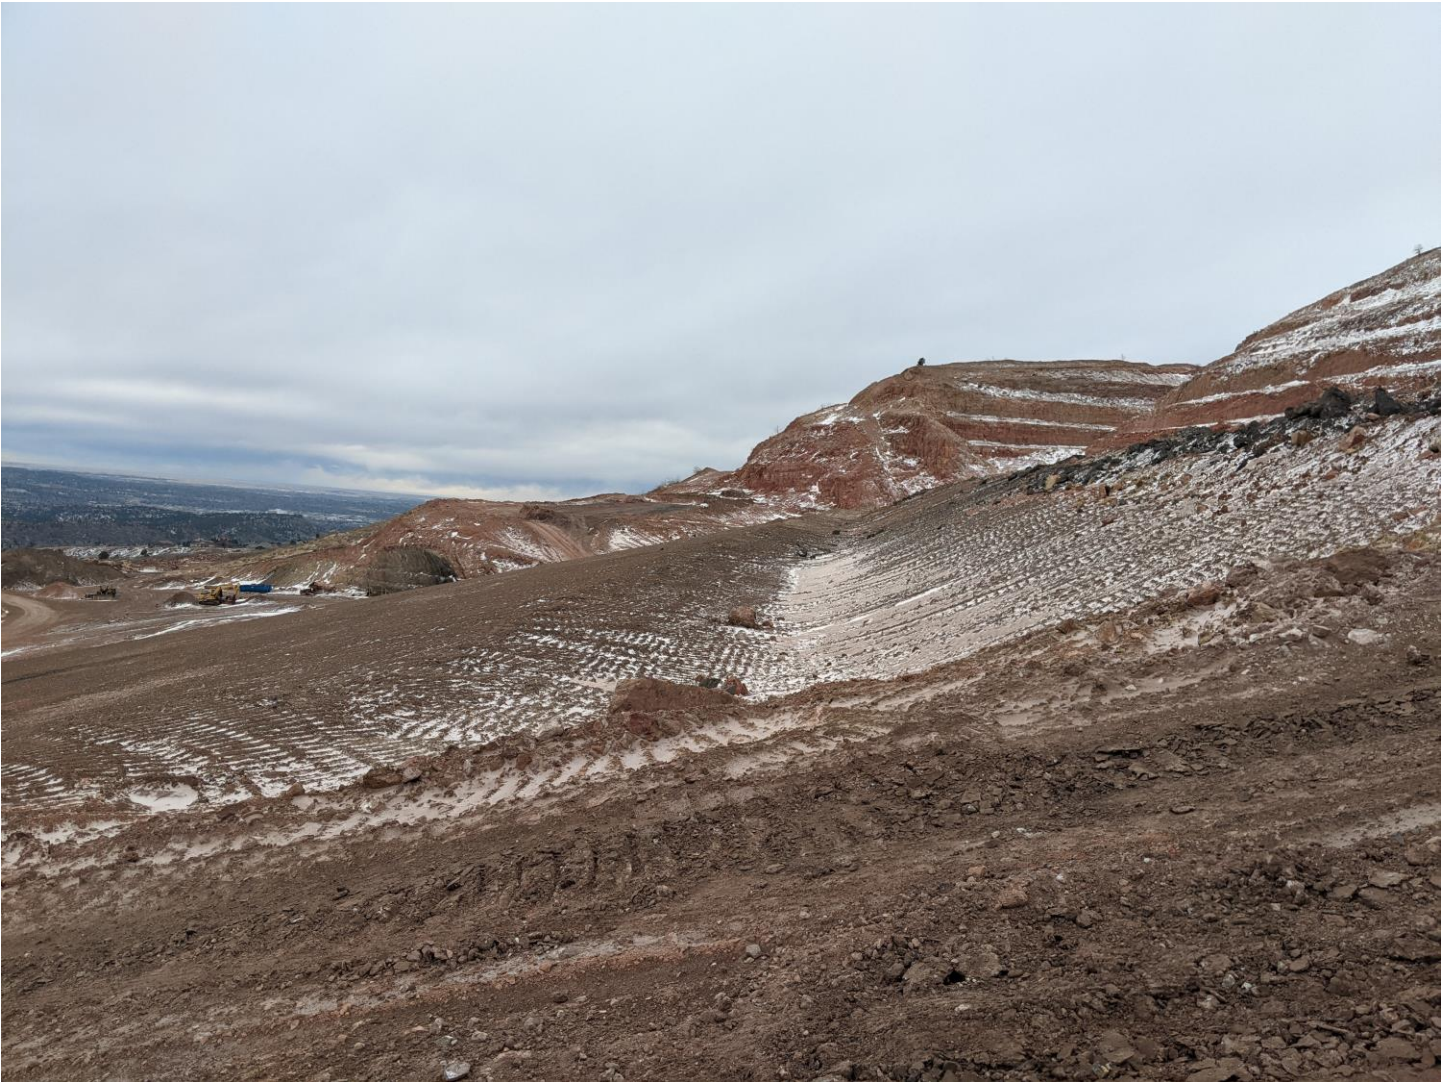
There was no backfill placement occurring on site during the inspection. Last activity on site was along the northern end where material was being pushed by dozer down gradient to the top lift of the buttress. The first portion of the buttress has been completed at a 3h:1v slope. The next portion of benching will be graded to a steeper 2h:1v slope. The benched excavation area located at the previous maintenance shop has almost all borrow material removed with the remaining amount located at the lower elevation. Excavated benches will eventually be graded to a continuous slope for final reclamation after all borrow material has been removed.

Bench transition of buttress.

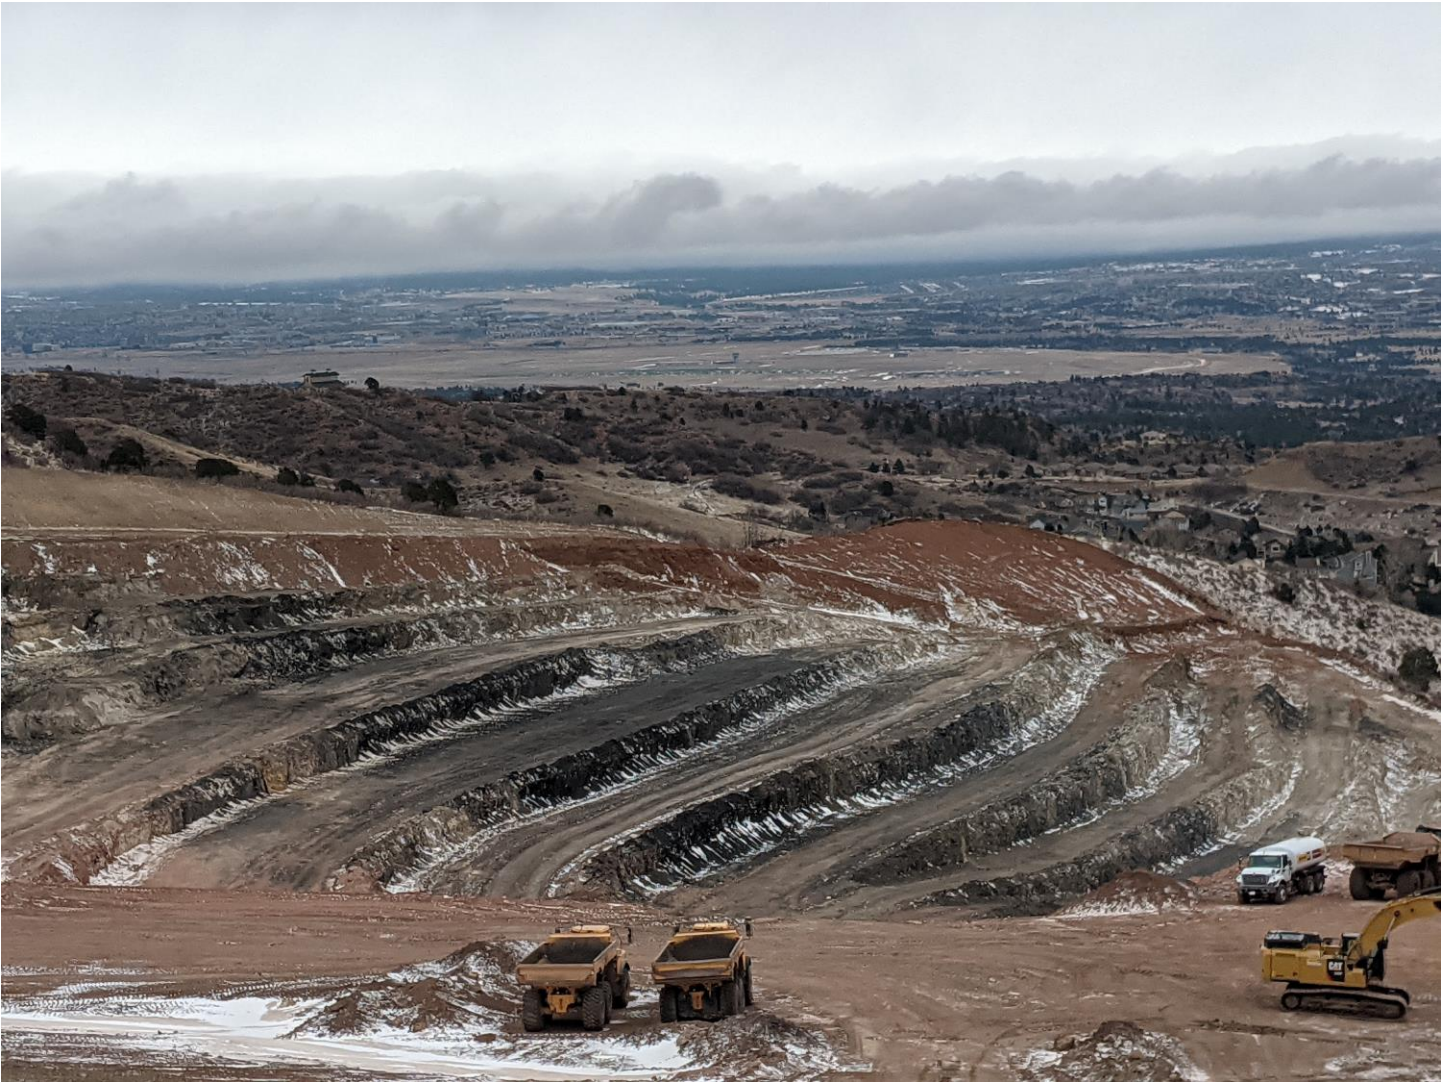
Excavated borrow area.

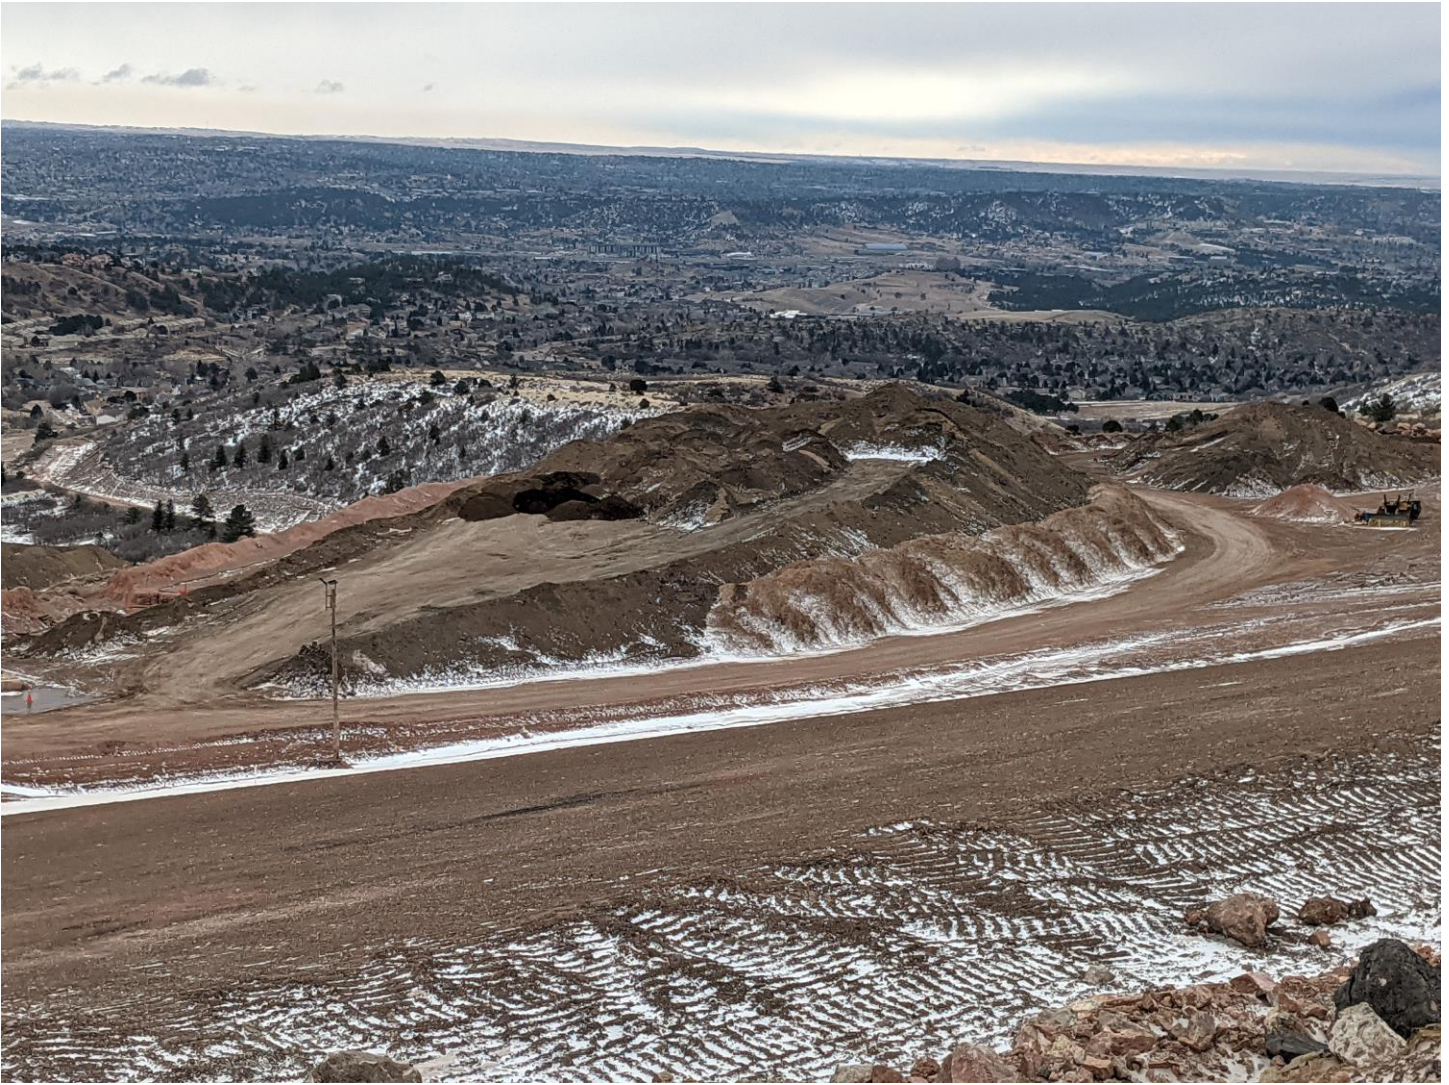
Additional topsoil was actively being delivered and stockpiled on site located below the buttress to the south. Approximately 5,000 c.y. has been imported since the last December inspection.

Topsoil stockpiling.
