MINERALS PROGRAM INSPECTION REPORT
PHONE: (303) 866-3567

MINE NAME: Combination Placer	MINE/PROSPECTING ID#: M-2013-028	MINERAL: Gold	COUNTY: Park
INSPECTION TYPE: Monitoring	WEATHER: Cloudy	INSP. DATE: July 21, 2022	INSP. TIME: 13:40
OPERATOR: Western States Minerals, LLC	OPERATOR REPRESENTATIVE: Ken Tunstall	TYPE OF OPERATION: 110(2) - Hard Rock Limited Impact

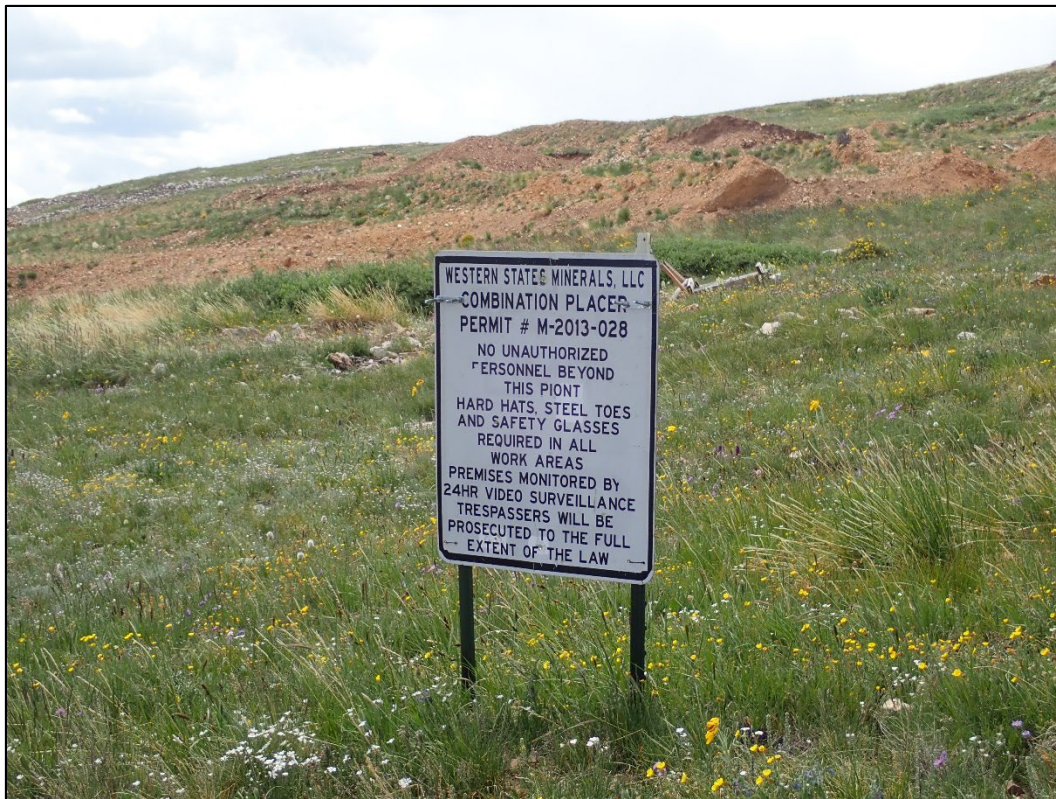
Photo 1. Mine identification sign; looking southwest.

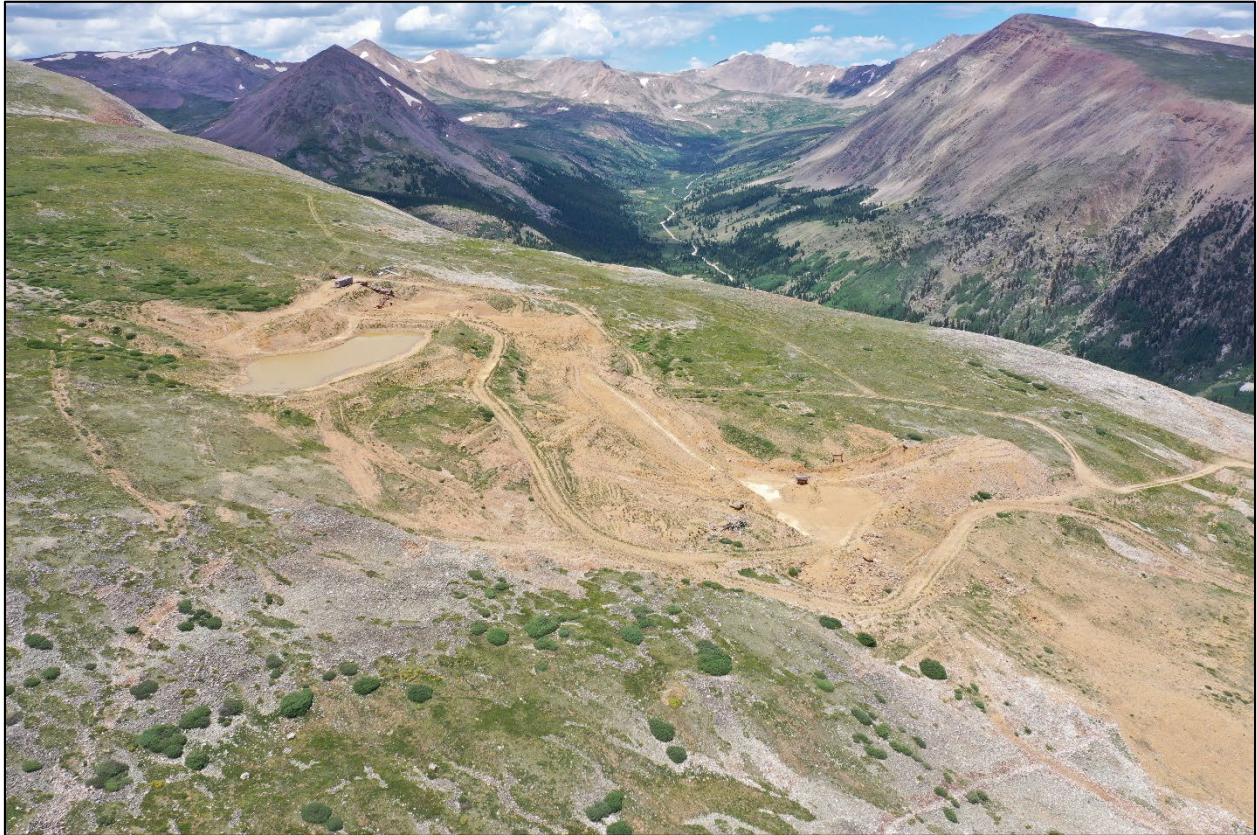
Photo 2. Aerial view of the site; looking north.

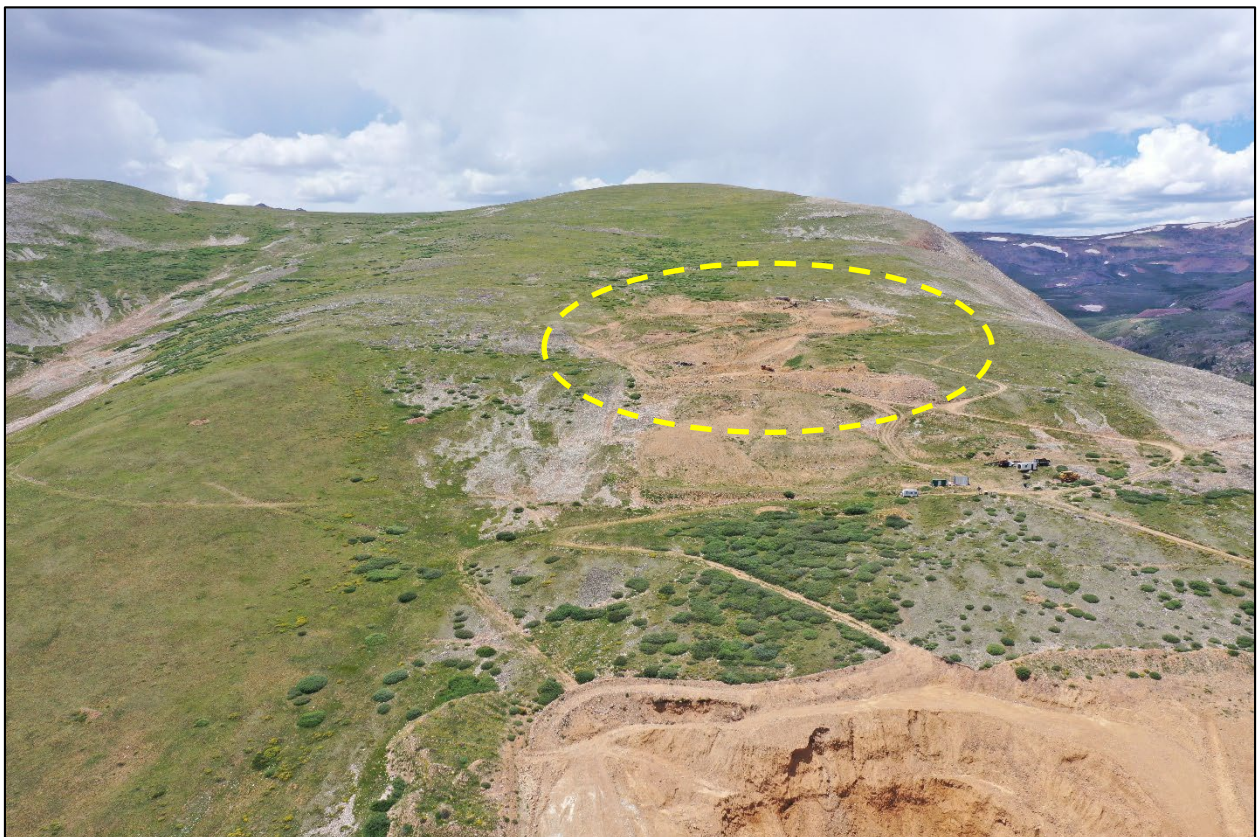
Photo 3. Combination Placer (circled) and Bullger Basin Placer in foreground; looking west.

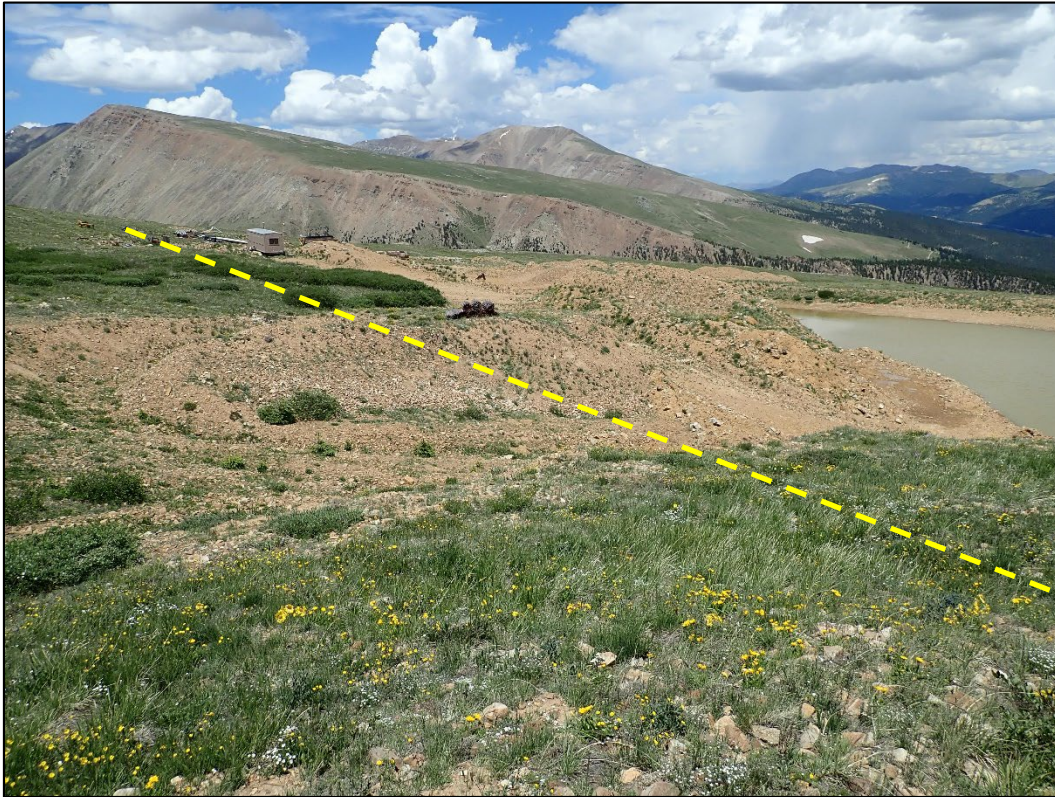
Photo 4. Overview of the western portion of the mine site, approximate permit boundary (dashed line) showing some pre-law disturbance off-site; looking north.

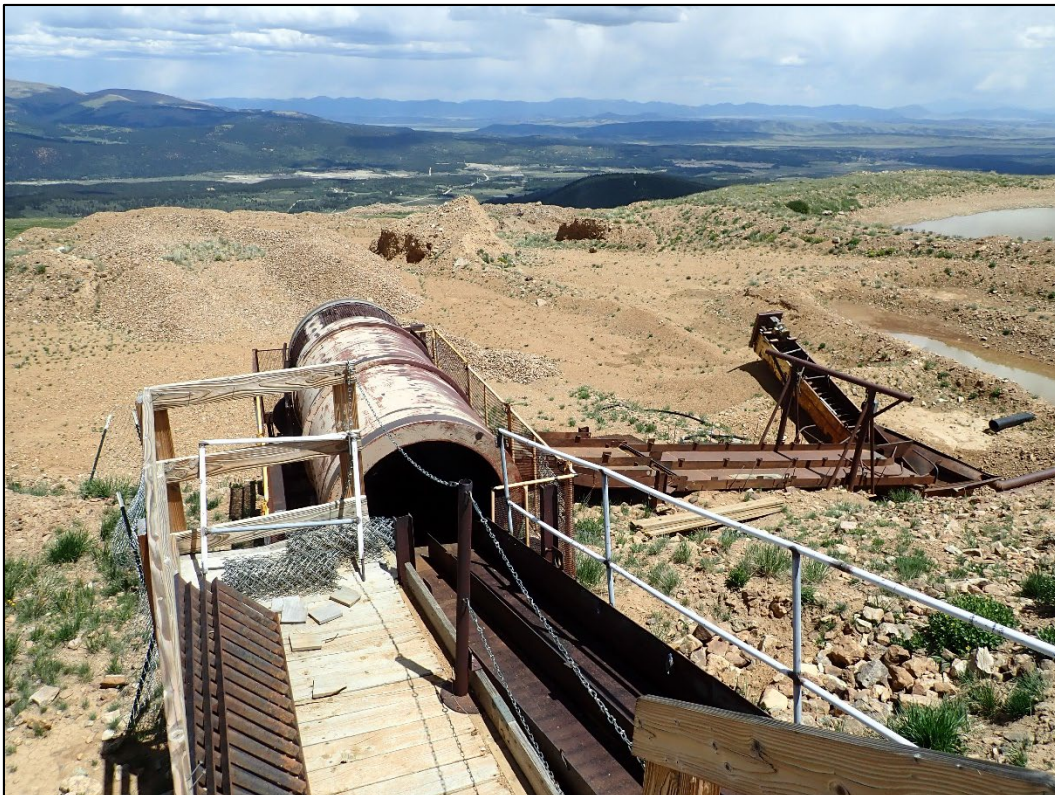
Photo 5. Wash Plant; looking east.

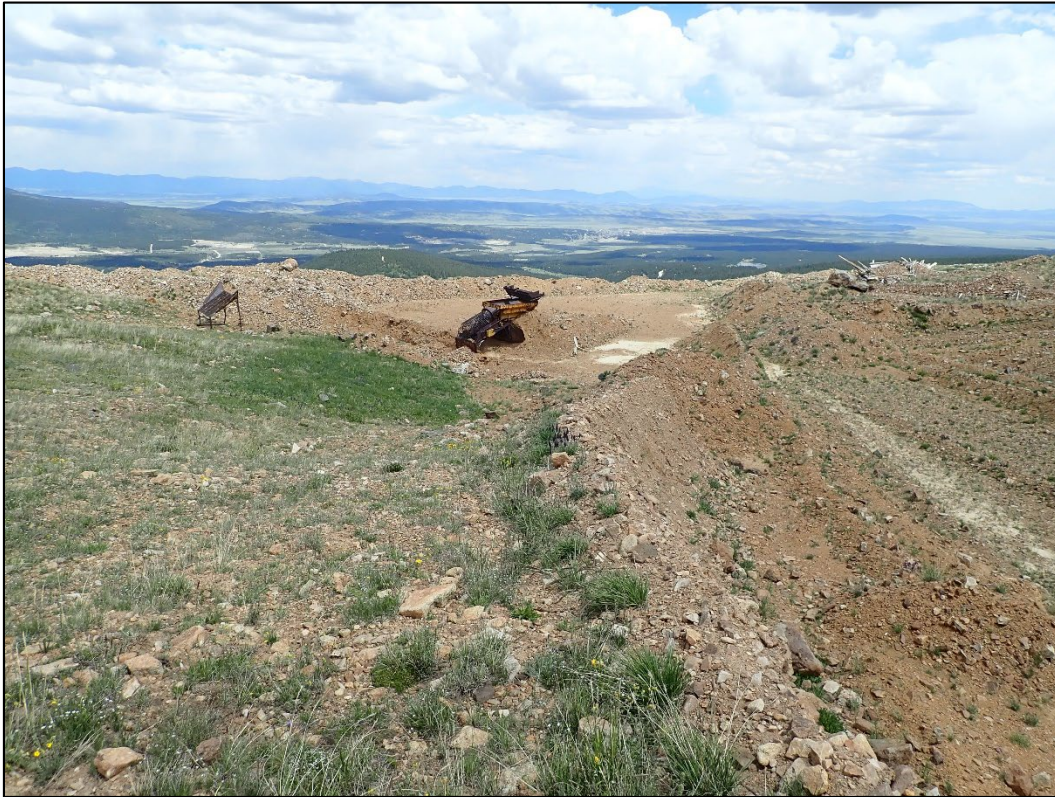
Photo 6. Lower mining area and dry screen; looking east.

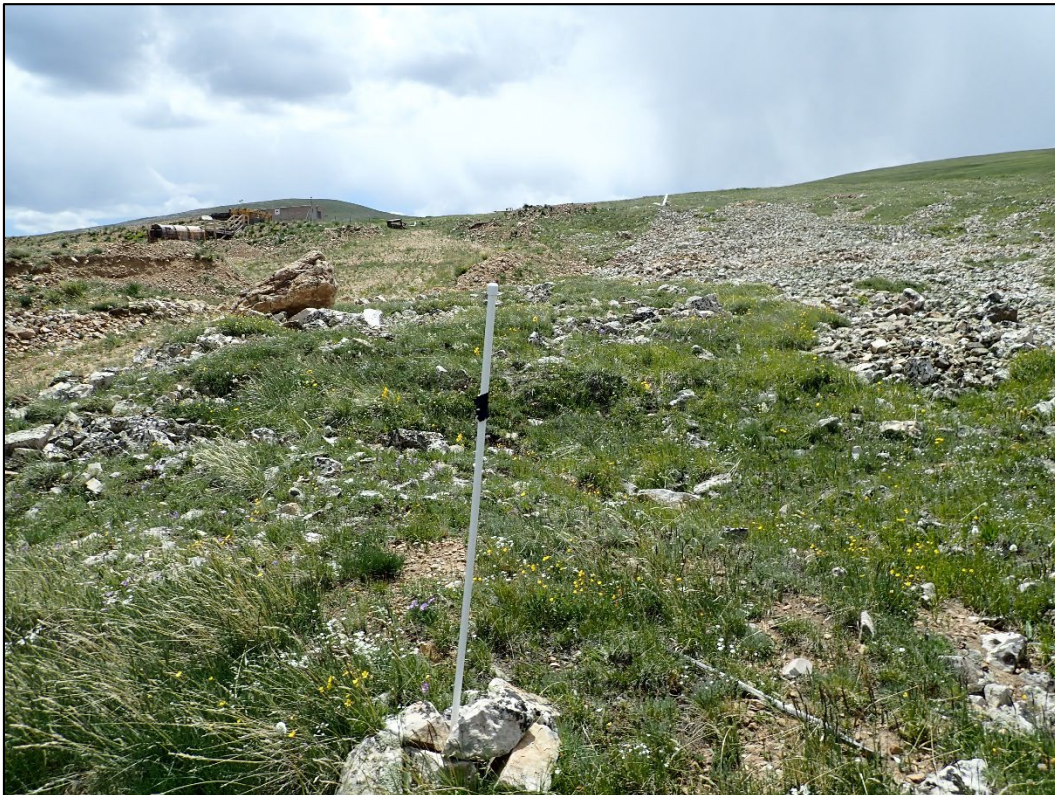
PROBLEM/POSSIBLE VIOLATION: Problem: The affected area boundary markers are missing or incorrectly placed. This is a problem for failure to maintain boundary markers around the affected area as required by Rule 3.1.12(2).

Signs and Markers: A permit sign is posted along the eastern edge of the site. Some of the permit boundary corners were delineated with white PVC pipes, however not all of the markers were in place at the time of the inspection. The Division was also not able to confirm if the operation's disturbance was fully within the approved 9.85-acre permit boundary due to the missing markers. The Division has cited this as a Compliance Problem, requiring the Operator to conduct a survey and establish all of the permit boundary makers. Given the elevation of the site, the Division has set a corrective action deadline to a time in the next operating season.

Photo 7. Marker along the northern permit boundary; looking southwest.

CORRECTIVE ACTIONS: The Operator shall conduct a survey and replace the boundary markers in the correct location(s). The operator shall provide proof to the Division that this has been done by the corrective action date.
