MINERALS PROGRAM INSPECTION REPORT
PHONE: (303) 866-3567

MINE NAME: East Bradbury Pit	MINE/PROSPECTING ID#: M-2010-016	MINERAL: Sand and gravel	COUNTY: Mesa
INSPECTION TYPE: Surety Release Inspection	WEATHER: Clear	INSP. DATE: January 10, 2023	INSP. TIME: 11:00
OPERATOR: Grand Junction Pipe & Supply Co.	OPERATOR REPRESENTATIVE: Jim Doody	TYPE OF OPERATION: 112c - Construction Regular Operation	
REASON FOR INSPECTION: Surety Release Requested	BOND CALCULATION TYPE: None	BOND AMOUNT: \$107,139.00	
DATE OF COMPLAINT: NA	POST INSP. CONTACTS: DRMS	JOINT INSP. AGENCY: None	
INSPECTOR(S): Amy Yeldell	INSPECTOR'S SIGNATURE:

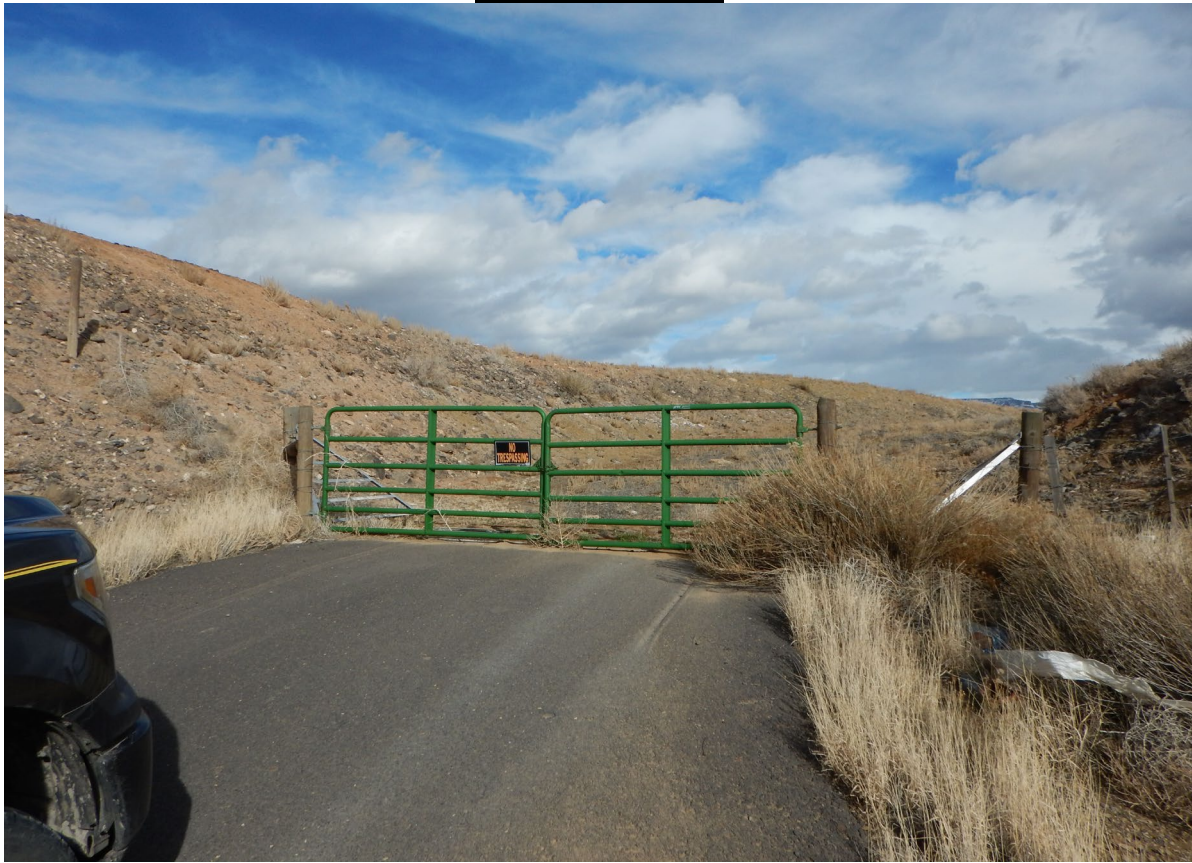
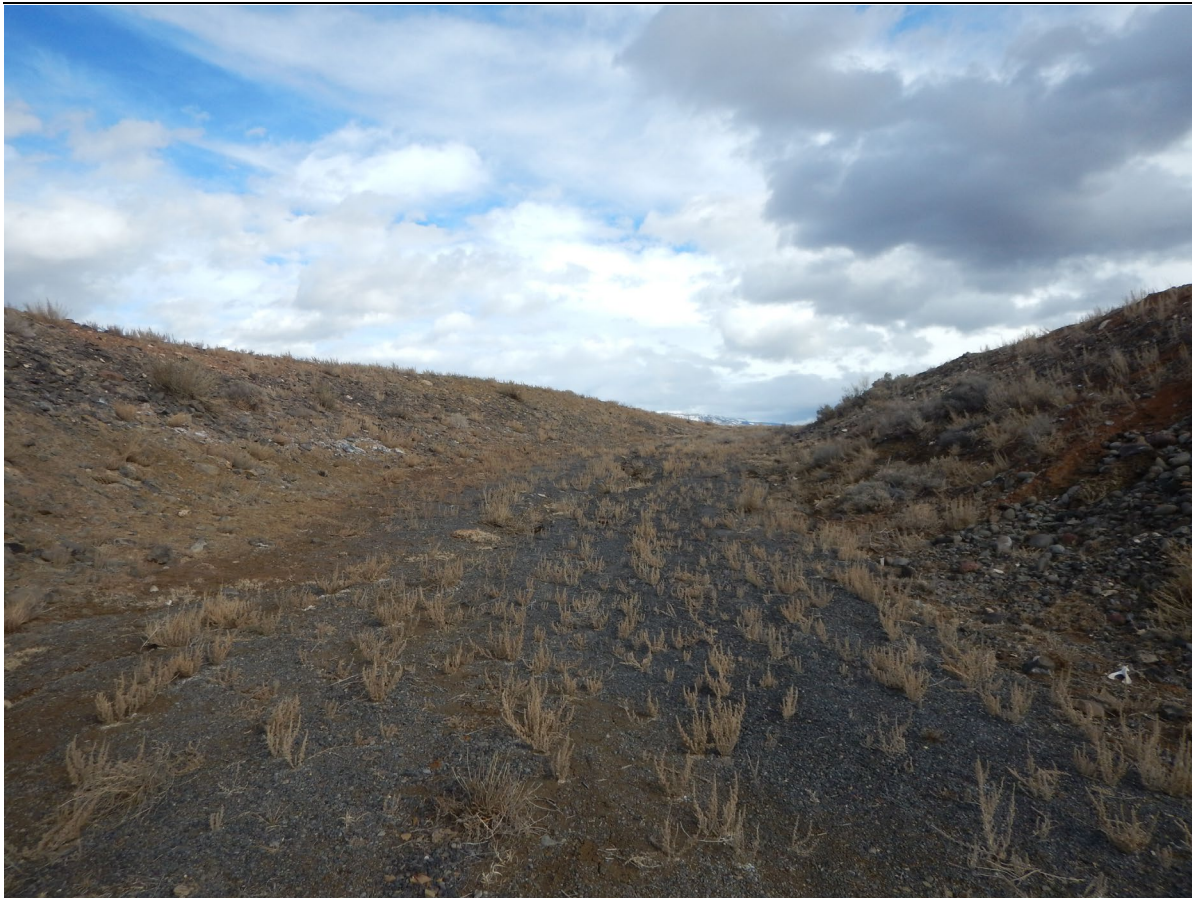
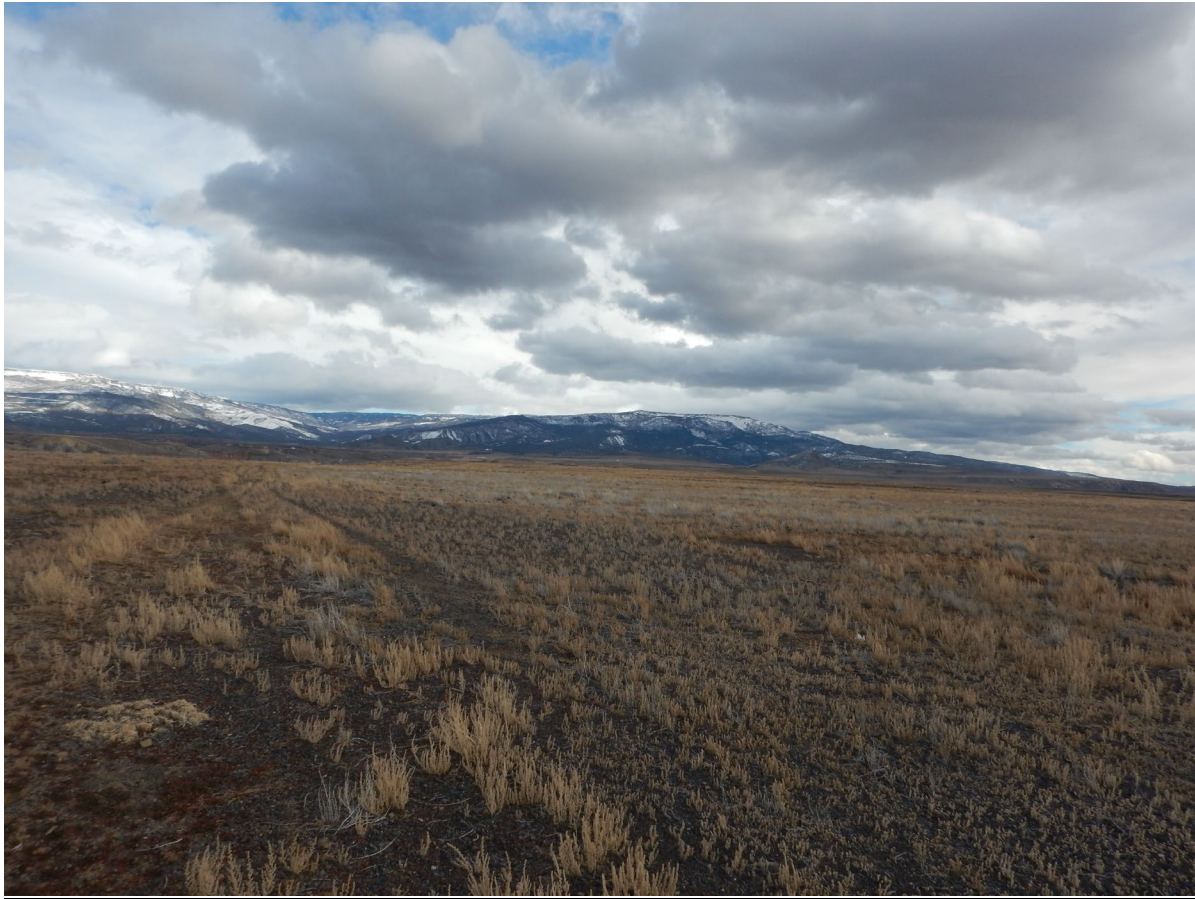
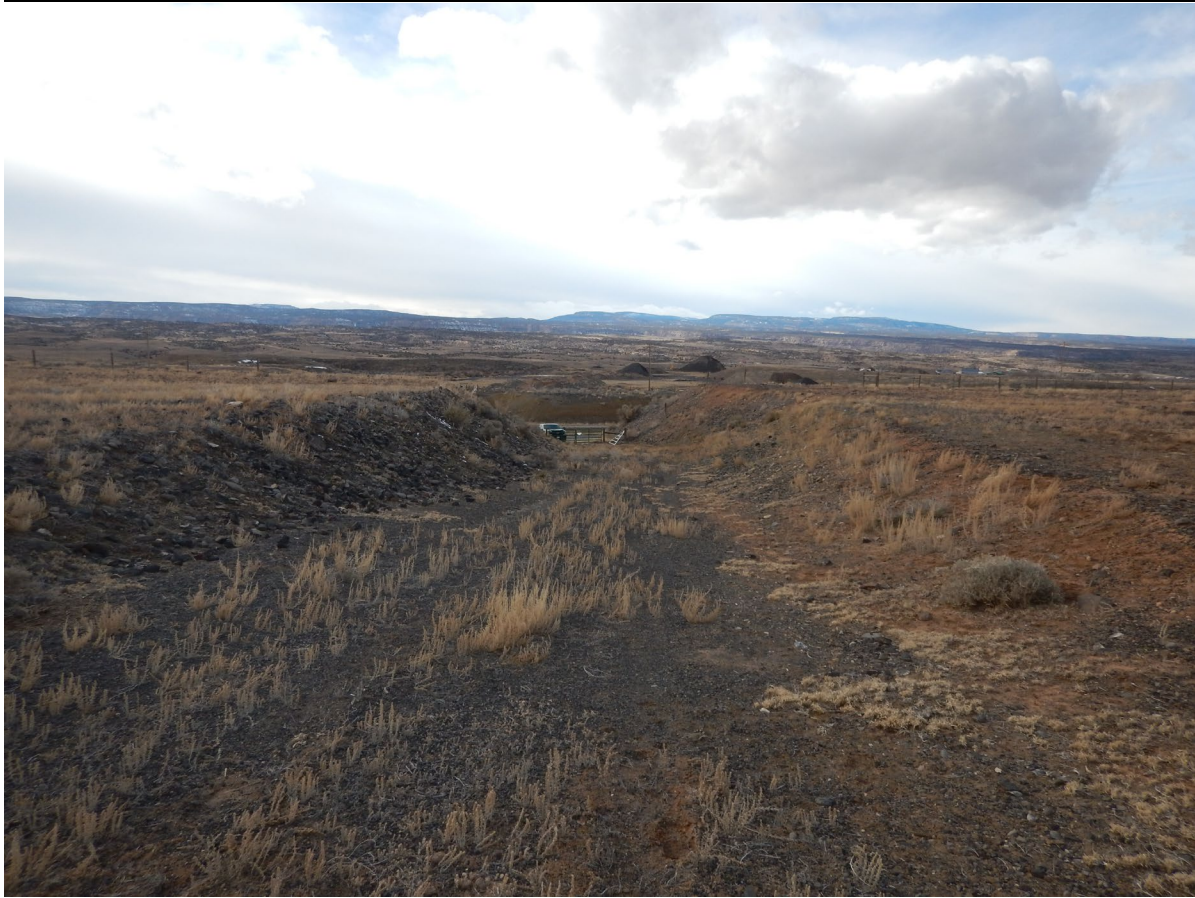
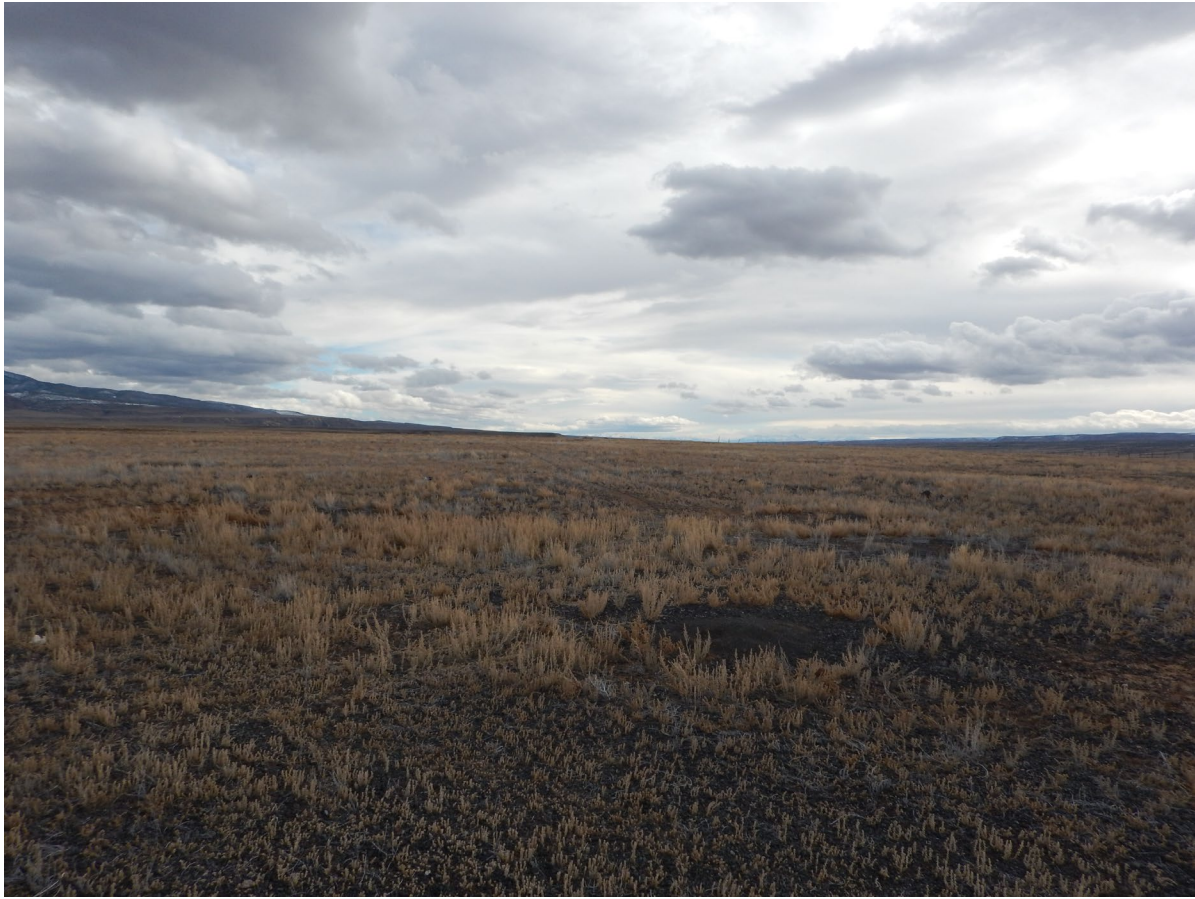
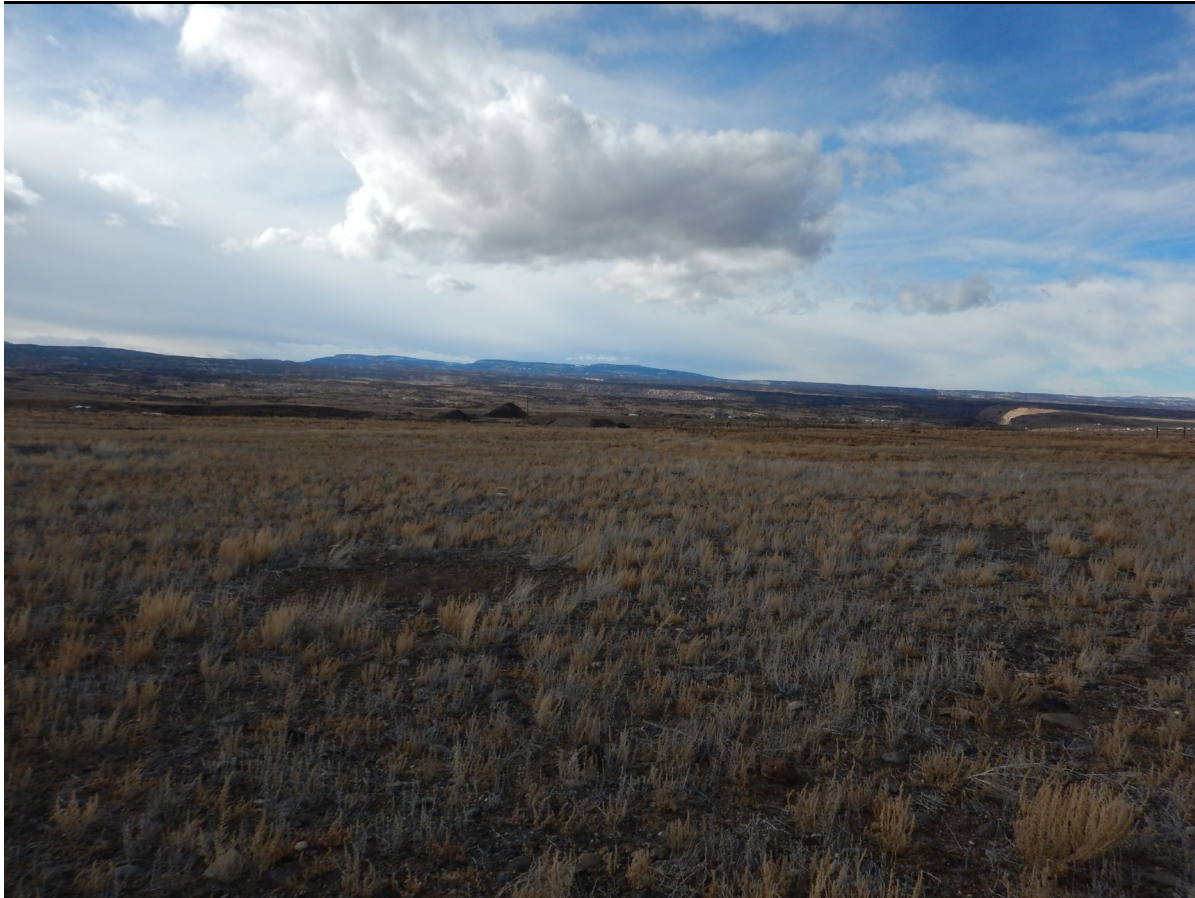
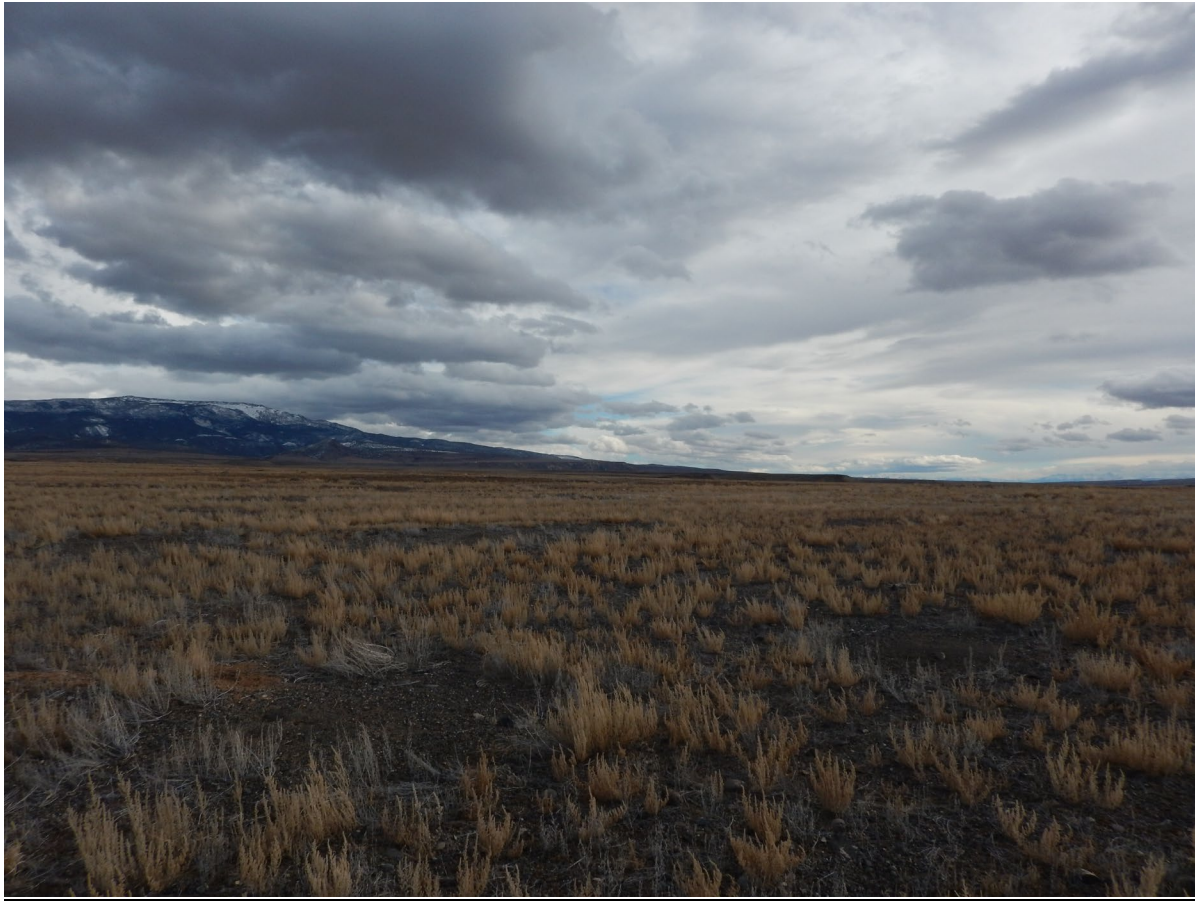
PHOTOGRAPHS

There is a locked gate to access the pit from Highway 50. The short access road to get on top of the bluff remains. This site has yet to commence mining activity and remains undisturbed. There are no stockpiles, equipment, fuel, structures or etc. on site. The access road and gate are a part of the approved reclamation plan and therefore may remain. Vegetation on the site overall is poor however since it was not affected by mining the Operator is not obligated to reclaim/ improve it. No problems or violations were noted during this inspection.
