**COLORADO**  
Division of Reclamation,  
Mining and Safety  
Department of Natural Resources

<b>Permit Number:</b> C1981044 <b>Mine Name:</b> Williams Fork Mines <b>Operator:</b> Moffat County Mining, LLC <b>Operator Address:</b>  Ms. Miranda Kawcak 29515 Routt County Road #27 Oak Creek, CO 80467	<b>County:</b> Moffat <b>Operation Type:</b> Underground <b>Permit Status:</b> Active <b>Ownership:</b> Federal  <b>Operator Representative Present:</b> Miranda Kawcak
This report was issued electronically from the Divisions' Denver Office.

<b>Inspection Start Date:</b> 31 October 2022 <b>Inspection Start Time:</b> 1:15 p.m. <b>Inspection End Date:</b> 2 November 2022 <b>Inspection End Time:</b> 3:15 p.m.	<b>Inspection Type:</b> Coal Complete Inspection <b>Inspection Reason:</b> Normal I&E <b>Weather:</b> Cloudy
<b>Joint Inspection Agency:</b>	<b>Joint Inspection Contacts:</b>
<b>Post Inspection Agency:</b>	<b>Post Inspection Contacts:</b>
<b>Inspector(s):</b> Robin A. Reilley, M.S. GISP	<b>Inspector's Signature:</b>

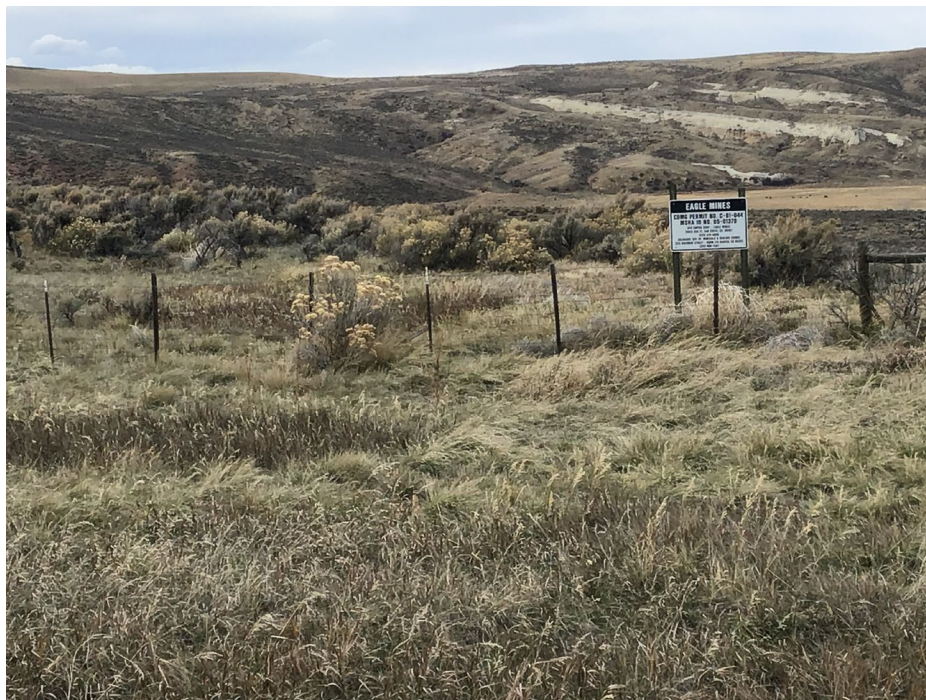
***Photo 1:*** Mine identification sign off Highway 13 at north end of site, looking east.

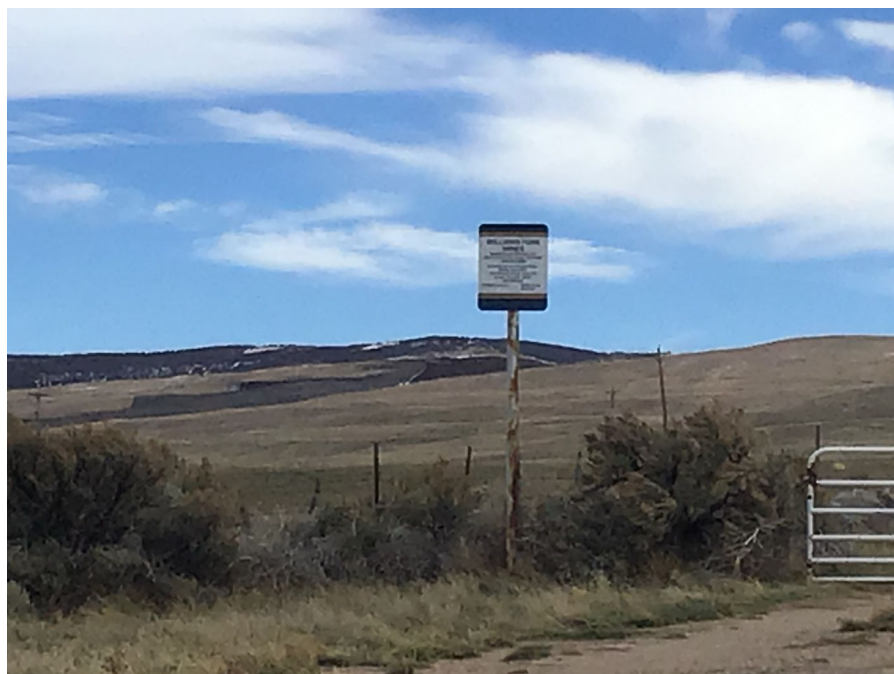
***Photo 2:*** Mine identification sign off Highway 13 at north end of site, looking west.

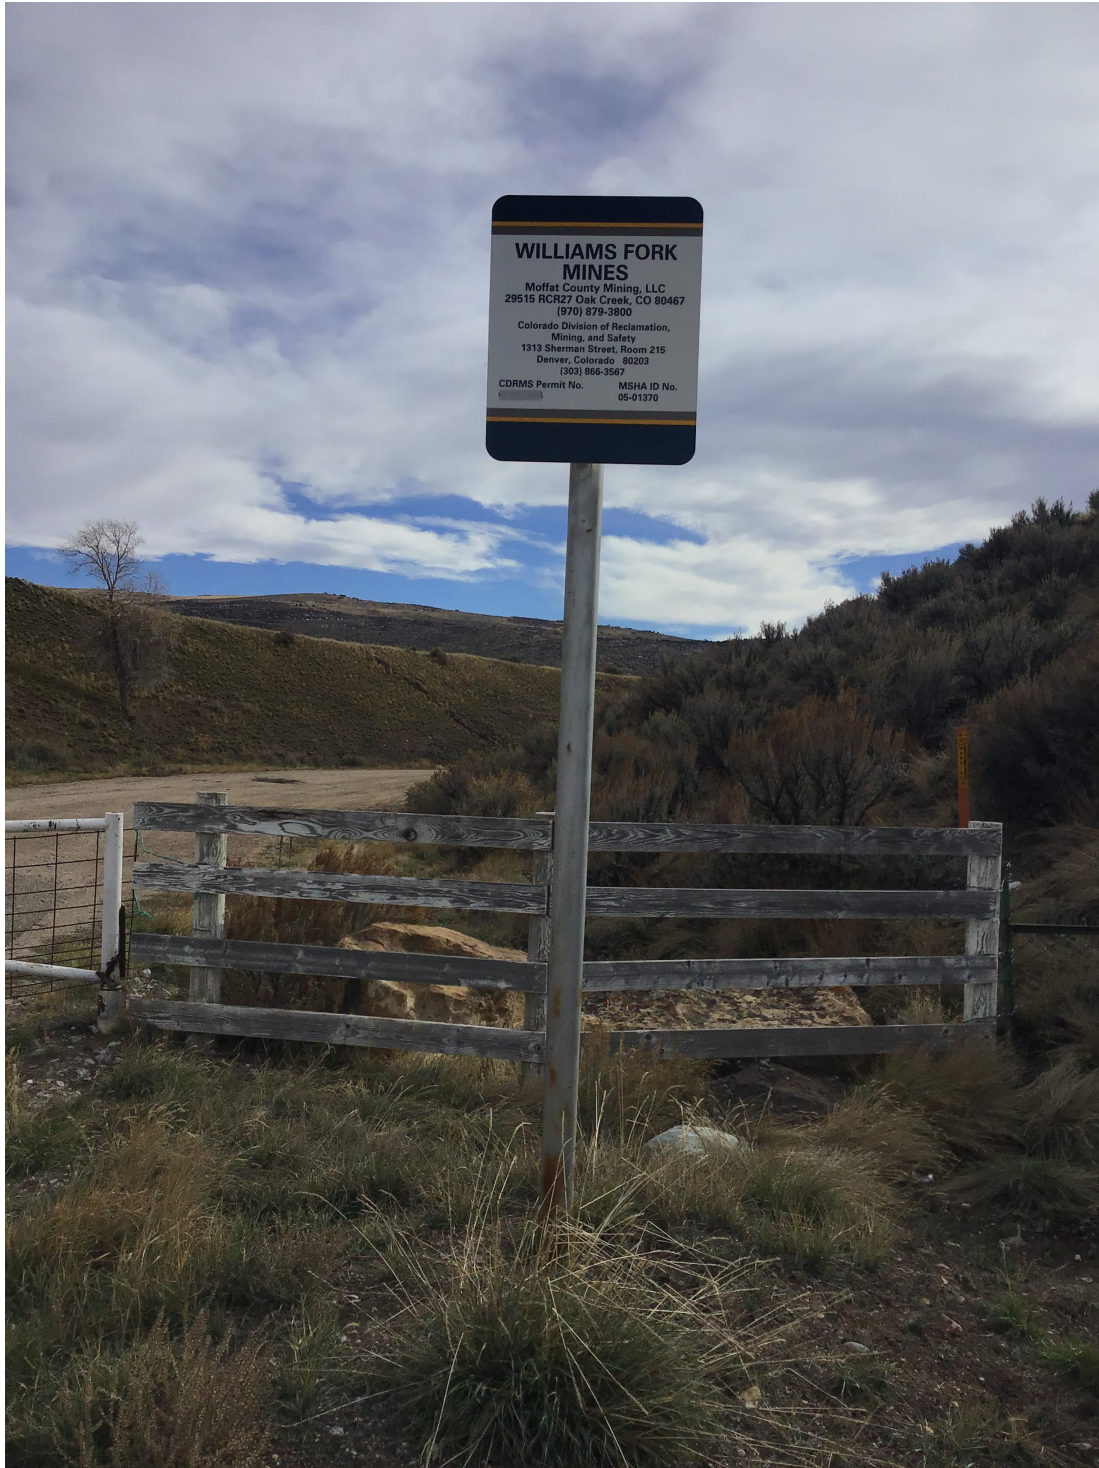
*Photo 3: Mine identification sign off Highway 13 at main site entrance.*

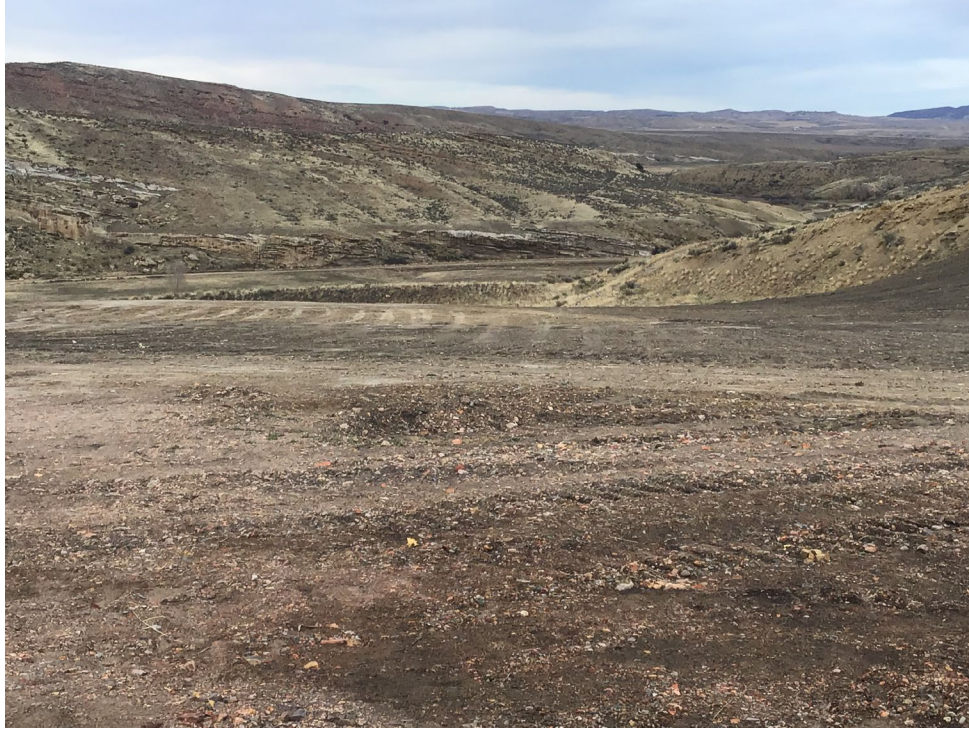
- Pond banks and dam at the 5A-P1 pond located below the 5A portal appeared stable and vegetated at the time of inspection.
- Backfilling and grading activities at the portal have established a swale that will transport surface flow to the 5A-P1 Pond below.
- None of the ponds held water at the time of inspection.
- Pond banks and dams throughout the site appeared stable and vegetated at the time of inspection.

***Photo 4:*** Looking north from service area across pad and to Pond 5A-P1.

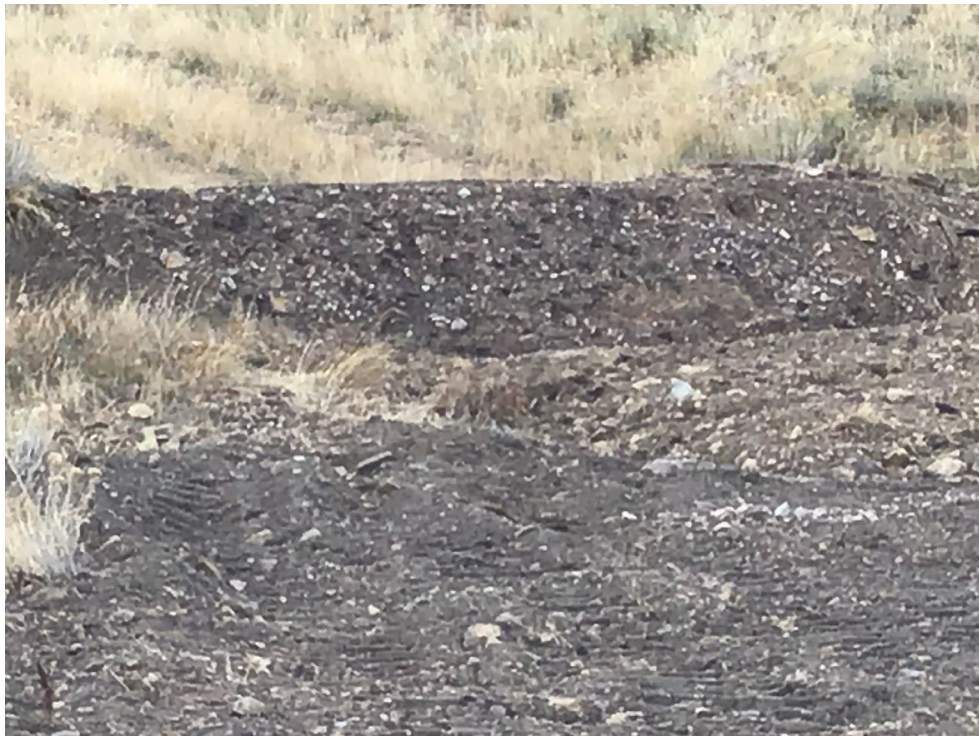
Reclamation is mostly completed as permitted. Facilities have been removed throughout the site. Reclamation, backfilling, grading and positive drainage at the 5A Portal are nearly completed and is anticipated to be finished by the end 2022. Topsoil from nearby topsoil piles will be hauled and placed. The 5A portal area was disturbed after August 1977 and prior to April 1978. A culvert below the portal was removed and the 5A-D1A ditch from the south to the 5A-P1 Pond has been bermed below the service building area to rout runoff to the pond.

***Photo 5:*** Bermed ditch routing water to Pond 5A-P1.

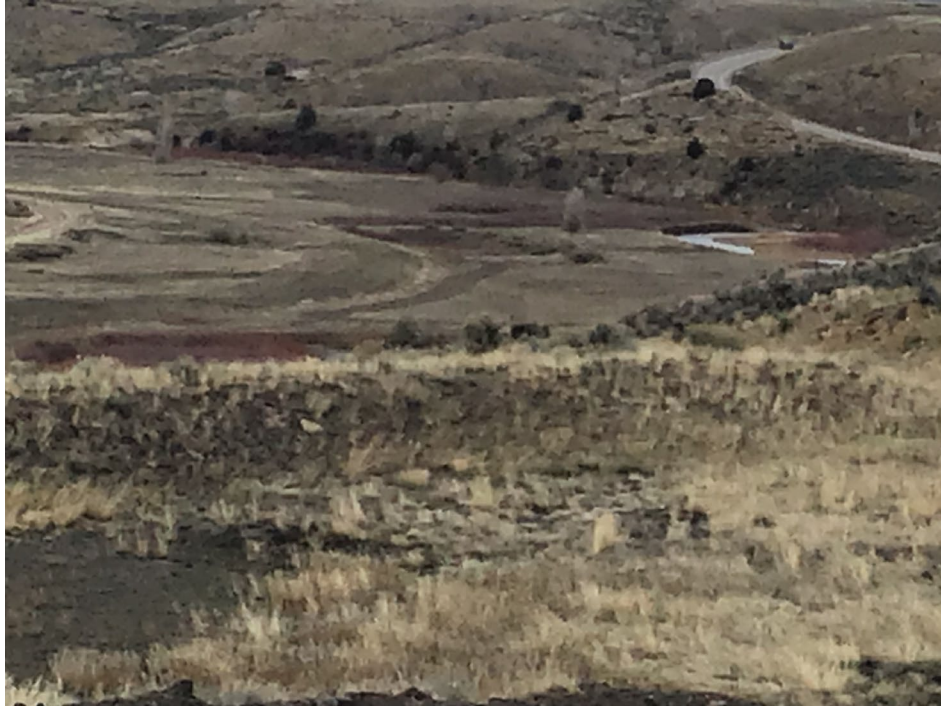
***Photo 6:** Overview of Williams Fork bottomlands from service area looking north.*

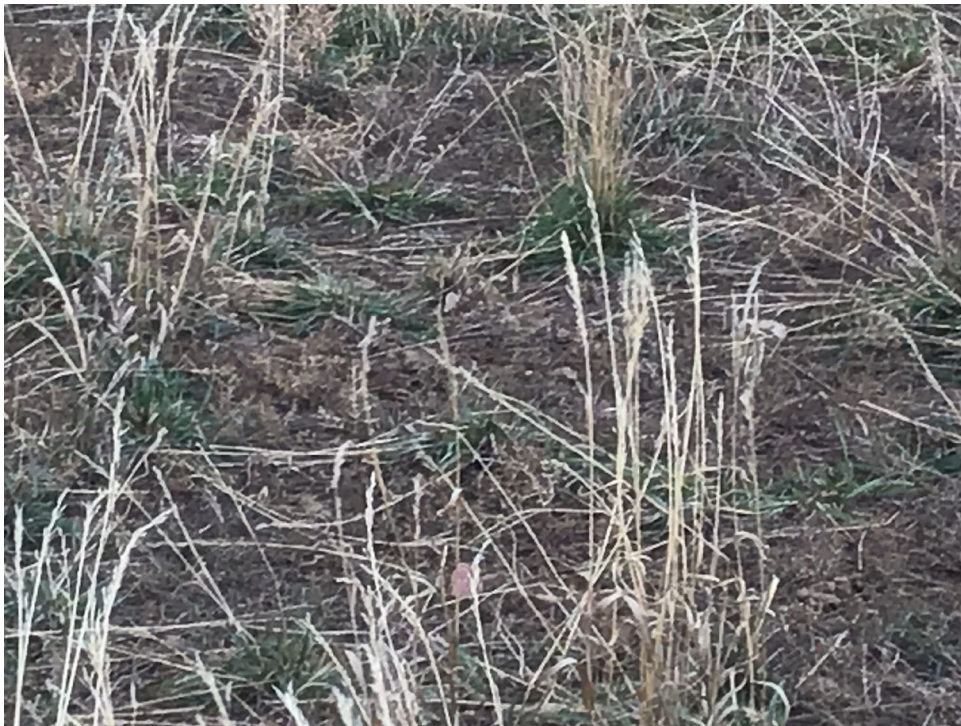
***Photo 7:** Close up of vegetation coverage at the Williams Fork bottomlands.*

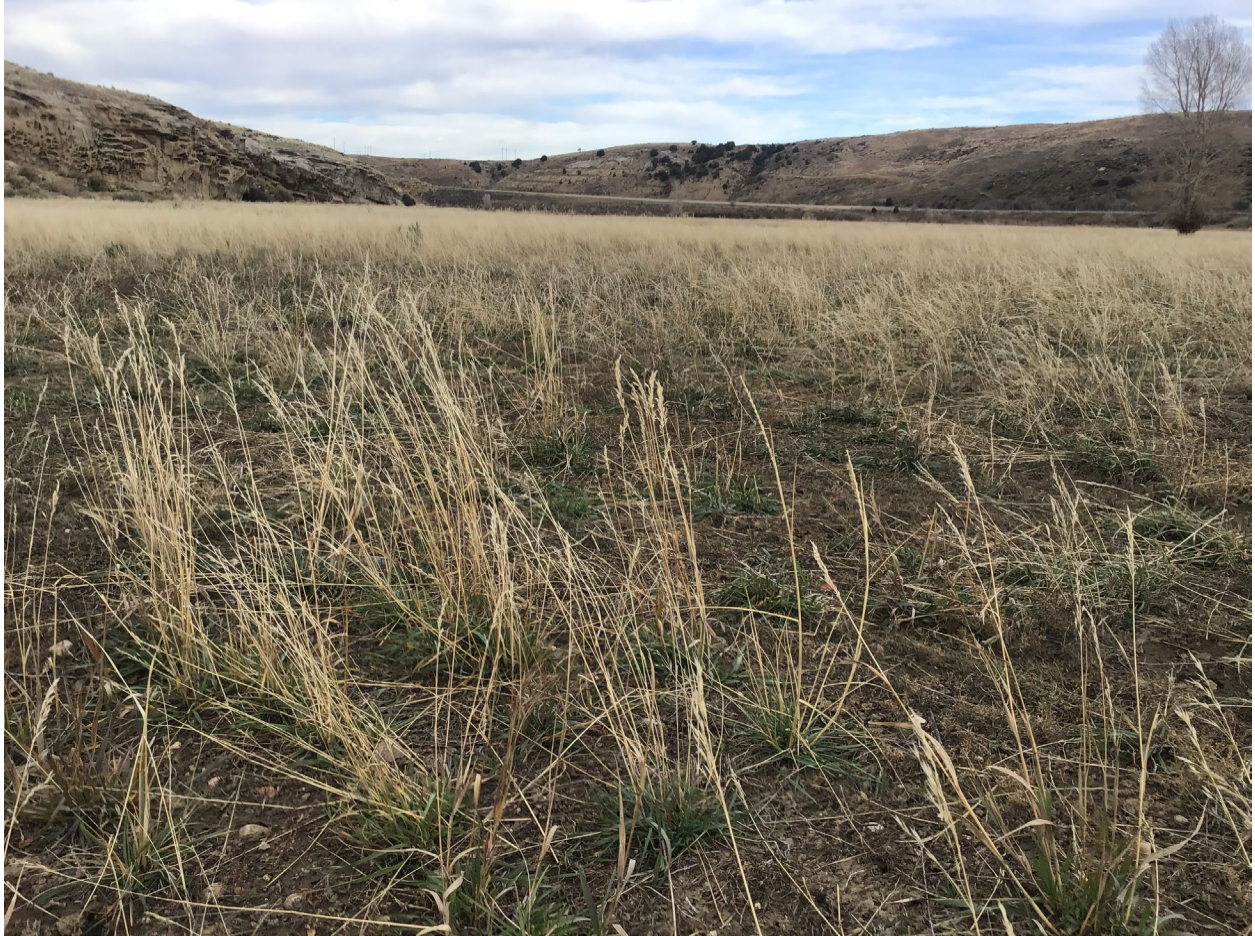
***Photo 8:** Overview of Williams Fork bottomlands vegetation looking north.*
